Re: Brownfields Cleanup Program Application/Remedial Investigation Work Plan  
900 Old Country Road - Garden City, New York

On behalf of our client, Equity One, Roux Associates is submitting a Brownfields Cleanup Program Application and a Remedial Investigation Cleanup Plan for 900 Old Country Road, Garden City, New York. Included in this submission is a hard copy with original signatures and an electronic copy on compact disc. Additionally, a hard copy and an electronic copy have been submitted to Walter Parish in NYSDEC Region 1.

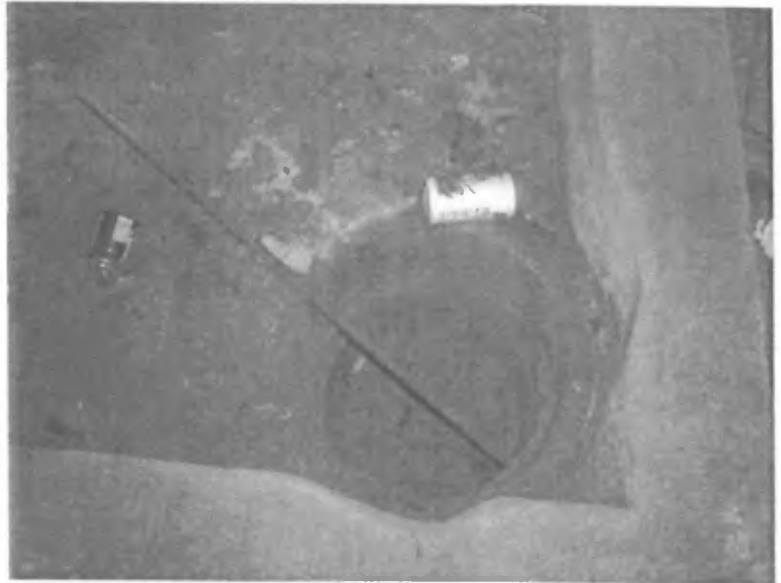
View of the discharge pit adjacent to the sump pump in the Manufacturing Building (Sample SED-1 Location).

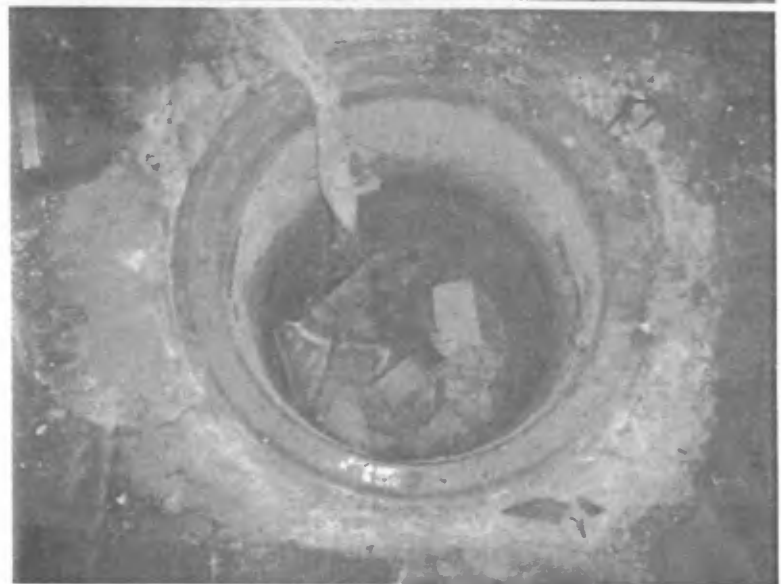
**Photo 2**

View of the discharge pit in the Manufacturing Building (Sample SED-2 Location).

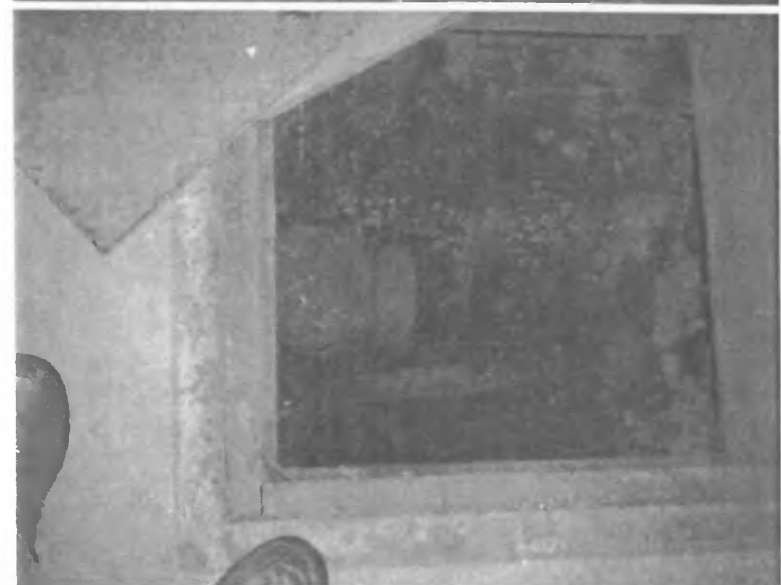
**Photo 3**

View of the seepage/discharge pit located in the Cendant South Building Warehouse (Sample SED-3 Location).

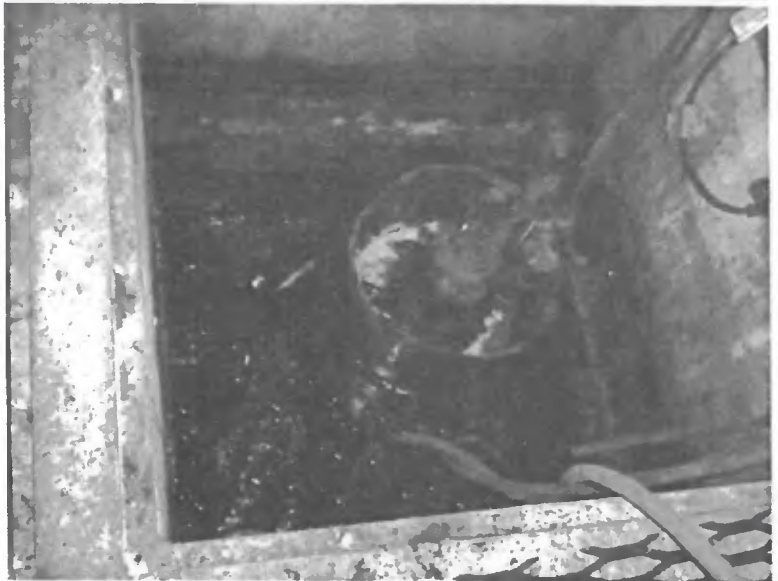
**Photo 5**

View of the oil/water separator and sump pump located in the truck loading dock of the Cendant Building (Samples SED-4 & AQ-1 Location).

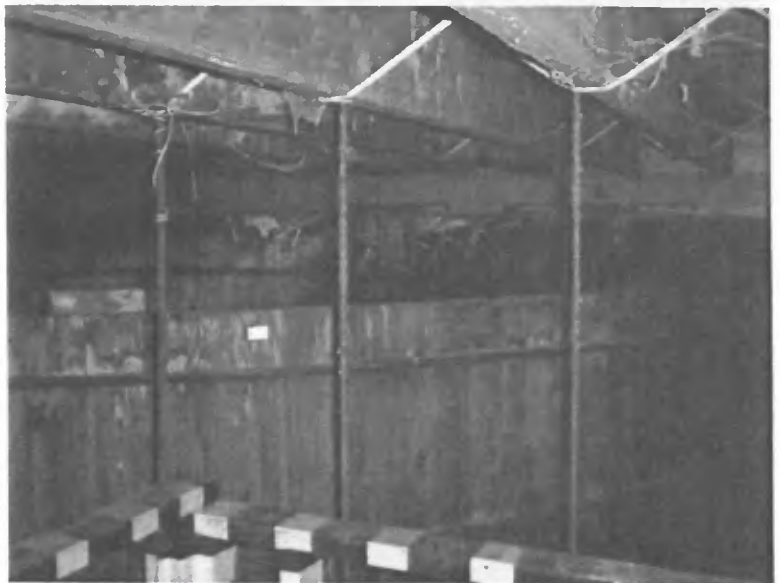
**Photo 6**

View of the large wooden tank in the Storage building (Sample AQ-2 Location).

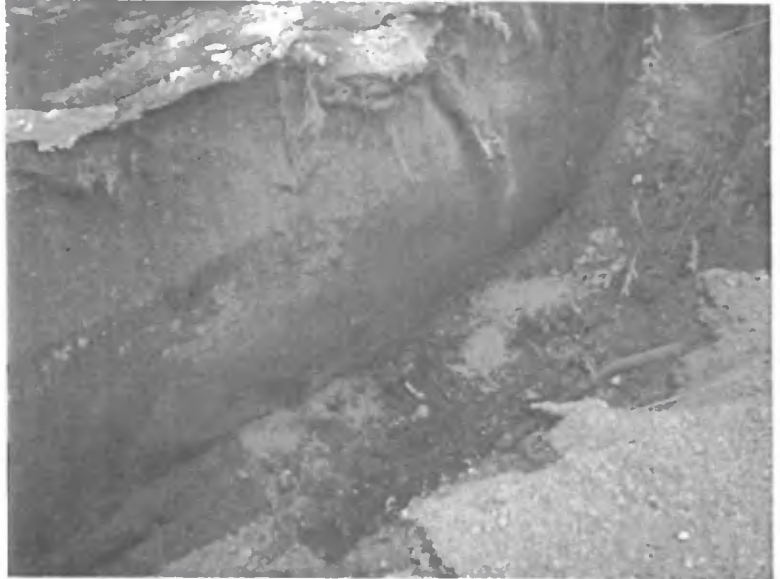
**Photo 7**

View of 3,000-gallon steel underground storage tank uncovered on the south side of the manufacturing building.

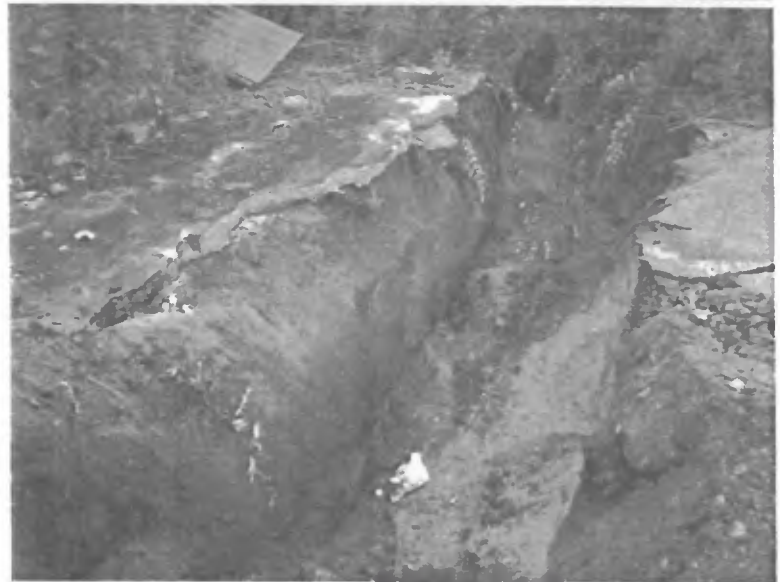
**Photo 8**

View of the exposed 3,000-gallon steel underground storage tank under concrete slab on the south side of the manufacturing building.
