Re: Final Engineering Report  
Bethpage Community Park Interim Remedial Measure (IRM)  
Order on Consent W1-0018-02-03

**TOWN OF OYSTER BAY  
BETHPAGE COMMUNITY PARK  
INTERIM REMEDIAL MEASURE - CONSTRUCTION AREA  
FINAL ENGINEERING REPORT**

| <b>Project Type:</b> | Interim Remedial Measure, OU3 – Former Grumman Settling Ponds, Grumman Aerospace-Bethpage Facility New York State Inactive Hazardous Waste Site (ID# 130003A). |

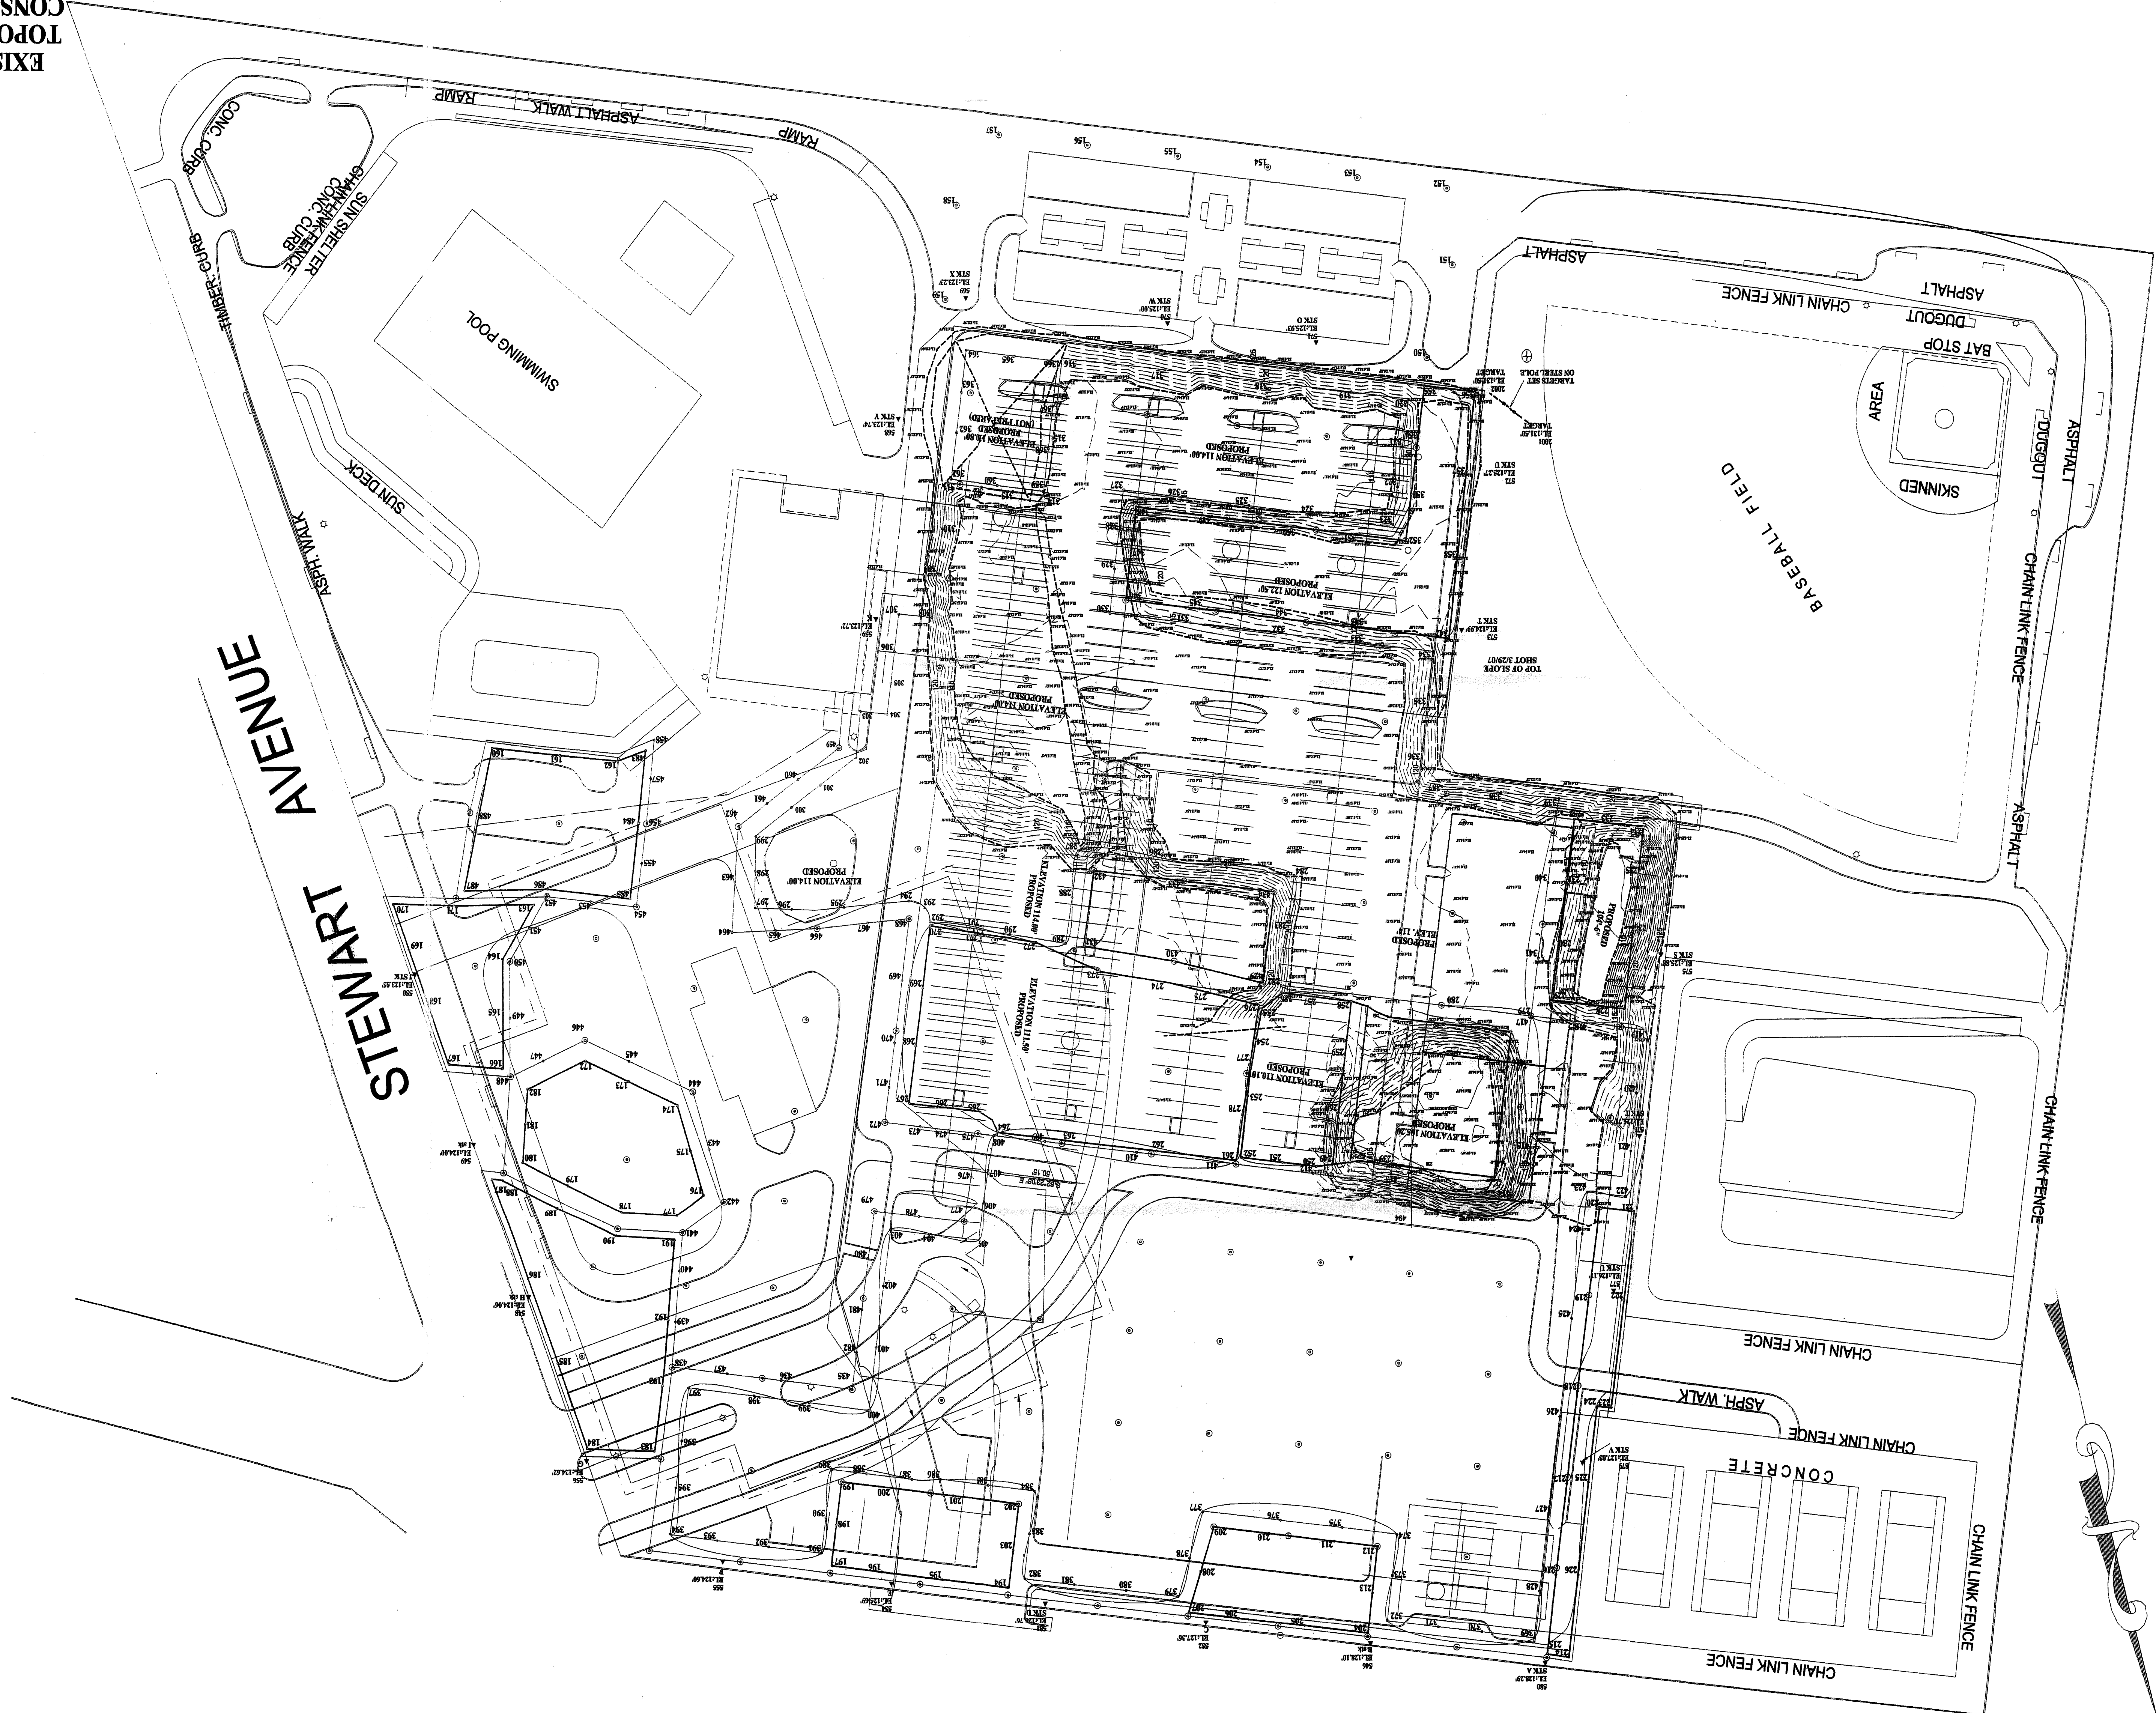
EXISTING CONDITIONS  
TOPOGRAPHICAL SURVEY  
CONSTRUCTION AREA IIRM  
SOIL REMEDIATION  
BETHPAGE COMMUNITY PARK  
TOWN OF OYSTER BAY  
NEW YORK  
SURVEY DATE: APRIL 9, 2007
