Re: Final Engineering Report  
Bethpage Community Park Interim Remedial Measure (IRM)  
Order on Consent W1-0018-02-03

**TOWN OF OYSTER BAY  
BETHPAGE COMMUNITY PARK  
INTERIM REMEDIAL MEASURE - CONSTRUCTION AREA  
FINAL ENGINEERING REPORT**

| <b>Project Type:</b> | Interim Remedial Measure, OU3 – Former Grumman Settling Ponds, Grumman Aerospace-Bethpage Facility New York State Inactive Hazardous Waste Site (ID# 130003A). |

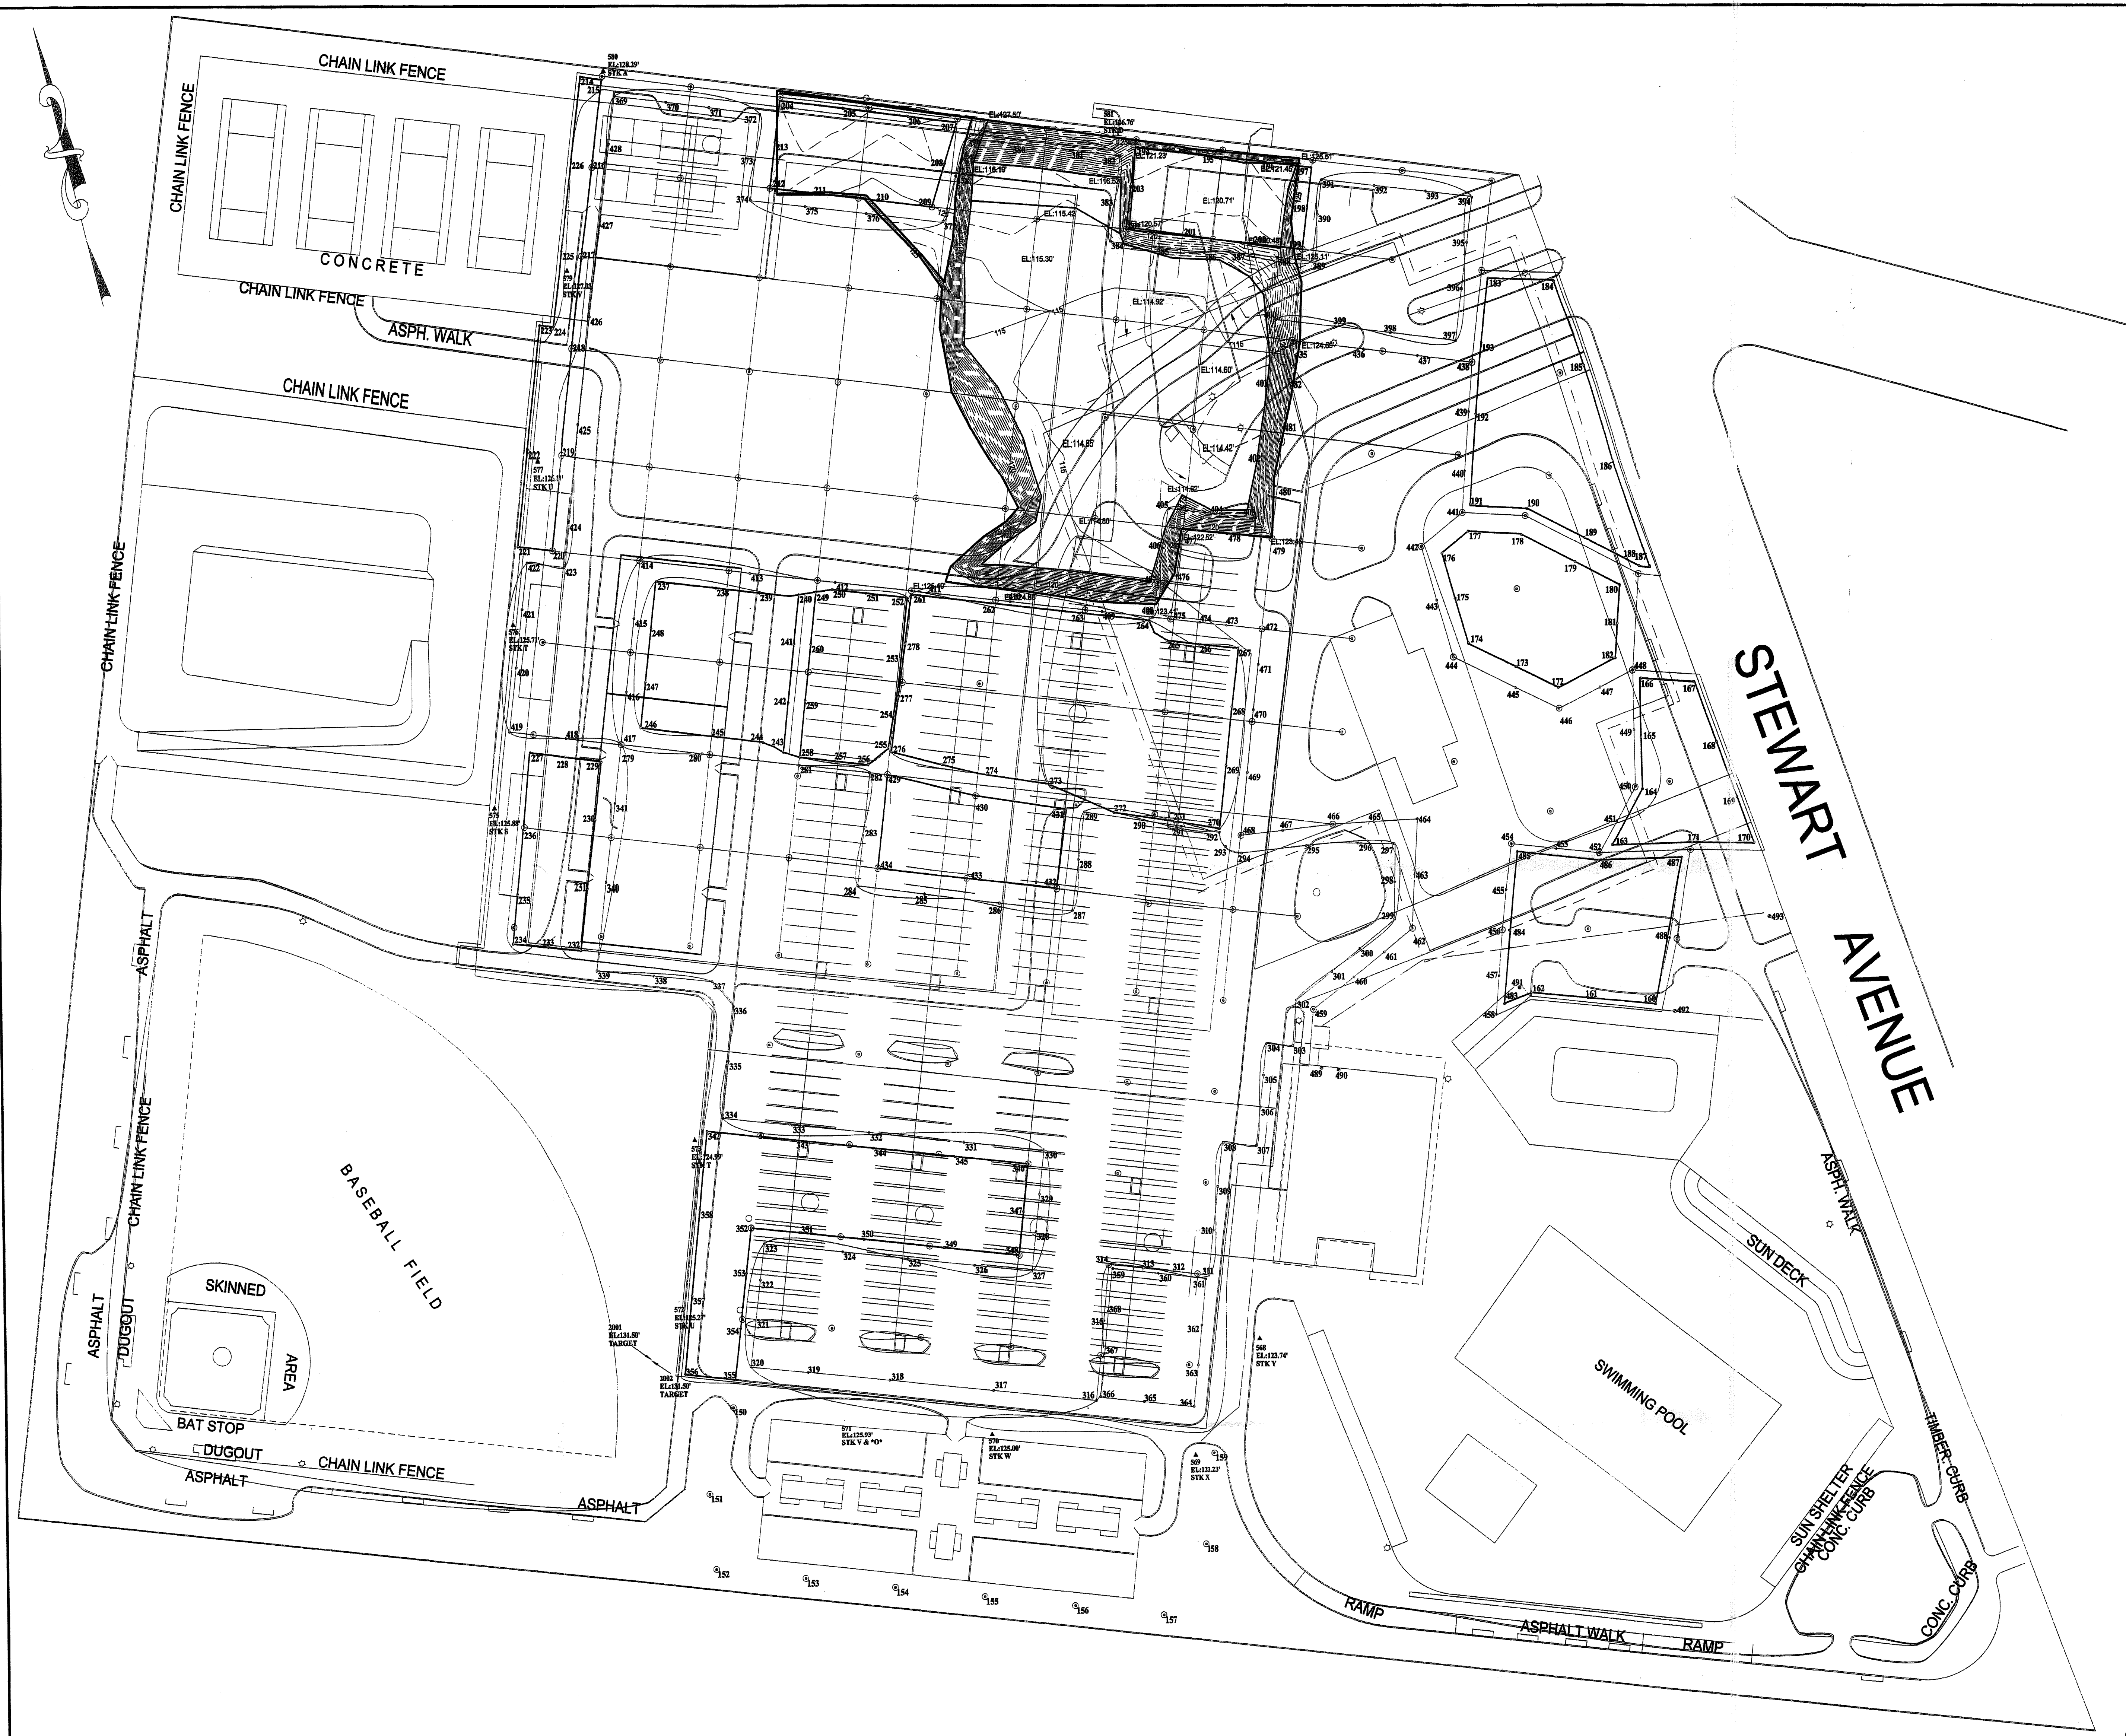
**FIGURE 5**

| FIGURE 5 | IRM SOIL REMEDIATION EXCAVATION PLAN |

A copy of the IRM remedial excavation plan, included as part of the project contract documents and the Site Operations and Excavation Plan, is included as Figure 5. The extent of remedial excavation was based on the results of the field investigation and the remedial strategy criteria. The specified depth of excavation at any given point within the IRM Construction Area was based on the deepest contamination identified at any of the surrounding nodes. As shown on Figure 5, a stabilizing slope (i.e., 1:1 cutback) was utilized to transition between varying depths of excavation. The IRM remedial excavation planned an estimated 100,000 cubic yards of contaminated soil for removal. Details on the quantity and type of soils excavated during the IRM are provided in the next section, Section 4.2 Soil Characterization, Quantity and Disposal Summary.

The remedial excavation initiated in the former rink area and across the northern portion of the IRM area. An excavation phasing plan, identified in the Site Operations and Excavation Plan and shown on Figure 5, was modified as the remedial activity progressed. The phasing plan was initially designed to permit remedial site work to be completed in the vicinity of the former ice rink then advance through the IRM area in a manner that would permit construction activity to commence on the new ice rink. Due to the rapid remedial excavation progress and the significant volume of on-site traffic and congestion associated with the remedial excavation work, the Town elected to permit the remedial excavation activity to continue to advance in the rapid manner and in an approach that would reduce coordination complications and enhance overall site safety.

The excavation limits and boundaries of the NYSDEC-approved IRM Remedial Action Plan are shown on Figure 5. After commencement of the IRM remedial field work, three deviations were made to the IRM Remedial Action Plan. These included deeper excavation in the “B-43 Area,” additional excavation outside the IRM boundary within

As discussed in Section 4.2., significant amounts of anthropogenic debris were uncovered during the IRM remedial excavation. In Contract Area 8, as shown on Figure 5, located in the southeast corner of the parking lot, debris was encountered up to the southern IRM boundary. The planned excavation depth in this area was 12 feet. In consideration of the excavation methodology, which utilized a cut back (i.e., 1:1) to transition between areas with different final excavation depths, the Town requested that the NYSDEC allow the remedial excavation to extend beyond the IRM boundary to permit removal of the visually identified debris up to the IRM boundary line and to the full depth of excavation, as specified in the IRM RAP.

The IRM site investigation identified significant PCB and metal contamination in the soils in the western portion of the IRM area near the ball field and recharge basin. Identified as Contract Area 1 in the remedial excavation plan, shown on Figure 5, the planned depth of excavation in this area was 20 feet. Visually impacted soils and a notable odor were identified in these soils during the IRM remedial excavation up to the IRM boundary. Consequently, as with the debris in Contract Area 8, the Town requested permission from the NYSDEC to extend the remedial excavation beyond the IRM boundary in Contract Area 1 to the extent required to excavate the visually impacted soils up to the IRM boundary line.

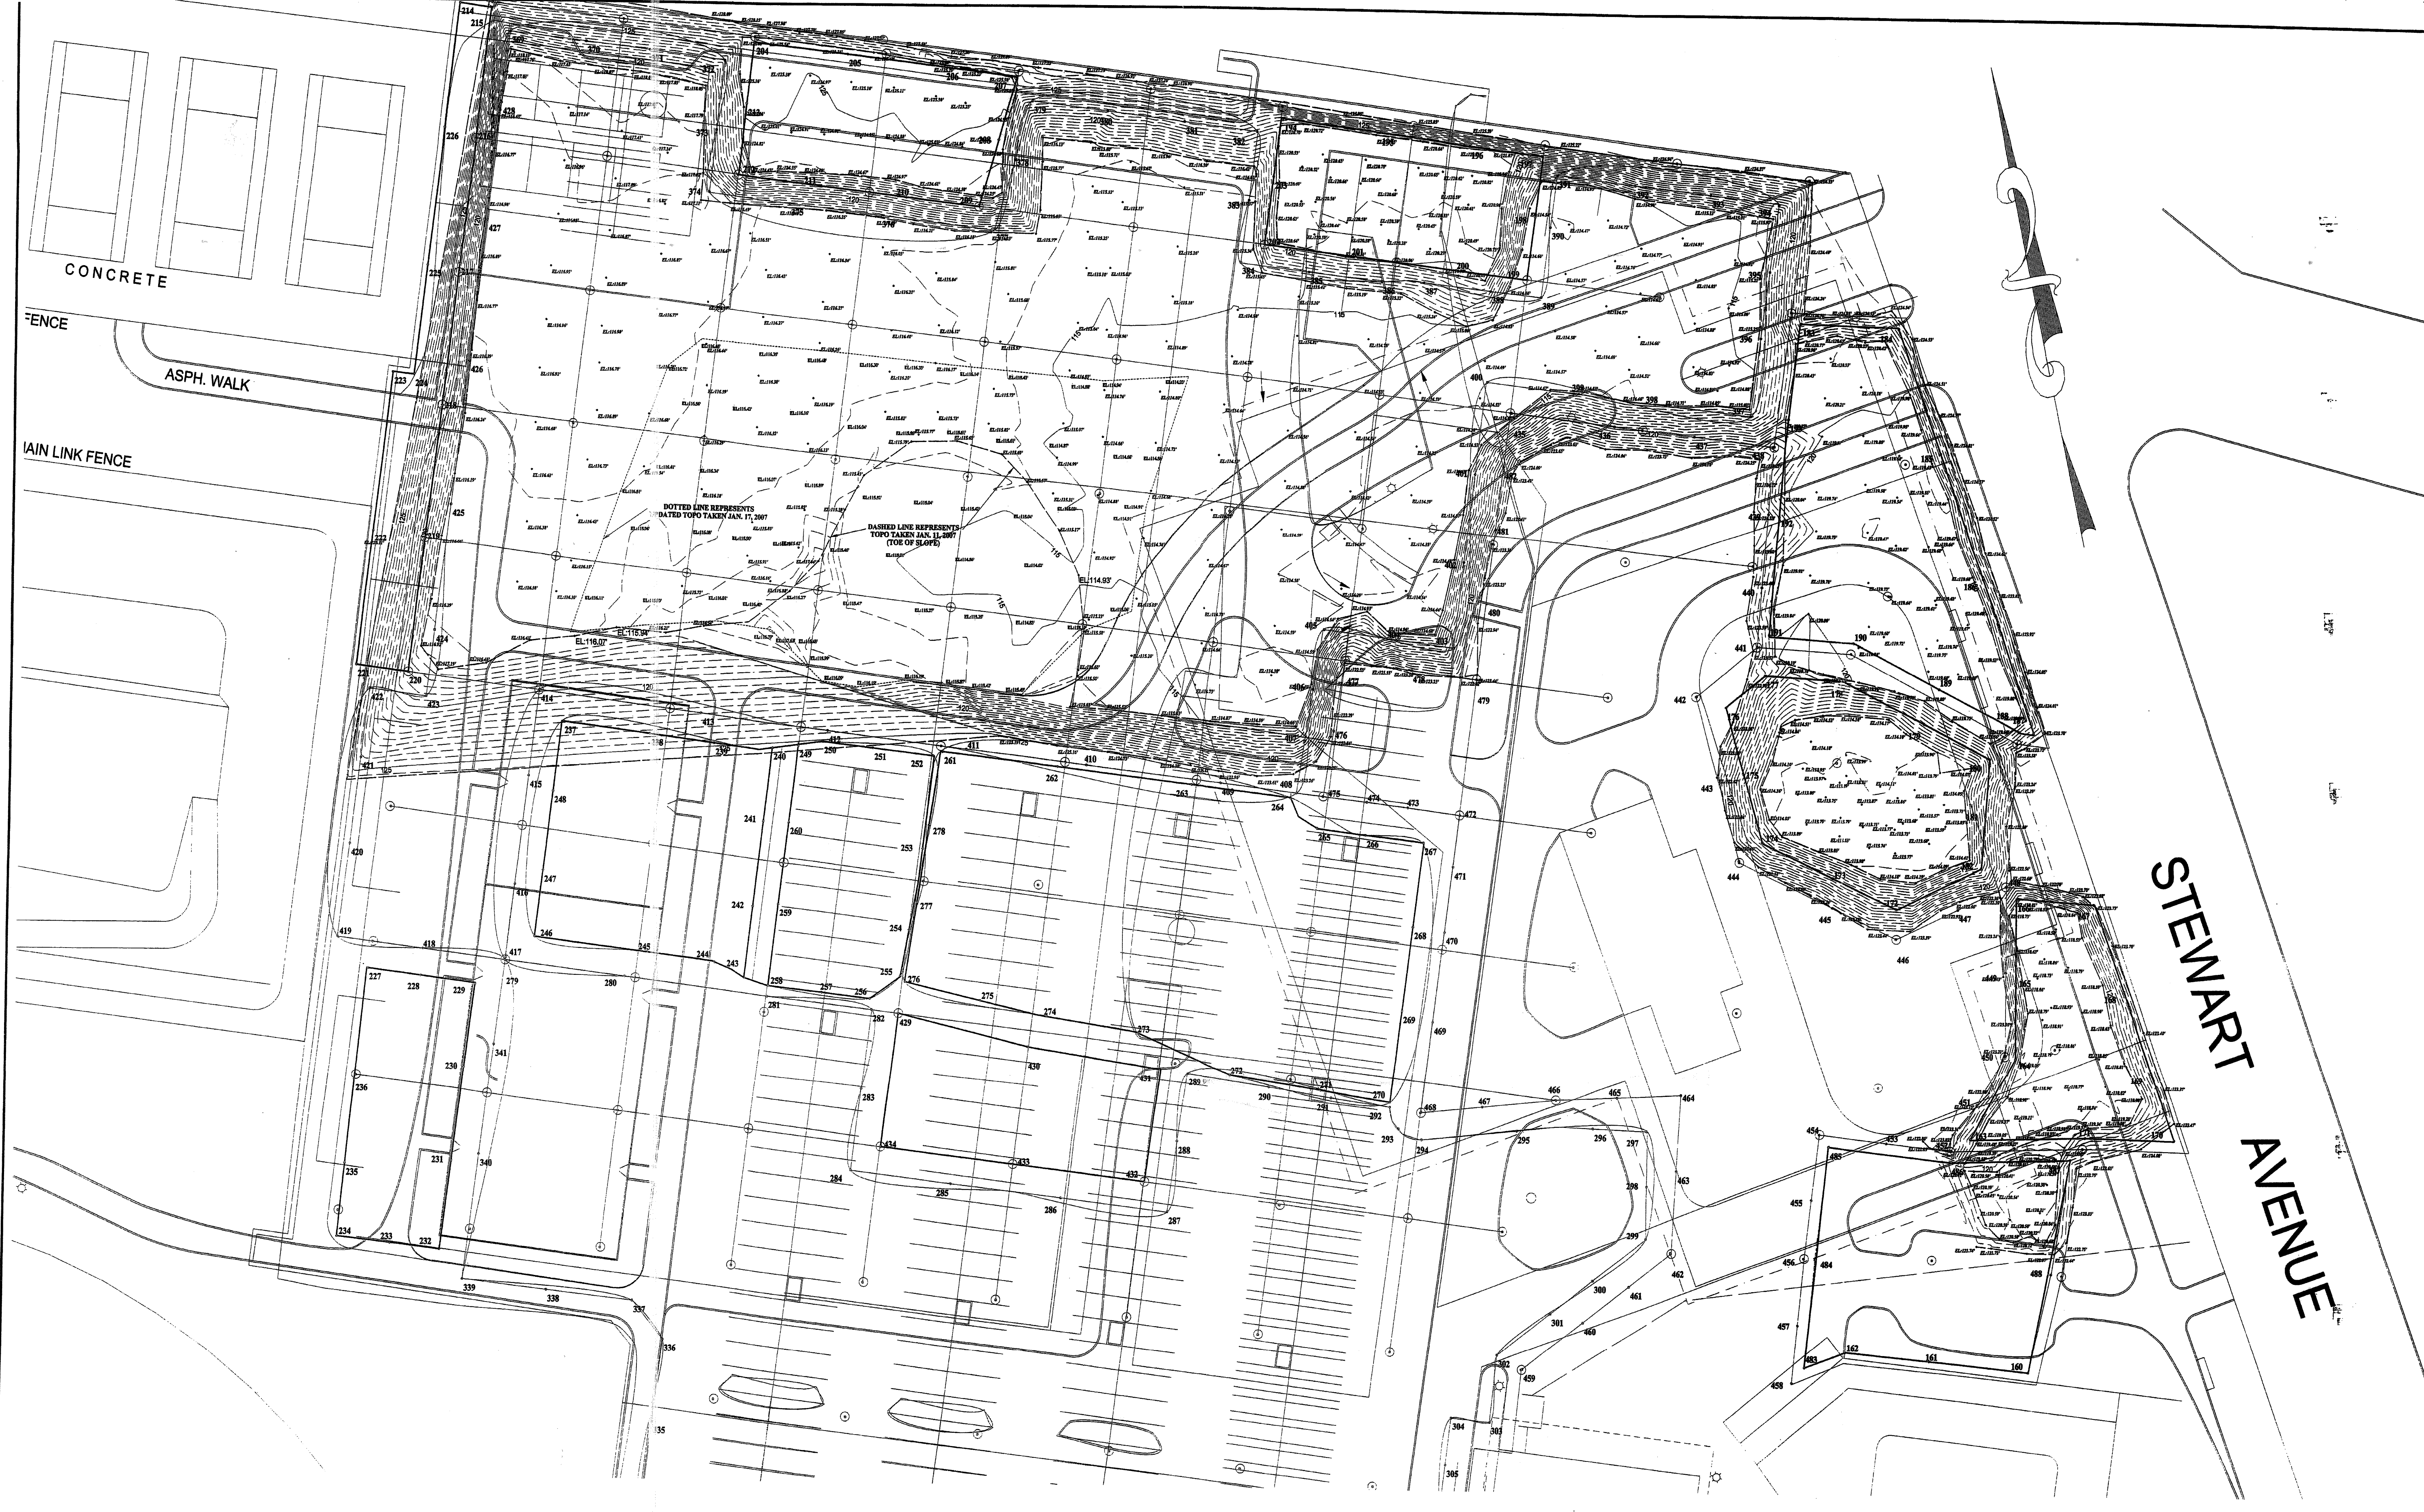
PAGE 2 OF 6  
TOPOGRAPHICAL SURVEY OF SITE  
NOTE: CONTOUR INTERVAL = 6"

EXISTING CONDITIONS  
TOPOGRAPHICAL SURVEY  
CONSTRUCTION AREA IRM  
SOIL REMEDIATION  
BETHPAGE COMMUNITY PARK  
TOWN OF OYSTER BAY  
BETHPAGE NEW YORK

SURVEY JANUARY 11, 2007  
UPDATE JANUARY 17, 2007
