**TOWN OF OYSTER BAY  
BETHPAGE COMMUNITY PARK  
INTERIM REMEDIAL MEASURE - CONSTRUCTION AREA  
FINAL ENGINEERING REPORT**

| <b>Project Type:</b> | Interim Remedial Measure, OU3 – Former Grumman Settling Ponds, Grumman Aerospace-Bethpage Facility New York State Inactive Hazardous Waste Site (ID# 130003A). |

Site work for the IRM remedial action was completed between November 2006 and June 2007. The IRM remedial program resulted in the removal and off-site disposal of approximately 173,032.4 tons of contaminated soil and non-hazardous debris. The cleanup levels applied to this IRM remedial action were NYSDEC TAGM #4046 cleanup guidelines<sup>[1]</sup>. In accordance with the remedial action plan, the excavation depths varied from two to twenty feet below grade. All open excavations were backfilled with NYSDEC-approved clean fill from an off-site source to restore grade. Site restoration including replacement of all Park amenities affected by this IRM RAP will be completed along with the construction work associated with the new ice rink facility.

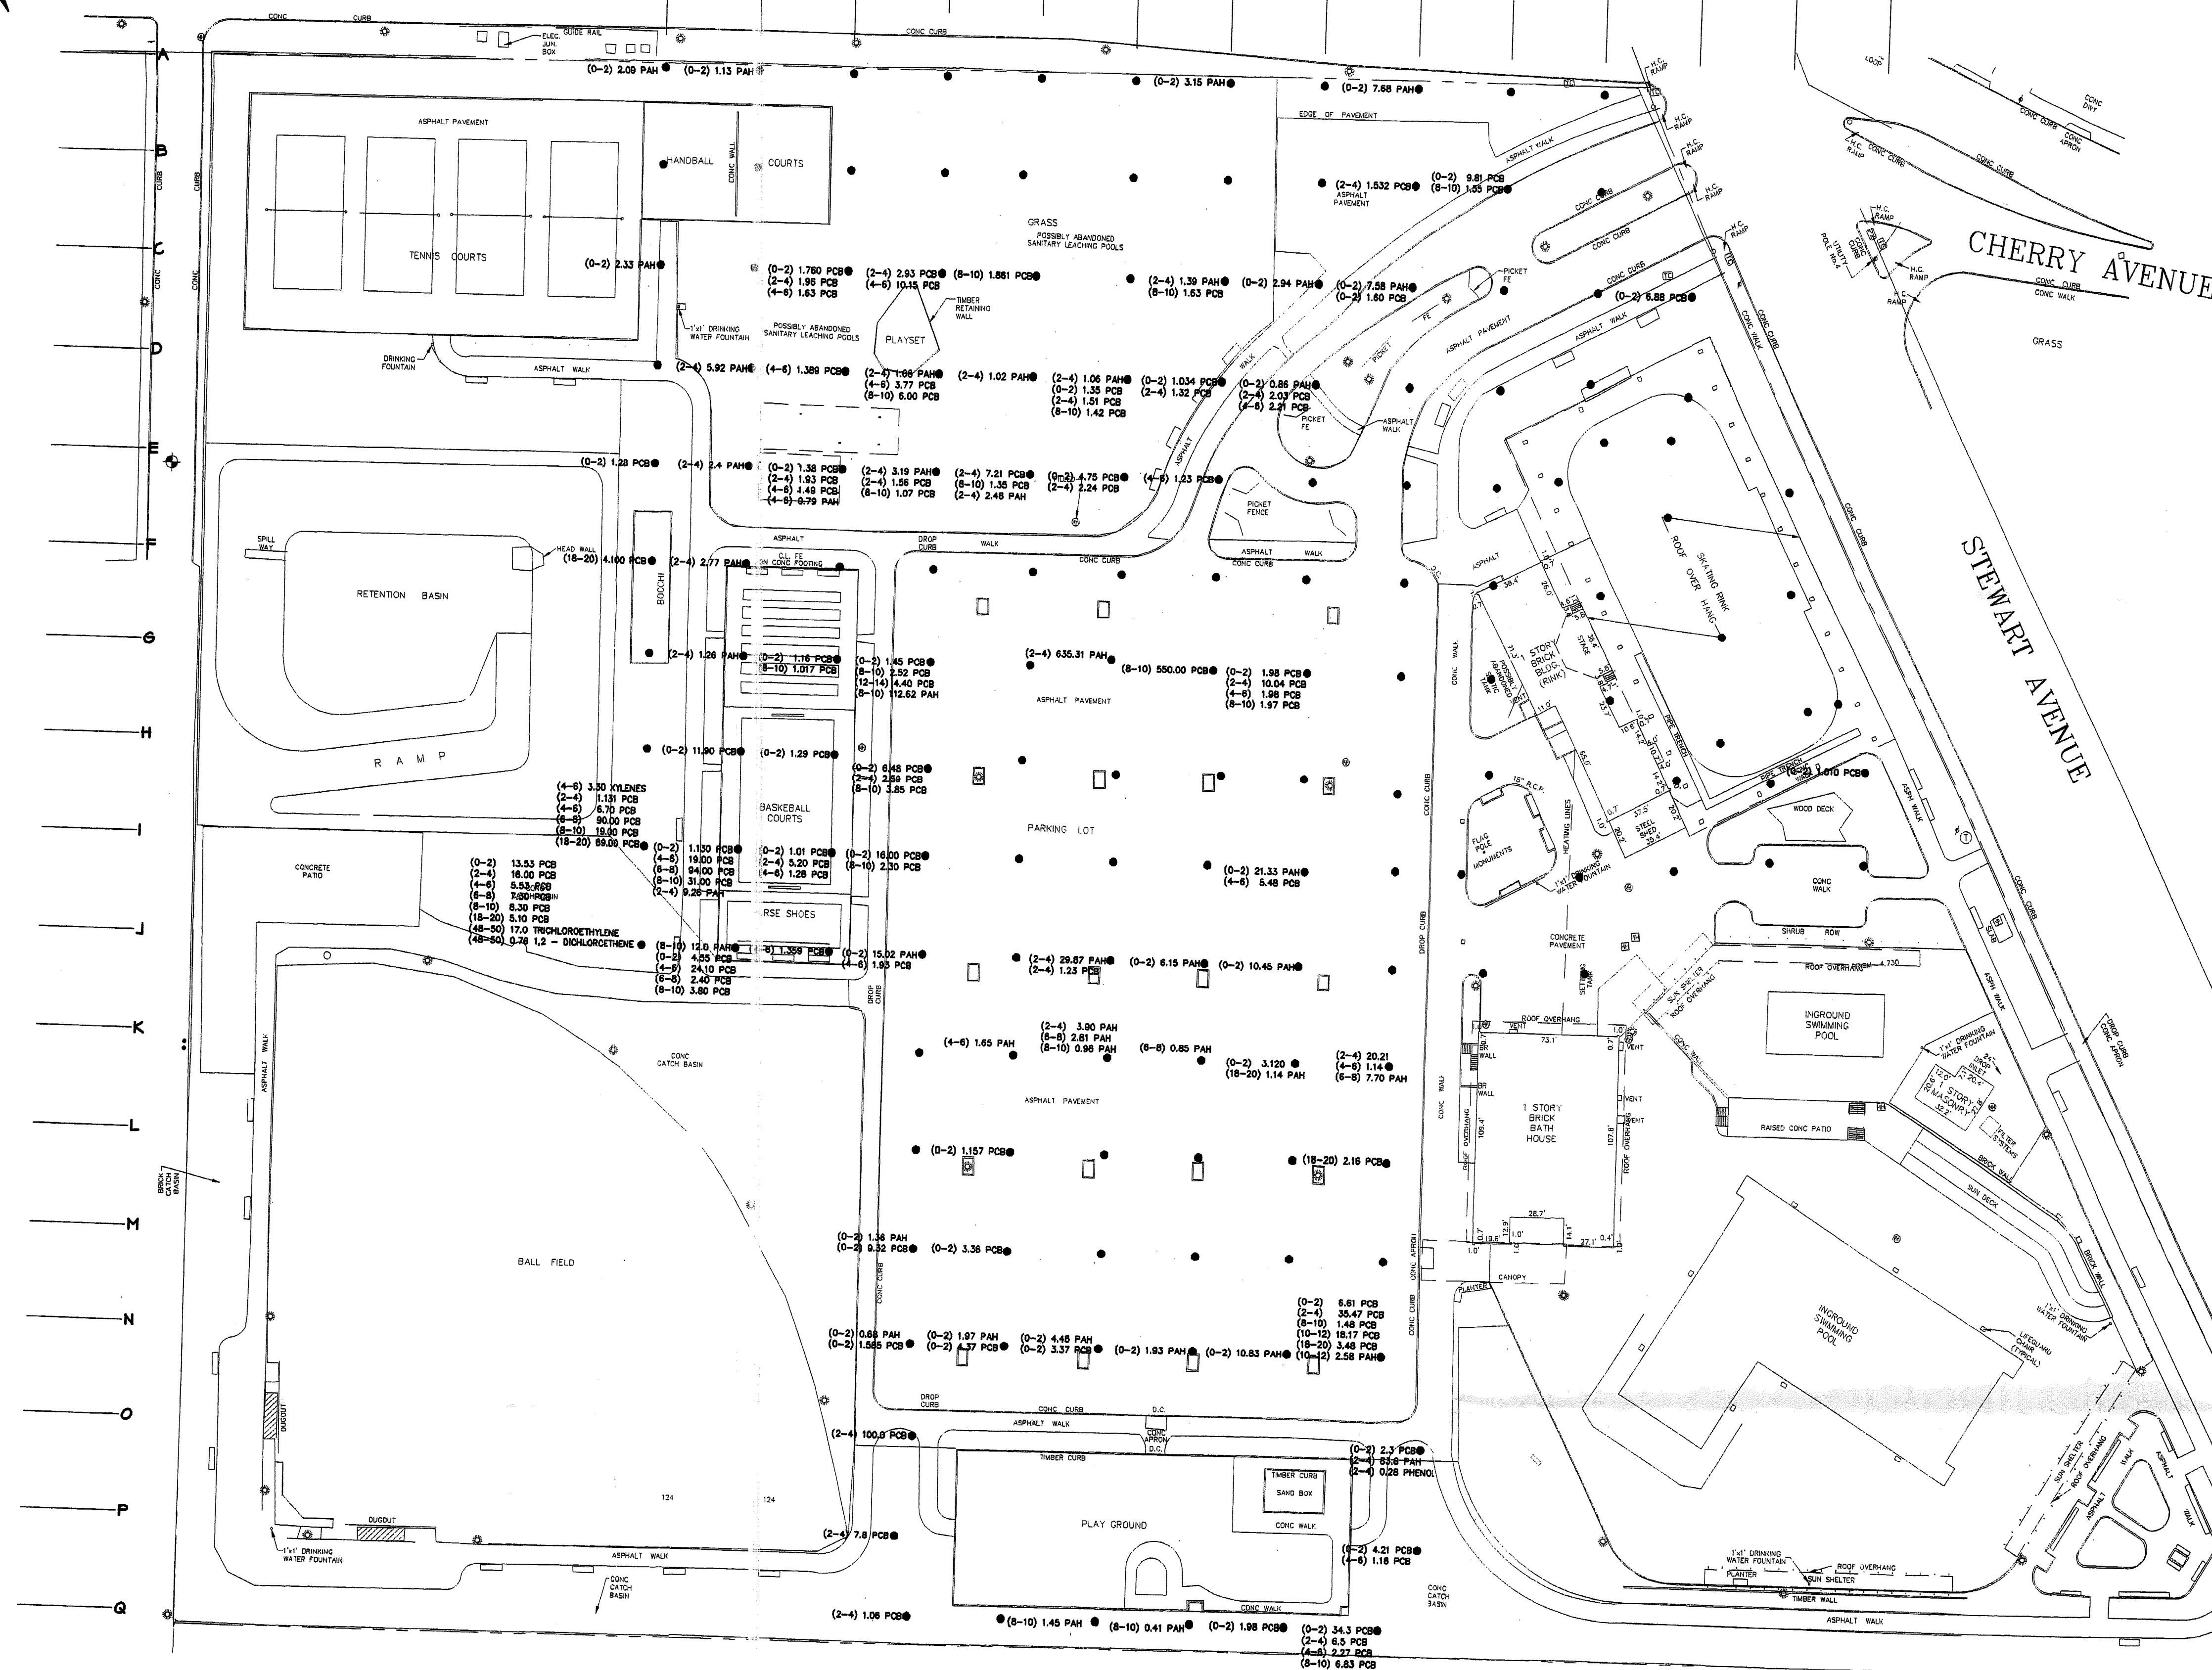
**FIGURE 4**

(0-2) 240 PAH • SOIL SAMPLING POINT - DEPTH IN FEET CONTAINMENT AND CONCENTRATION IN MG/KG

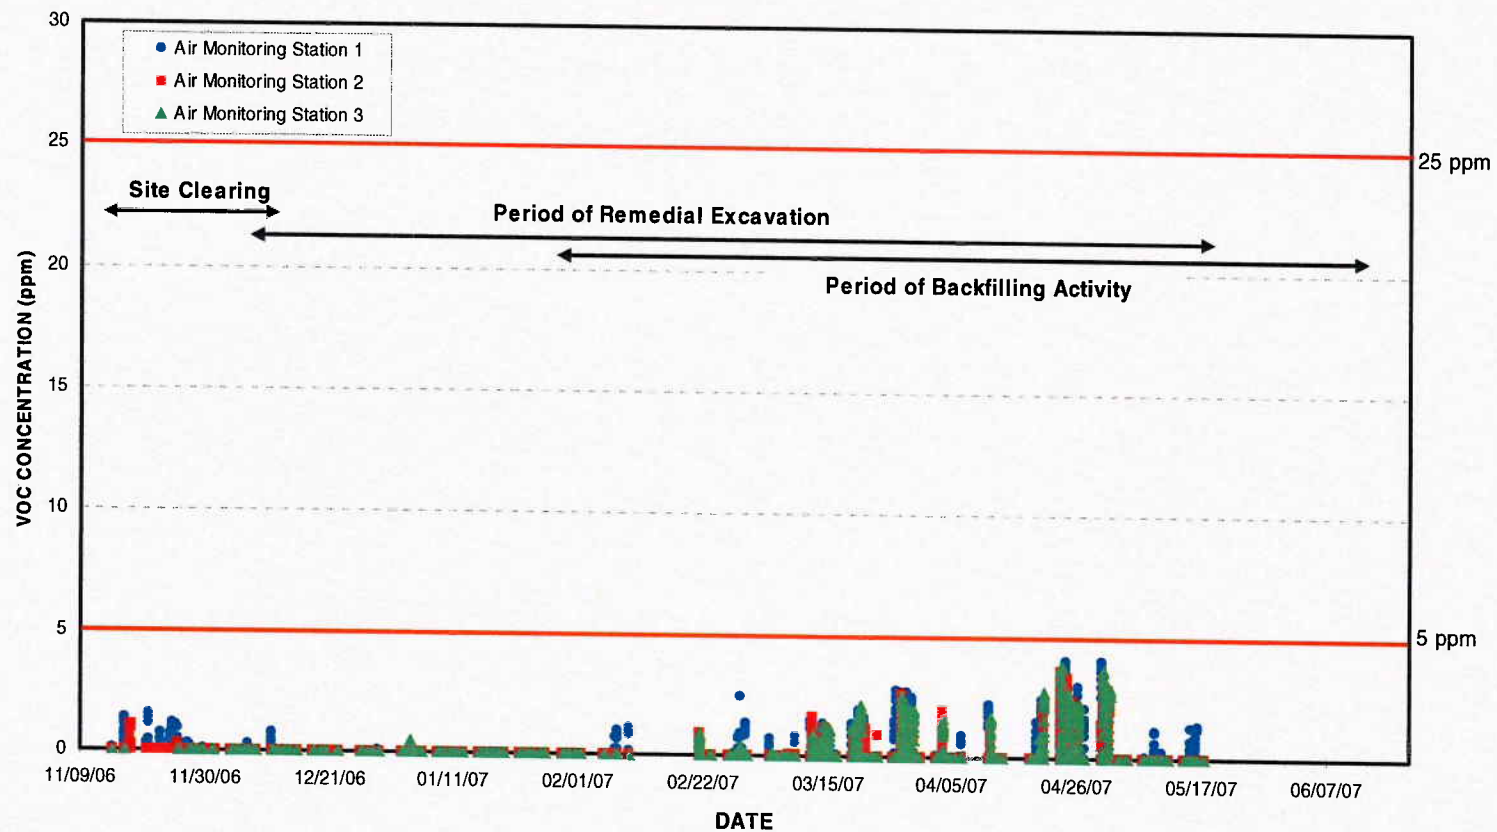
FIGURE 13. AIR MONITORING SUMMARY FOR VOLATILE ORGANIC COMPOUNDS (VOCs) DURING IRM REMEDIAL SITEWORK.

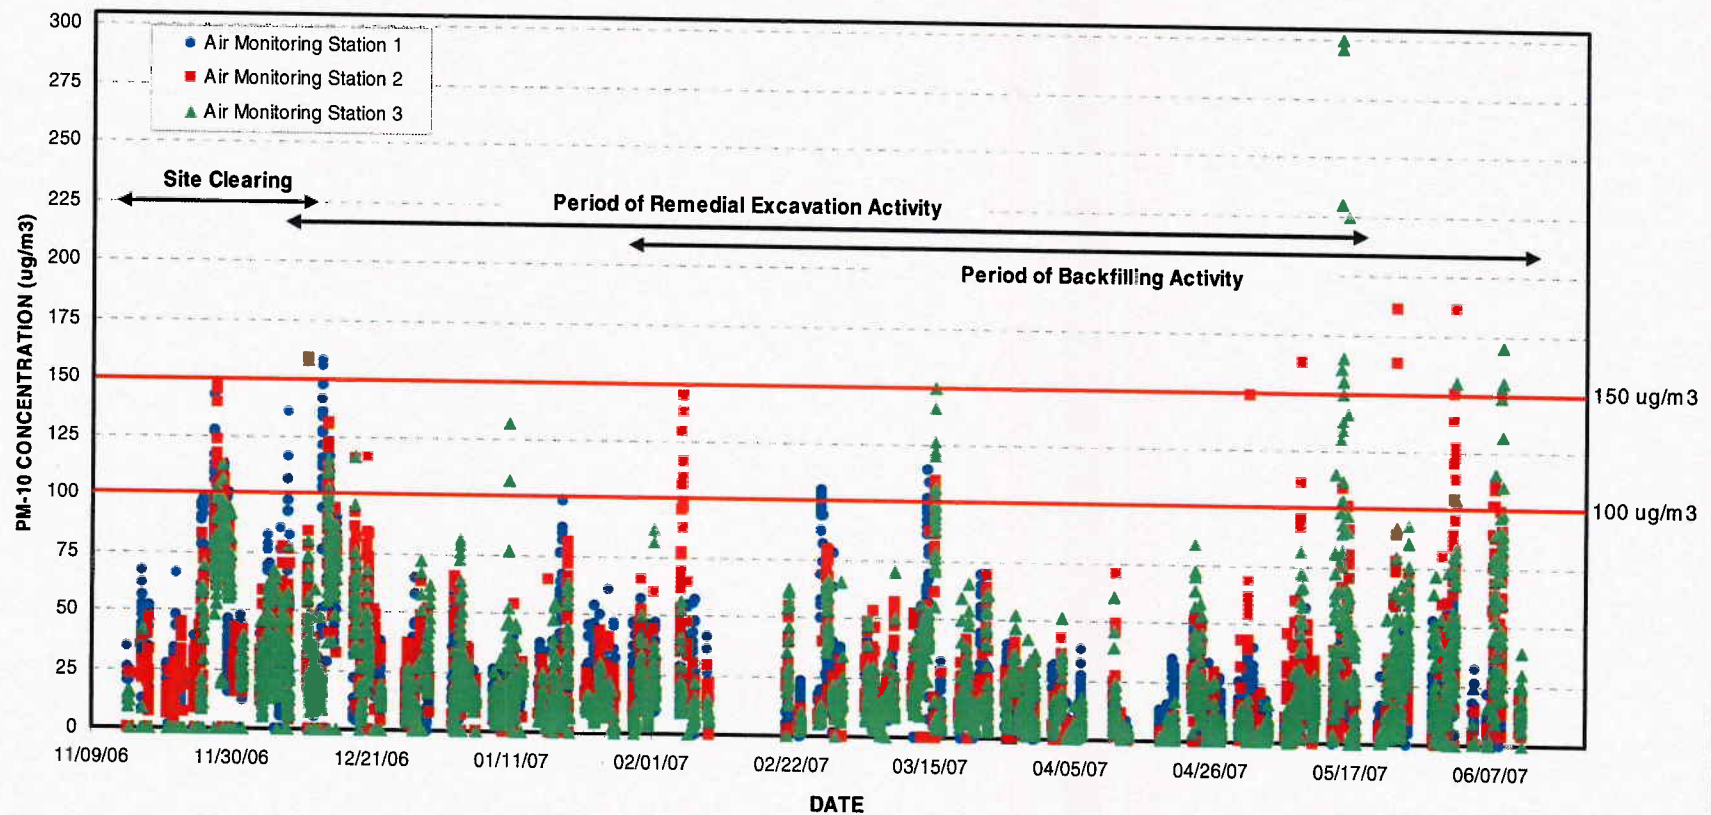
FIGURE 14. AIR MONITORING SUMMARY FOR PARTICULATES (PM-10) DURING IRM REMEDIAL SITEWORK.

was reached until the dust levels were reduced below the threshold. Nearly all threshold exceedences were attributable to backfilling operations. The remaining threshold exceedences occurred during the first week of site operations. At this time, site work involved non-hazardous soil excavation in the vicinity of the former ice rink and removal of the concrete building and rink foundations. The air monitoring stations were positioned in close proximity to this work due to the location of the former rink relative to the IRM and property boundaries where the air monitoring stations were positioned. A summary of the air monitoring measurements for particulates is provided as Figure 14.
