March 31, 2014
Project: M11048A

RE: Focused Subsurface Site Investigation
3206-3224 Long Beach Road
Oceanside, New York 11572

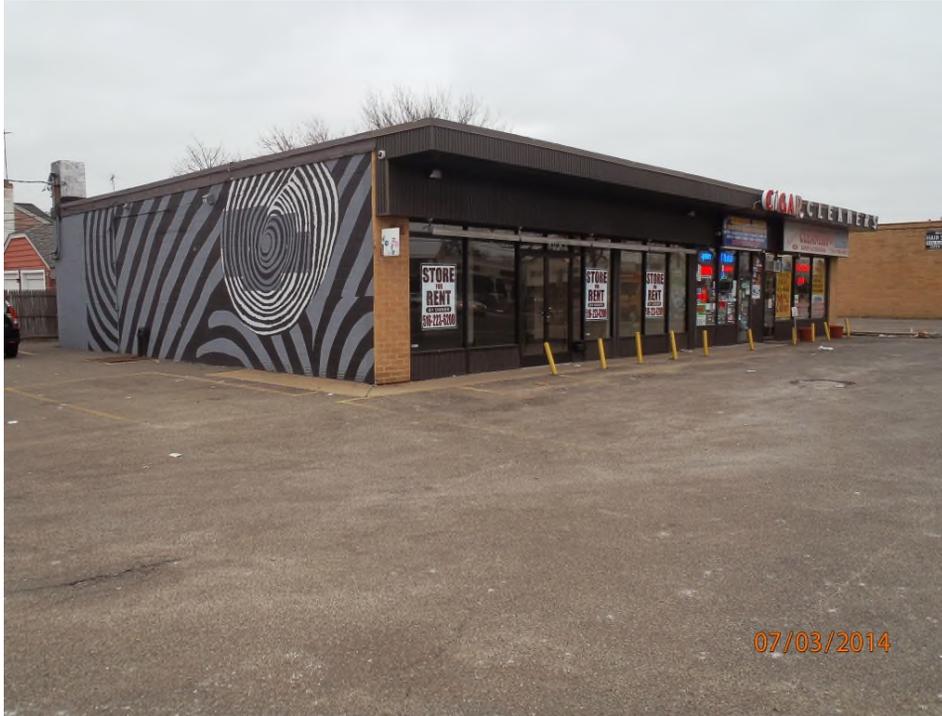
Photograph 1: View of the south Site building looking northwest from the intersection of Long Beach Road and Montgomery Avenue. The dry cleaner space is visible at far right.

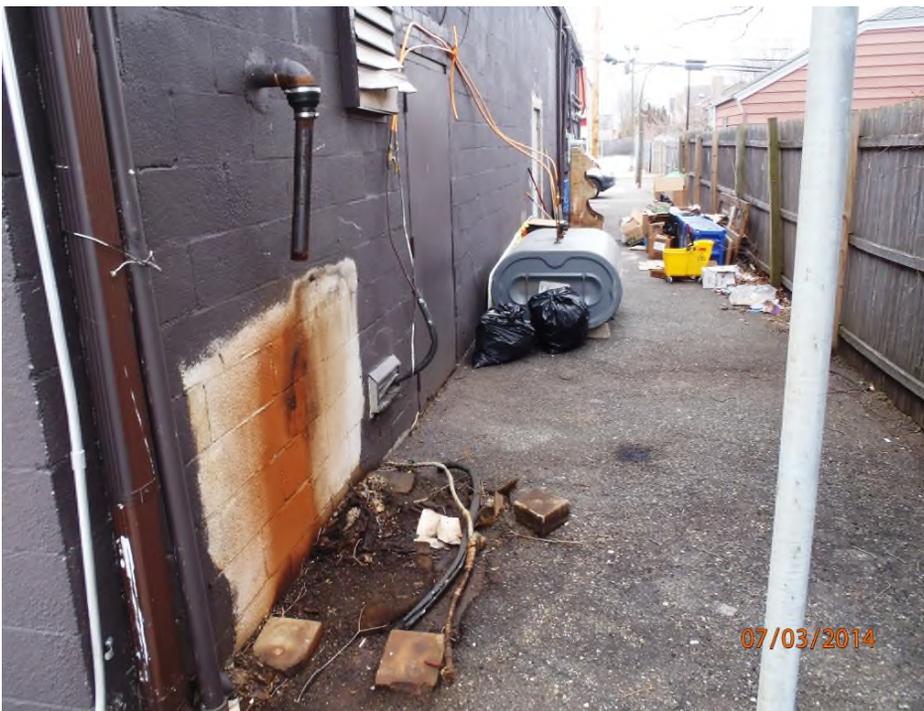
Photograph 2: Alley behind the south Site building. White patch on wall at left denotes the former location of the removed heating oil AST. B4 was installed directly beneath this patch. Photographer facing south.

MECC has identified no evidence that the reported heating oil spill at the former AST location within the Site adversely impacted subsurface soil quality and no further investigation or corrective action is recommended.

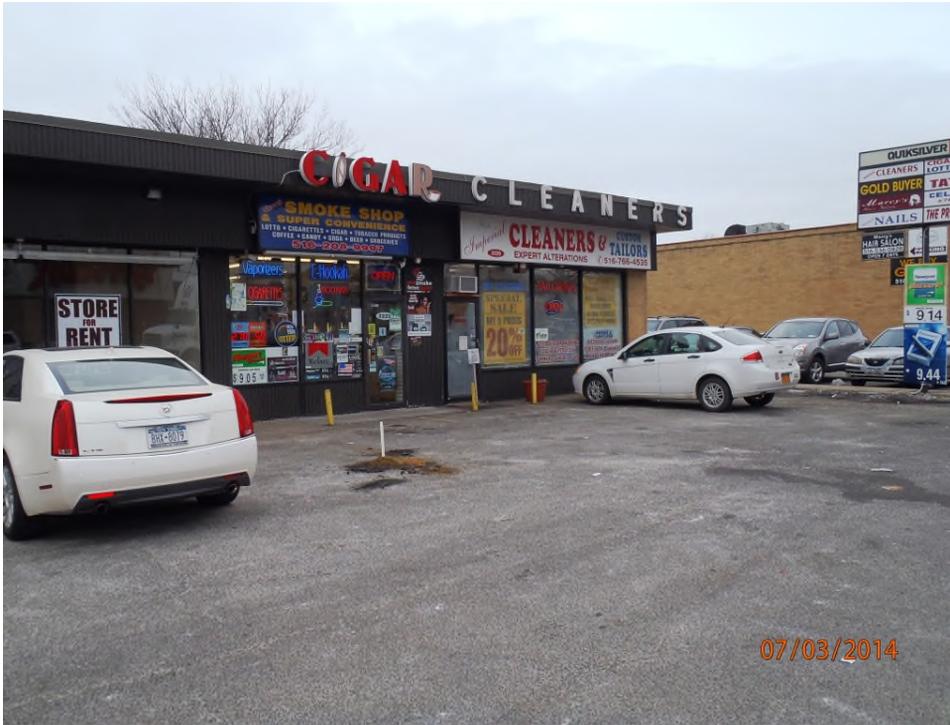
Photograph 3: View of the temporary well point installed at B3. Photographer facing northwest.

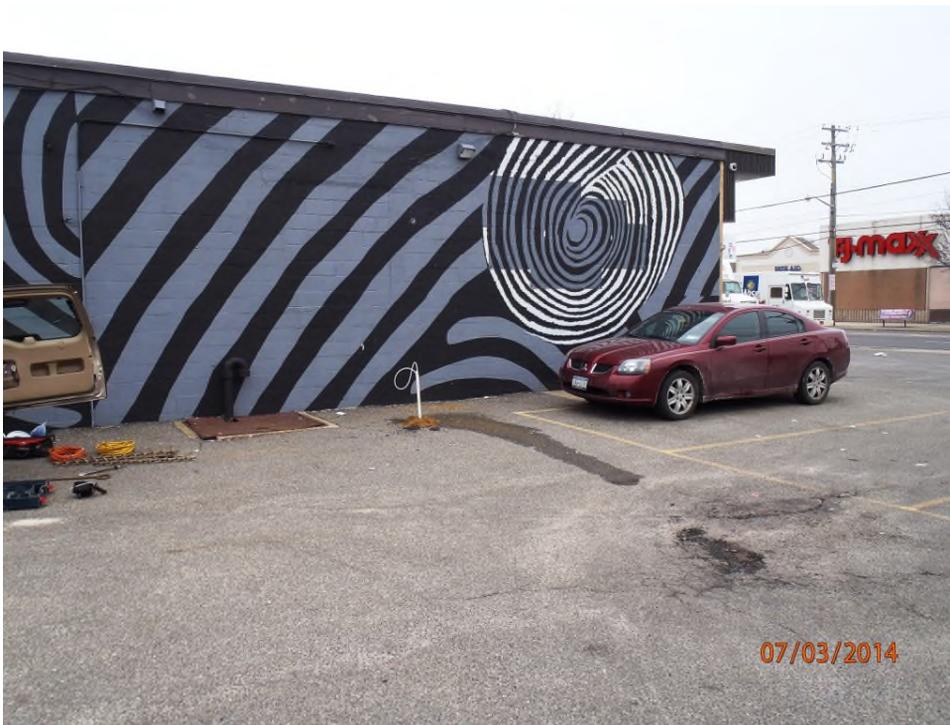
Photograph 4: View of the well point installed at B2. Photographer facing northeast.

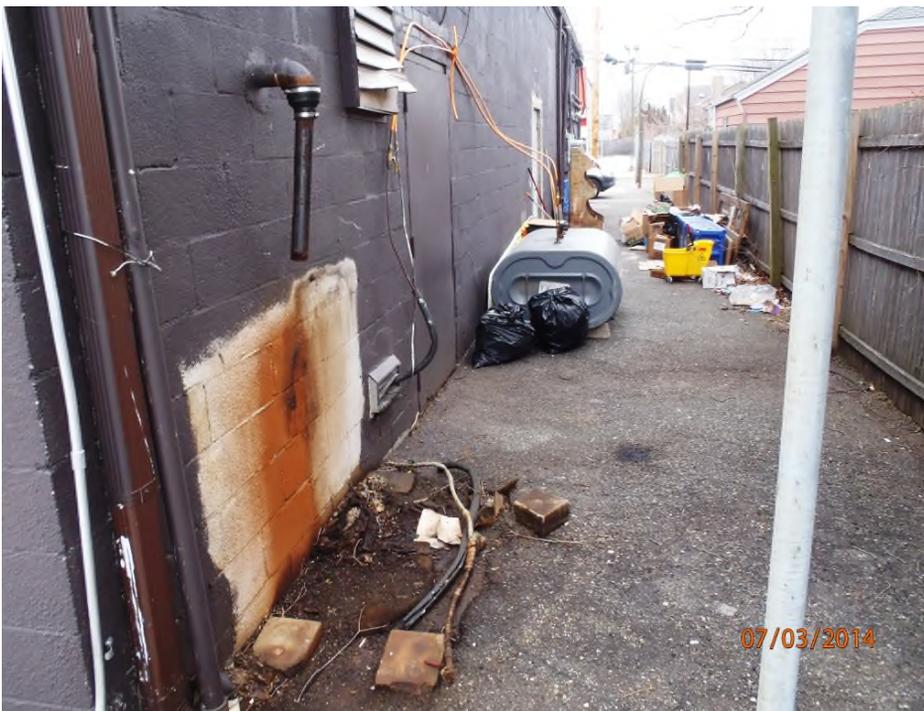
Photograph 2: Alley behind the south Site building. White patch on wall at left denotes the former location of the removed heating oil AST. B4 was installed directly beneath this patch. Photographer facing south.

MECC has identified no evidence that the reported heating oil spill at the former AST location within the Site adversely impacted subsurface soil quality and no further investigation or corrective action is recommended.

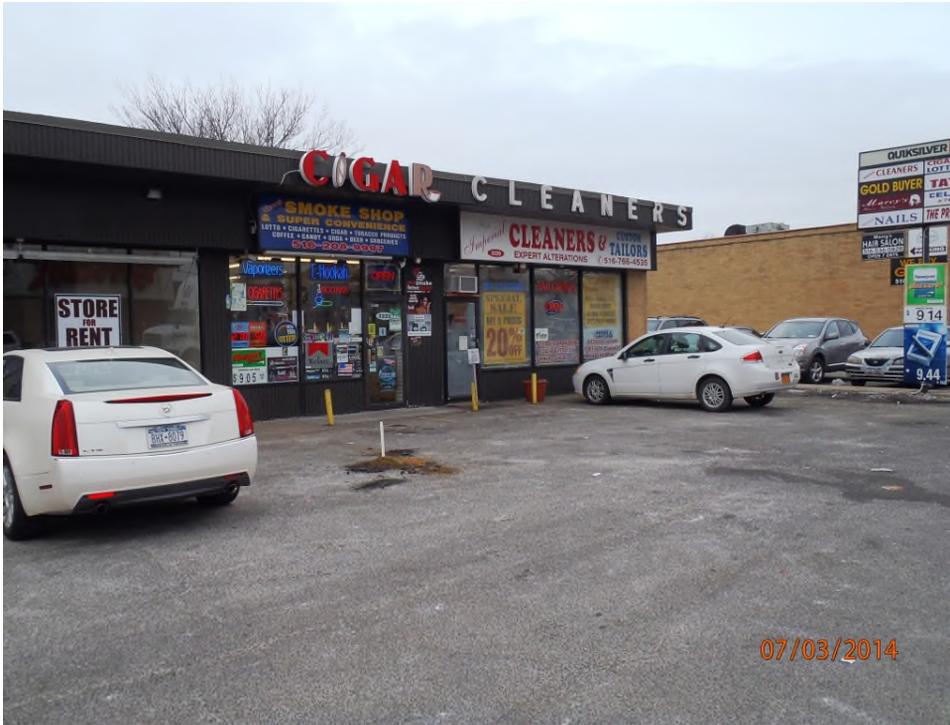
Photograph 3: View of the temporary well point installed at B3. Photographer facing northwest.

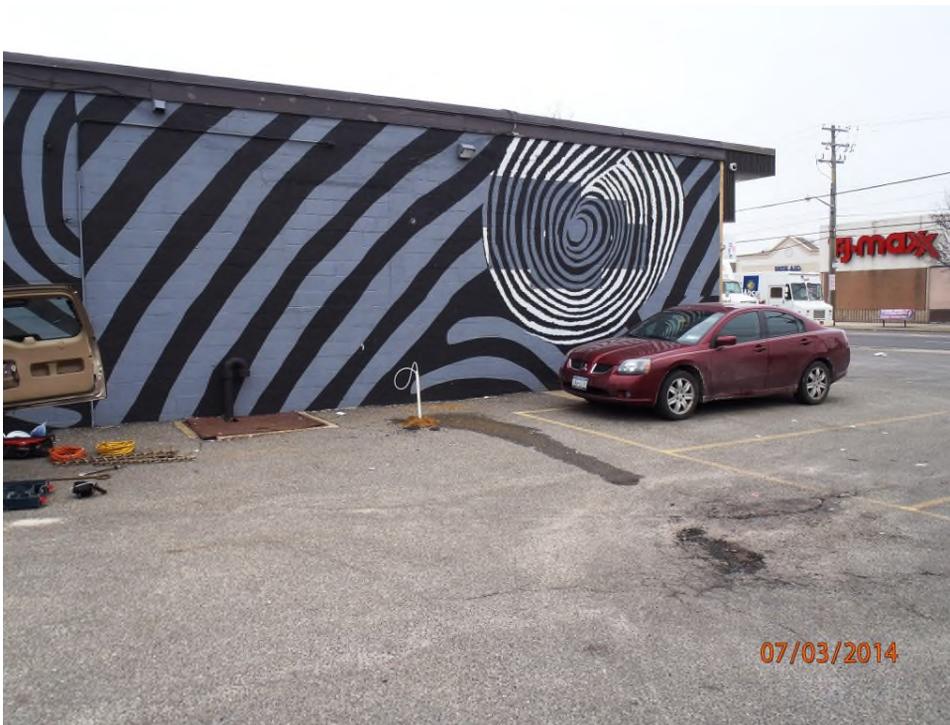
Photograph 4: View of the well point installed at B2. Photographer facing northeast.
