# **OFF-SITE INTERIM REMEDIAL MEASURE CONSTRUCTION COMPLETION REPORT**

**FORMER IMPERIAL CLEANERS SITE  
218 LAKEVILLE ROAD  
LAKE SUCCESS, NEW YORK 11020  
NYSDEC BCP SITE #C130225**

**AUGUST 2024**

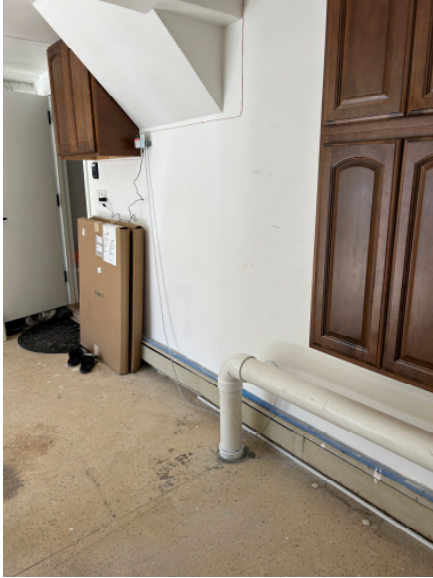
Photograph #1

Interior SSD-1 system configuration in garage.

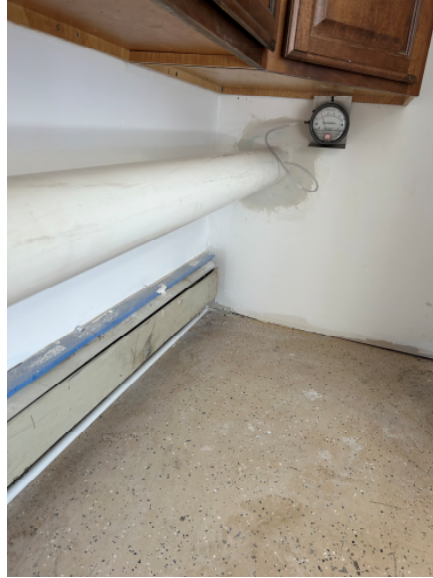
Photograph #2

View of the PVC pipe penetration exiting the east wall of the house and the pressure gauge.

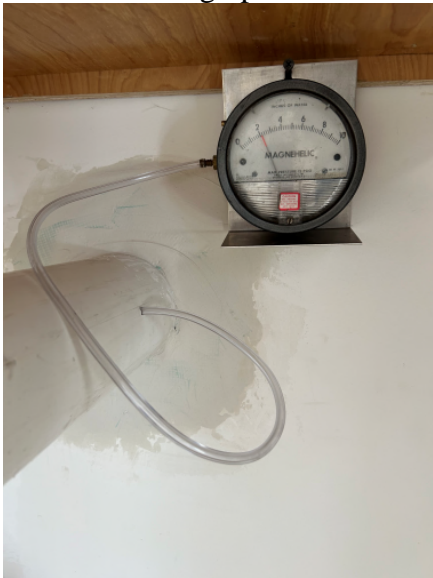
Photograph #3

SSD-1 Pressure gauge (Dwyer Magnehelic)

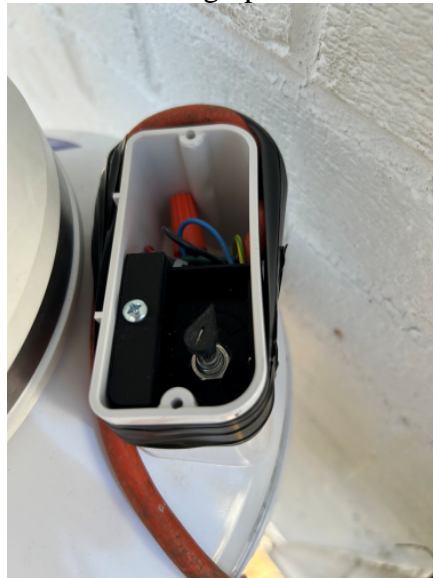
Photograph #4

Inside configuration of exhaust fan Radon Away model GP501c.

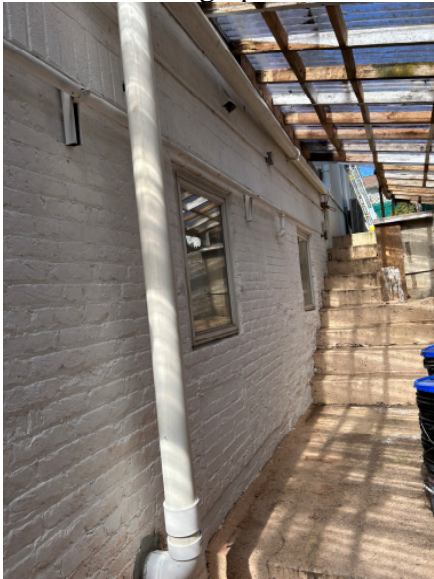
Photograph #5

System configuration along the exterior wall.

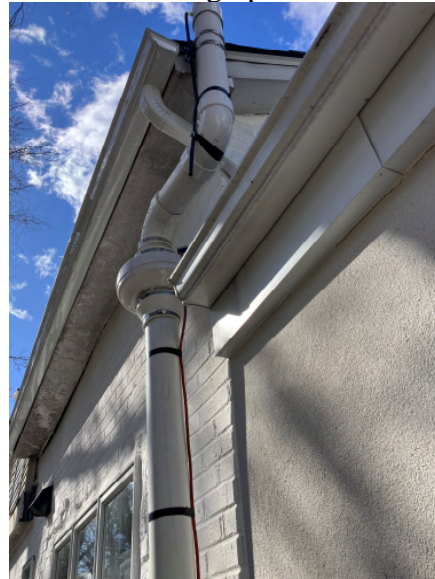
Photograph #6

View of SSD-1, exhaust fan, including vent pipe above the roof.

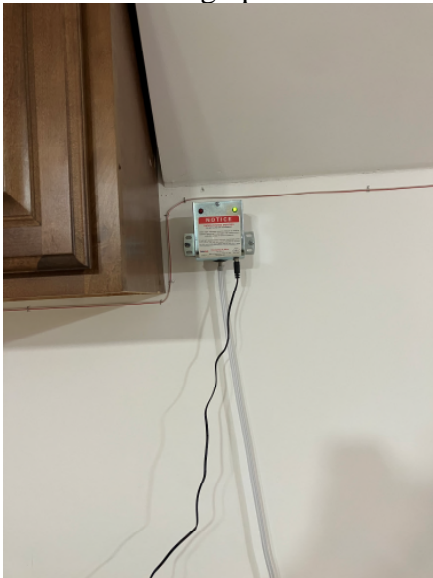
Photograph #7

System Radon Alarm

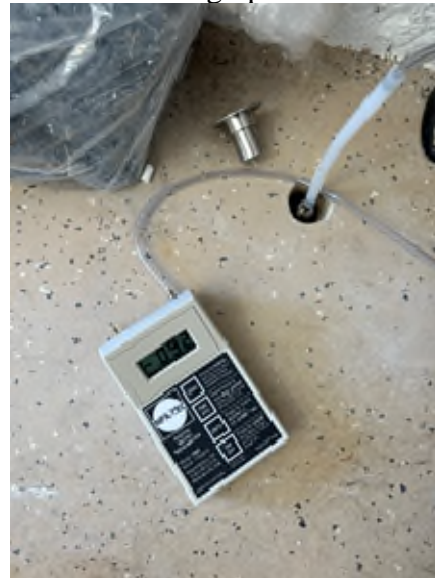
Photograph #8

MP-01 reading under final operating setting  
(-0.092 in WC)

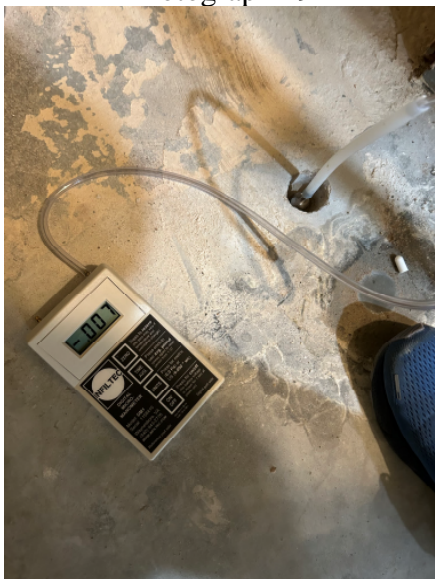
Photograph #9

MP-02 reading under final operating settings (-0.007 in WC)

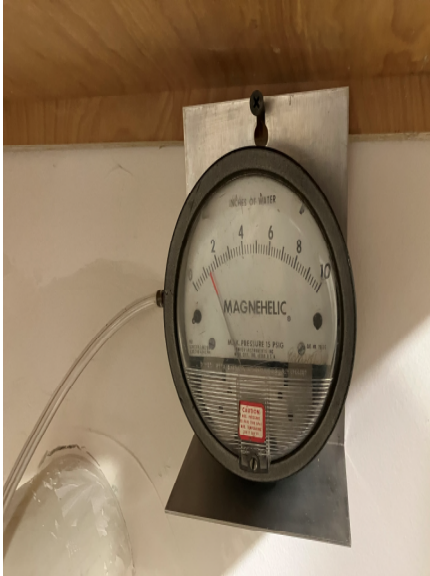
Photograph #1

SSD-1 Pressure gauge (Dwyer Magnehelic)

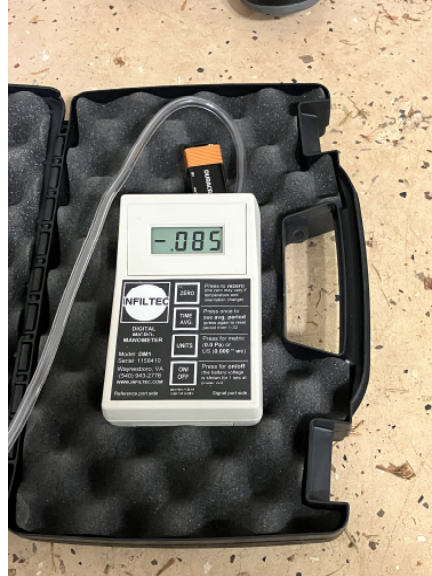
Photograph #2

MP-01 reading under final operating settings  
(-0.085 in WC)

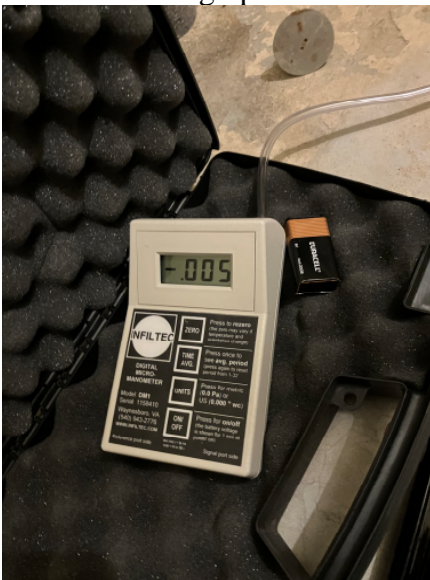
Photograph #3

MP-02 reading under final operating settings  
(-0.005 in WC)

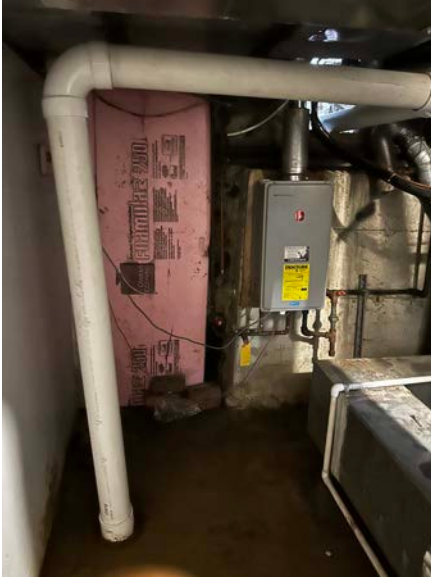
Photograph #1

Interior SSD system configuration and penetration through wall.

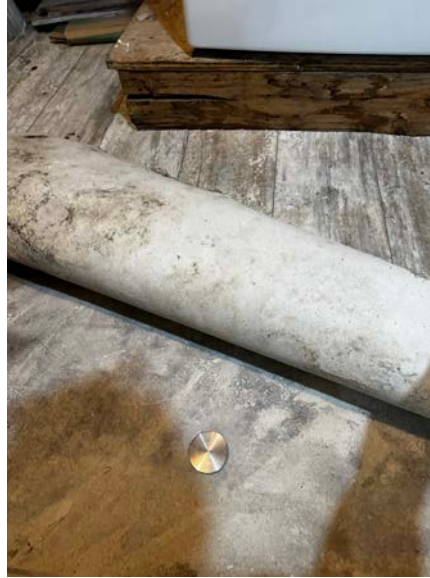
Photograph #2

MP-01 stainless-steel vapor pin.

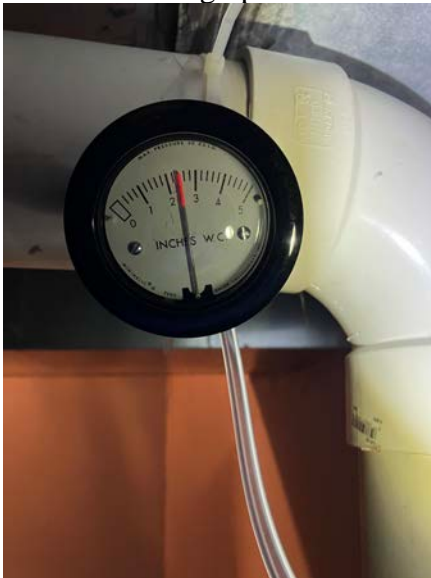
Photograph #3

SSD-1 Pressure gauge

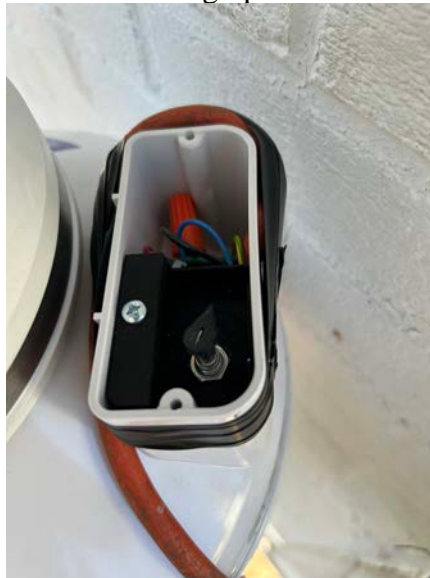
Photograph #4

Inside configuration of exhaust fan Radon Away model GP501c.

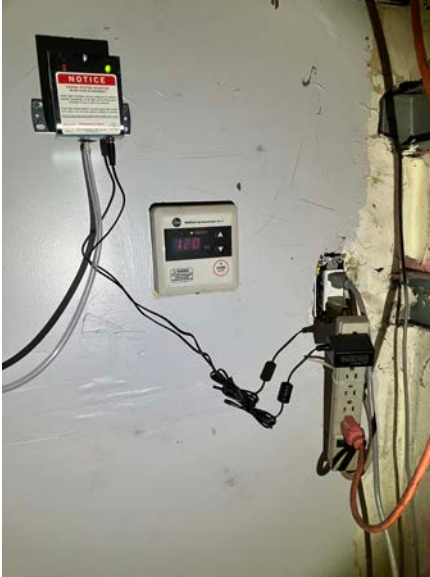
Photograph #5

System Radon Alarm

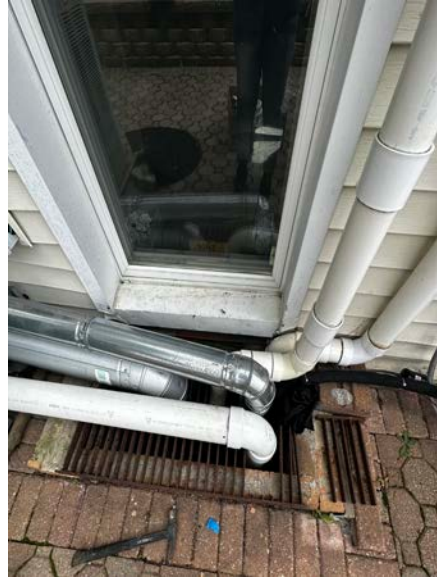
Photograph #6

System configuration from the basement window pit

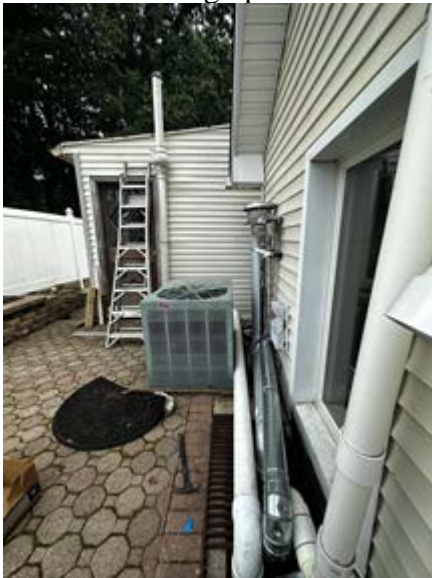
Photograph #7

System configuration along the exterior wall.

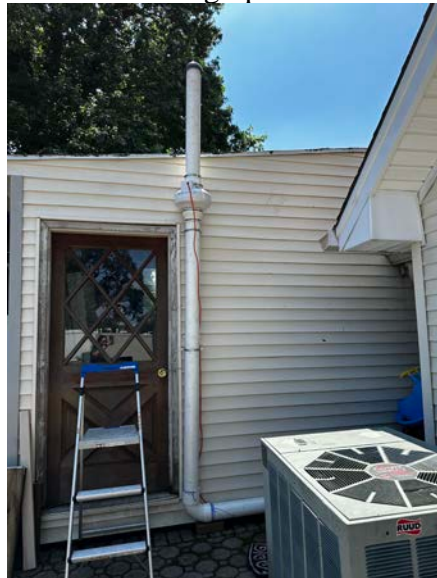
Photograph #8

System configuration along the exterior wall.

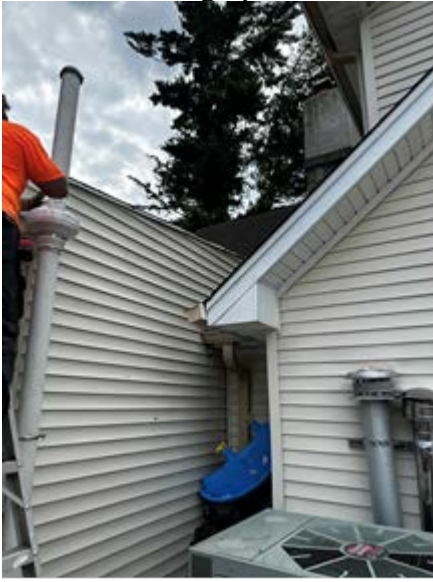
Photograph #9

View of SSD-1 vent pipe above the roof

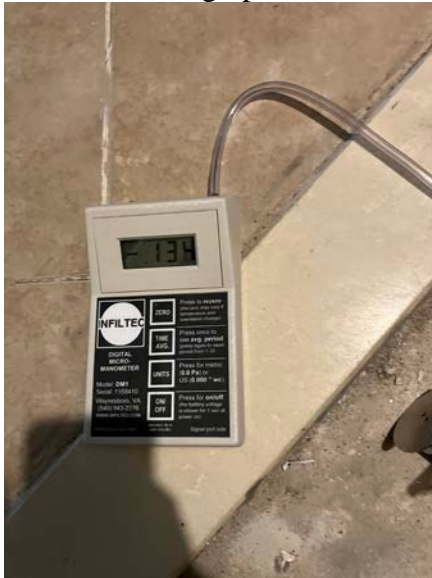
Photograph #1

MP-01 reading under final operating settings  
(-0.134 in WC)

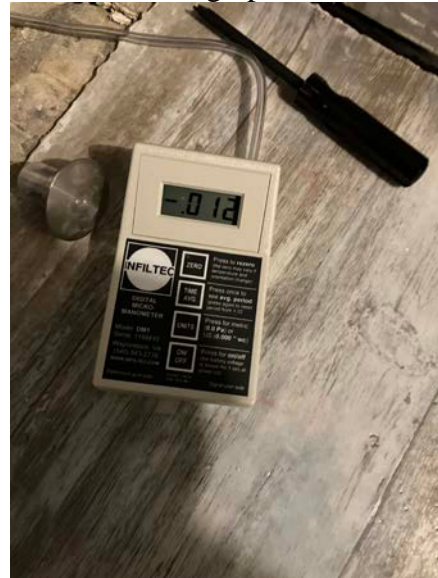
Photograph #2

MP-03 reading under final operating settings  
(-0.012 in WC)

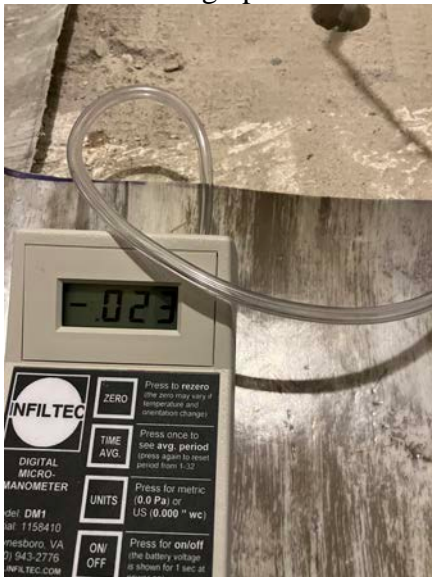
Photograph #3

MP-04 reading under final operating settings  
(-0.023 in WC)
