Re: Remedial Work Plan
Former Imperial Cleaners Site (BCP #C130225)
218 Lakeville Road, Lake Success, NY

REMEDIAL WORK PLAN

**FORMER IMPERIAL CLEANERS SITE
218 LAKEVILLE ROAD
LAKE SUCCESS, NEW YORK 11020**

NYSDEC BCP SITE #C130225

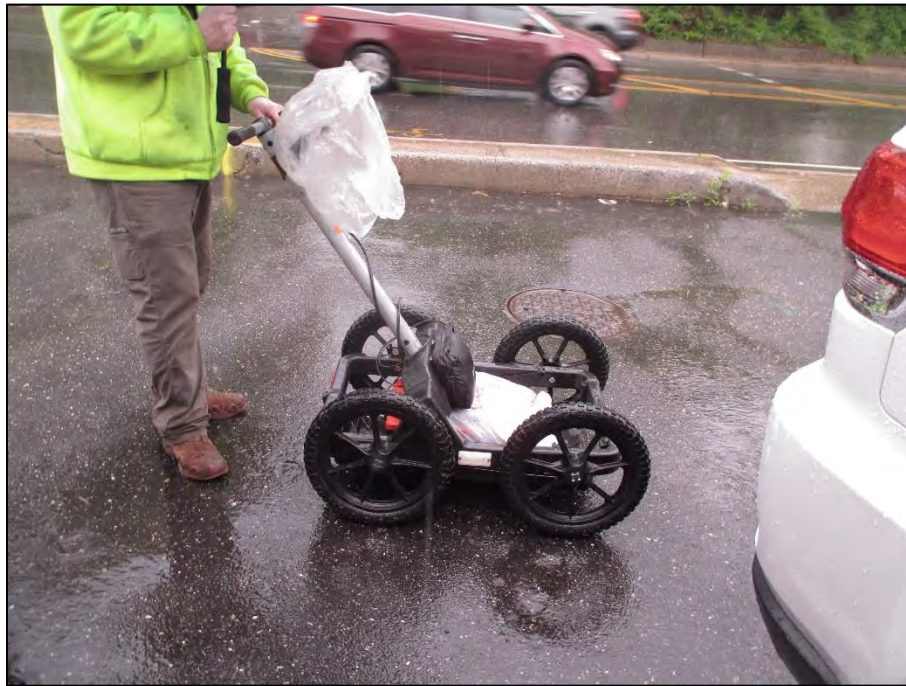
Photograph 1

Ground penetrating radar (GPR) survey for utility markout purposes.

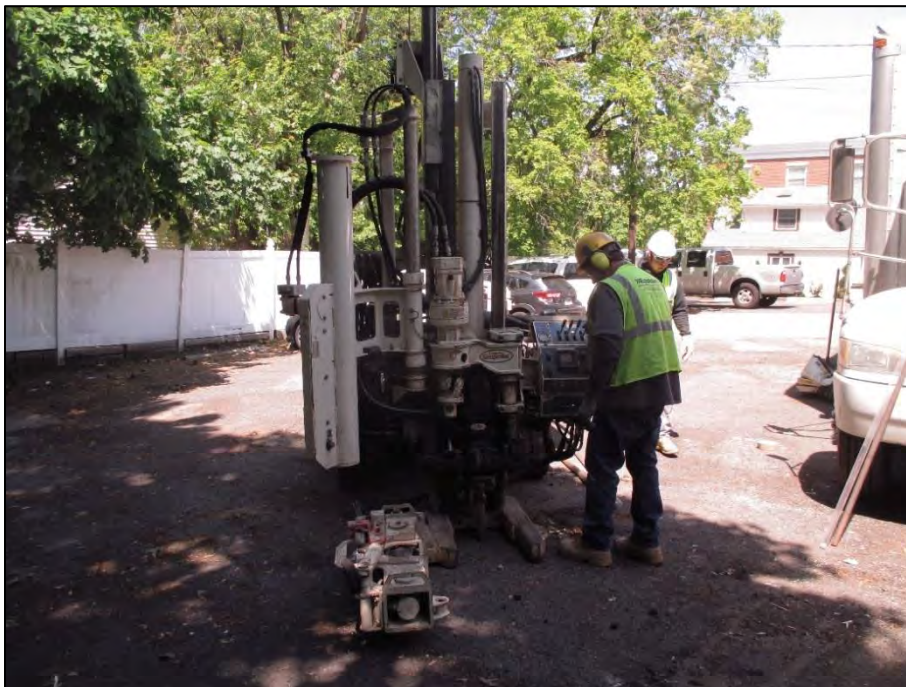
Photograph 2

Representative view of direct-push (Geoprobe) drilling activities.

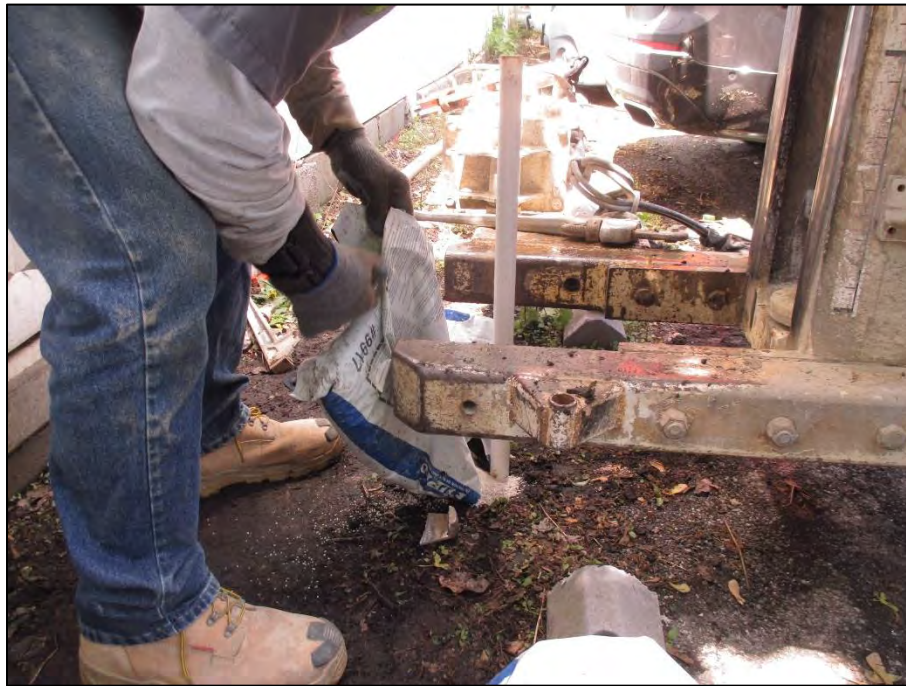
Photograph 3

Representative view of temporary monitoring well installation.

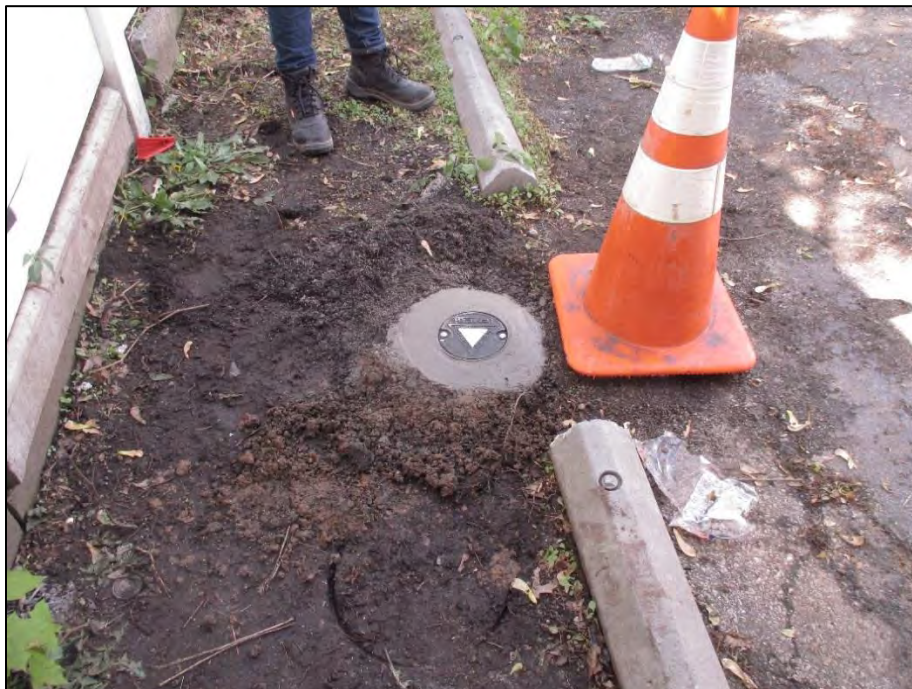
Photograph 4

Representative view of completed temporary monitoring well.

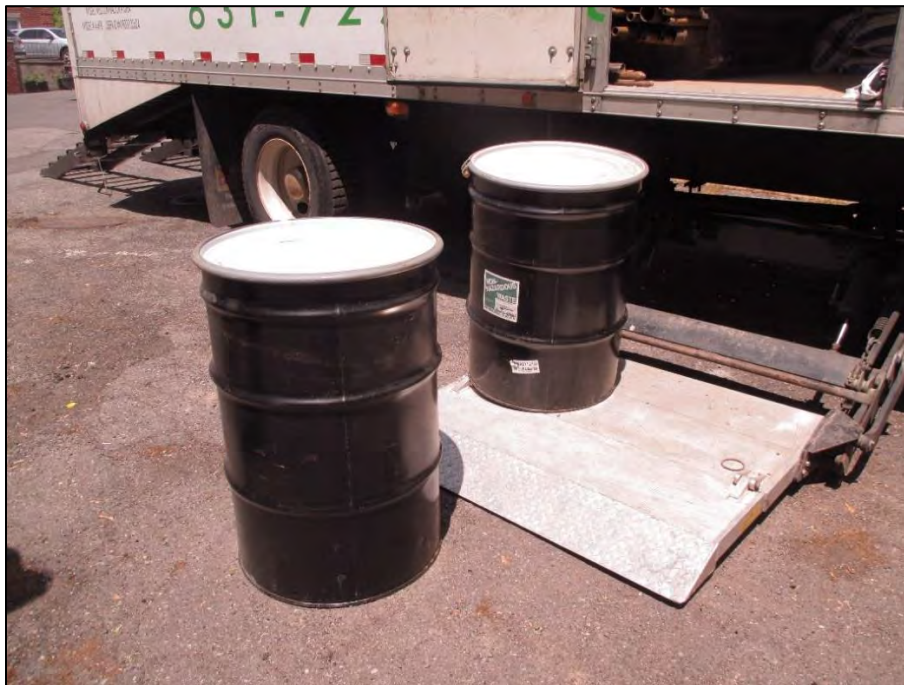
Photograph 6

Removal of waste drums for off-site disposal.
