Re: Phase II ESA Report
Verizon New York Inc., GLC33536
Roslyn Garage
45 Lumber Road
Roslyn, New York

**Results of Geophysical Investigation
Verizon New York, Inc.
45 Lumber Road
Roslyn, New York**

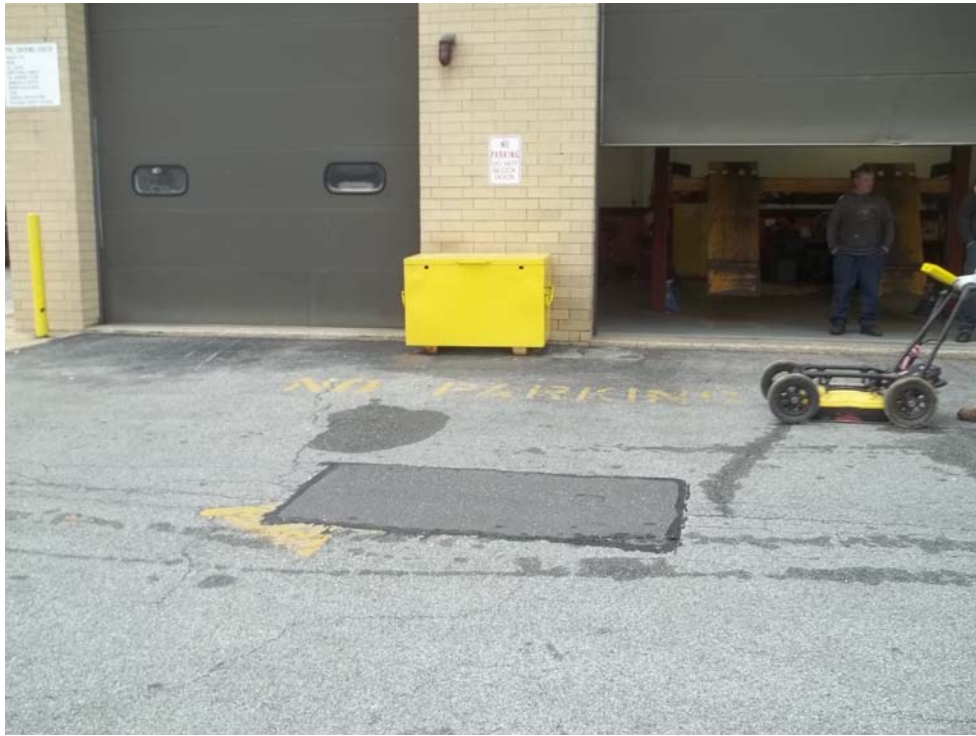
Based on the GPR findings, evidence of the former waste oil UST was not identified, indicating that the components of the former USTs appear to have been removed. Additionally, the garage area known to contain the building's former floor drains and

Photograph 1: Location of former 275-gallon waste oil UST.

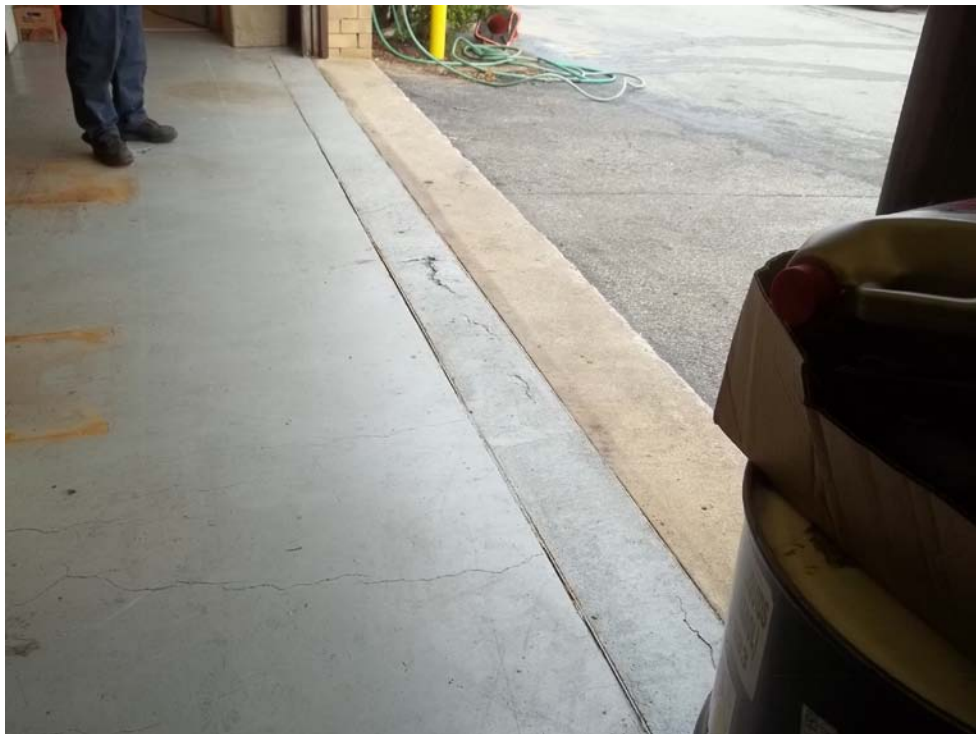
oil/water separator were also inspected. The former drains and oil/water separator were determined to be abandoned with concrete. No anomalies were detected by GPR in the building's garage area. The reported former drywell utilized as a discharge point for the former oil/separator currently exists in the southwest portion of the property. A visual inspection of the drywell showed that the drywell appears to be piped to the approximate area of the former oil/water separator. The pipe was "snaked" to determine its terminus, which was the outside edge of the garage portion of the building, indicating that the piping on the interior of the garage was abandoned or sealed.

Photograph 2: Location of former trench drain in maintenance bay.

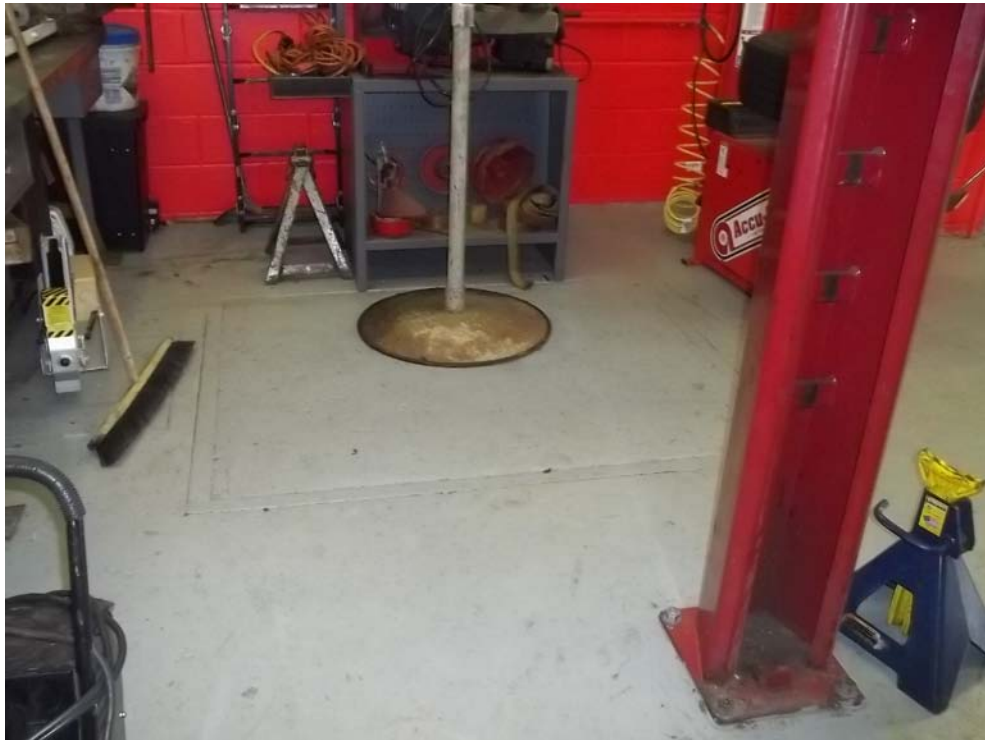
Photograph 3: Location of former oil-water separator.

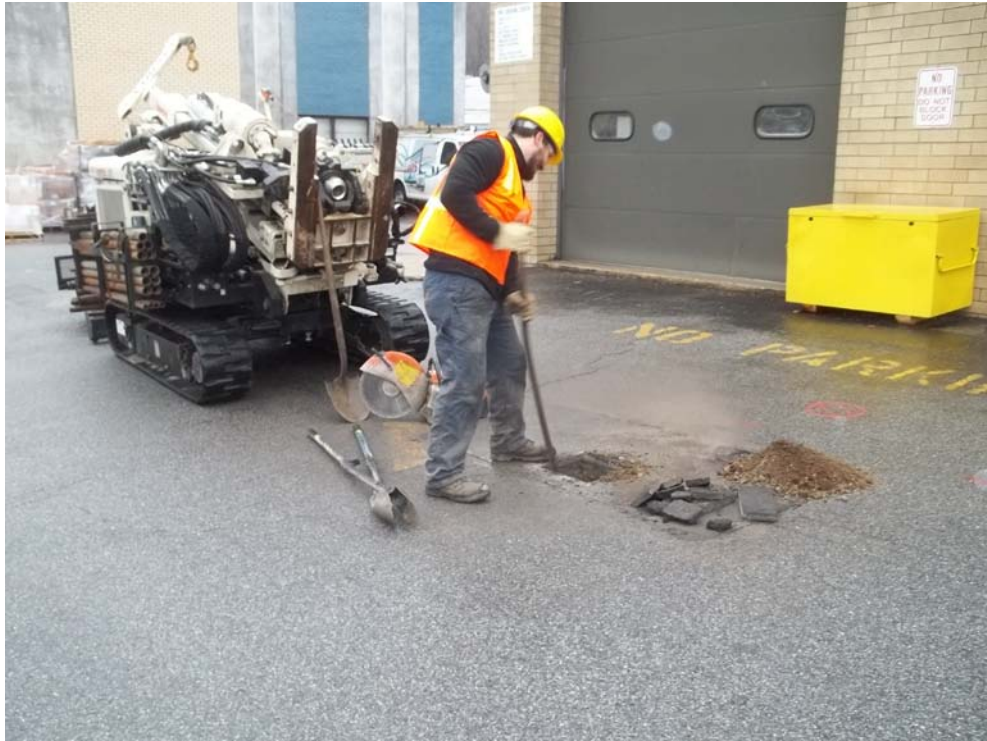
Soil boring SB-1 was installed in the area of the former waste oil UST to a depth of approximately 10 ft. bg. Subsurface boring DW-1 was installed within the drywell bottom sediments to a depth of approximately 15 ft. bg (note the depth to bottom sediments within the drywell is approximately 11 ft. bg.). A photo-ionization detector (PID) was used to screen soil from each boring. No visual or olfactory evidence of contamination was identified and no PID readings indicative of contamination were detected in the borings. Soil boring logs are included as **Attachment C**.

Photograph 5: Location of SB-1 within area of former 275-gallon waste oil UST.

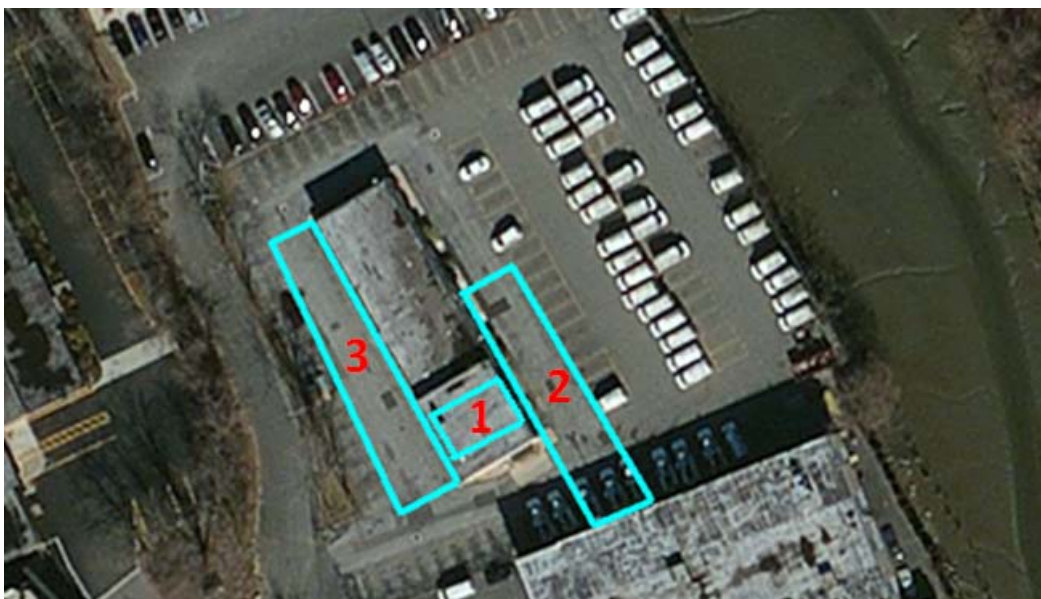
The first area of concern (AOC) was located within the vehicle maintenance garage. The garage contained a large hydraulic lift and portions were covered by stored materials and tools. The second AOC was an approximately 28 by 110-foot asphalt paved portion of the parking lot located at the east side of the building near the vehicle maintenance garage. This area includes the former location of a 280-gallon waste-oil underground storage tank (UST) and four 4,000-gallon gasoline USTs. All five USTs have been excavated. This AOC was bound to the south by a chain-link fence and to the east by a row of parked vehicles. The third AOC was an approximately 30 by 144-foot asphalt paved portion of the parking lot located at the west side of the building. This AOC was bound to the west by a row of parked vehicles and to the east by the site building.

Approximate extents of AOCs (Bing Maps)

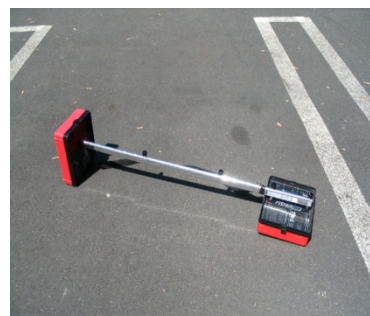
The Fisher TW-6 Pipe and Cable Locator, also known as the M-Scope, is a type of hand-held electromagnetic metal-detector. The instrument consists of a transmitter coil and a receiver coil mounted at opposite ends of a 4-foot horizontal staff. The transmitter is fixed in a vertical position. The receiver's orientation is then adjusted to the horizontal, exactly perpendicular to the transmitter. When the receiver is in this perpendicular orientation, its response to the transmitter is at a minimum. Metallic objects in the vicinity of the instrument pick up the transmitted signal and, acting as secondary transmitters, cause detectable interference at the receiver. By adjusting the gain of the instrument as well as its position relative to a buried metallic object, an experienced operator can often obtain information as to the size or shape of the target.

TW-6 hand-held metal detector

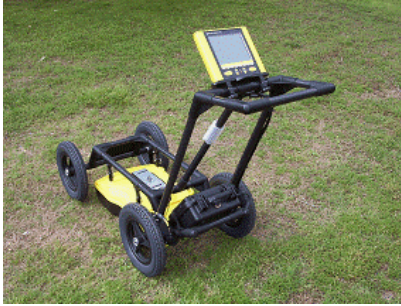
The Sensors & Software Smart Cart GPR system utilizing a 250 MHz antenna was selected to investigate the vehicle maintenance garage, anomalies identified by the TW-6, and the areas in the vicinity of the former USTs. The GPR antenna radiates short pulses of electromagnetic energy into the ground. Whenever these pulses strike an interface having variant dielectric properties, part of the wave is reflected back and detected at the surface. These profiles are then examined in real-time for parabolic reflections that could be interpreted as representing subsurface utilities.

GPR with 250 MHz antenna

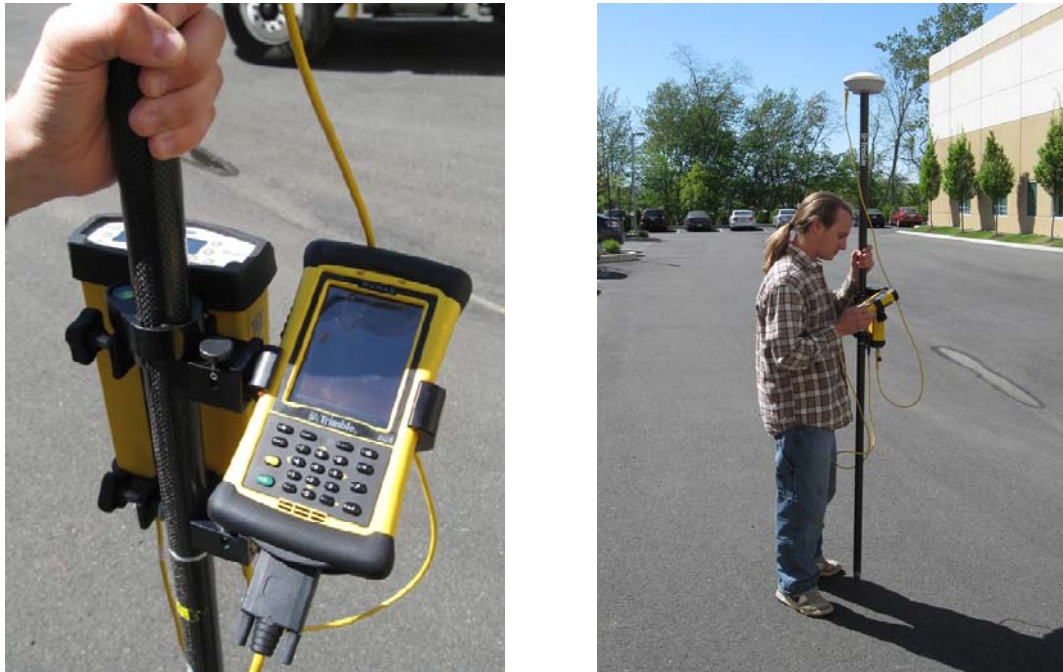
The Trimble GPS was utilized for creating a geo-referenced culture map. The GPS consists of a Pathfinder ProXRT receiver with a GLONASS satellites option, a Nomad 800GXC hand-held computer with a Terrasync software package for data recording, and a Tornado external dual-frequency antenna mounted on a 2-meter (6.56 feet) carbon fiber range pole. The GPS data was post-processed using Pathfinder Office software at our Congers, New York office to achieve sub-foot accuracy. After the post processing, the GPS data was exported into AutoCAD® format for the final map in New York State Plane coordinates.

Trimble GPS and Nomad hand-held computer

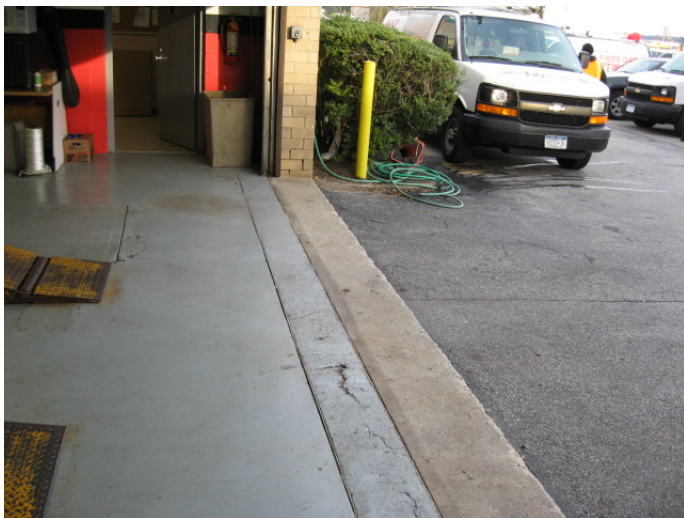
All of the drainage structures within the vehicle maintenance garage were filled with concrete; therefore NAEVA's ability to determine the routing of possible subsurface piping was limited. These features include a trench drain along the garage entrance, two former floor drains, and a former oil/water separator. Since there was no access to the interiors of each feature, GPR data was collected over the accessible portions of the garage in an effort to identify subsurface piping. The floor slab was found to be constructed of RC which inhibited the penetration of the GPR's signal; therefore we could not conclusively identify evidence of subsurface utilities at this location.

Photo 1: Trench drain filled with concrete within the vehicle maintenance garage.

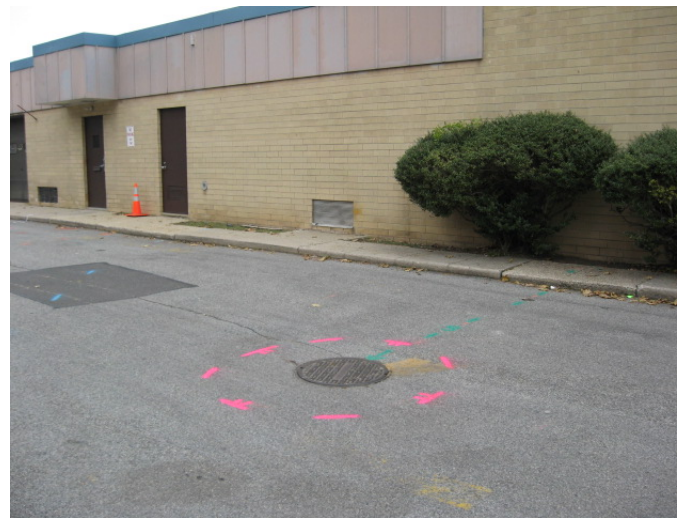
The former oil/water separator was located approximately 40 feet from the southernmost corner of the building. This location is in line with a sewer vault, located outside of the building

in AOC-3 (see Plate 1). From this vault a sewer pipe was visible at approximately 2 feet deep. This line was traced back to the building utilizing a tracing signal that was applied onto a flexible steel antenna. The steel antenna could only be inserted into the pipe for approximately 16 feet before resistance within the pipe was encountered. It is believed that this resistance is caused by the concrete used to seal the oil/water separator. The sewer vault was filled with water; therefore NAEVA could not determine if an outlet pipe is present or if this feature is merely a drywell. A visual inspection of areas to the west of the sewer vault including Lumber Road did not indicate any evidence of other manholes that may be related.

Photo 2: View looking east of the sewer vault and line related to the oil water separator within the garage.

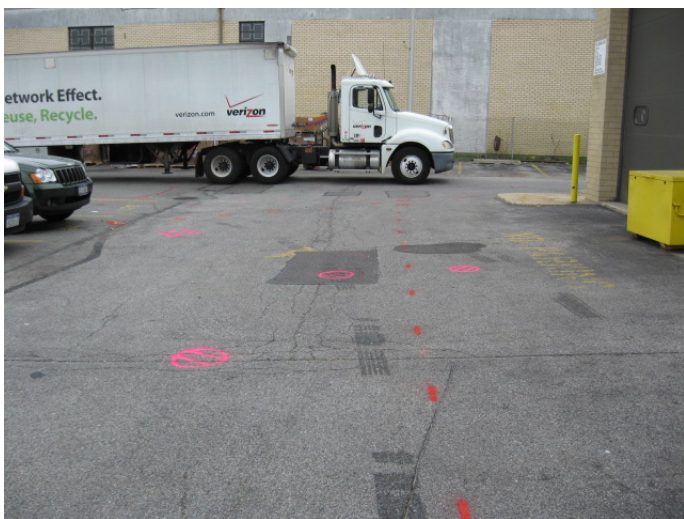
An asphalt patch was visible approximately 15 feet east of the vehicle maintenance garage marking the location of the former 280-gallon waste-oil UST. The location of the former 4,000-gallon gasoline USTs was obstructed by parked vehicles. An approximately 9 by 20-foot RC pad which once contained a fuel dispenser was located immediately south of the former gasoline UST area. The northern edge of this pad was irregularly shaped suggesting that it may have been impacted when the USTs were removed. Five electrical conduits and two former suspected UST vent lines were located immediately east of an above ground waste-oil storage tank located at the south side of the building. The two western conduits were 2-inches in size and were traced east toward a light pole and storage container located at the southeast corner of the parking lot. The remaining three 1-inch conduits and the two former vent lines were traced east along the curb line then approximately 25 feet northeast to the limit of the tracing signal that was applied to each line. The termination points of these lines likely represent the edge of the excavation for the former gasoline USTs.

Photo 3: View looking south. The asphalt patch in the center of the photo represents the former location of the 280-gallon waste oil UST. The electric line servicing the light pole located opposite the tractor trailer is visible immediately west of the asphalt patch.

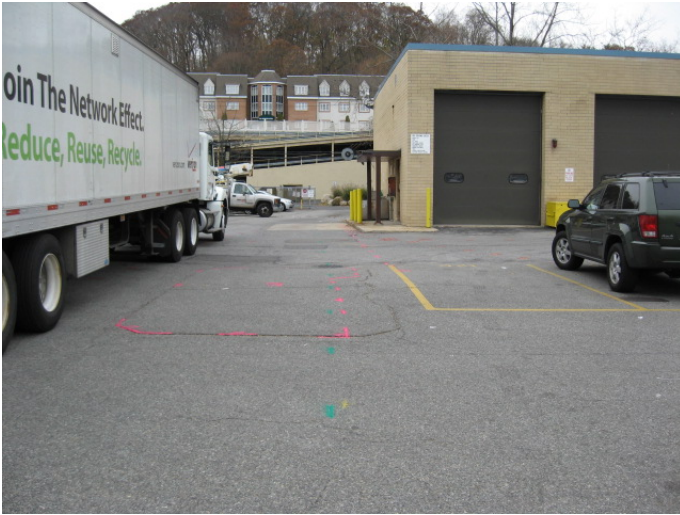
Photo 4: View looking west of the former pump island RC pad located adjacent to the tractor trailer.

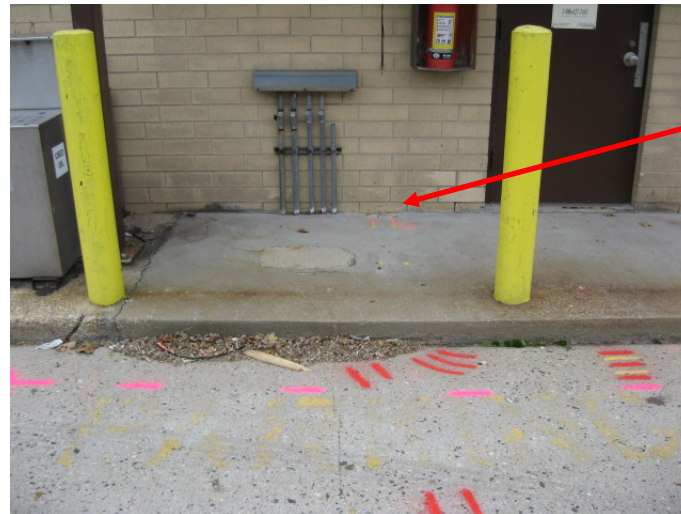
Two cut UST
vent lines.

Photo 5: View of the south side of the building showing the five electric conduits and two cut UST vent lines.

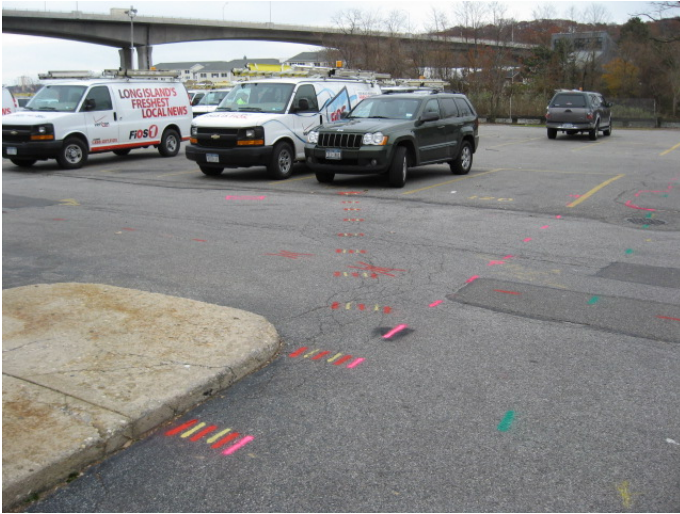
Photo 6: View looking northeast of the electric and vent lines which once serviced the former USTs.
