# Technical Memorandum

Project Title: Former Baron Blakeslee Property Site Number C152204

Subject: 2023 Annual Periodic Review Report and Certification  
Sub-Slab Depressurization System Date: May 11, 2023

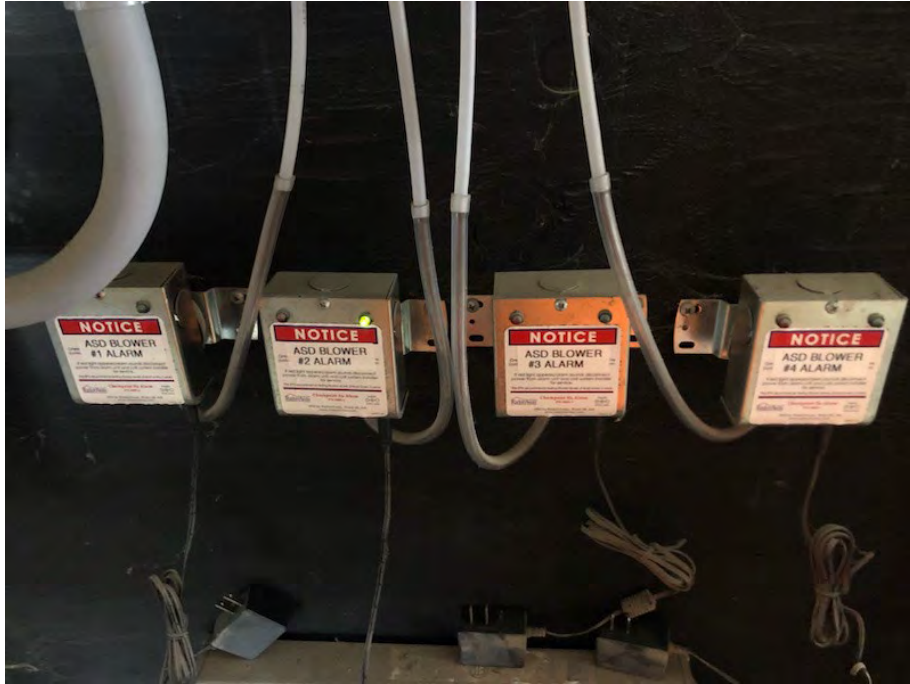
**Photograph 1:** View of the alarms for the SSDS fans. Only the alarm for SP2 is plugged in since this is the only required SSDS fan to be operating.

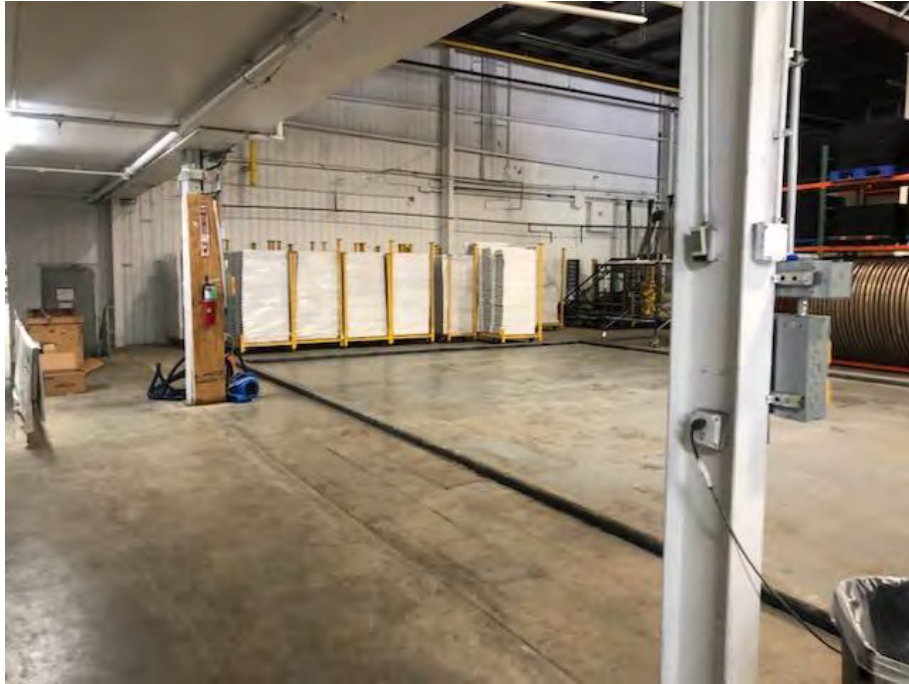
**Photograph 3:** View of the main warehouse in the area of SP2.

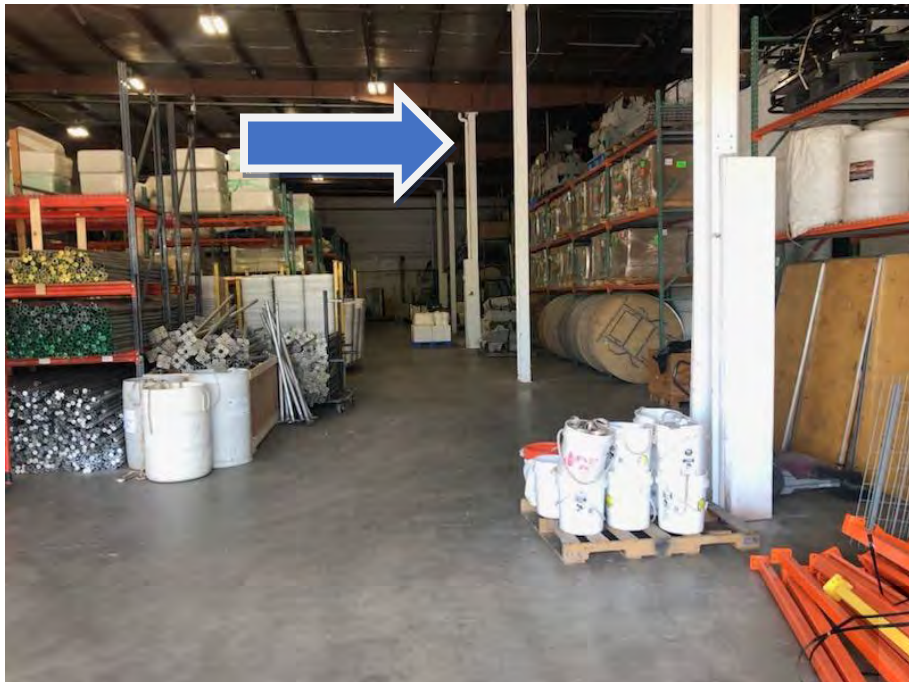
**Photograph 4:** View of the main warehouse and the piping for SP-2.
