PHASE I - SITE ASSESSMENT  
OF  
BH AIRCRAFT  
441 EASTERN PARKWAY  
FARMINGDALE, NEW YORK

JANUARY 2001

PREPARED FOR:  
STATE BANK OF NEW YORK  
2 JERICHO PLAZA  
COLJERICHO, NEW YORK 11753

PREPARED BY:  
TYREE BROTHERS ENVIRONMENTAL SERVICES, INC.  
208 ROUTE 109  
FARMINGDALE, NEW YORK 11735  
(631) 249-3150

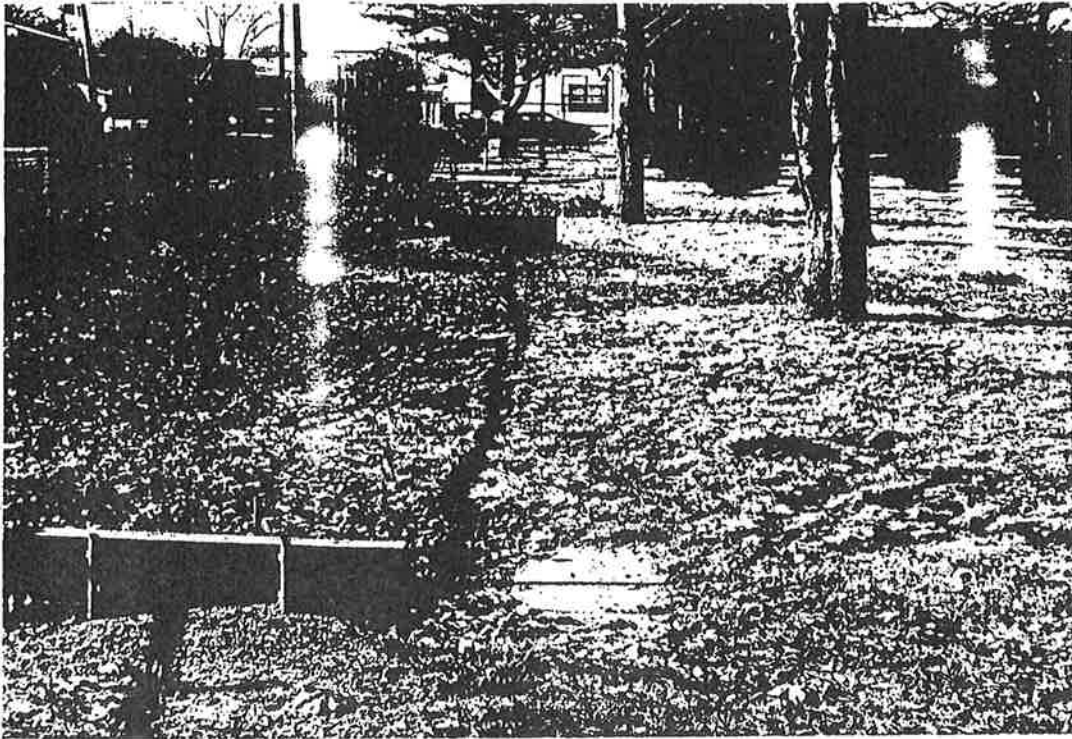
**Photo 36:** *View of suspected former sanitary leaching field.*
