Phase I Environmental Site Assessment Report

MEI Project Number 16-1337

Property located at 71 New Street in Huntington, New York

February 6, 2017

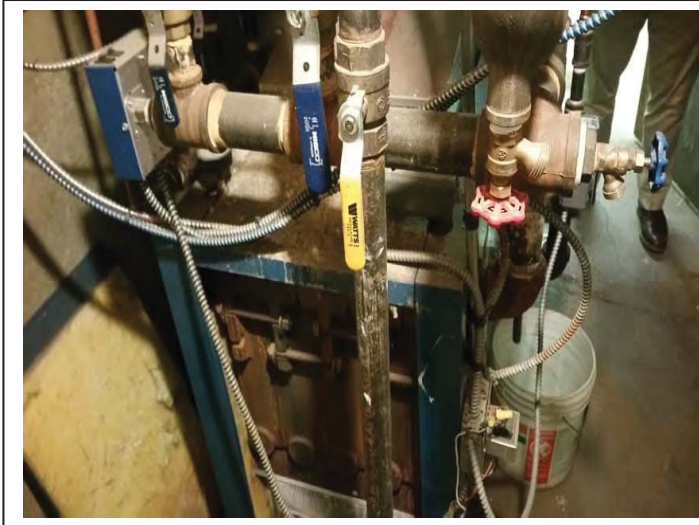
BOILER UNIT

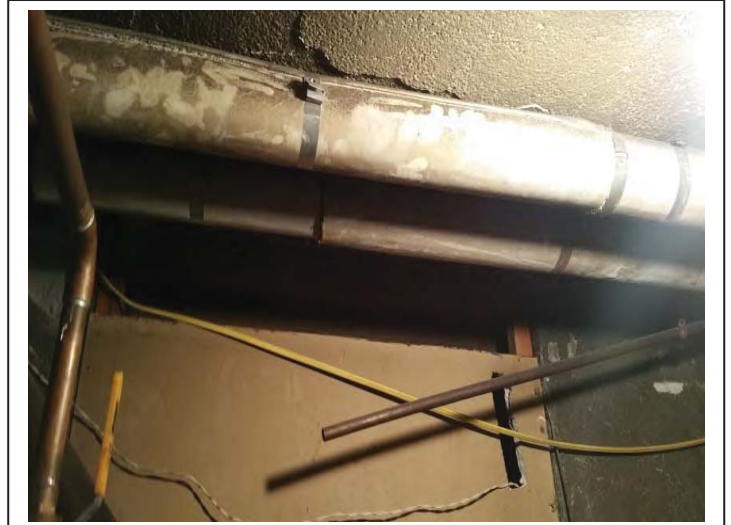
It should be noted that the limited visual screening survey conducted under the scope of work for this assessment does not constitute a full asbestos inspection, in which all areas of the building would have been thoroughly surveyed and sampled. MEI observed the presence of approximately 20 linear feet of asbestos containing pipe wrap on the overhead pipes in the basement area of the building. The observed ACM material was found to be in fair to good condition. MEI observed small areas of 9 by 9 inch floor tiles in the building which were also in good condition. However, prior to any planned demolition activities, it is recommended that a full ACM survey be conducted and all ACM be properly removed and disposed. MEI did not observe any signs of ACM spray-on fireproofing inside the building.

ACM ON OVERHEAD PIPE

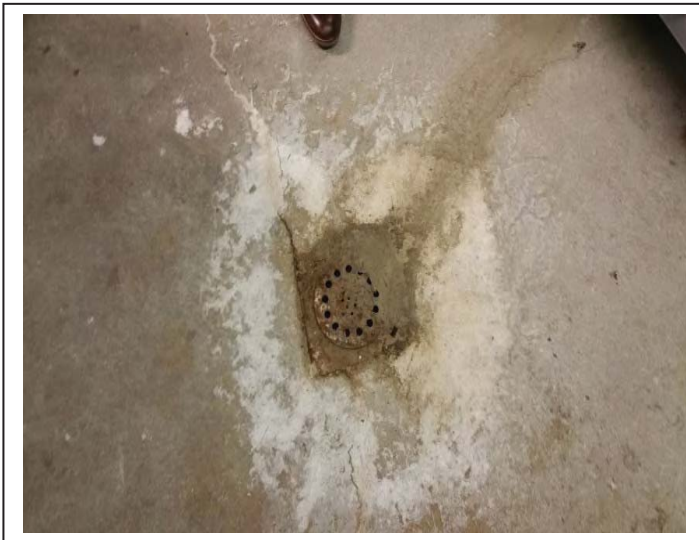
MEI observed one (1) floor drain inside the basement area of the building. The observed floor drain did not show any signs of chemical or petroleum staining. Given the past usage of the Subject Property and the fact that the building is to be demolished in the near future, it is recommended that this floor drain be dye tested to determine discharge endpoint. If drain discharges directly to the ground or an on-site cesspool or drywell, it is recommended that a sample of the sediment from the base of the drain or cesspool/drywell should be extracted and analyzed to determine if any contamination from past embalming activities has impacted the subsurface. MEI did not observe any storm water drywells at the Subject Property.

MEI observed one (1) floor drain inside the basement area of the building. The observed floor drain did not show any signs of chemical or petroleum staining. Given the past usage of the Subject Property and the fact that the building is to be demolished in the near future, it is recommended that this floor drain be dye tested to determine discharge endpoint. If drain discharges directly to the ground or an on-site cesspool or drywell, it is recommended that a sample of the sediment from the base of the drain or cesspool/drywell should be extracted and analyzed to determine if any contamination from past embalming activities has impacted the subsurface.

FLOOR DRAIN IN BASEMENT

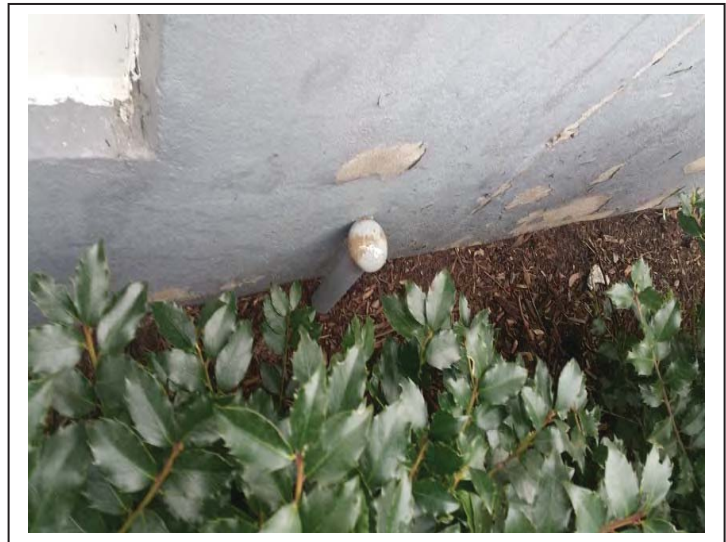
MEI observed the presence of a vent pipe associated with a 1,000 gallon underground fuel oil storage tank. The property manager indicated that this tank has been abandoned in place. However, there was no documentation pertaining to any past tank tests or abandonment information. Given the fact that the building is to be demolished in the near future, it is recommended that soil borings be extracted from the perimeter of this tank to determine if any contamination from past tank leakage has impacted the subsurface.

VENT FOR UST

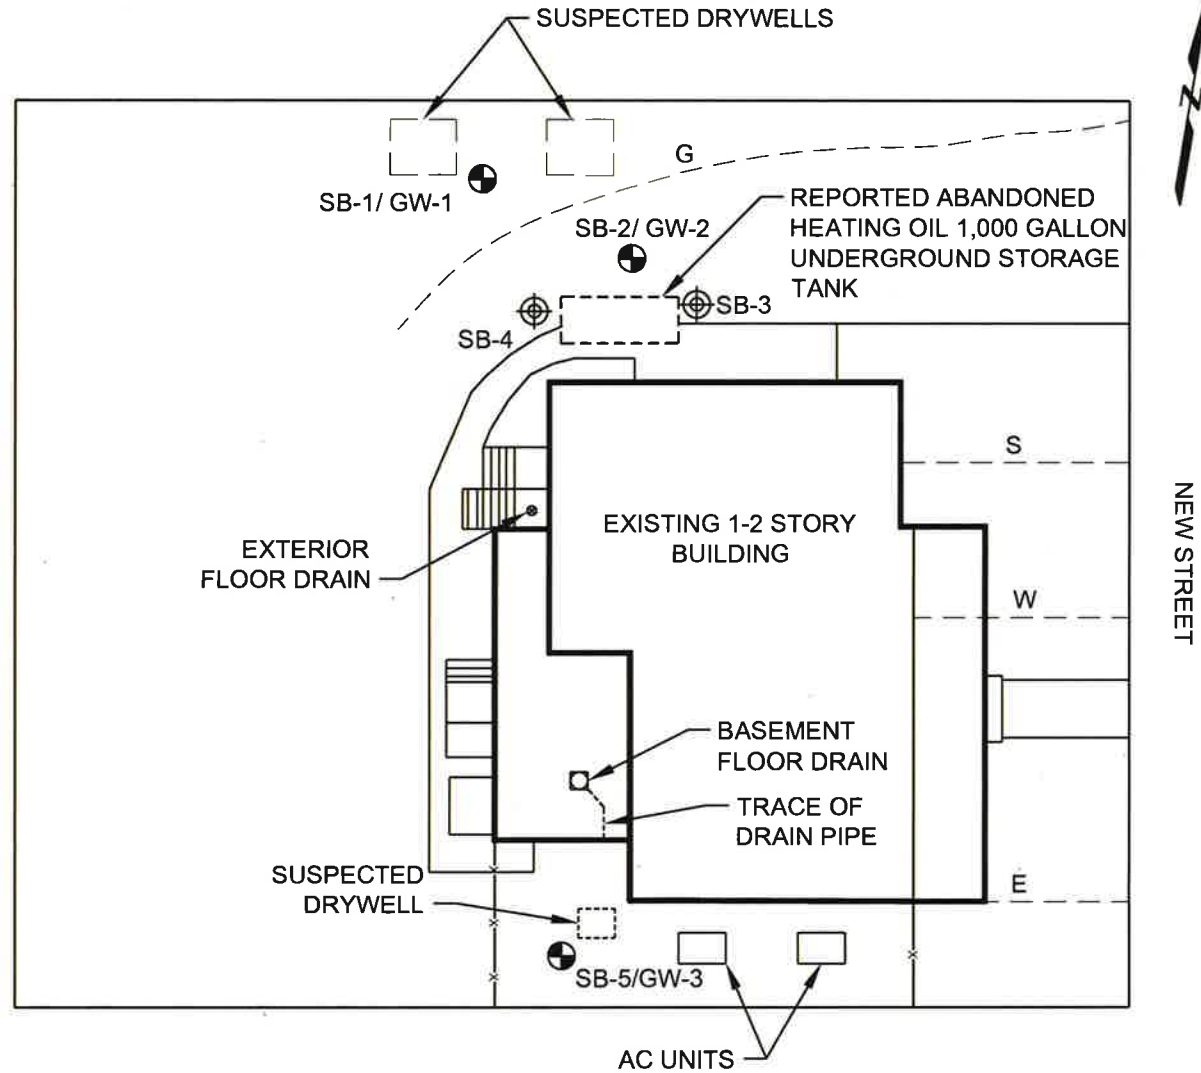
⊕ SB-4 SOIL BORING & SAMPLE LOCATION

G - UNDERGROUND GAS LINE
 S - UNDERGROUND SANITARY LINE
 W - UNDERGROUND WATER LINE
 E - UNDERGROUND ELECTRIC LINE
