Re: Groundwater Well Decommissioning for the Parkview Commons Site
located at 436 East 161st Street, Bronx, New York
Brownfield Cleanup Site #: C230014
ESI File: LB03027.70

This Groundwater Well Decommissioning Letter Report (Letter Report) summarizes fieldwork performed by Ecosystems Strategies, Inc. (ESI) on the above-referenced property. ESI personnel oversaw the decommissioning of three groundwater monitoring wells (MW-2R, MW-4, and MW-5; see the Attached map) at the Site. This work was completed according to the New York State Department of Environmental Conservation (NYSDEC) approved Groundwater Monitoring Well Decommissioning Procedure, submitted to the NYSDEC by ESI on January 28, 2009.

**Decommissioned
 Monitoring Well
 Location Map
 "Parkview
 Commons Site"**

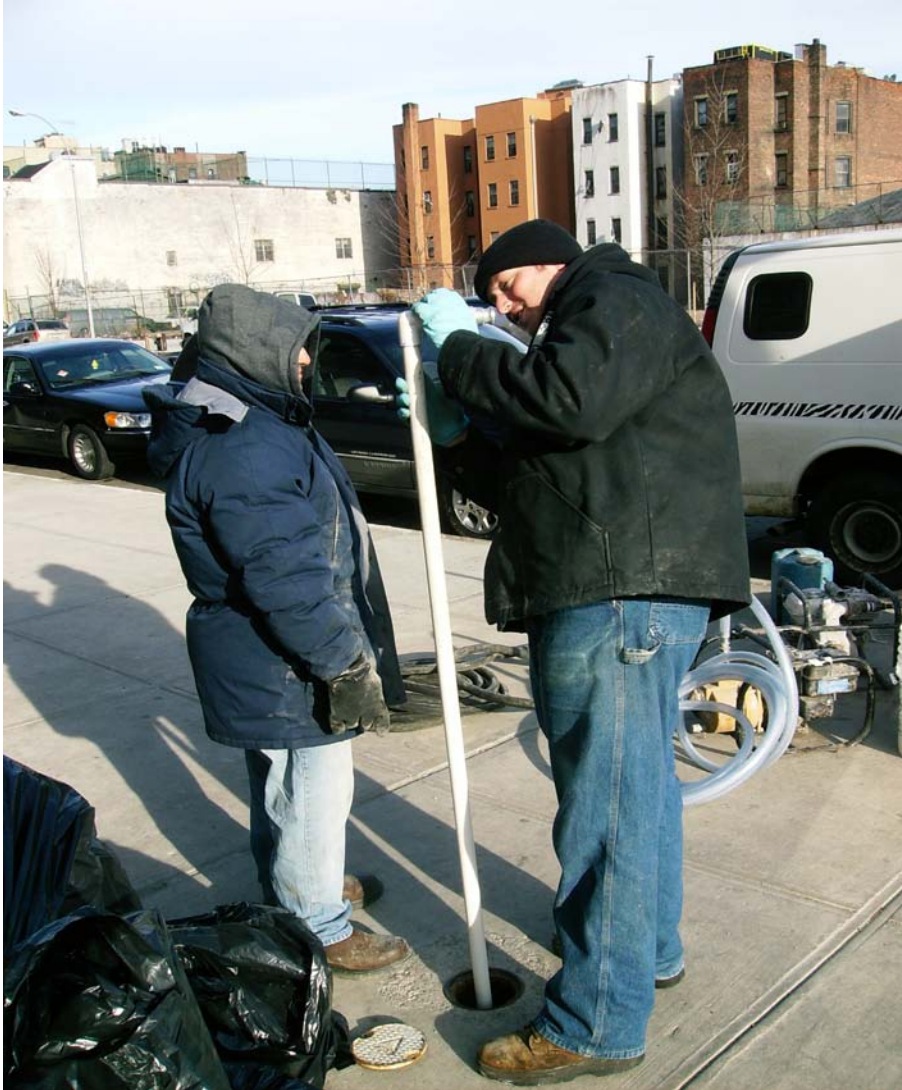
1. Insertion of pipe into well.

- Each well was opened, and piping was inserted to the bottom of the well.
- The grout was mixed in a 55 gallon drum.
- The grout mixture was pumped into the well through the pipe, placing the grout from the bottom to the top of the well.
- The well cap was filled with concrete.

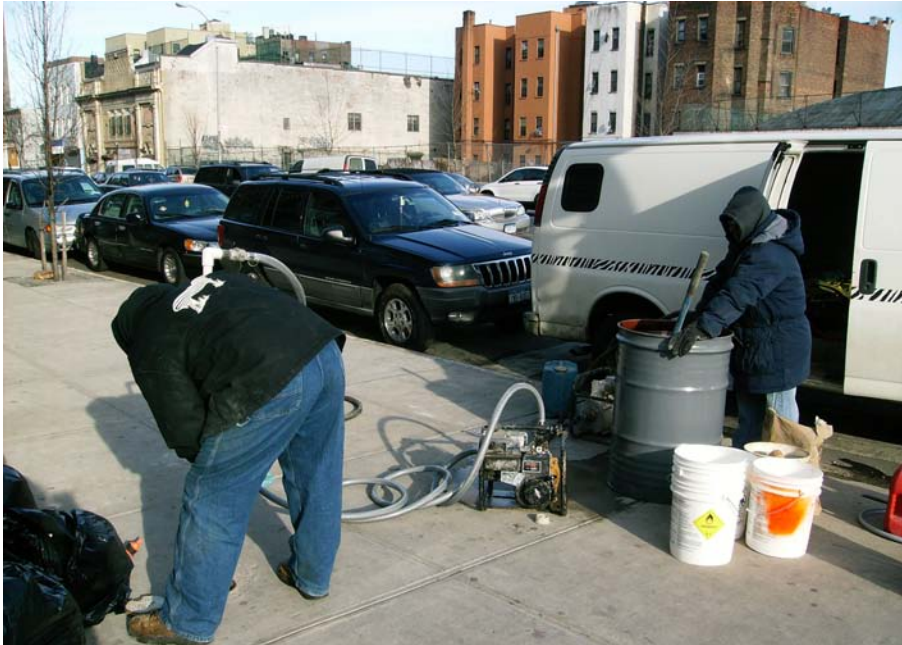
2. Pump utilized to pump grout into well.

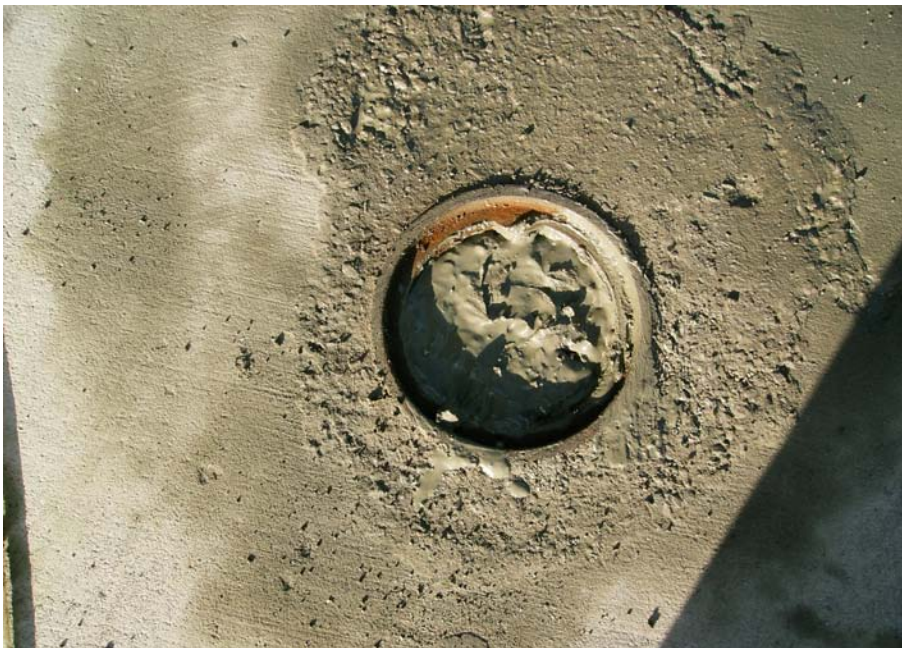
3. Well cap filled with concrete.

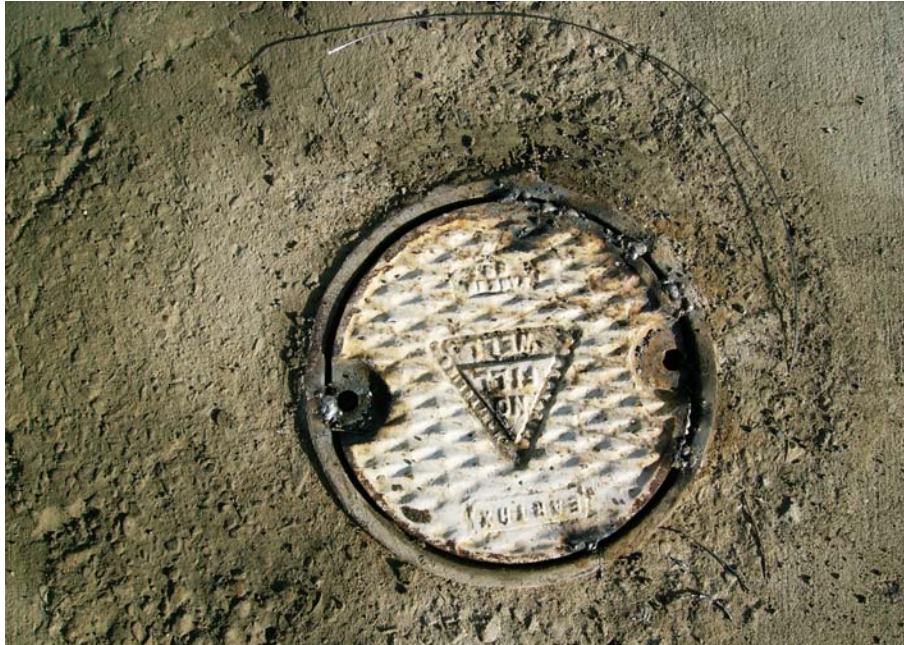
4. Well cover welded in place.

- The cover was welded into place; the asphalt was patched for the monitoring well located in the parking lot behind the building.
