Periodic Review Report 2013

**New Housing New York Legacy Project
700-730 Brook Avenue
BRONX, NEW YORK
Site # C203043**

August 2013

**Stephen J. Osmundsen, P.E.
514 Pantigo Road
East Hampton, NY 11937**

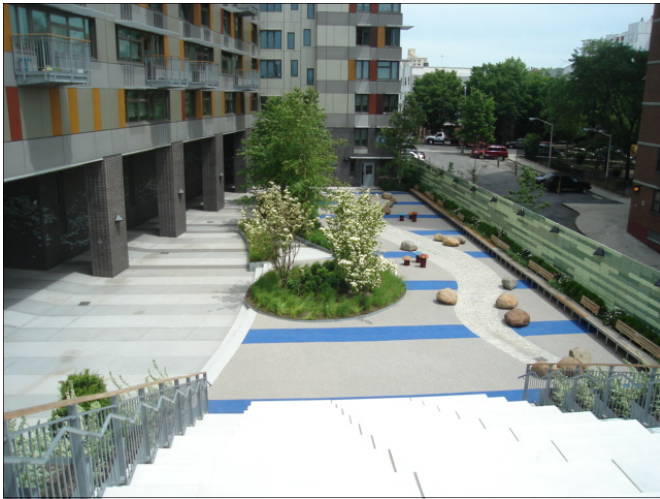
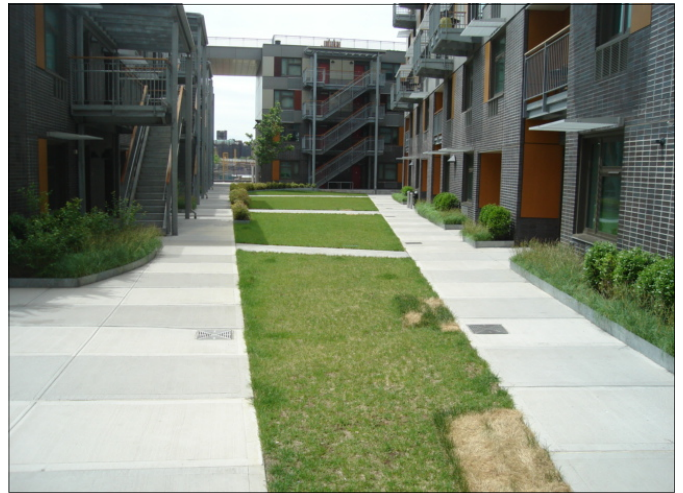
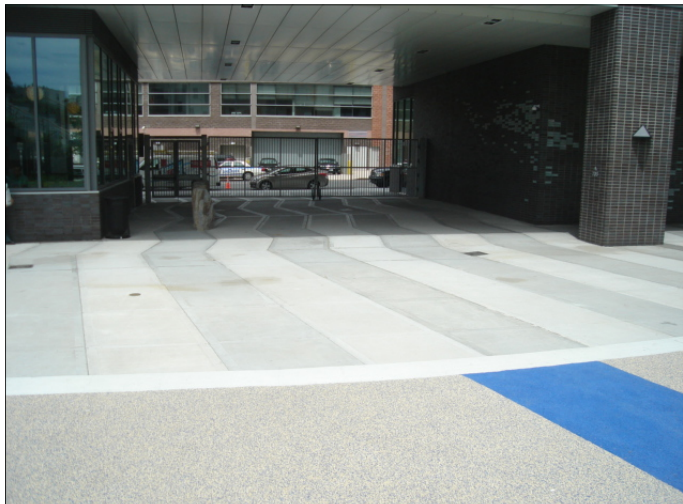
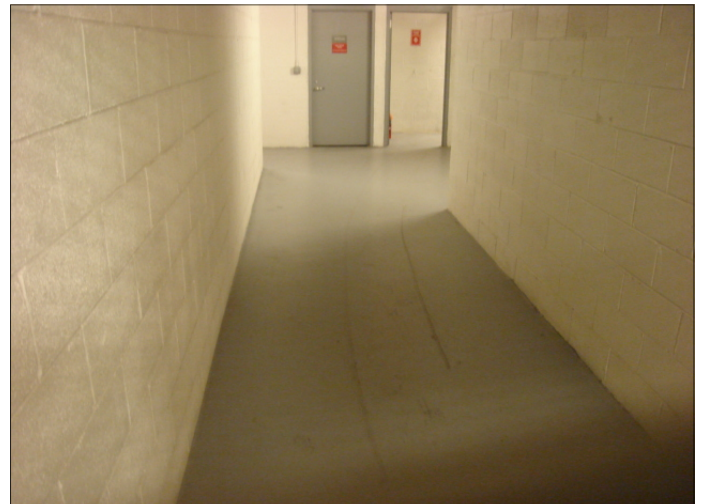
Composite Cover System

The Site inspection included a visual inspection of the composite cover system to determine if it was intact and free from damage that might render it unsuitable for its intended purpose. Richard Izzo did not identify any areas where the cover system appeared impaired, compromised, or otherwise damaged. In addition, Mr. Colon indicated that there have been no breaches of the composite cover system since the completion of construction.

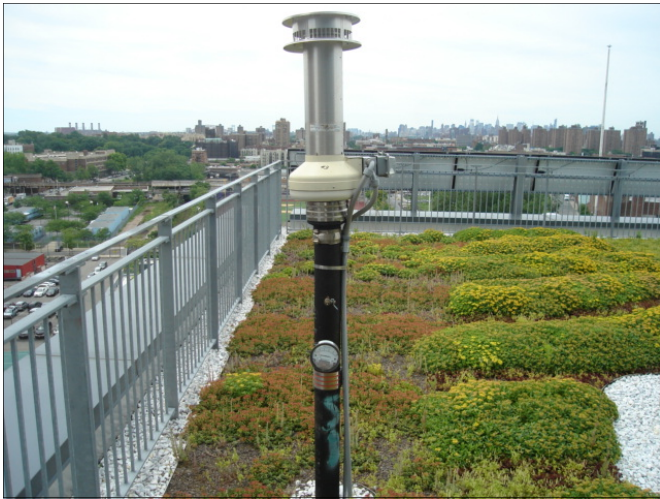
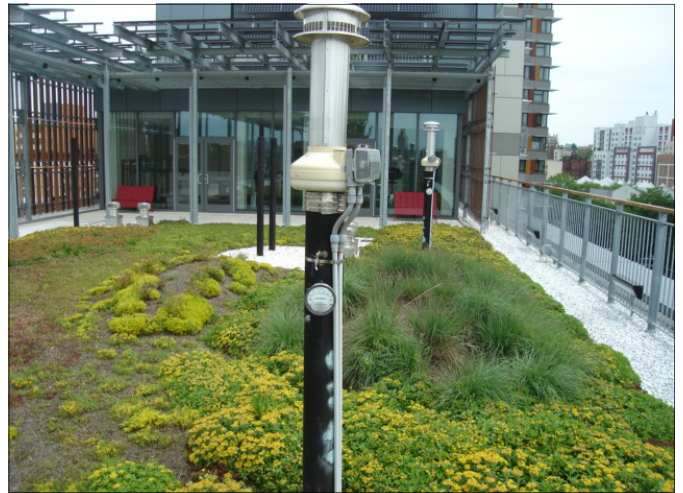
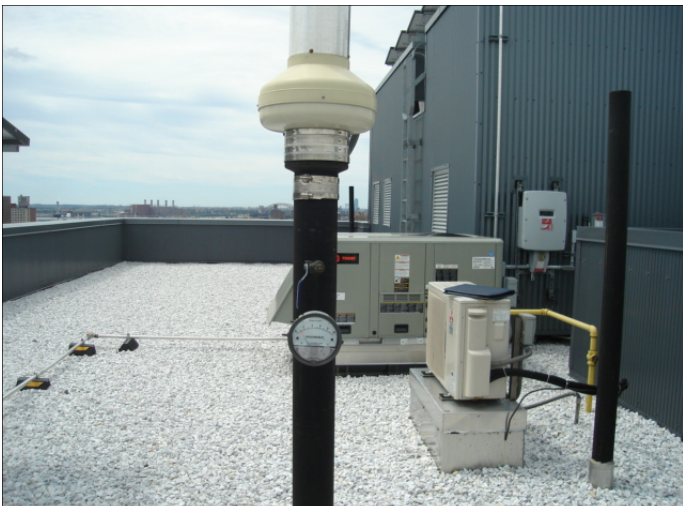
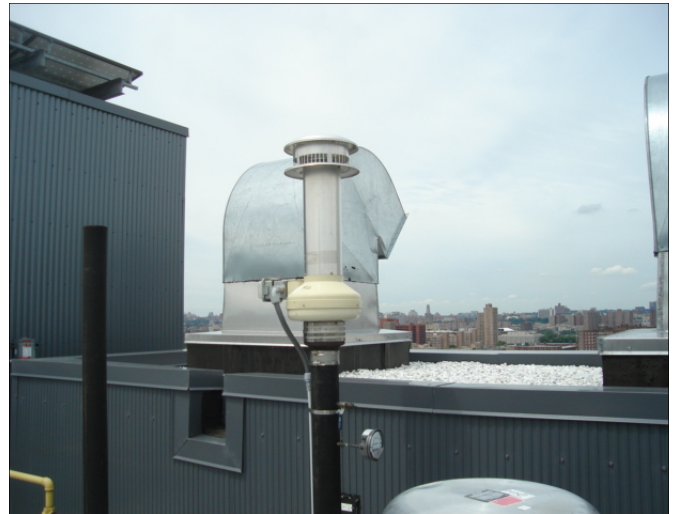
SSD System

No additional site-wide inspections were conducted as there were no emergencies. However, it should be noted that the SSD fans were inspected shortly after storm Sandy in October, 2012. The system was found to be operating properly and no repairs were needed. Select photographs of the Site during the inspection are enclosed as Appendix A. The site-wide inspection form and hurricane project status forms are enclosed in Appendix B.

No penetrations of the vapor barrier were observed during the June 6, 2013 inspection.
