Periodic Review Report 2016

**New Housing New York Legacy Project
700-730 Brook Avenue
BRONX, NEW YORK
Site # C203043**

May 2016

**Prepared by:
CA RICH Consultants, Inc.
17 Dupont Street
Plainview, NY 11803**

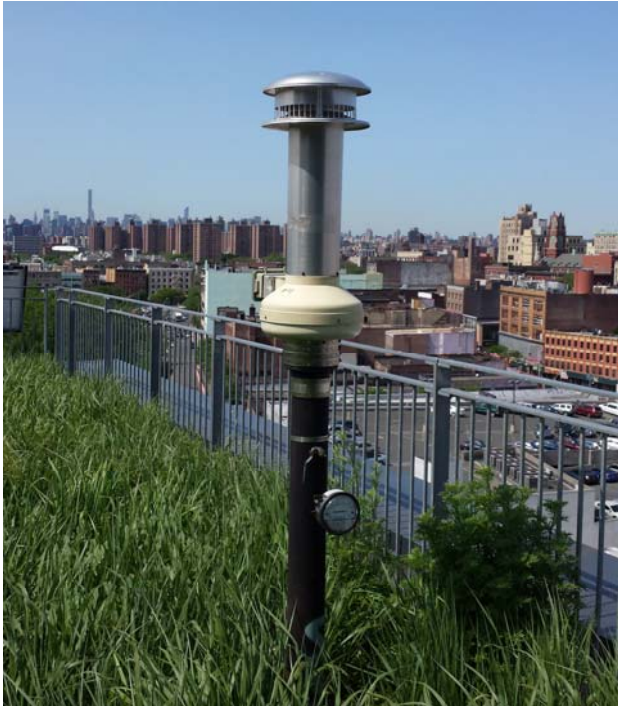
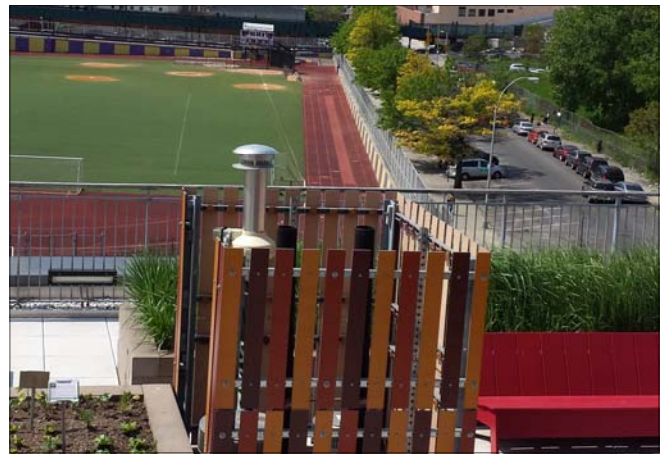
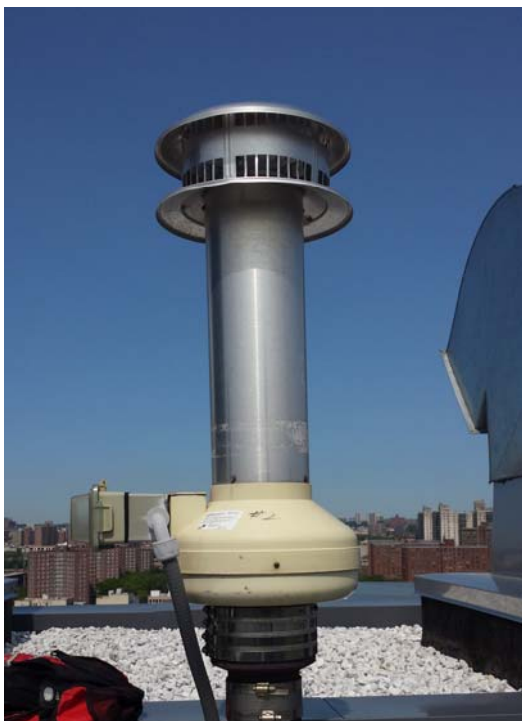
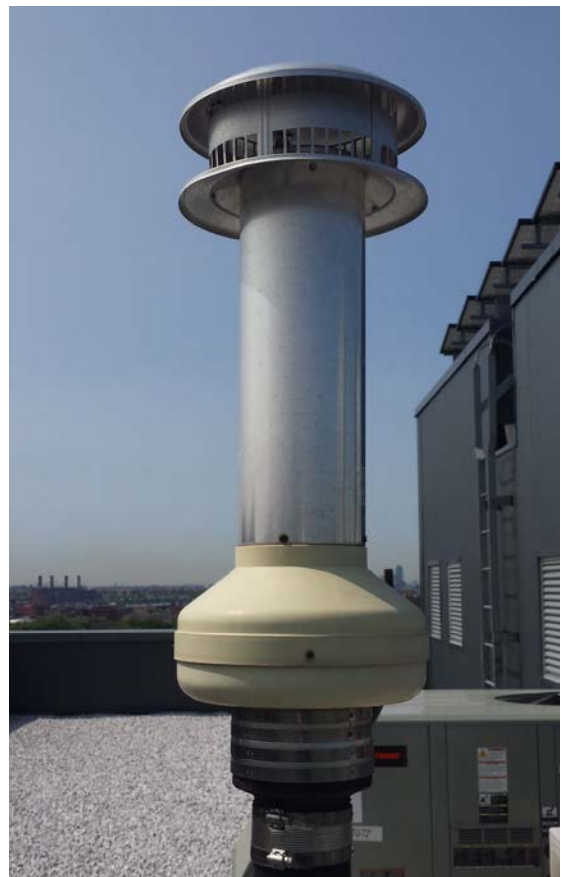
SSD System

As discussed in Section 4.1, the system was found to be operating properly, and no repairs were needed at the time of the May 20, 2016 inspection.

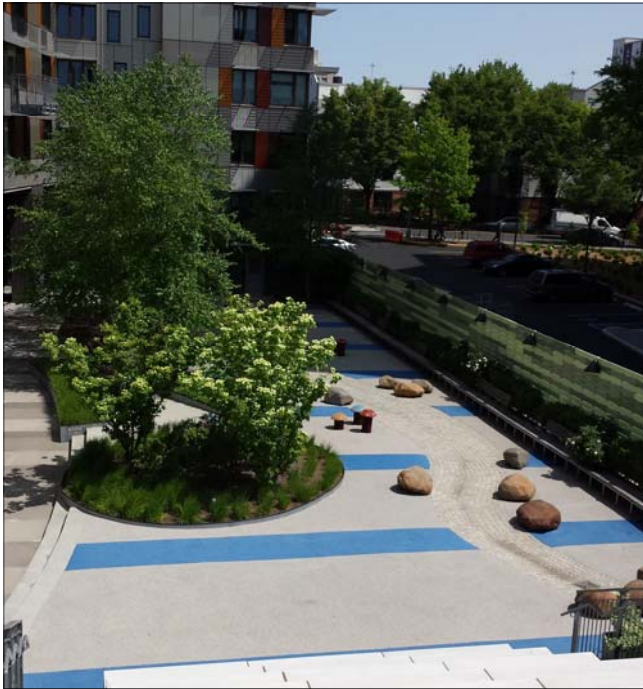
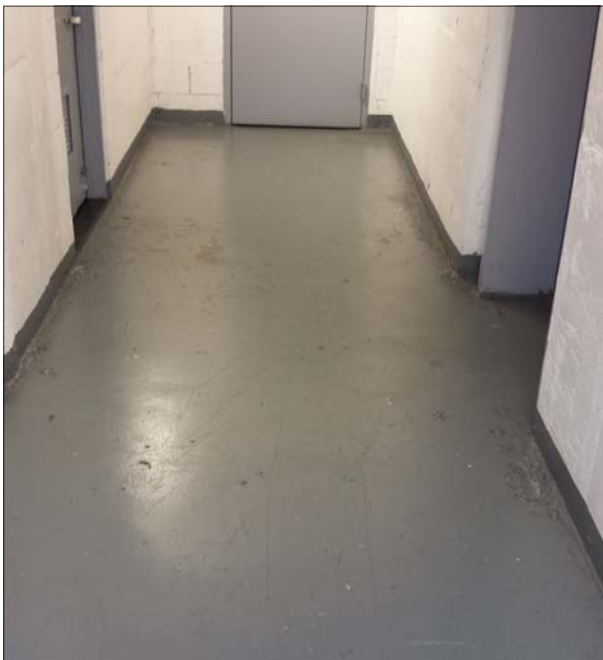
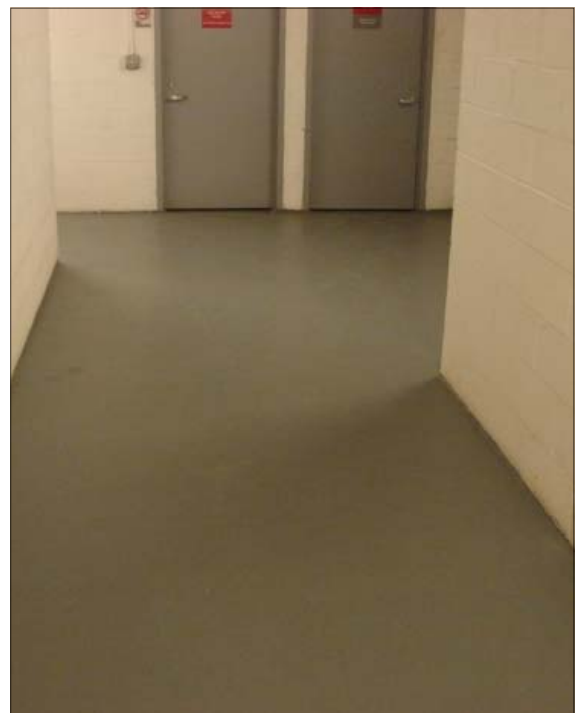
Composite Cover System

The Site inspection included a visual inspection of the composite cover system to determine if it was intact and free from damage that might render it unsuitable for its intended purpose. Mr. Izzo did not identify any areas where the cover system appeared impaired, compromised, or otherwise damaged. In addition, Mr. Colon indicated that there have been no breaches of the composite cover system since the completion of construction.
