Periodic Review Report 2017

**New Housing New York Legacy Project
700-730 Brook Avenue
Bronx, New York
Site # C203043**

June 2017

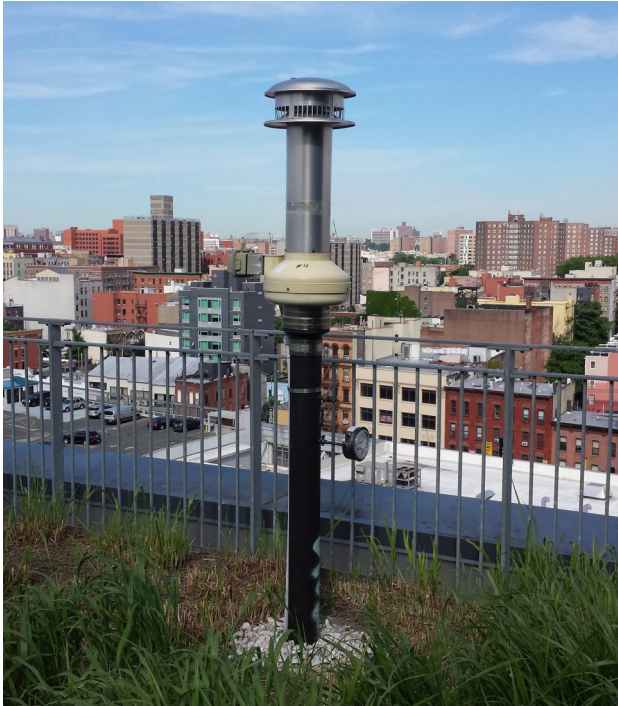
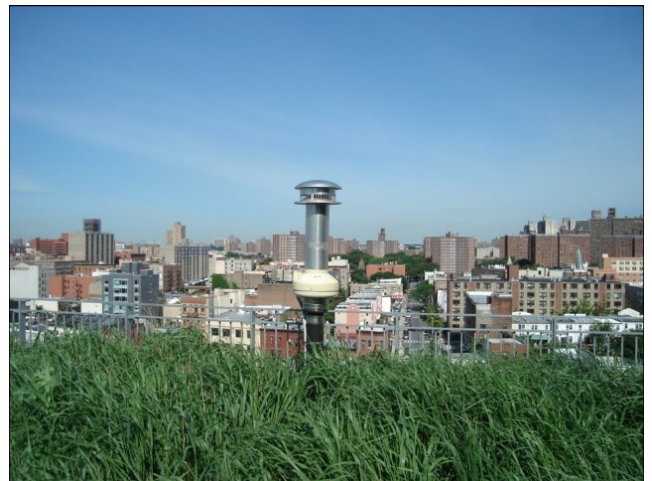
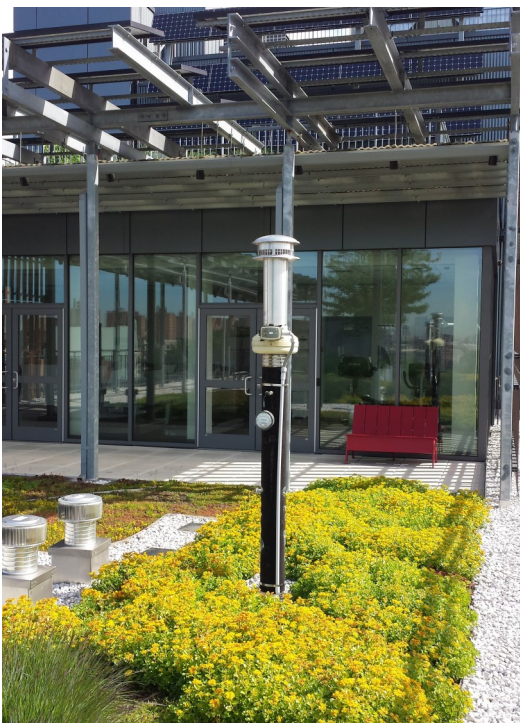
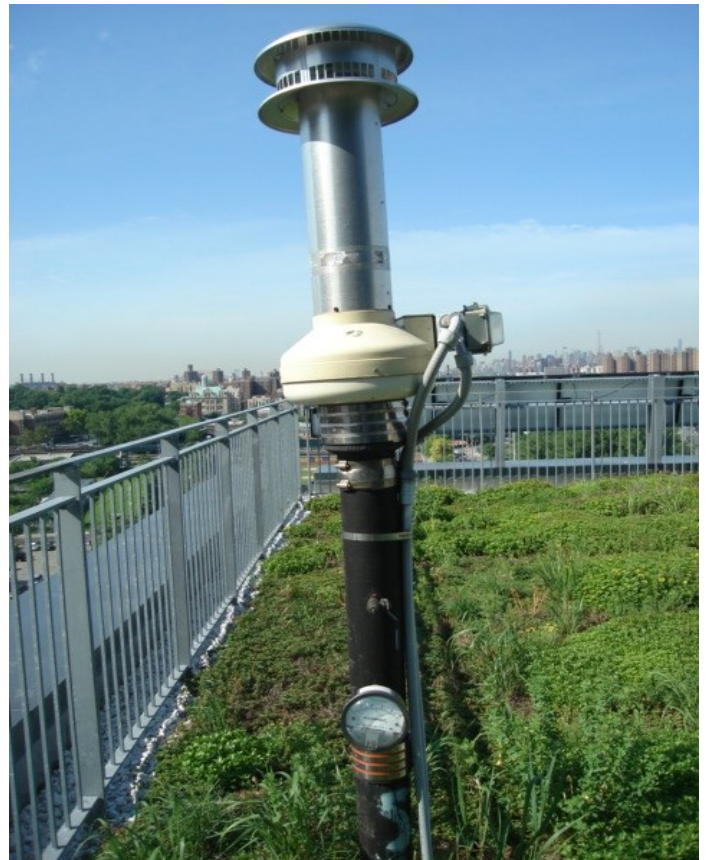
SSD System

A start-up test was conducted on April 19, 2012 to confirm that sufficient vacuum has been achieved beneath the building slab. The start-up test was conducted in accordance with Section 2.3.2 of the SMP. The results of the start-up test confirmed that sufficient vacuum has been obtained. The PID registered zero at all locations except risers 5, 6 & 9 where readings of 1.6, 1.1 and 1.2 ppm were recorded (respectively). The SSDS start-up test results were certified by a Professional Engineer in 2013. As discussed in Section 4.1, the system was found to be operating properly, and no repairs were needed at the time of the June 9, 2017 inspection.

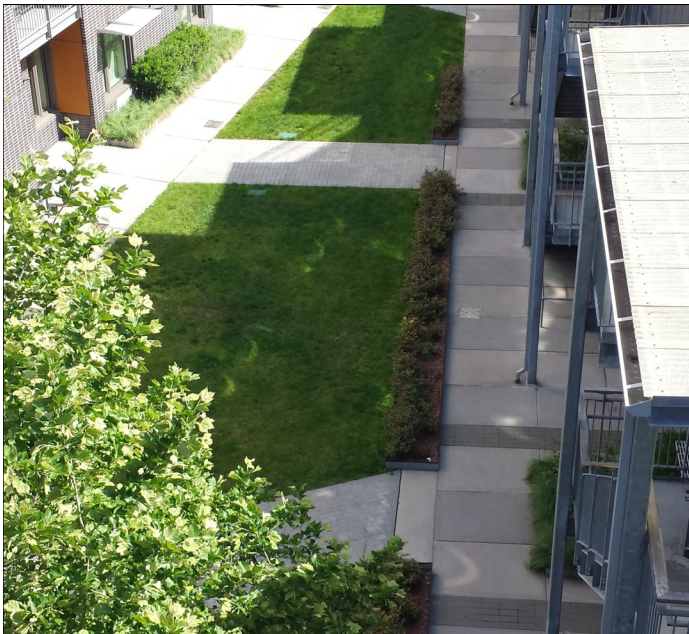
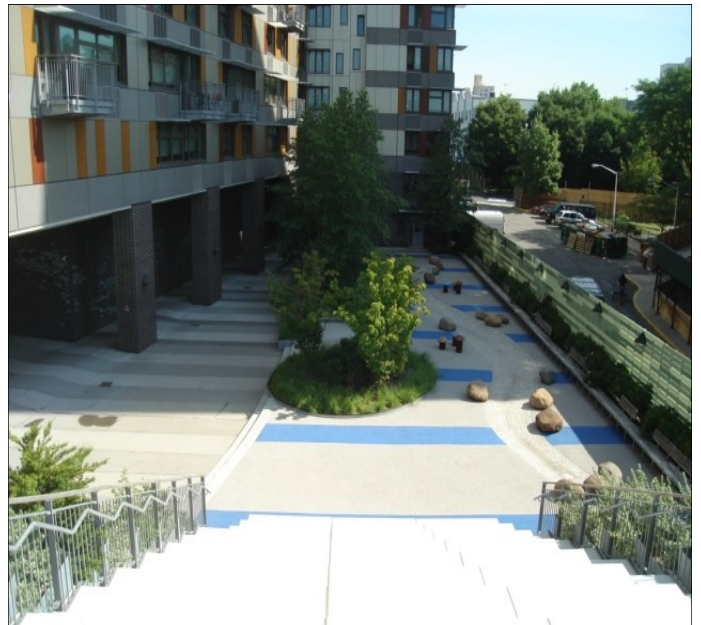
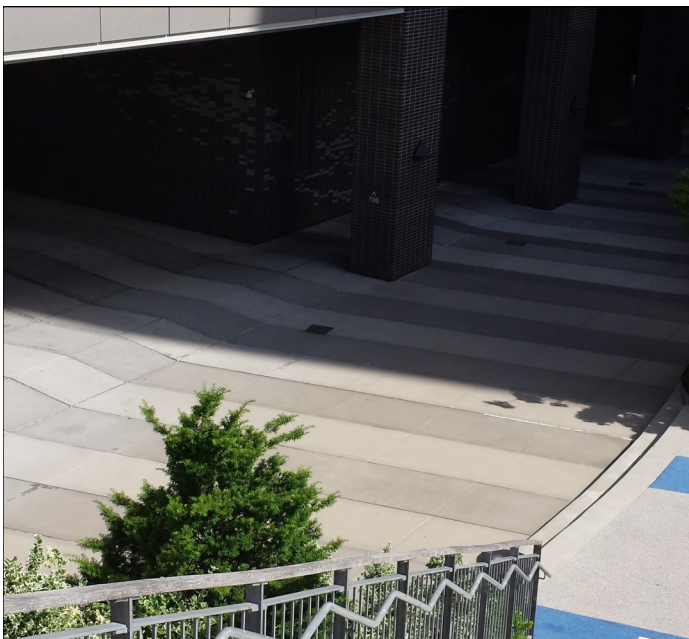
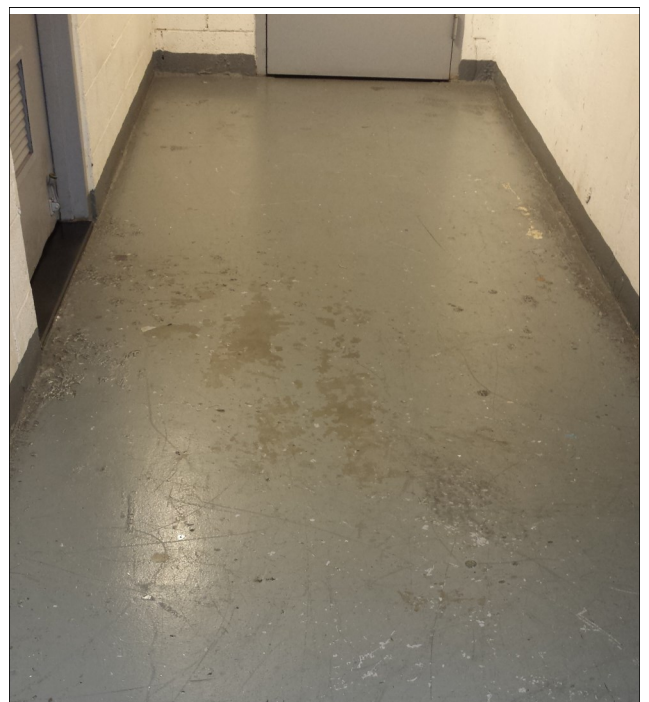
Composite Cover System

The Site inspection included a visual inspection of the composite cover system to determine if it was intact and free from damage that might render it unsuitable for its intended purpose. Mr. Izzo did not identify any areas where the cover system appeared impaired, compromised, or otherwise damaged. In addition, Mr. Colon indicated that there have been no breaches of the composite cover system since the completion of construction.
