## **Periodic Review Report 2019**

**New Housing New York Legacy Project  
700-730 Brook Avenue  
Bronx, New York  
Site # C203043**

**May 2019**

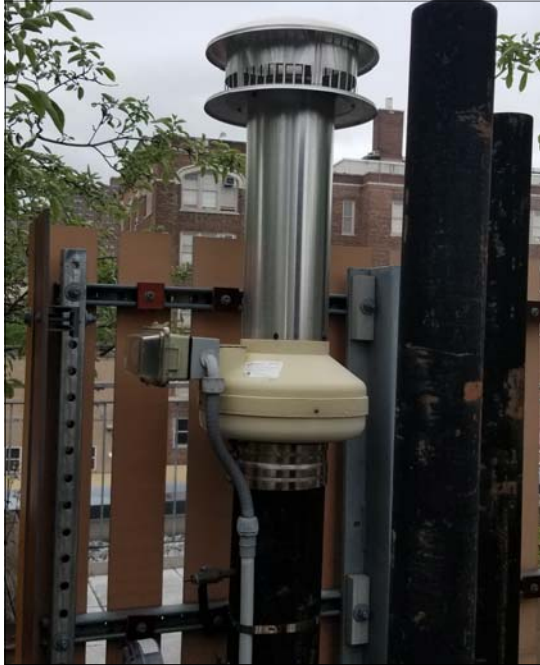
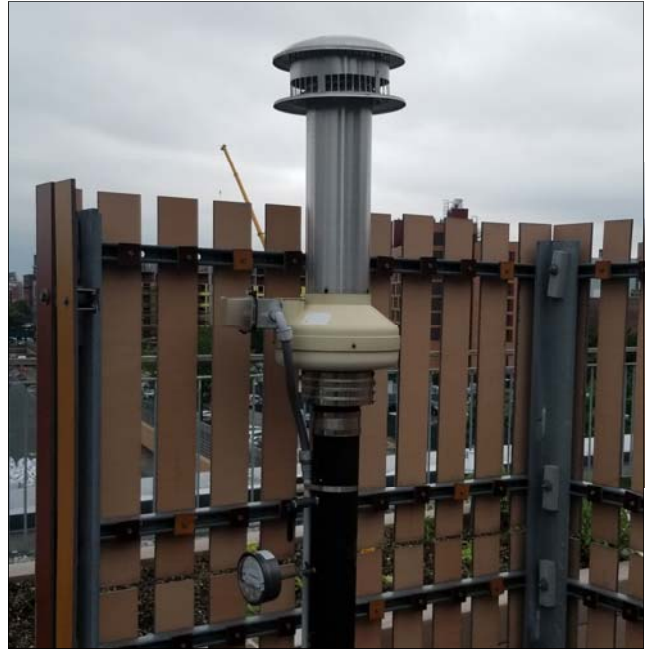
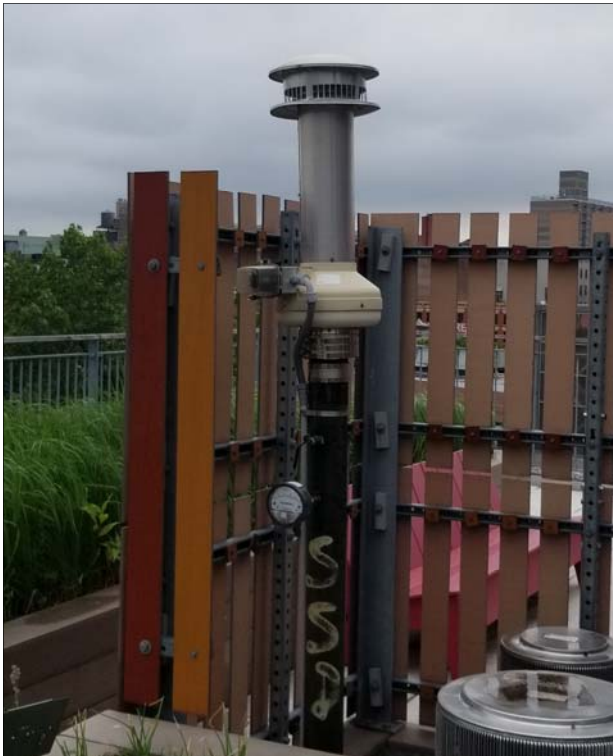
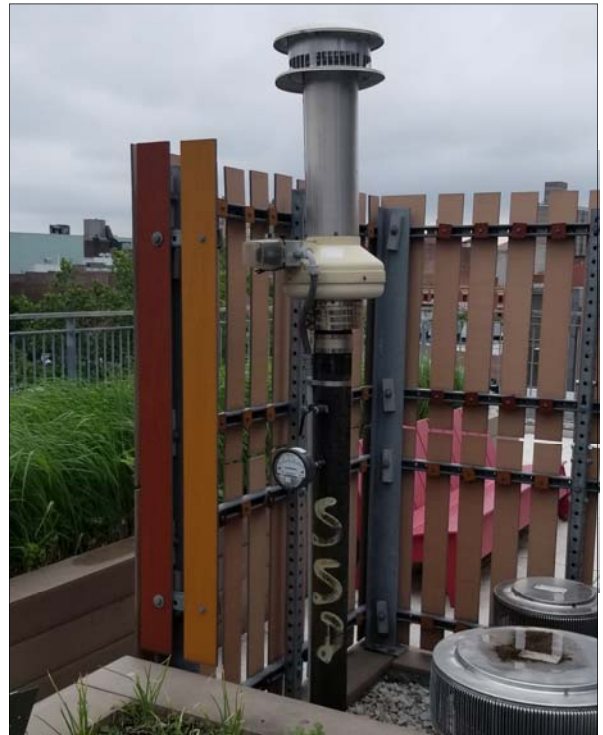
**SSD System**

A start-up test was conducted on April 19, 2012 to confirm that sufficient vacuum has been achieved beneath the building slab. The start-up test was conducted in accordance with Section 2.3.2 of the SMP. The results of the start-up test confirmed that sufficient vacuum has been obtained. The PID registered zero at all locations except risers 5, 6 & 9 where readings of 1.6, 1.1 and 1.2 ppm were recorded (respectively). The SSDS start-up test results were certified by a Professional Engineer in 2013. As discussed in Section 4.1, the system was found to be operating in passive mode, and no repairs were needed at the time of the May 28, 2019 inspection.

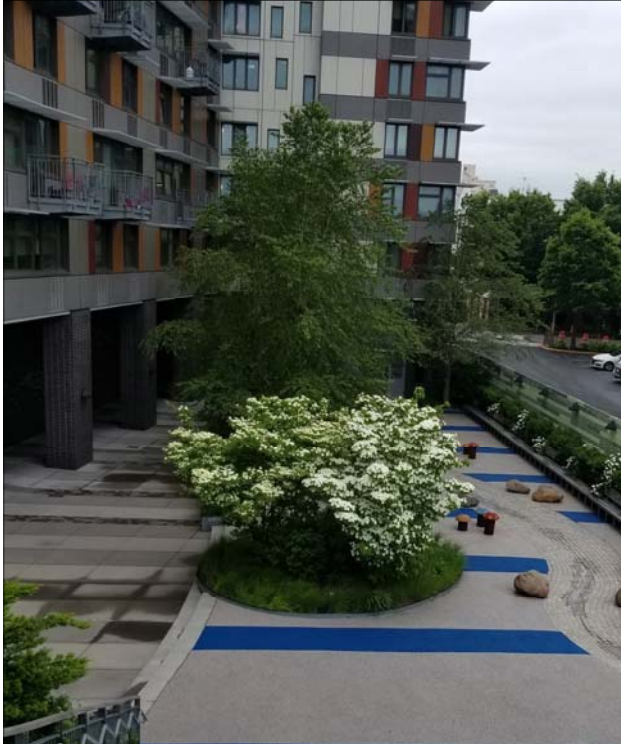
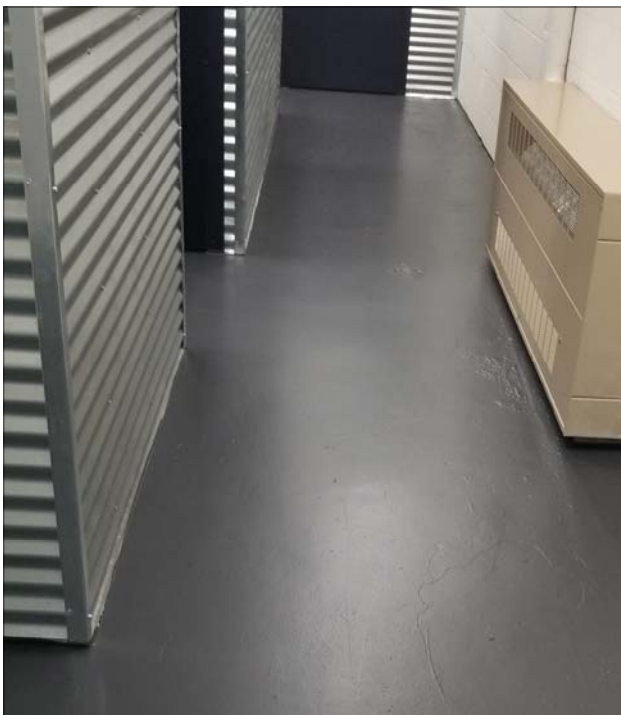
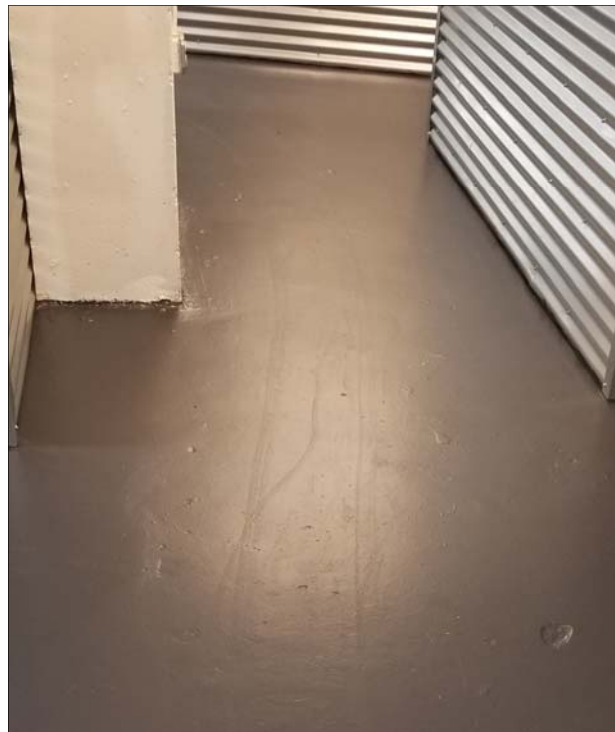
**Composite Cover System**

The Site inspection included a visual inspection of the composite cover system to determine if it was intact and free from damage that might render it unsuitable for its intended purpose. Mr. Izzo did not identify any areas where the cover system appeared impaired, compromised, or otherwise damaged. In addition, Mr. Colon indicated that there have been no breaches of the composite cover system since the completion of construction.
