FINAL ENGINEERING REPORT

**1095 Southern Boulevard
Block 2727, Lot 41
New York, NY 10459
NYSBCP Site No. C203055**

**Urban Health Plan, Inc.
1065 Southern Blvd., Bronx, NY 10459**

**May 24, 2024
Langan Project No. 170199904**

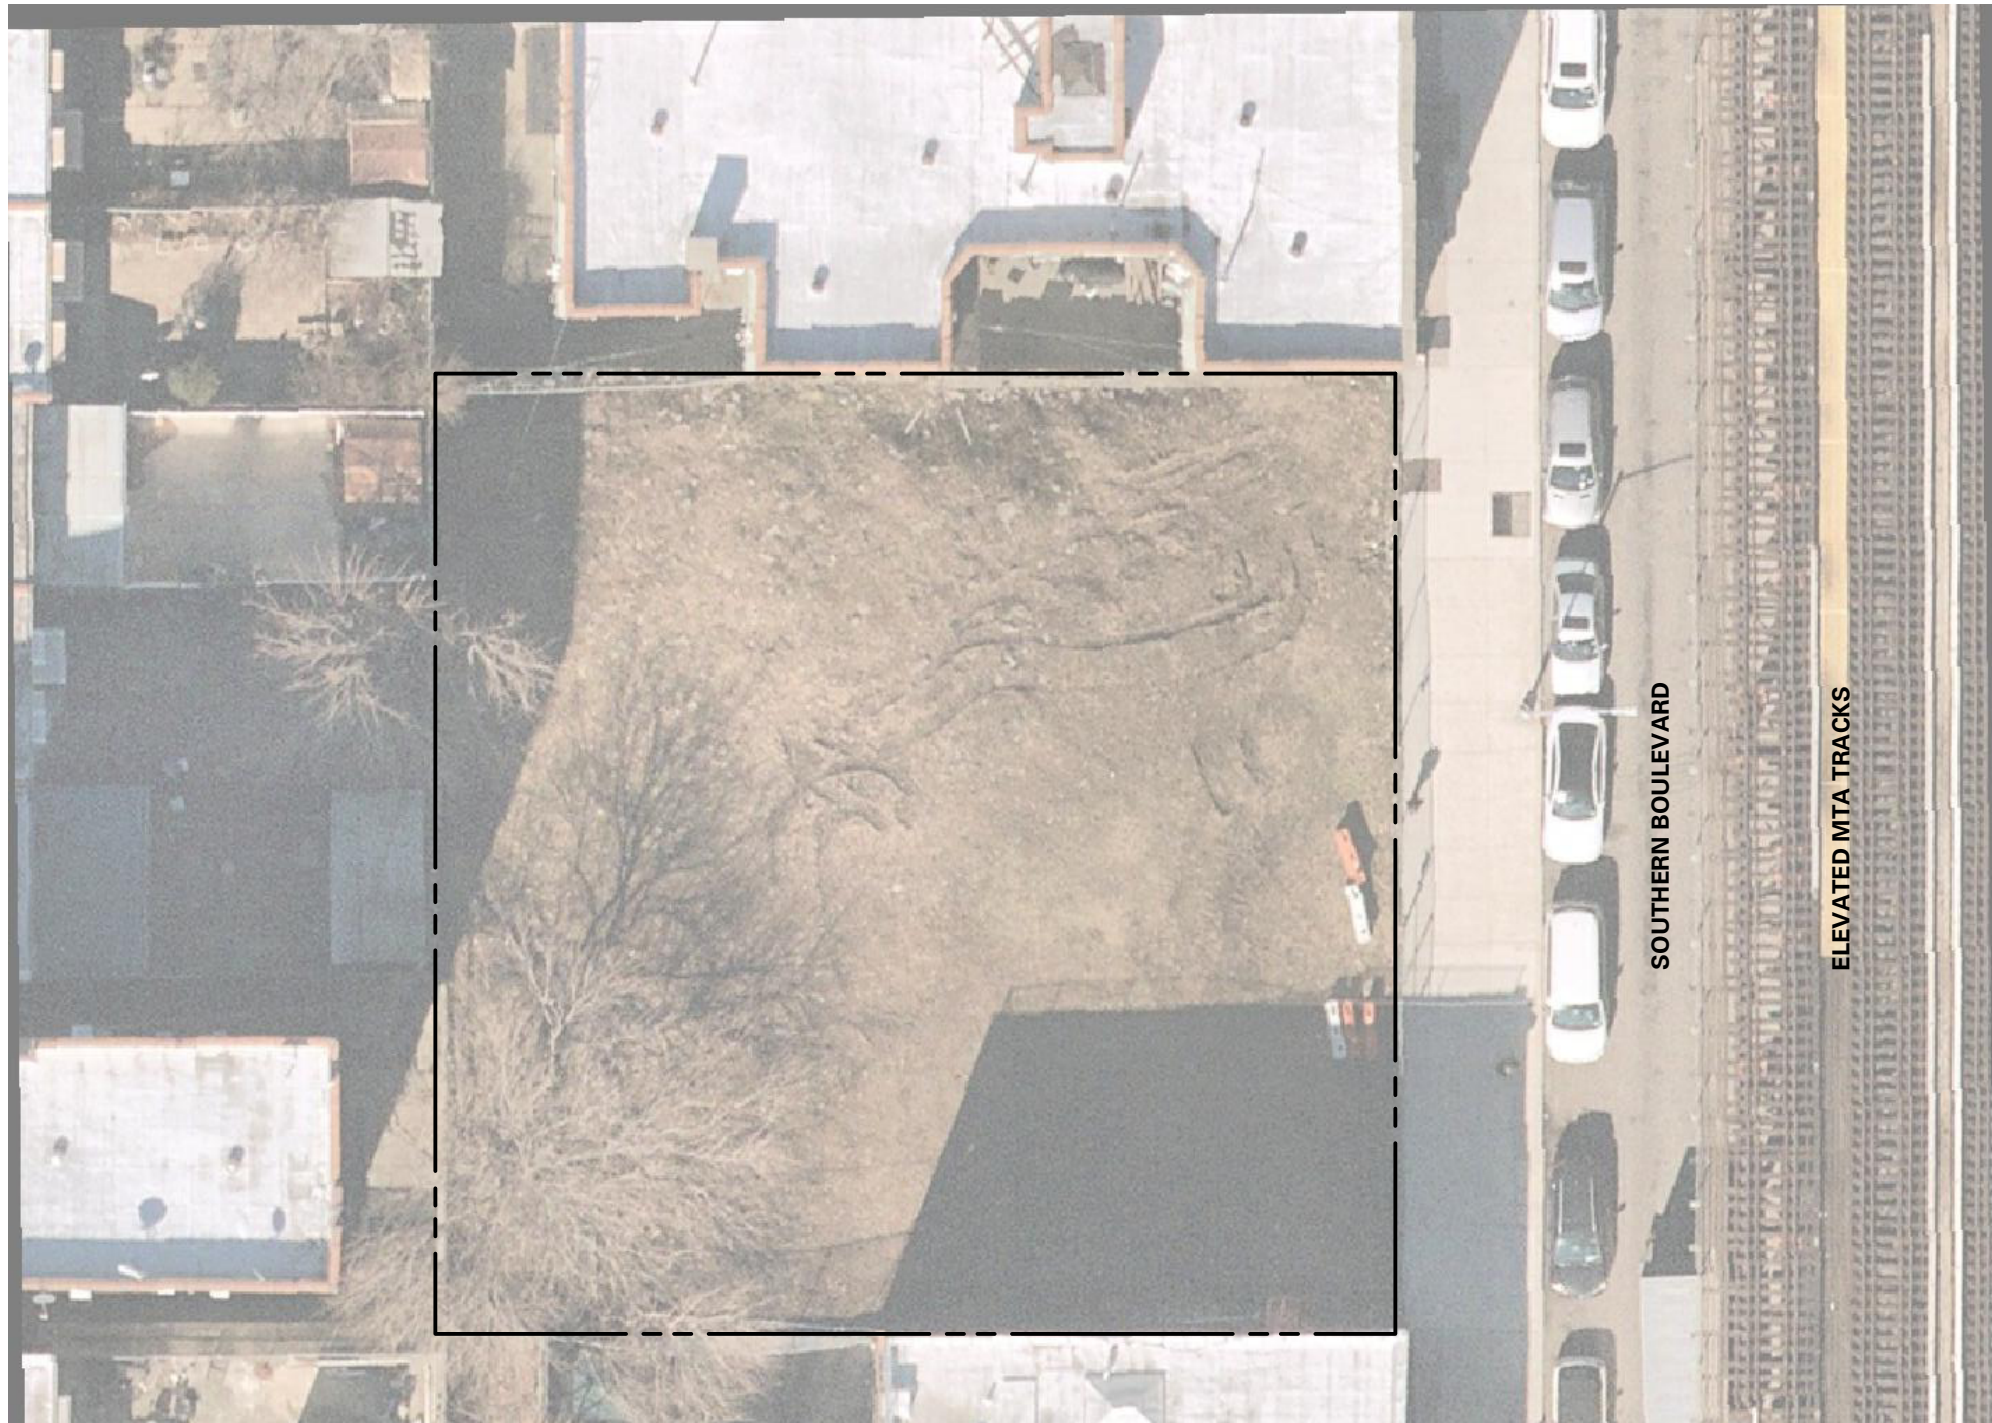
1. PRE-CONSTRUCTION BASE MAP IS TAKEN FROM NEARMAP AERIAL IMAGERY, DATED FEBRUARY 27, 2022.
2. NOTED SCALES ARE APPROXIMATE.

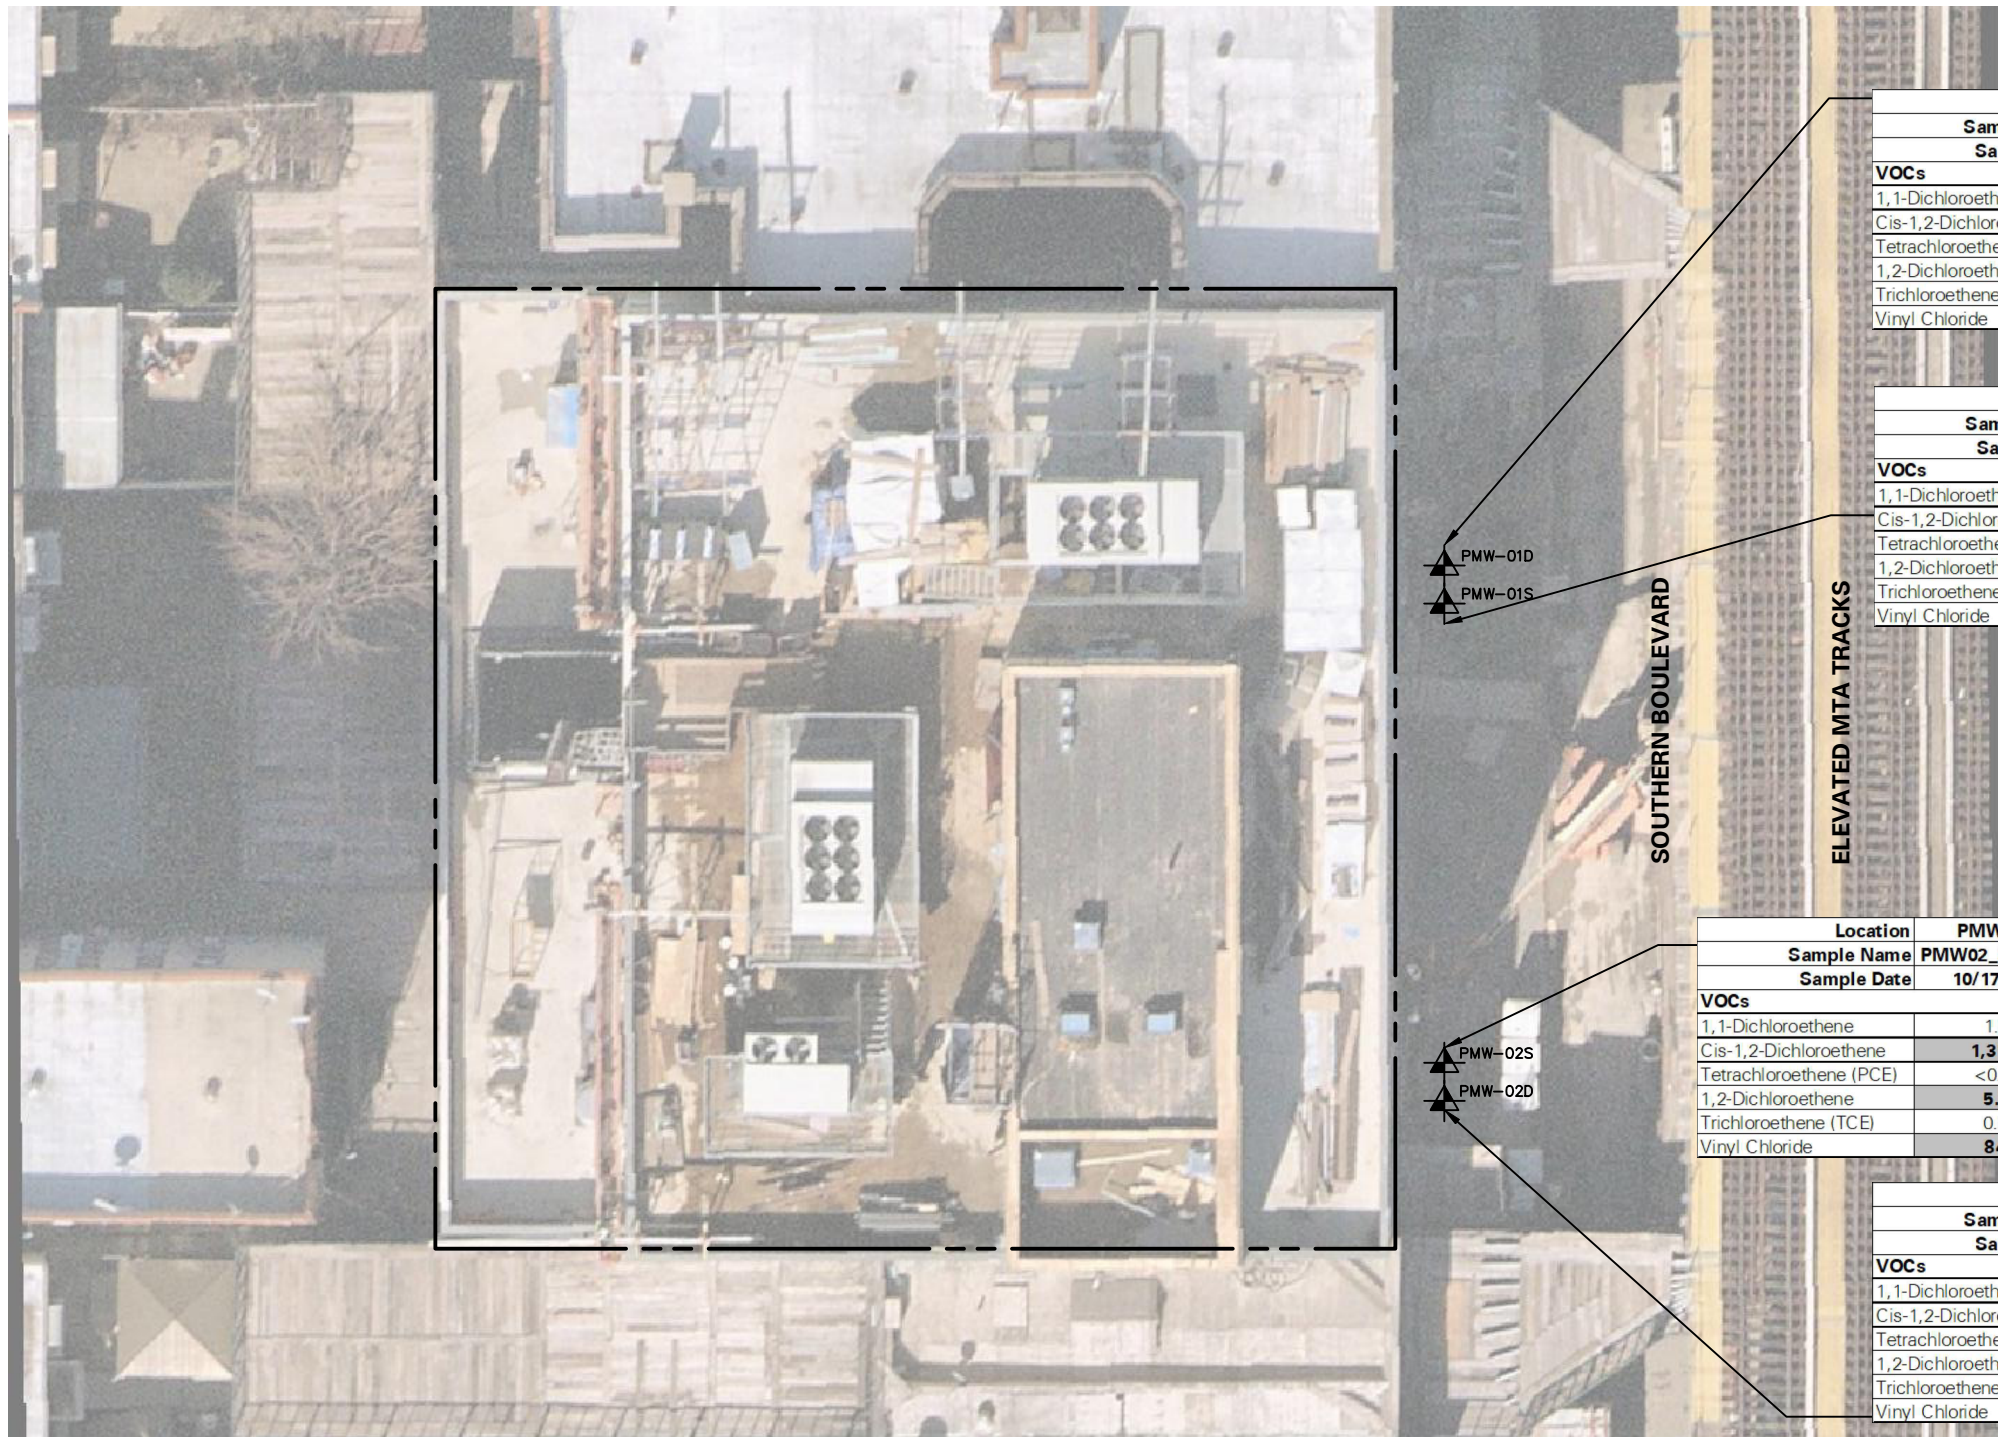
Location	PMW01_D
Sample Name	PMW01_D_101723
Sample Date	10/17/2023
VOCs	
1,1-Dichloroethene	1.9
Cis-1,2-Dichloroethene	705 D
Tetrachloroethene (PCE)	18.3
1,2-Dichloroethene	7.92
Trichloroethene (TCE)	47.7
Vinyl Chloride	61.2

Location	PMW01_S
Sample Name	PMW01_S_101723
Sample Date	10/17/2023
VOCs	
1,1-Dichloroethene	5.05
Cis-1,2-Dichloroethene	2,420 D
Tetrachloroethene (PCE)	1.63
1,2-Dichloroethene	36.4
Trichloroethene (TCE)	8.23
Vinyl Chloride	110

Location	PMW02_S	PMW02_S
Sample Name	PMW02_S_101723	GWDUP01_101723
Sample Date	10/17/2023	10/17/2023
VOCs		
1,1-Dichloroethene	1.61	2.55
Cis-1,2-Dichloroethene	1,310 D	1,450 D
Tetrachloroethene (PCE)	<0.5 U	<0.5 U
1,2-Dichloroethene	5.73	9.51
Trichloroethene (TCE)	0.66	0.98
Vinyl Chloride	84.7	131

Location	PMW02_D
Sample Name	PMW02_D_101723
Sample Date	10/17/2023
VOCs	
1,1-Dichloroethene	<0.5 U
Cis-1,2-Dichloroethene	2.07
Tetrachloroethene (PCE)	<0.5 U
1,2-Dichloroethene	<0.5 U
Trichloroethene (TCE)	<0.5 U
Vinyl Chloride	<0.5 U

The laboratory analytical results identified CVOCs at concentrations above the SGVs, but at concentrations substantially less than pre-remediation conditions. Average PCE and TCE concentrations in overburden and bedrock groundwater decreased by about 3 to 4 orders of magnitude. When compared to pre-remediation conditions, the October 2023 performance sampling indicated an increase in average concentrations of cis-1,2-dichloroethene and vinyl chloride (PCE daughter products), which demonstrates that CVOCs are undergoing natural attenuation via reductive dichlorination. The ratio of cis-1,2-dichloroethene concentrations to vinyl chloride also shows that reductive dichlorination is not stalling at cis-1,2-dichloroethene. The lack of accumulation of vinyl chloride shows that complete mineralization of PCE to carbon dioxide and water is occurring. Now that the on-site source has been completely removed through the implementation of the Track 1 remedy, off-site groundwater concentrations that already demonstrate bulk reduction will continue to decline over time.
