## APPENDIX X

**BRINKERHOFF ENVIRONMENTAL SERVICES, INC.**  
**DAILY FIELD ACTIVITY REPORT**

NYSDEC Project No:	C203057	OER E-Number:	E-227	Date:	08/20/2015
Location:	255 E. 138 <sup>th</sup> Street, Bronx, New York	Job:	Excavation of NYSDEC BCP # C203057

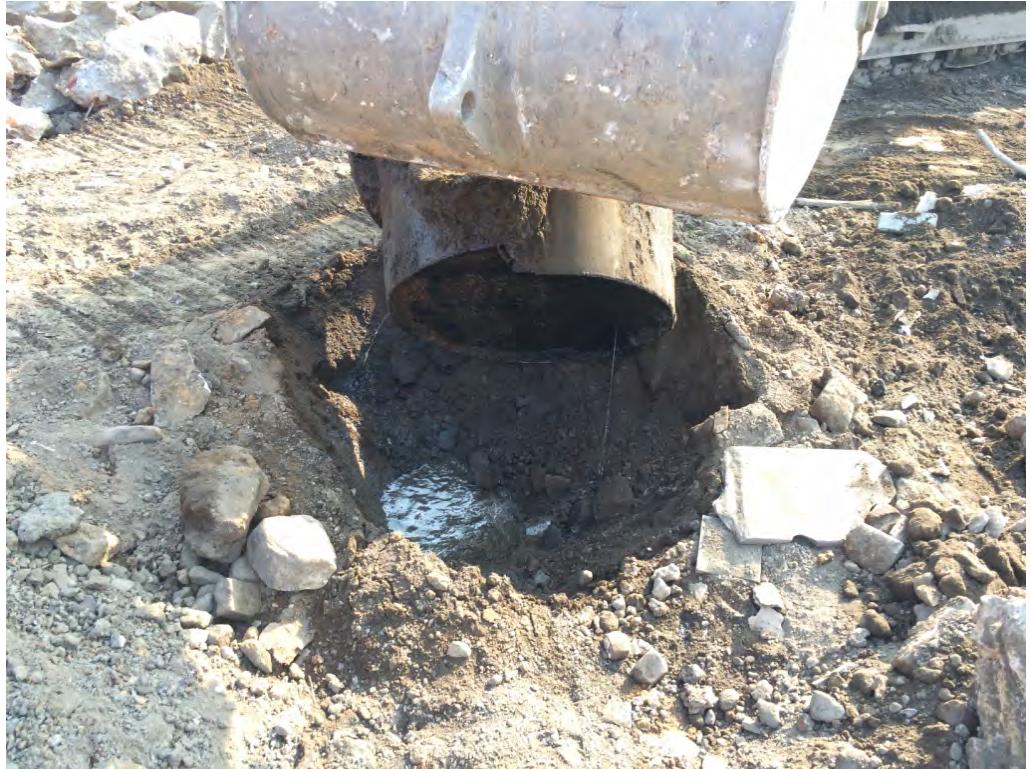
View of the UST-14 removal. Leaking was observed at the base of UST-14.

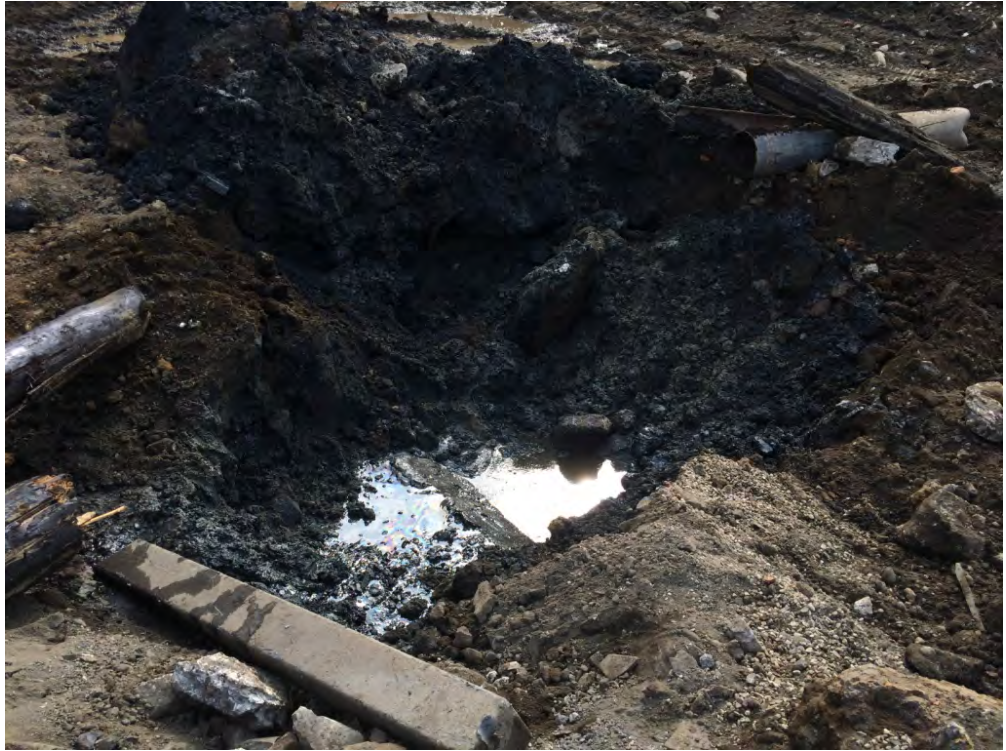
View of the petroleum-impacted soil that was observed beneath UST-15.

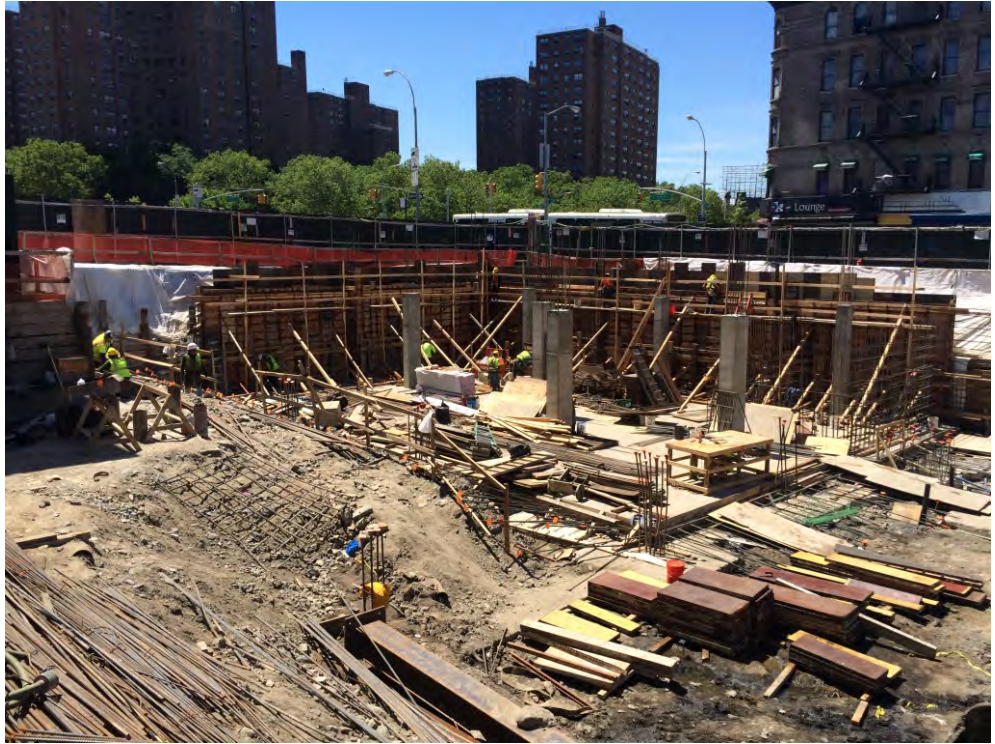
View of the installed foundation slab and sidewall formwork in the southeastern corner of the Site, facing south.

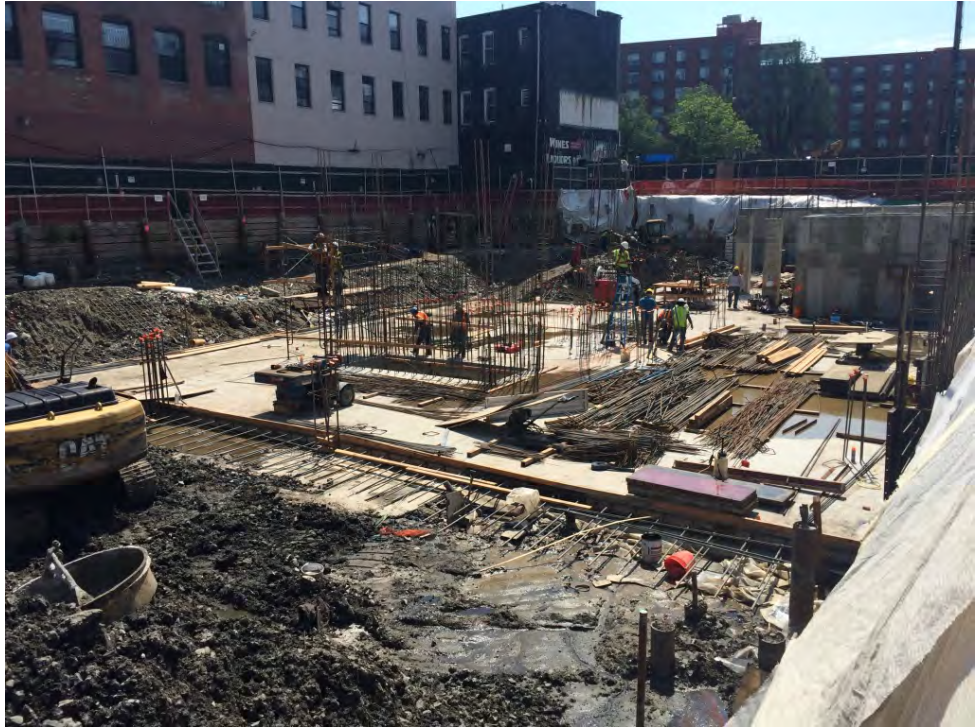
View of the installed foundation slab in the central portion of the Site, facing east.

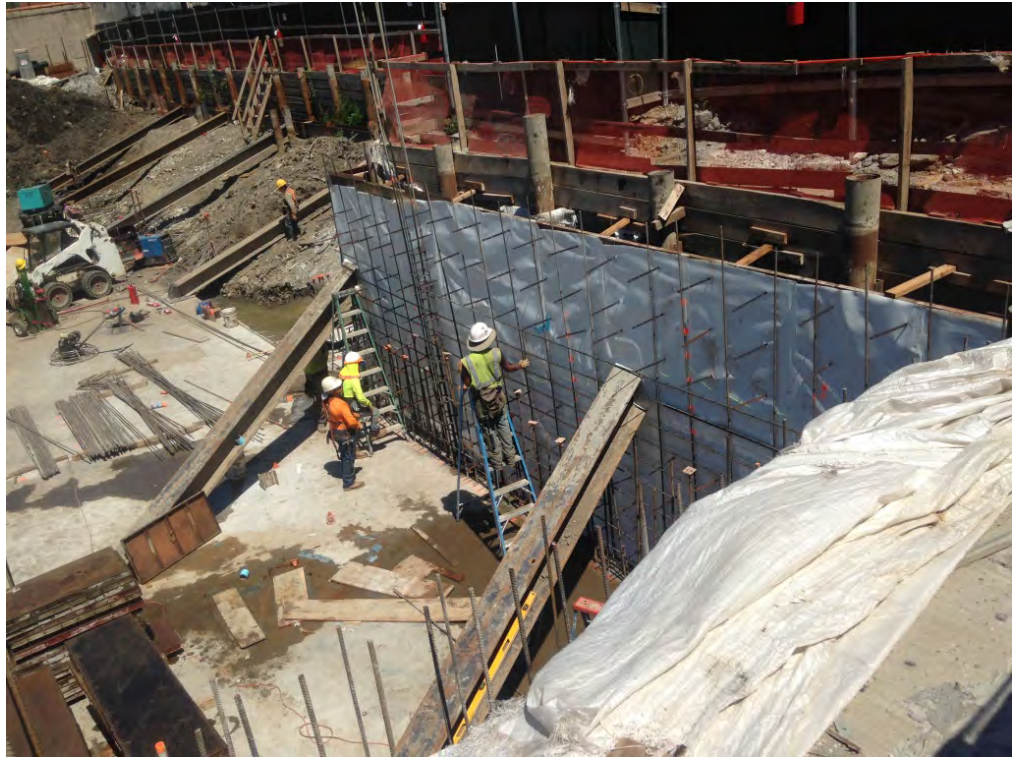
View of the contractor installing rebar for the installation of the foundation wall in the northeast boundary of the Site, facing northwest.

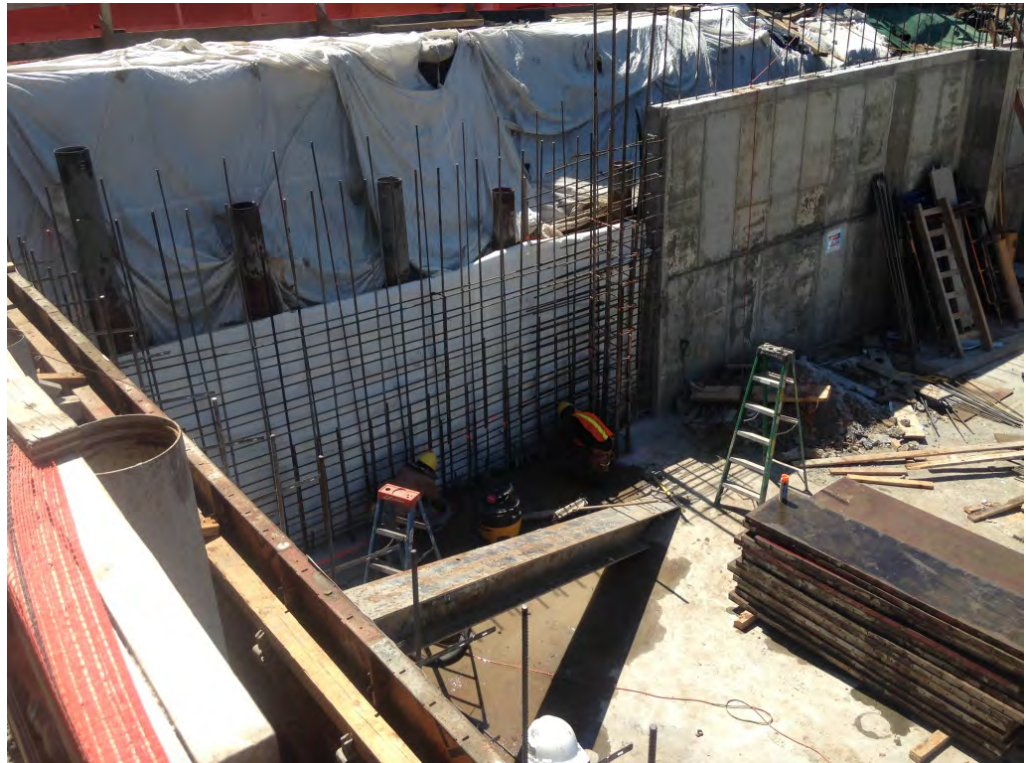
View of the contractor installing rebar for the installation of the foundation wall along the eastern boundary of the site, facing southeast.

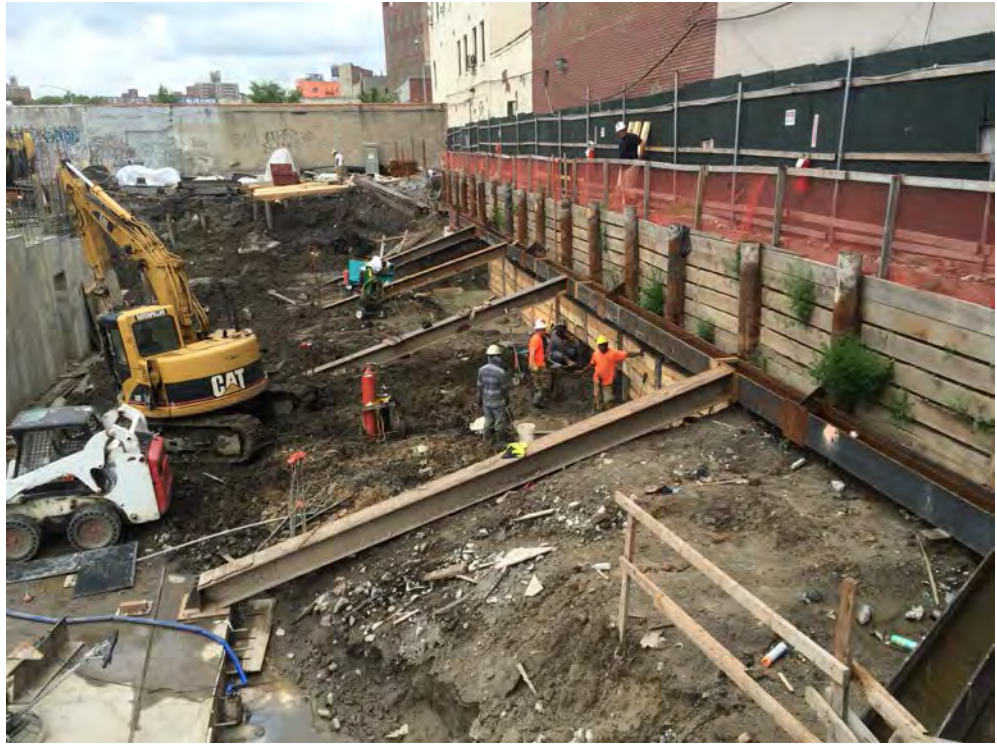
View of the installed rakers along the northern boundary of the site, facing northwest.

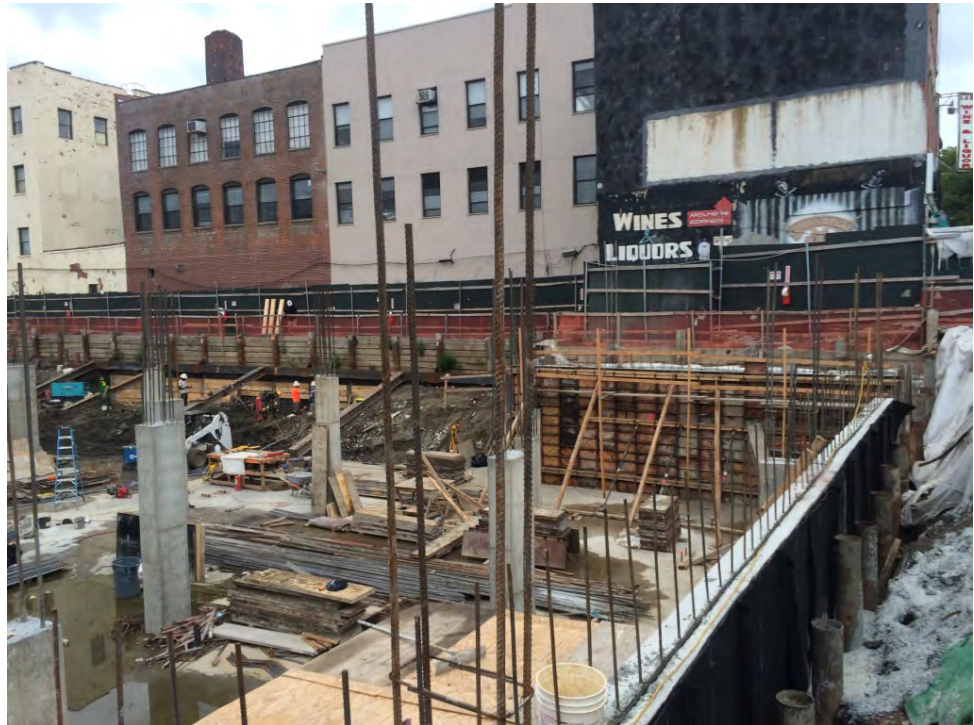
View of the installed foundation slab in the northeast corner of the site, facing north.

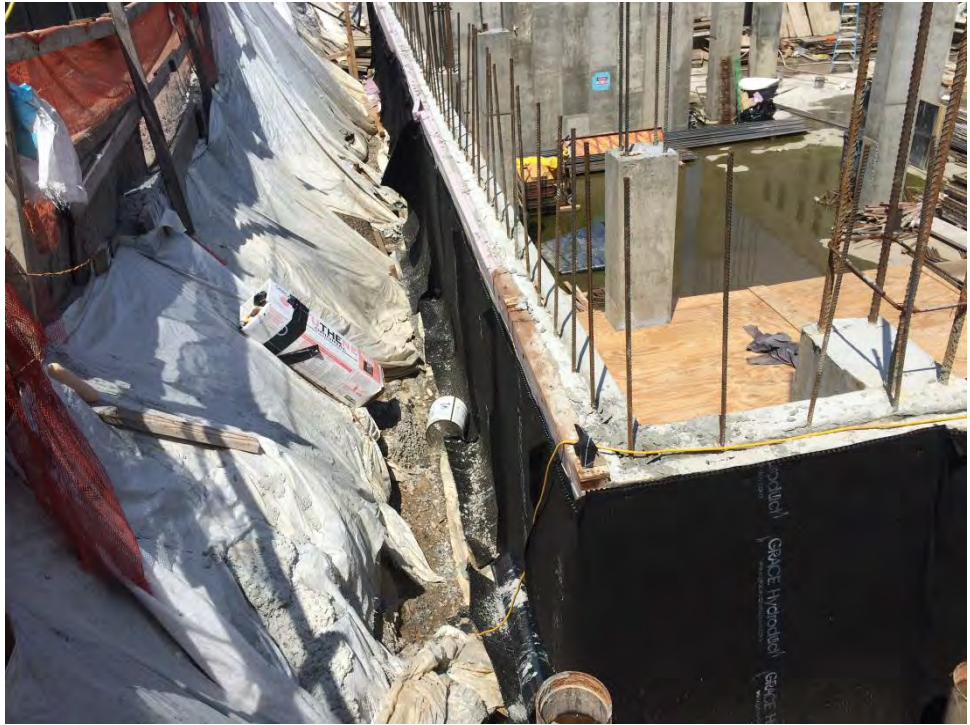
View of the previously installed Bituthene R Primer B2 LVC waterproofing membrane, manufactured by Grace Industries, installed along the exterior portion of the southern and eastern sidewalls.

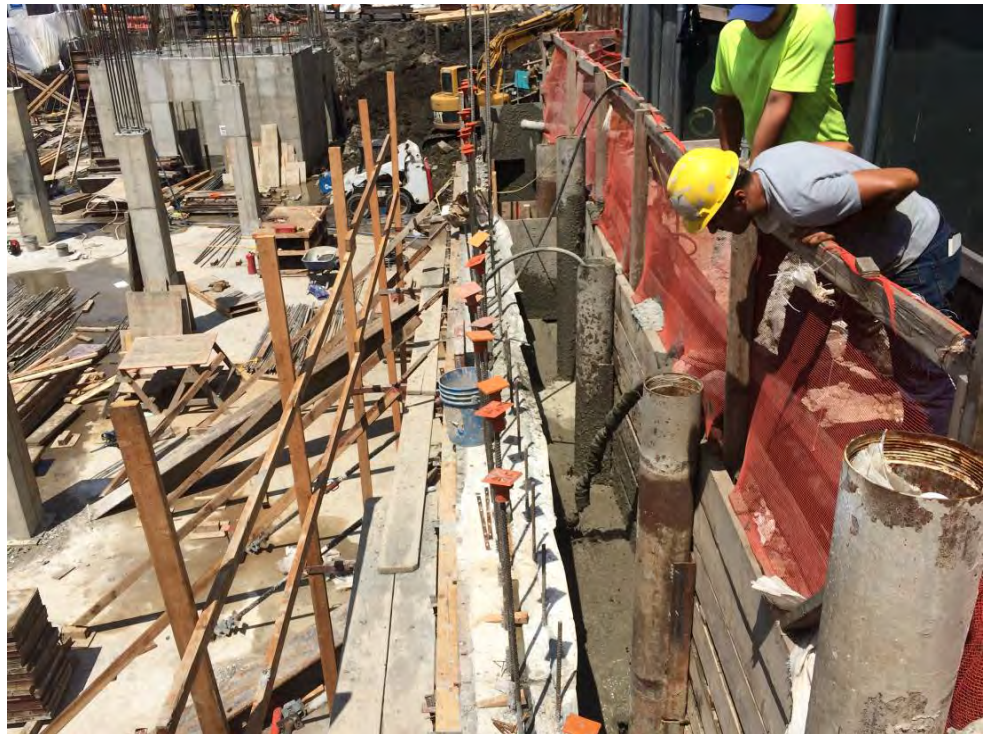
View of the contractor pouring concrete between the foundation sidewall and lagging along the northeast boundary of the Site, facing west.

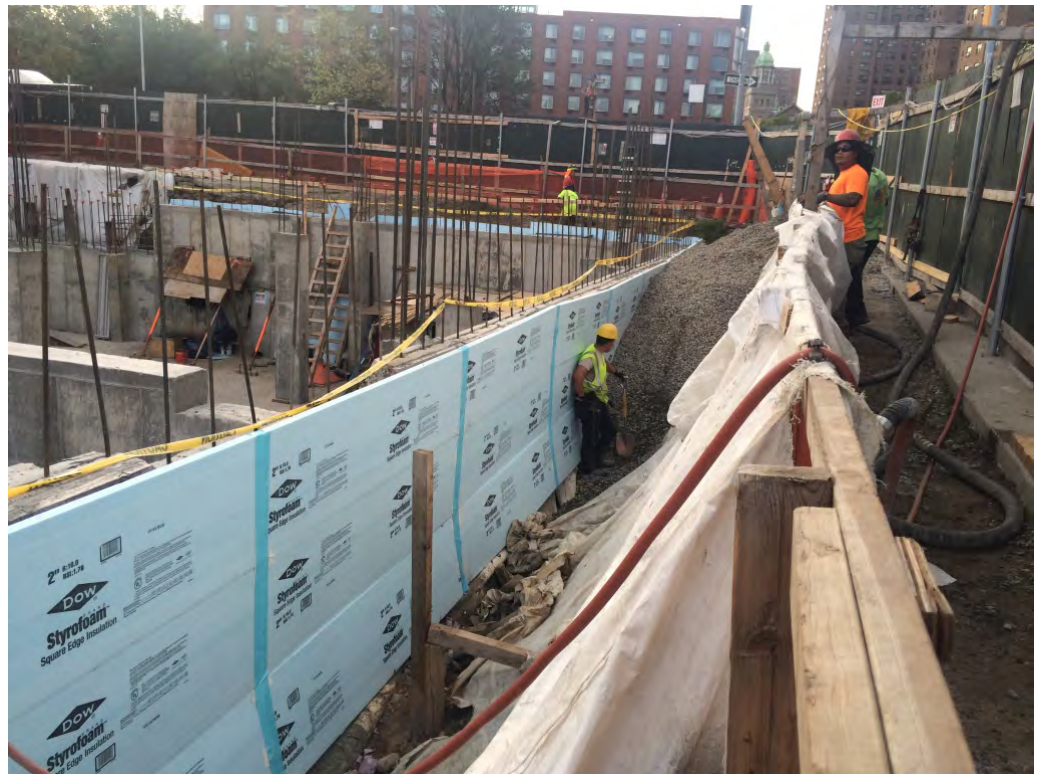
View of the ¾-inch RCA (not blend) imported to the E. 138<sup>th</sup> Street sidewalk behind the southern foundation wall, facing east. Note that this area is outside of the property line.

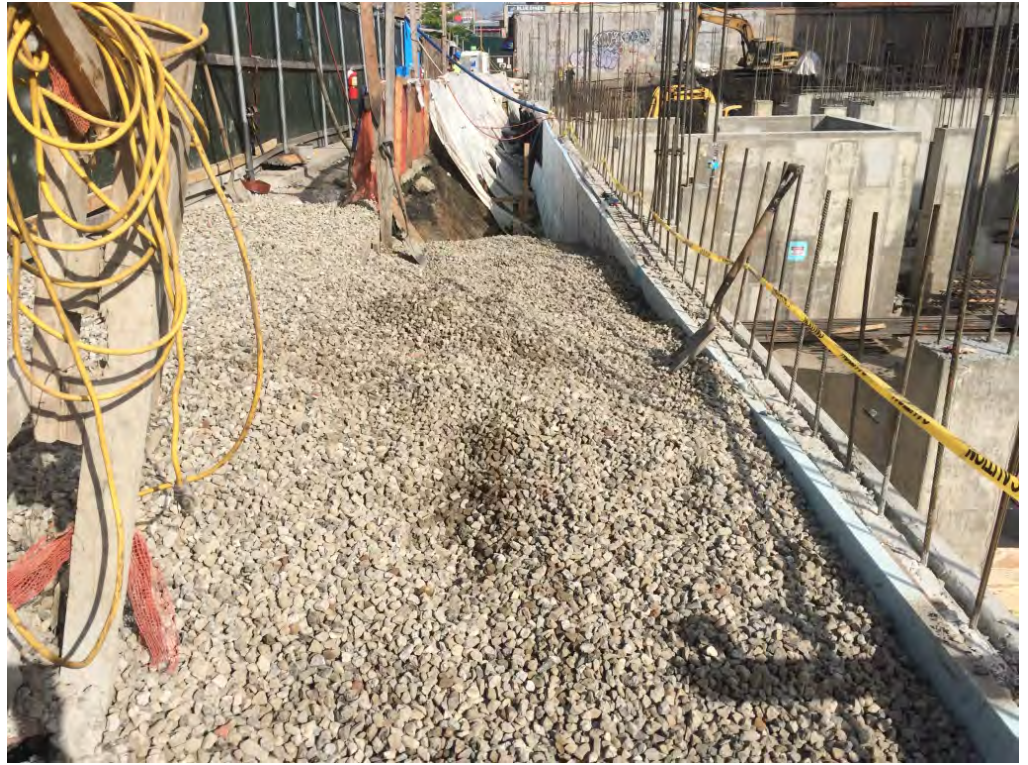
Additional view of the  $\frac{3}{4}$ -inch RCA (not blend) imported to the E. 138<sup>th</sup> Street sidewalk behind the southern foundation wall, facing northwest. Note that this area is outside of the property line.

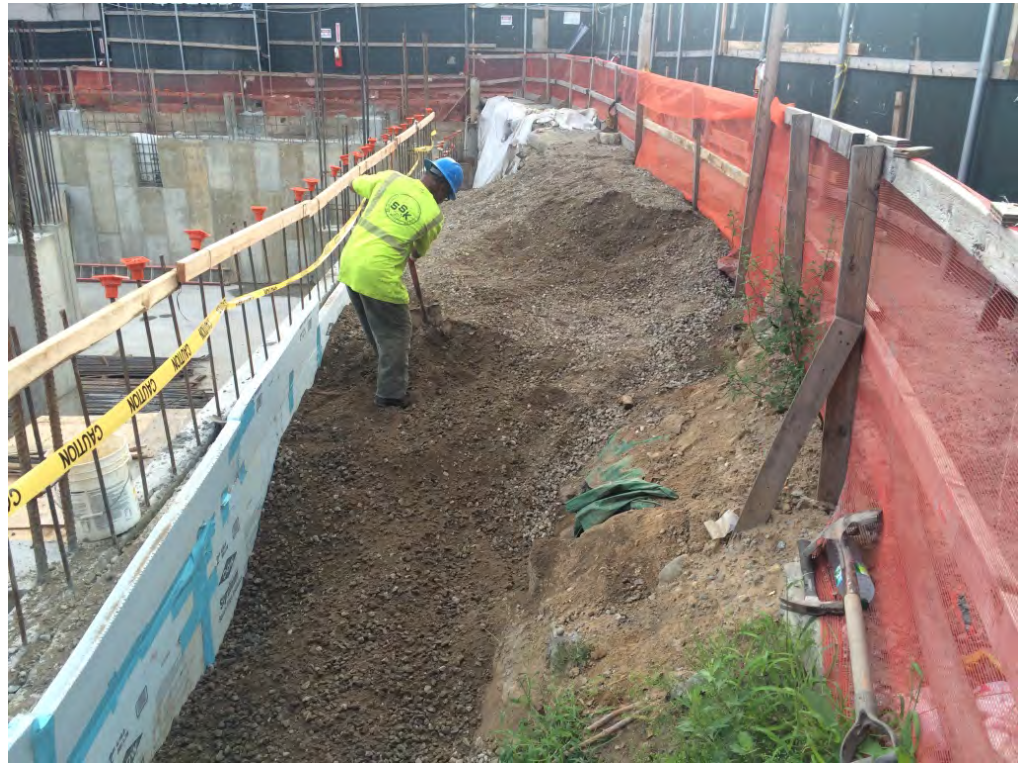
View of the  $\frac{3}{4}$ -inch RCA Blend placed in the Third Avenue sidewalk behind the eastern foundation wall, facing northeast. Note that this area is outside of the property line.

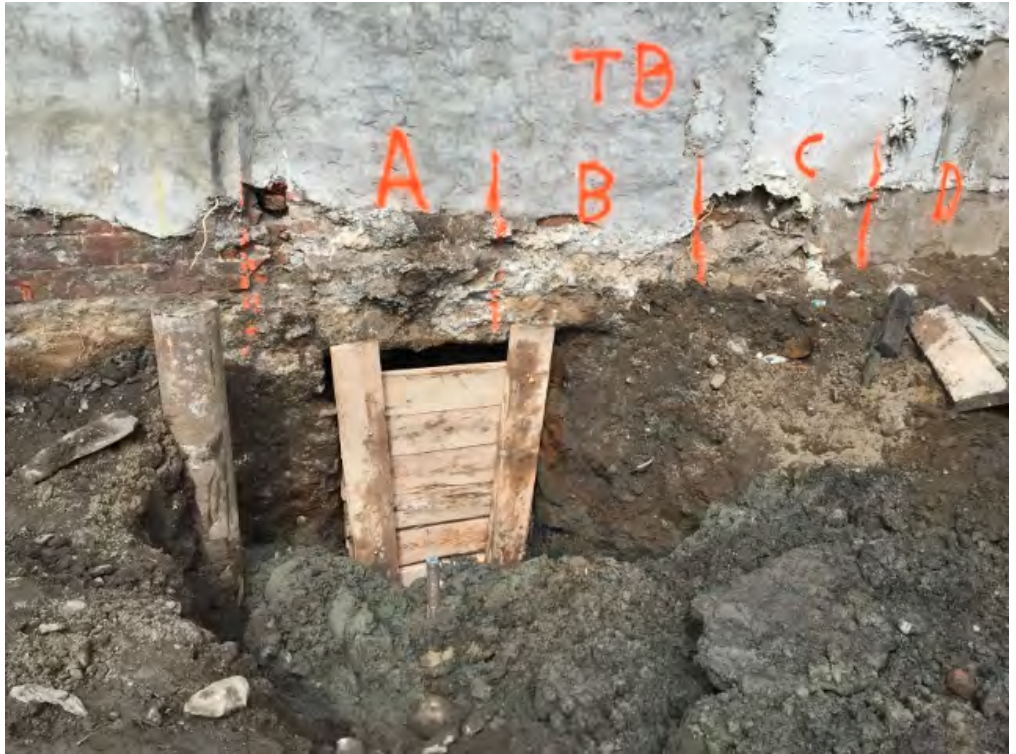
View of the installed lagging within the underpinning excavation, facing northwest.

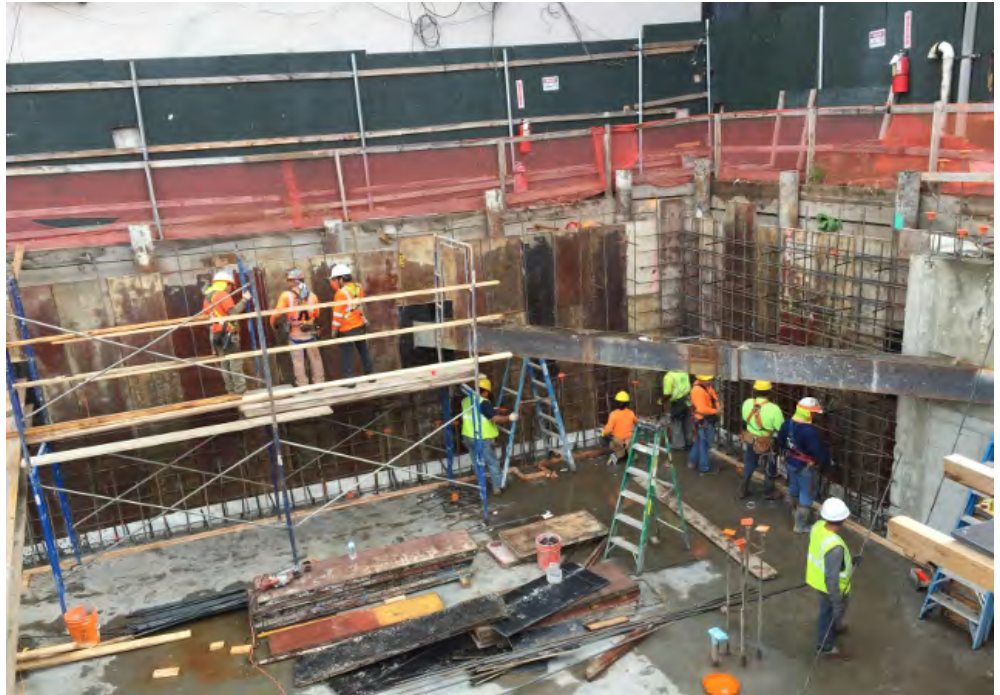
View of the contractor installing formwork and rebar for the foundation wall in the northeast portion of the Site, facing east.
