**810 RIVER AVENUE**

**BRONX, NEW YORK**

# **Remedial Investigation Report**

**NYC VCP Site Number: 14CVCP171X**

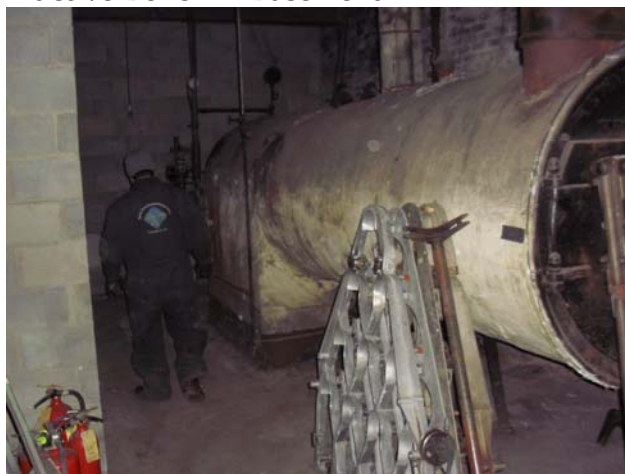
Suspect asbestos-containing materials were observed at the Subject Property in the inactive boiler in the partial basement. The possible presence of asbestos-containing materials may impact upon the environmental quality of the Subject Property, and therefore, should be considered a REC.

**Inactive Boiler in Basement**

This report is not intended to serve as a full asbestos survey or lead-based paint survey. These surveys are commonly performed for the purpose of building demolition/renovation or the recognition/identification of any building materials that may contain asbestos or lead-based paint and it is recommended that they be performed prior to any such work.

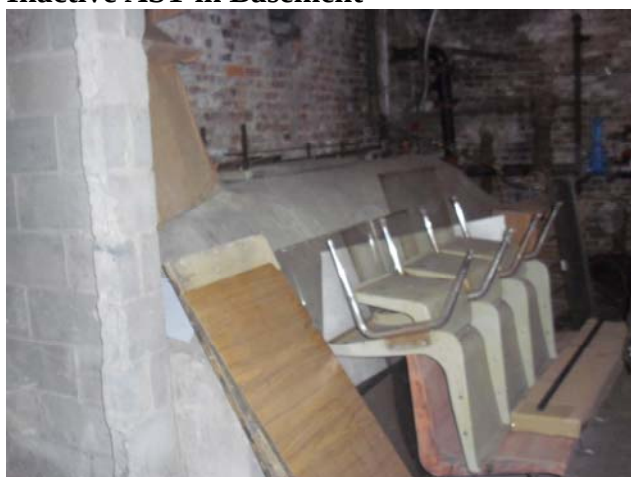
Evidence of one (1) aboveground storage tanks (AST) was observed at the Subject Property in the partial basement. The AST is 1,080 gallons in volume and is encased in concrete. The encasement is in good condition with no evidence of stains, odors or spills. The AST is no longer in use. The presence of the inactive AST should be considered a REC.

**Inactive AST in Basement**
