Periodic Review Report

Webster Avenue Residences

NYSDEC Site Number C203075

October 25 2022

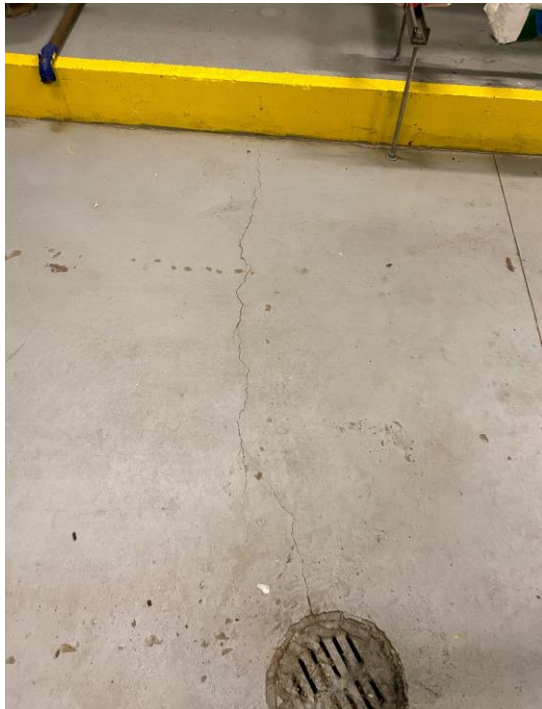
Photo No. 13	Date: 9/30/2022

During the annual Site inspection of the Site Cover System, minor/insignificant cracks were observed in the floor. The inspection confirmed that the integrity of the Site Cover System remains intact. A copy of the Inspection Form is provided as Appendix B.

A photograph showing a vertical crack in a light-colored concrete floor. A yellow metal curb is visible at the top of the frame, and a circular floor drain is at the bottom.
Direction Photo Taken: N/A		
Description: Small Crack in Boiler Room 1

19	SSD System - Are there any holes or cracks in the floor?		X	No significant cracks. Vacuum readings normal (10/14/22)	Evaluate need for sealing/repairs in combination with vacuum monitoring readings.

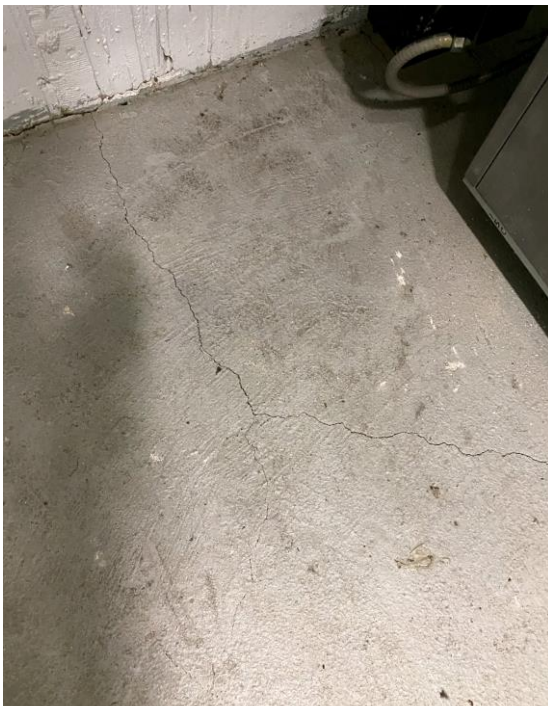
Photo No. 14	Date: 9/30/2022

Direction Photo Taken: N/A		
Description: Small Crack in Boiler Room 2

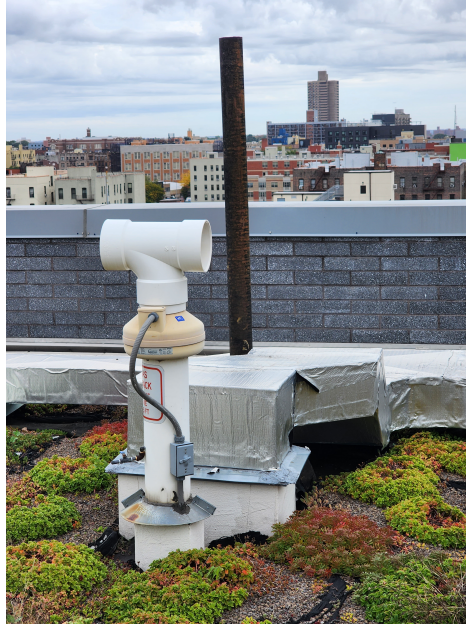
The data for SP-01 and SP-02/SP-03 were similar to the readings collected during the startup testing and March 2018 events. SP-4 displayed a slightly lower applied vacuum than during the startup test. This data was recorded in the Operations Log which can be found in Appendix D.

Description:
Vapor Stack - SP-01

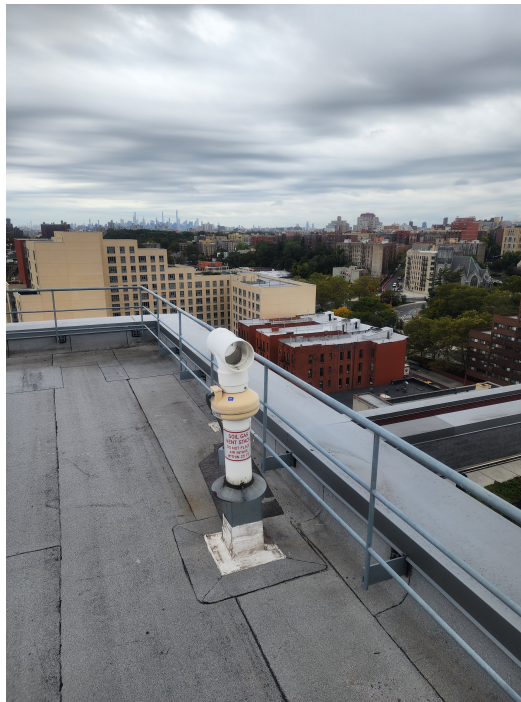
Photo No.
20

Description:
Vapor Stack -
SP-02/SP-04
