2135 Westchester Avenue Remedial Investigation Work Plan

2135 Westchester Avenue
Bronx, NY 10462
Bronx County
Block 3934, Lot 1
Site No. C203093

March 2018

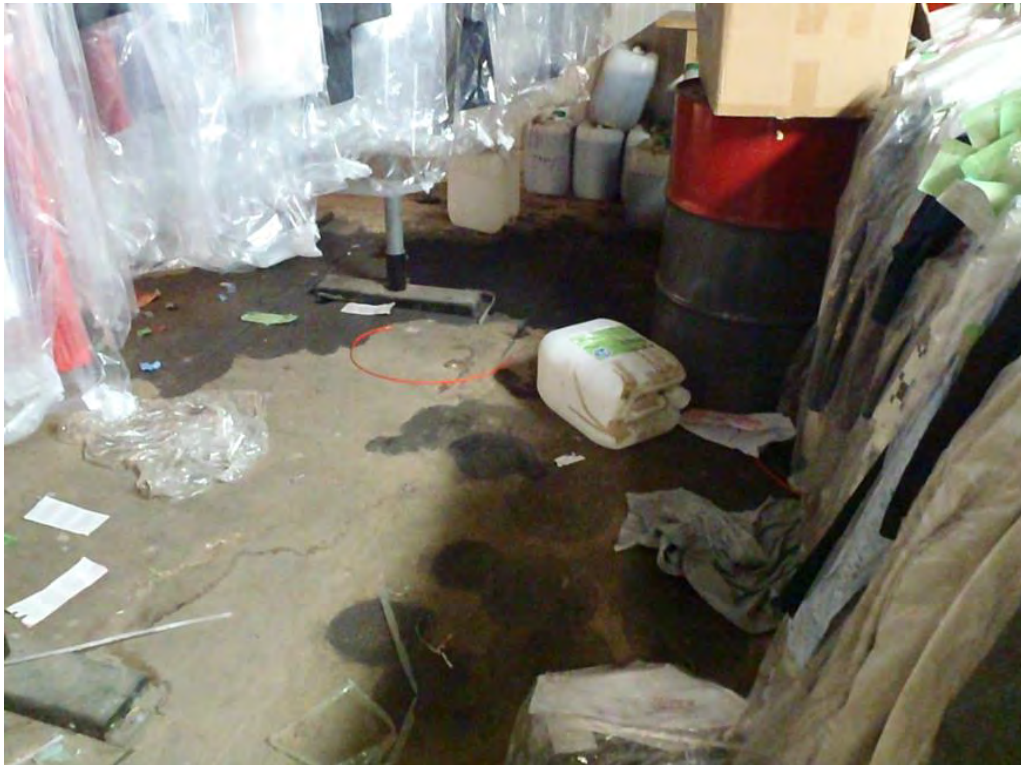
Photo 5: View of the stained area observed in the basement of the drycleaners.

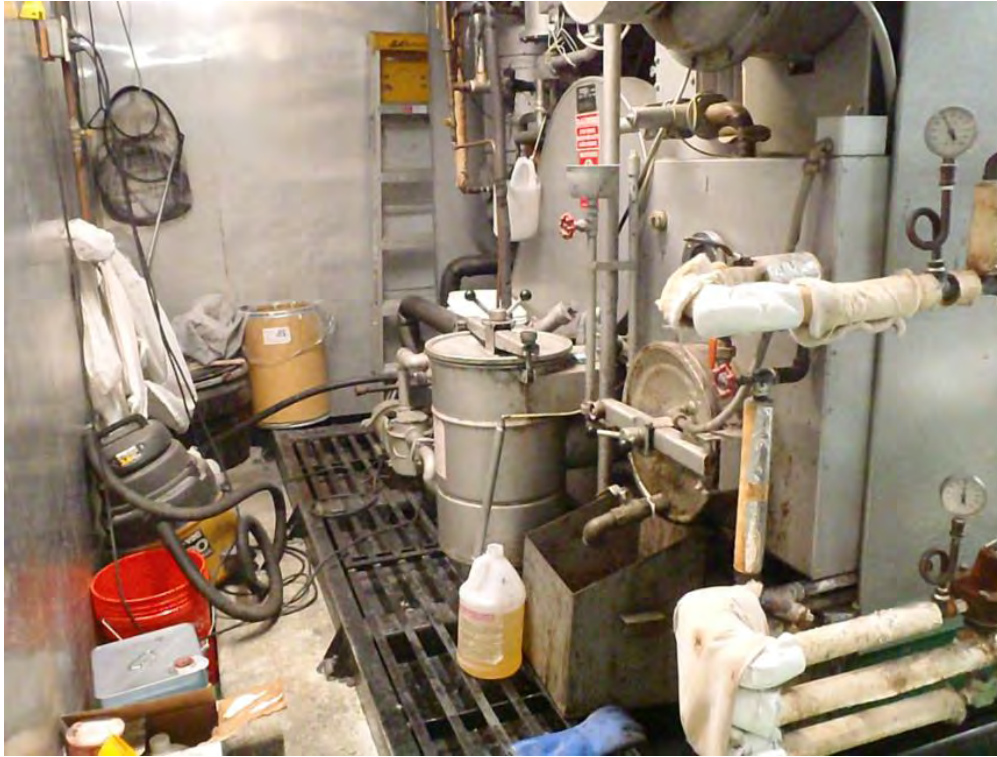
Photo 7: View of the rear of the PERC dry cleaning machine.

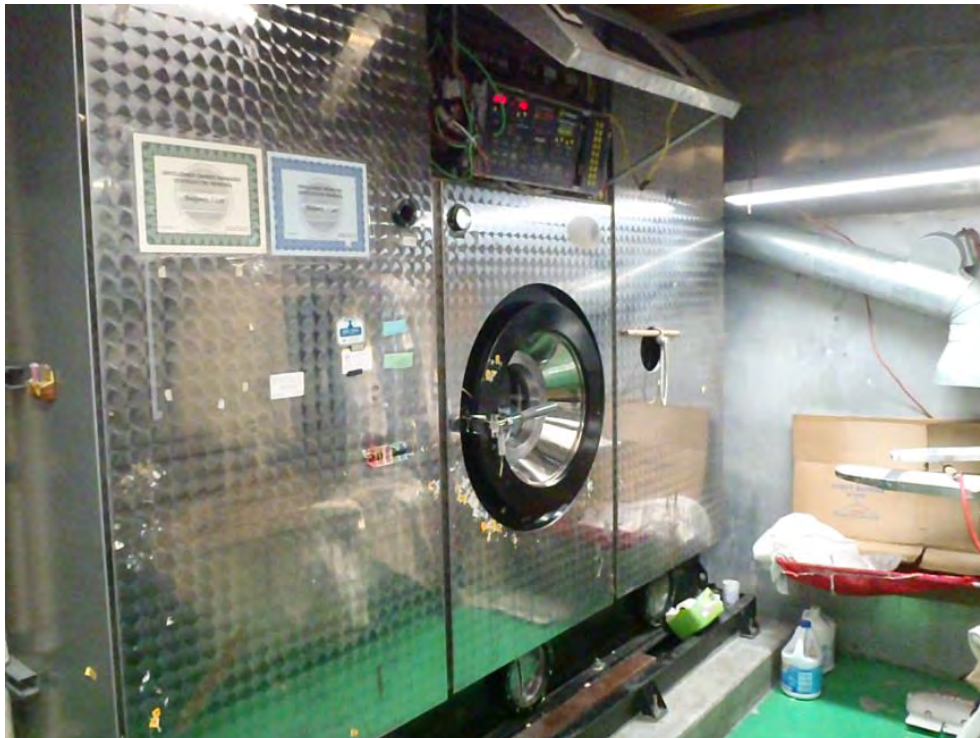
Photo 8: Front view of the perc dry cleaning machine.

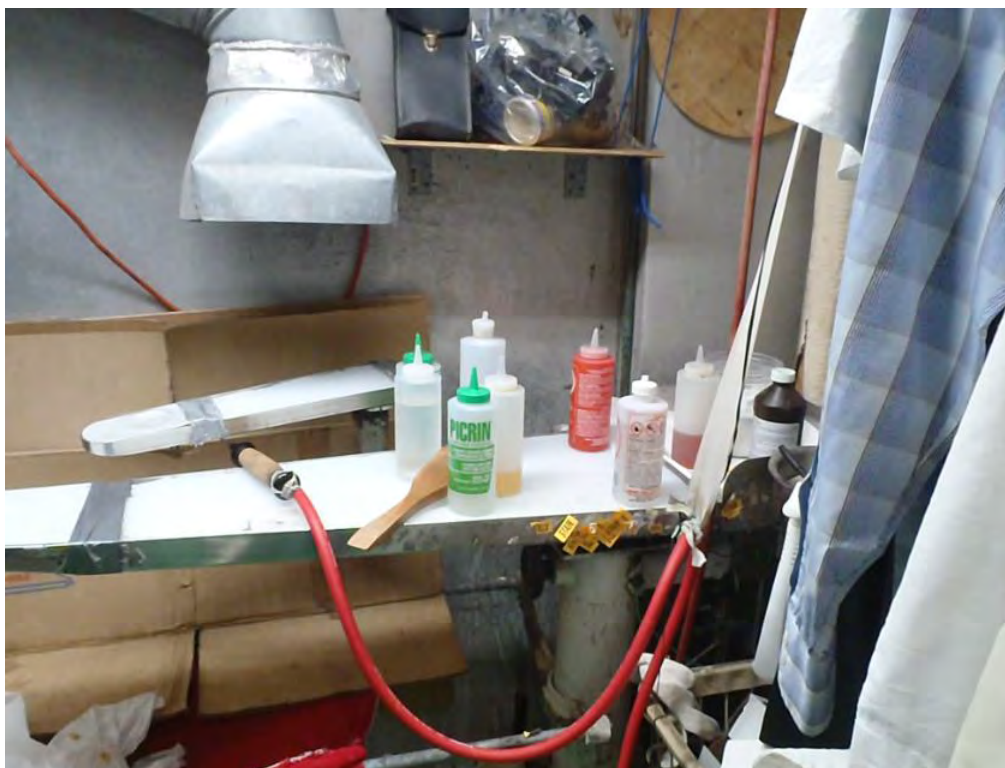
Photo 9: View of the spot chemicals observed in the dry cleaning facility.

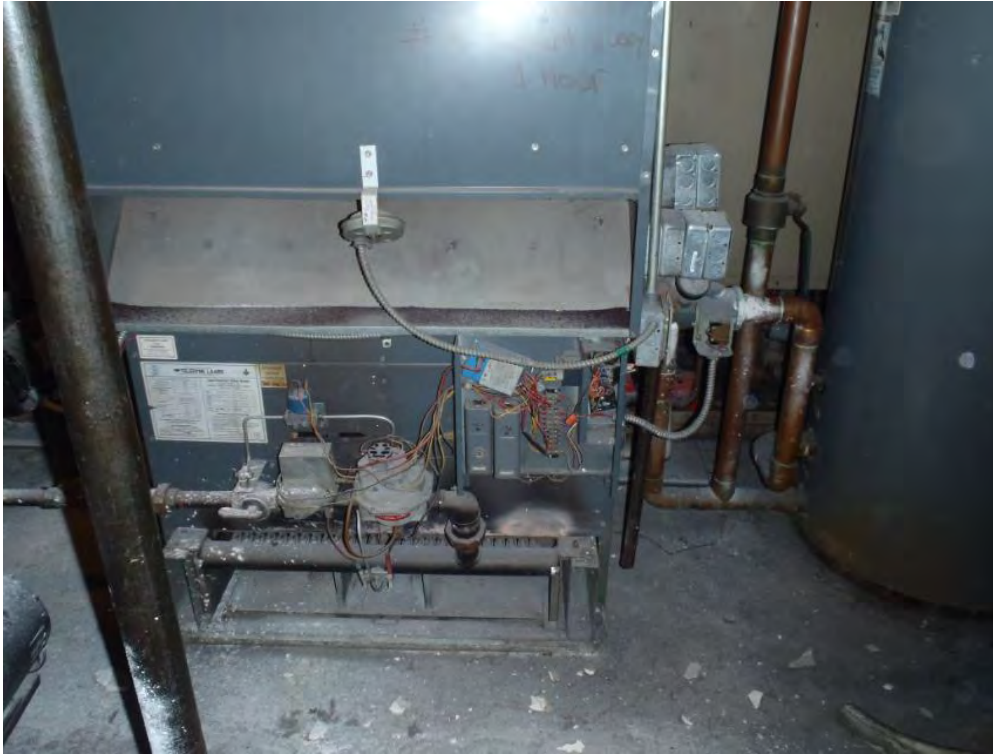
Photo 11: View of the natural gas fired furnace observed in the basement of the building.

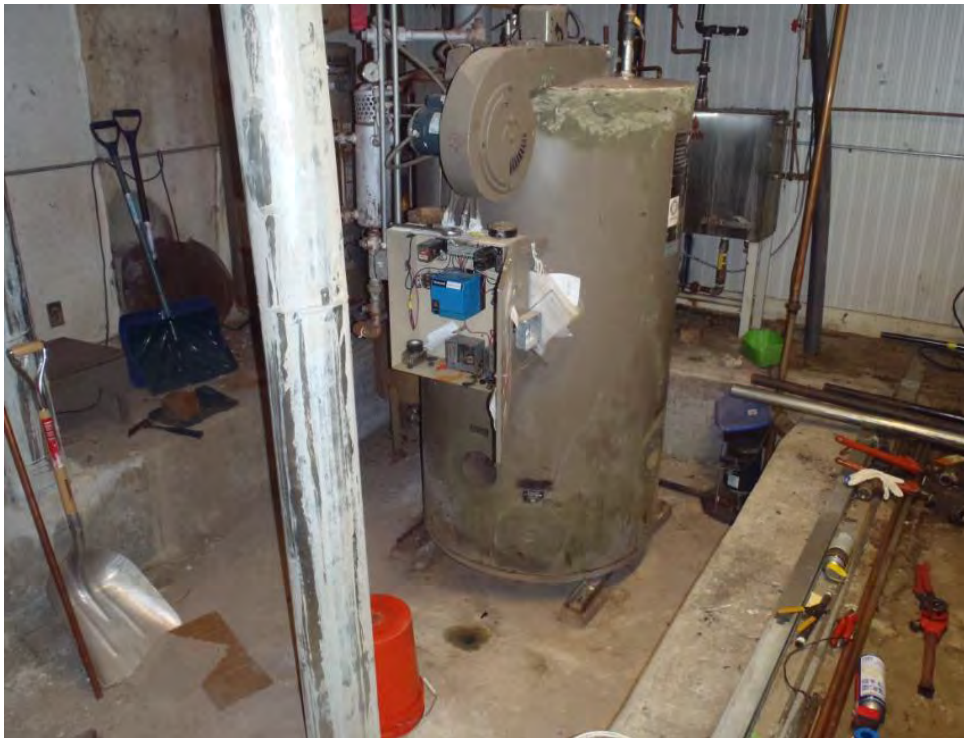
Photo 14: View of the natural gas fired boiler maintained on the basement of the building.

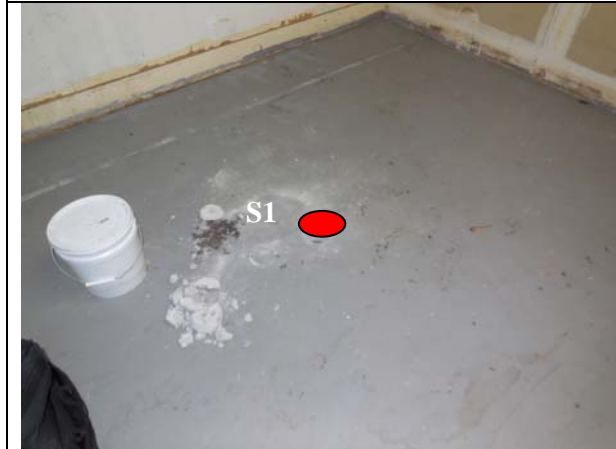
(1) View of Sampling Location S1

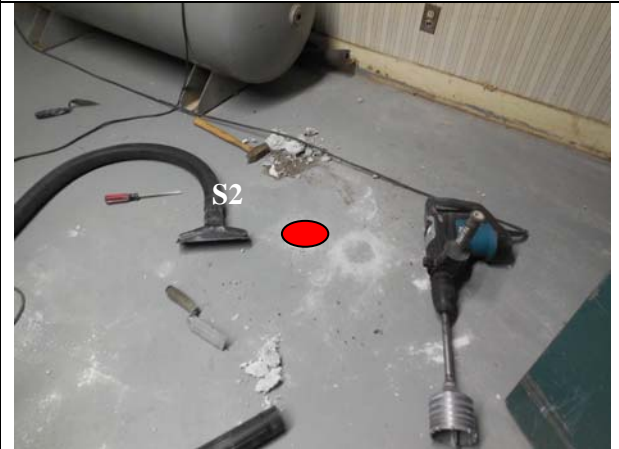
(2) View of Sampling Location S2

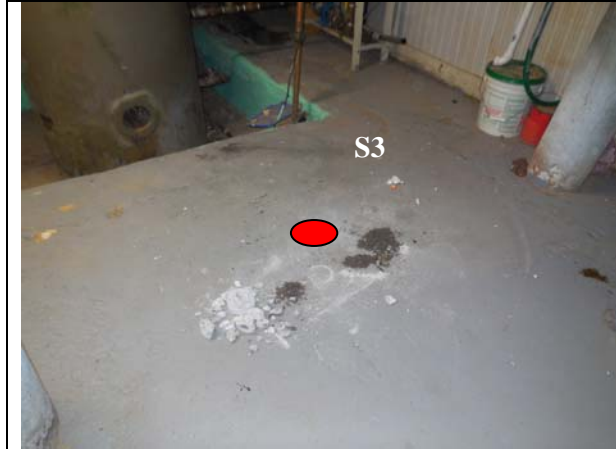
(3) View of Sampling Location S3
