3500 Park Avenue Apartments Site

Periodic Review Report

NYSDEC Brownfield Cleanup Program Site Number: C203096

MAY 2022

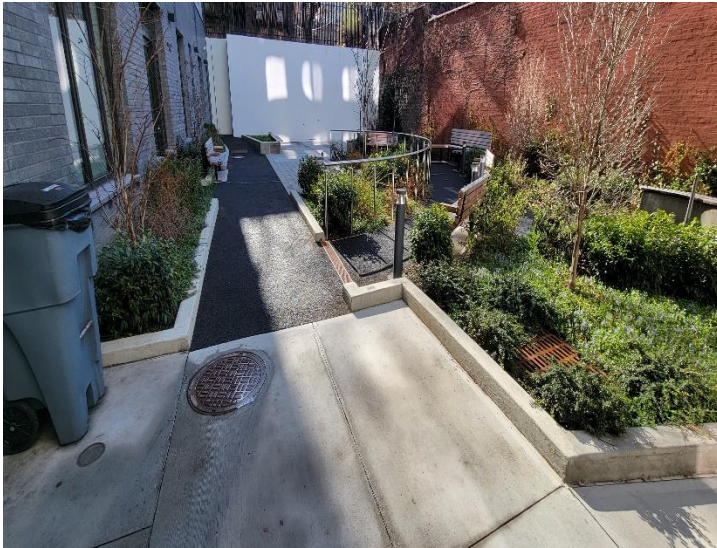
On April 8, 2022, AKRF performed the annual site-wide inspection of the cover system, which consisted of observing the first floor, crawl space, and landscaped courtyard for holes, significant cracking, and/or signs of damage. During the inspection, the site cover was found to be intact, with no signs of significant cracking or damage, as documented on the Site-wide Inspection Form provided in Appendix A. No soil disturbance or significant breaches to the cover system occurred at the Site during this certification period. No corrective actions were recommended following the completion of this inspection. A photographic log for the Site is included as Appendix B.

Photograph 1: The rear courtyard with various hardscaping and landscaping components, view facing east.

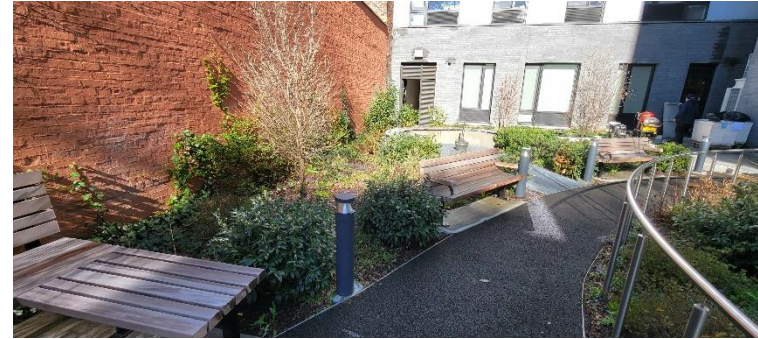
Photograph 2: The rear courtyard with various hardscaping and landscaping components, view facing west.

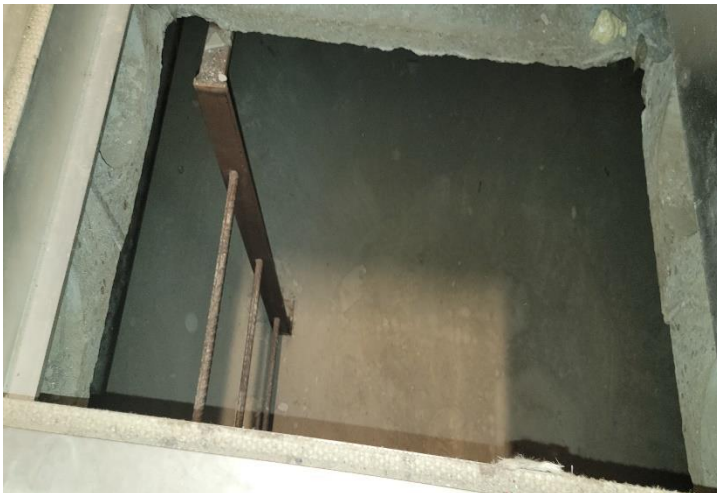
Photograph 3: A crawl space access hatch and a portion of the crawl space slab located within the northeastern section of the Track 4 portion of the Site.

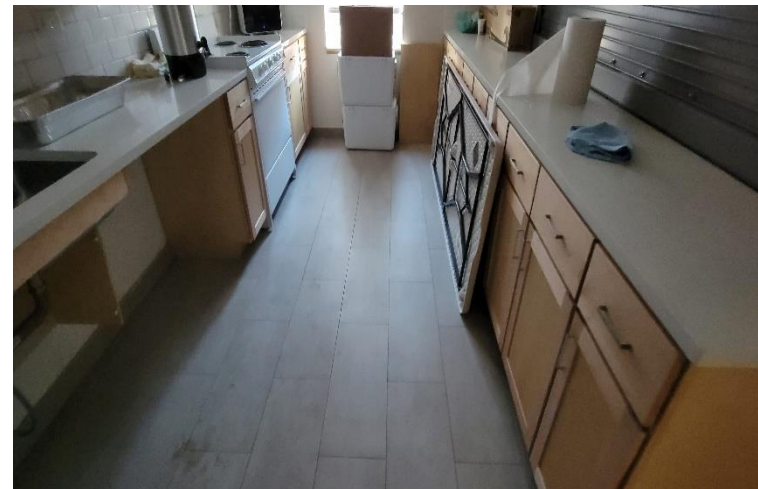
Photograph 4: The kitchen within the residential unit on the ground floor, view facing south.
