# **Hunts Point Food Distribution Center Redevelopment Plan**

## **Site Investigative Report for Operable Unit 2 Portion of Parcel E, Bronx, NY**

**June 2007**

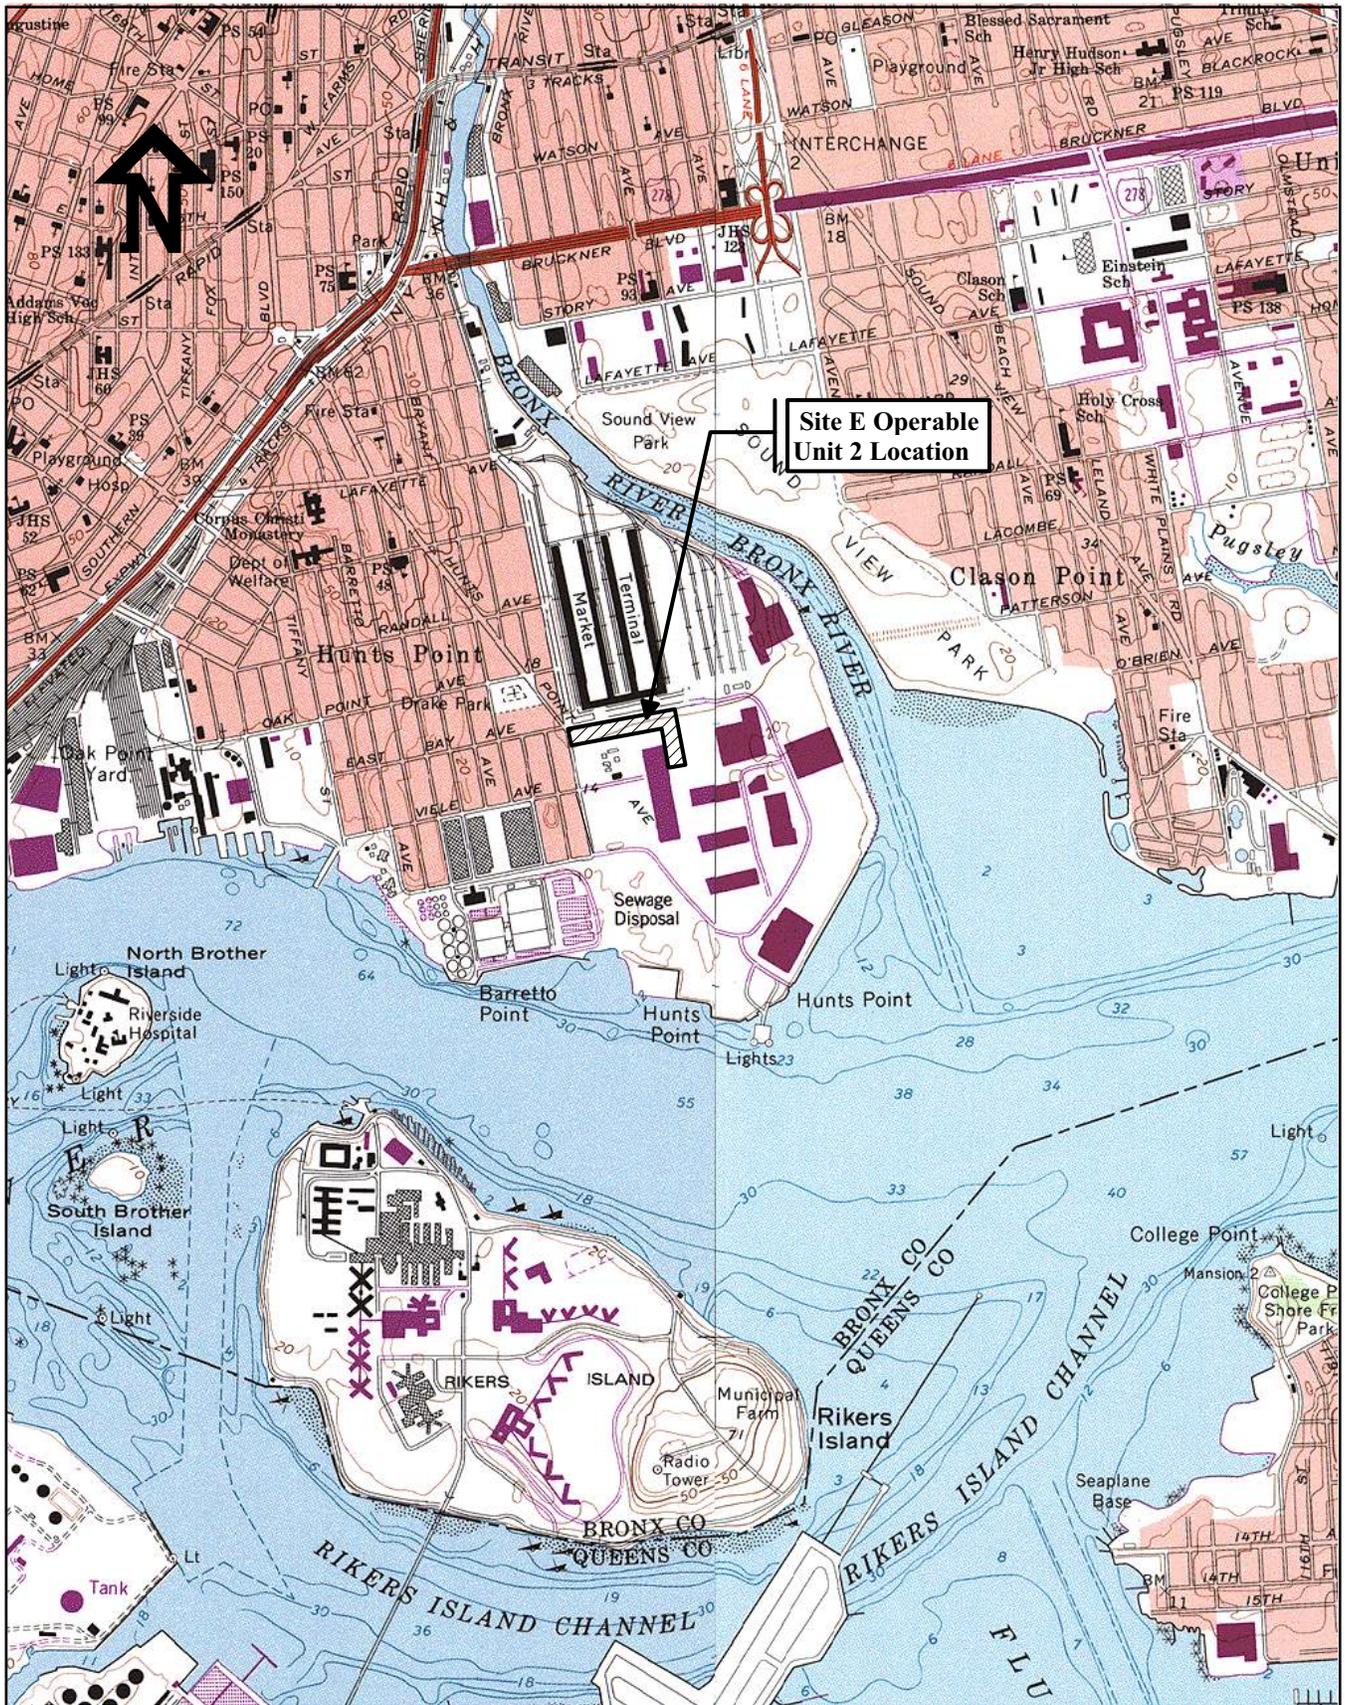
**Site E Operable Unit 2 Location**

Site E OU-2 can be described as an inverted and reversed "L" shaped site. The top section lies parallel and adjacent to the southern boundary of East Bay Avenue from the intersection of Halleck Street, approximately 950 ft east. This is referred in this report to the northern portion of Site E OU-2.

The bottom leg of the parcel begins at East Bay Avenue at the eastern end of the previously described "northern section" of E OU-2, and continues south approximately 600 ft. This is referred to in this Report as the southern portion of Site E OU-2.

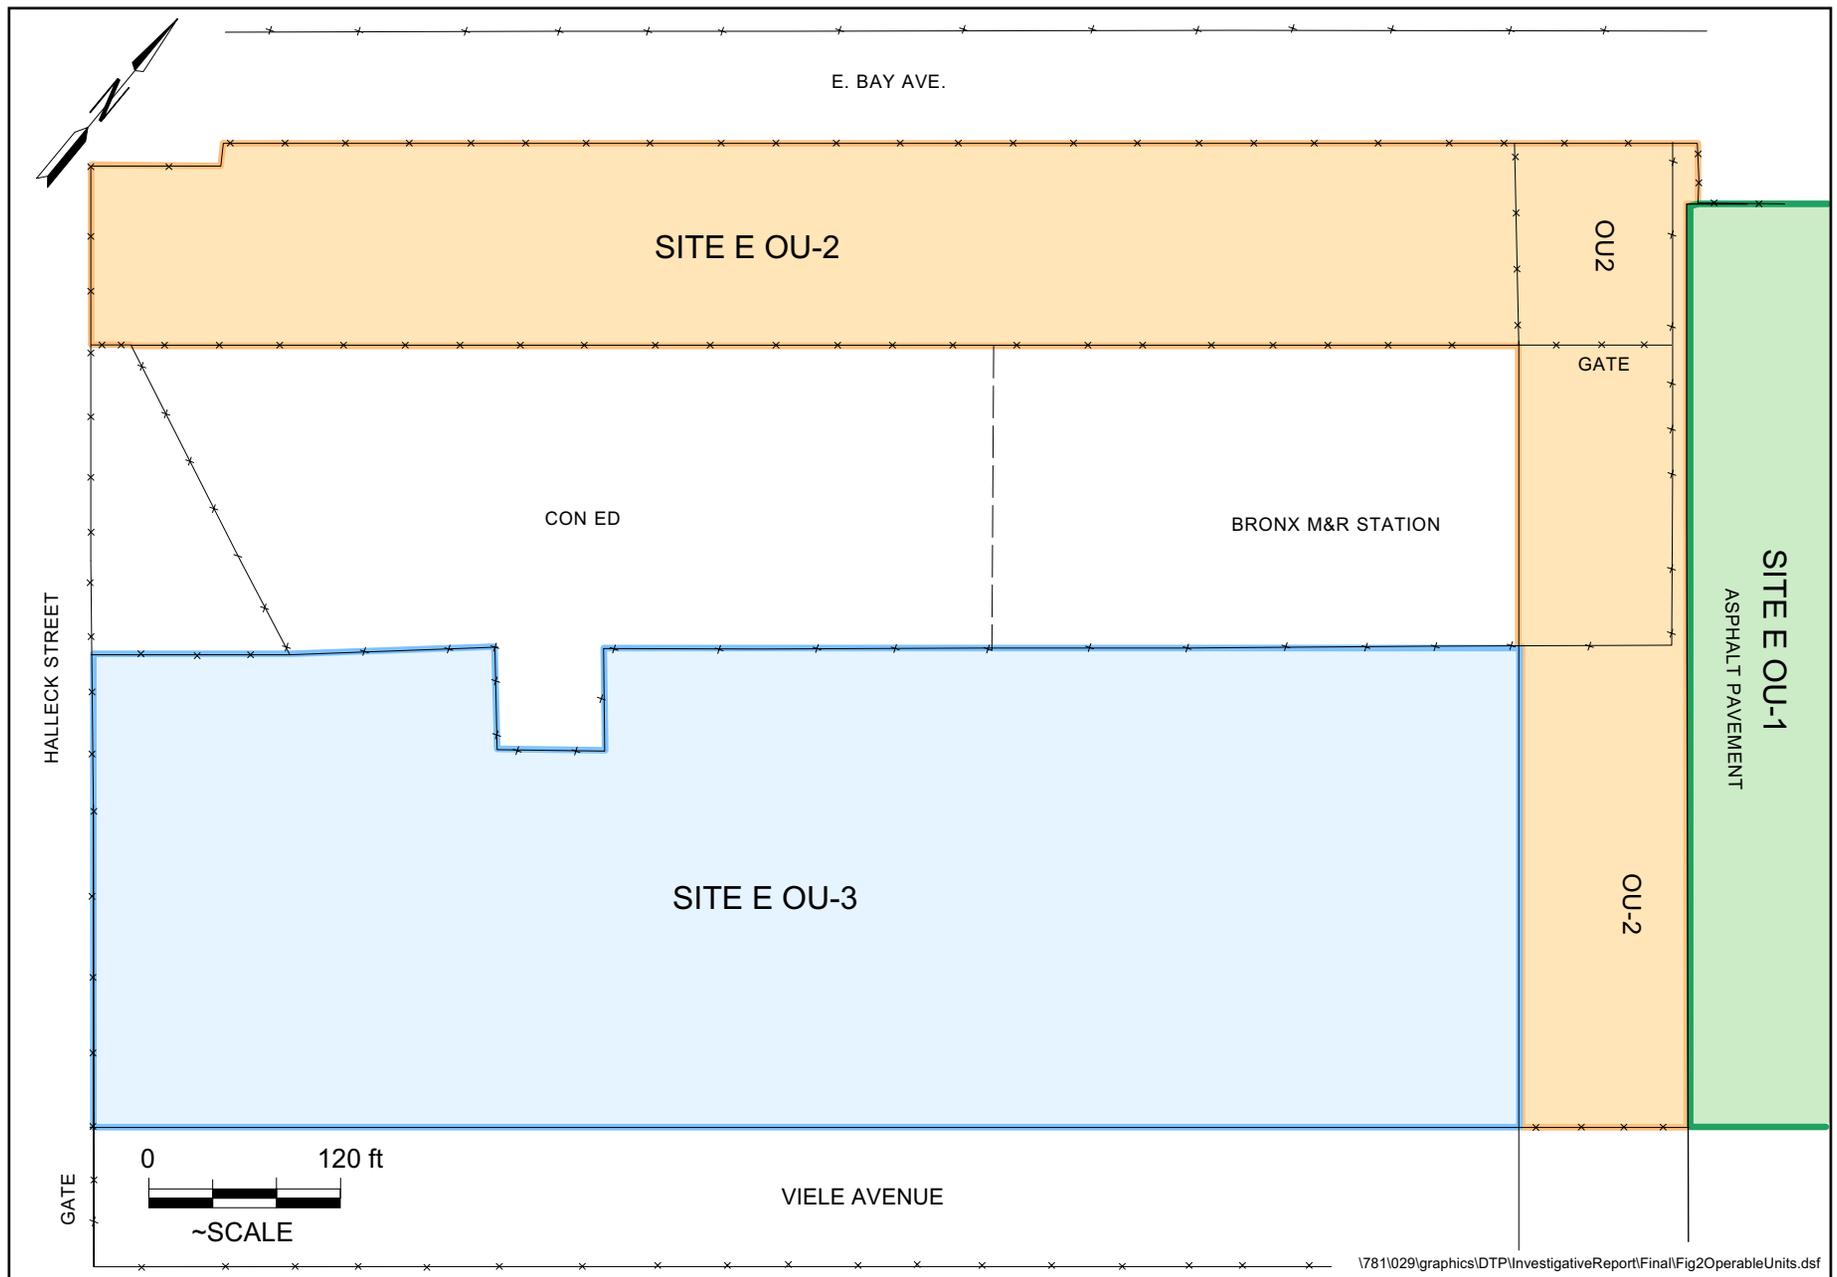
### Site E Operable Units

OU-3 covers the southwestern portion of Site E and is shaped as an east/west orientated rectangular strip of land (see Figure 2). OU-3 is bounded on the north by the Con Ed and the M&R Station, on the west by Halleck Street, on the east by OU-2, and on the south by Viele Avenue which is currently the northern most section of the new Fulton Fish Market employee parking lot.

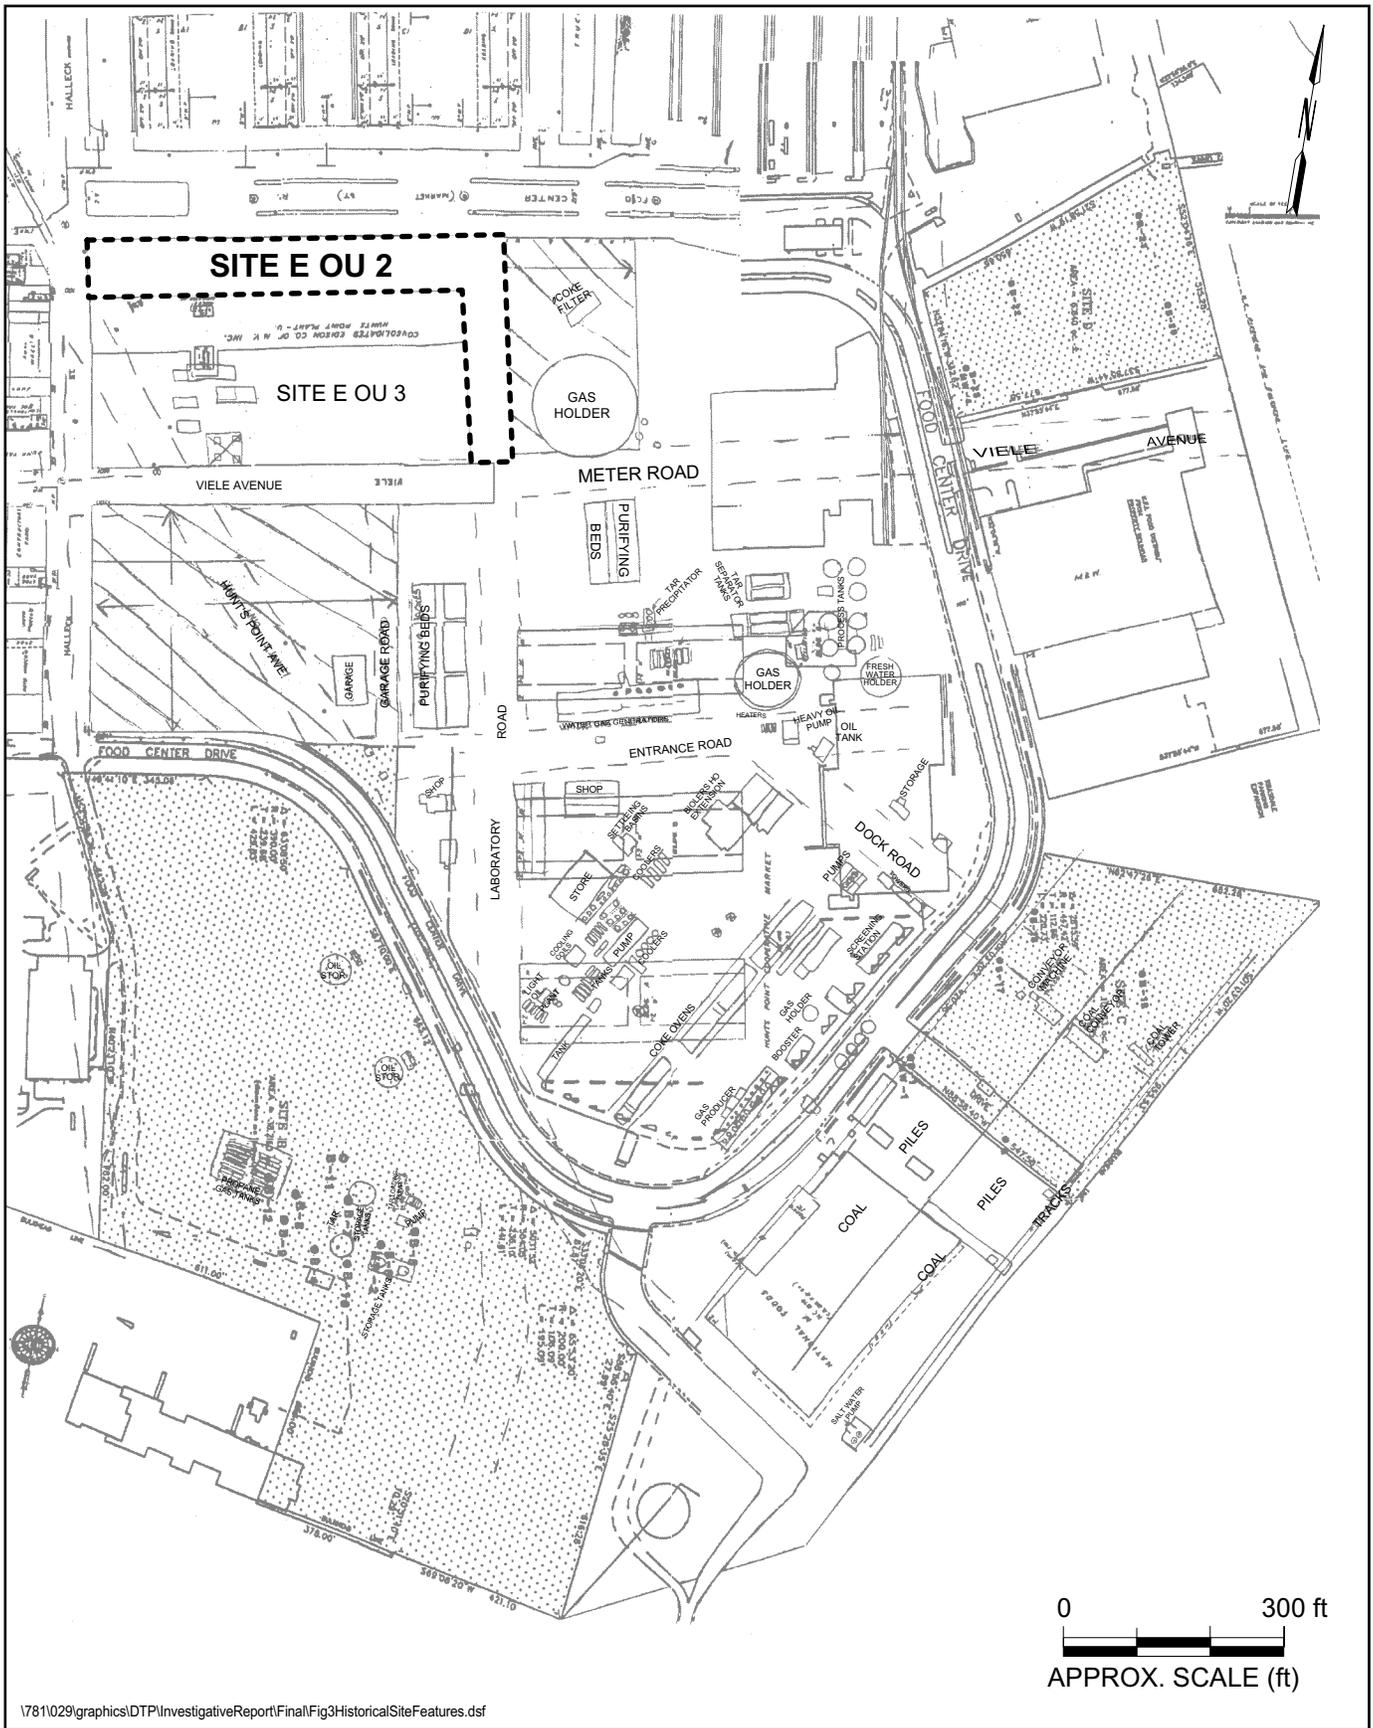
Figure  
 3

Historic Site and topographic maps have been reviewed and a composite showing Site conditions that were identified on those maps is included as Figure 3. Historic aerial photographs were also reviewed (see Aerial Photos 1, 2, 3, 4 and 5). The intrusive work in this report takes into account the information shown on these maps and photos performed and documented. The parcel is located northwest of the former location of the 15 million cubic feet gas holder structure and coke filter.

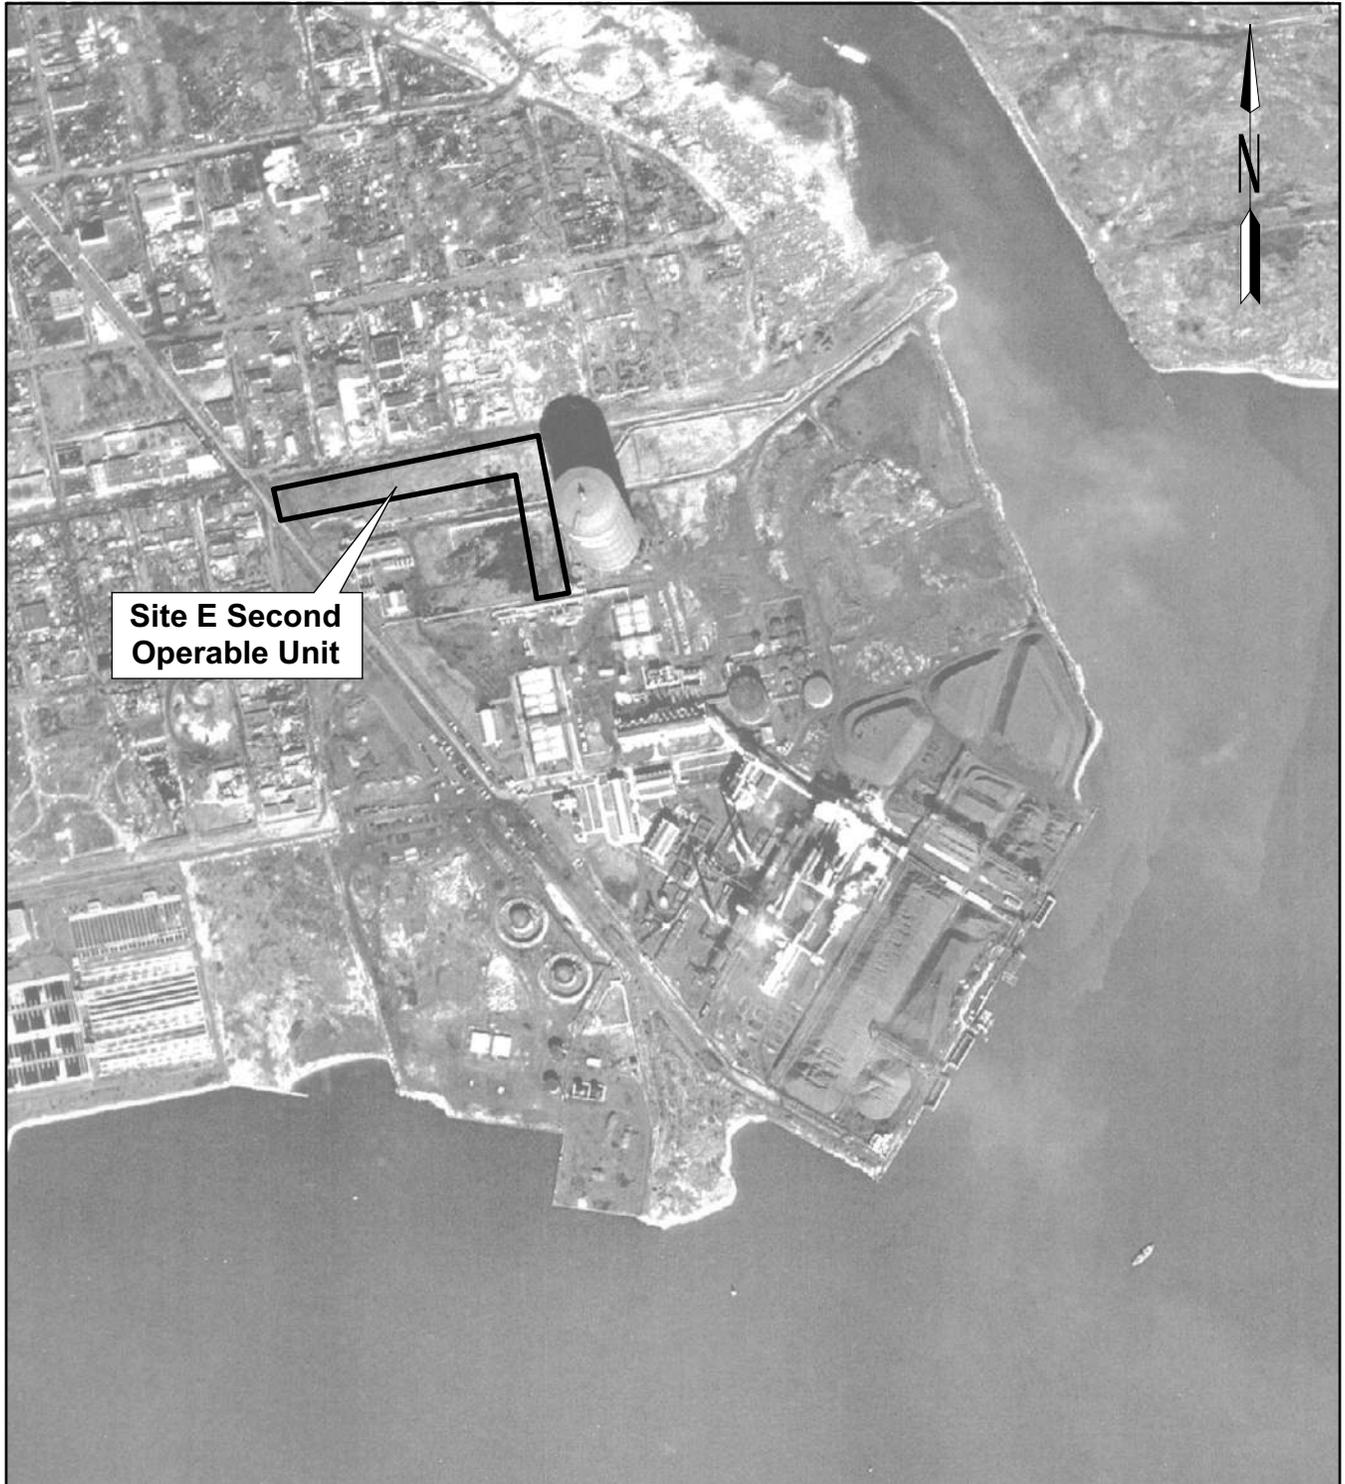
**Aerial  
Photo  
1**

**Hunts Point Site E -  
1954 Aerial Photograph**

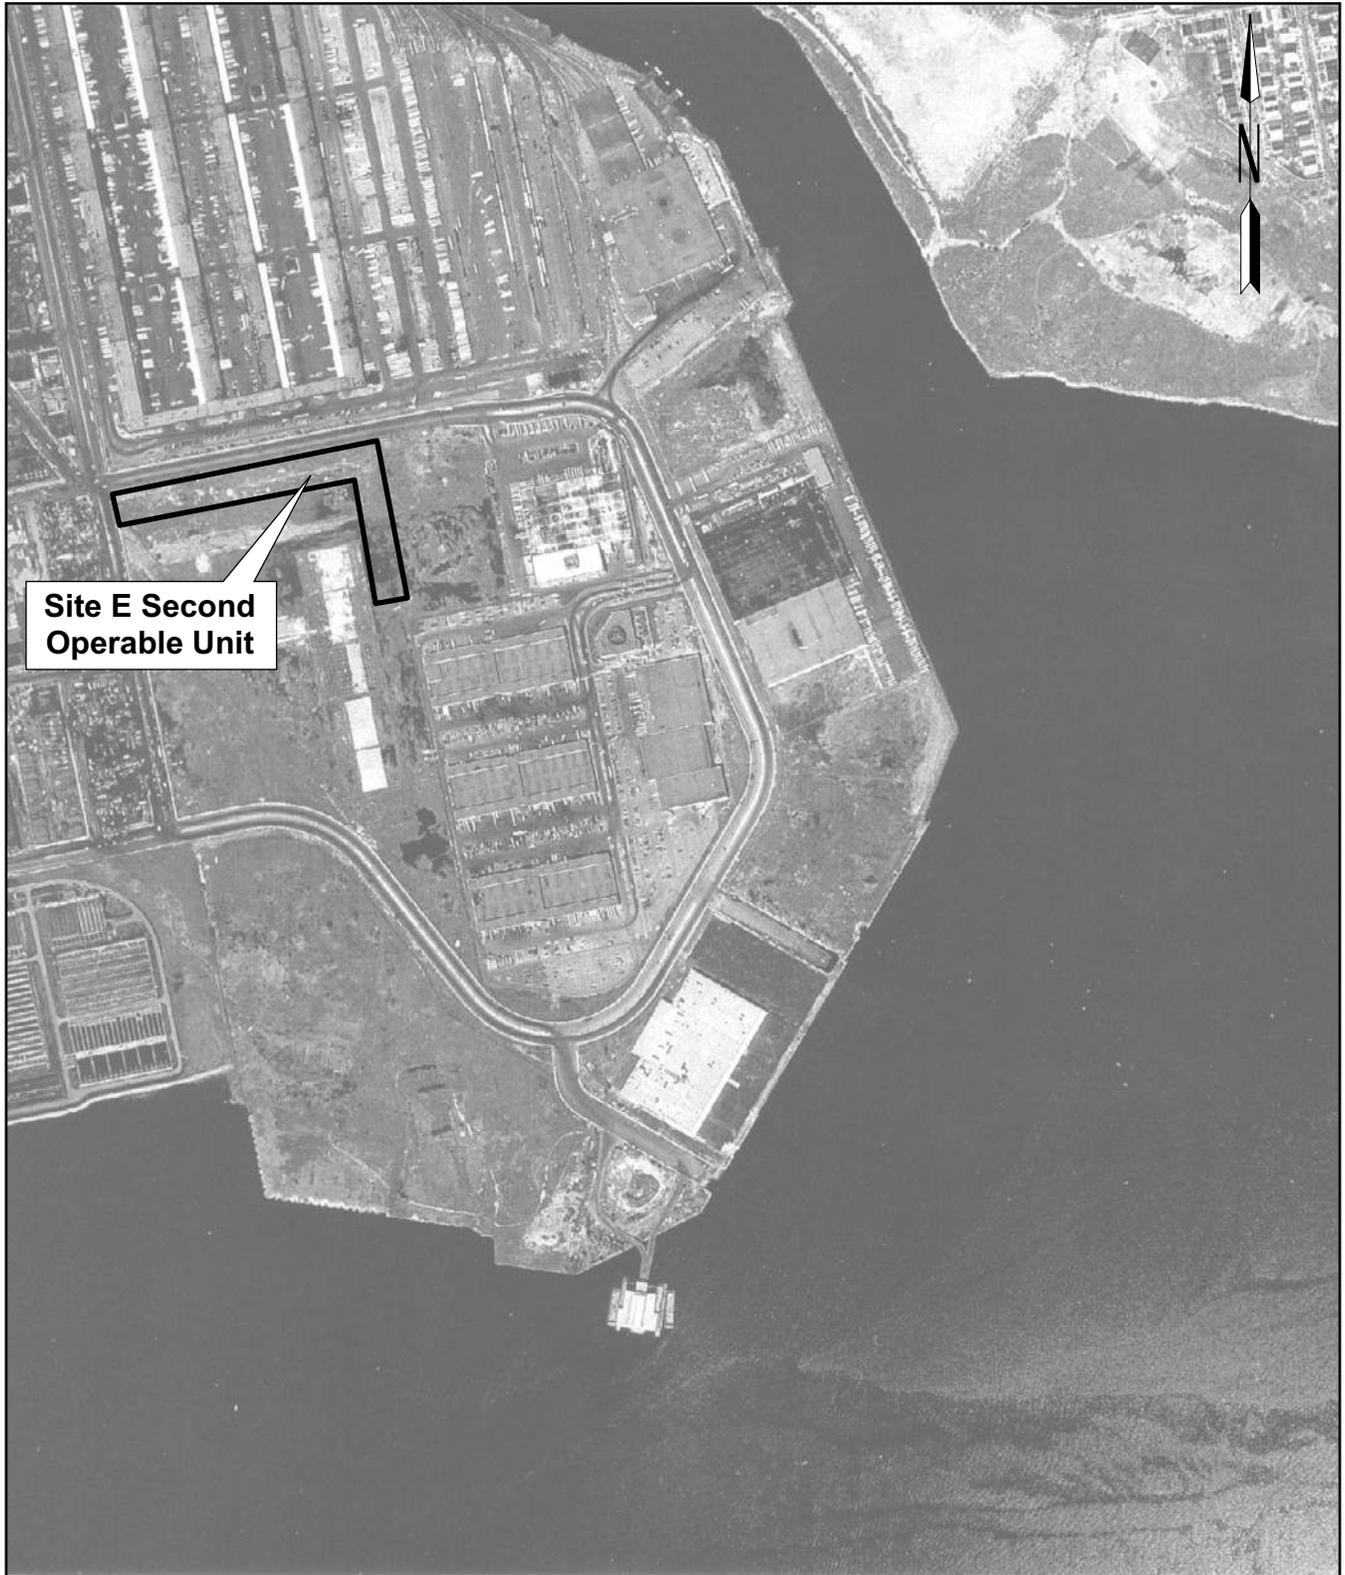
**Aerial  
Photo  
3**

**Hunts Point Site E -  
1975 Aerial Photograph**

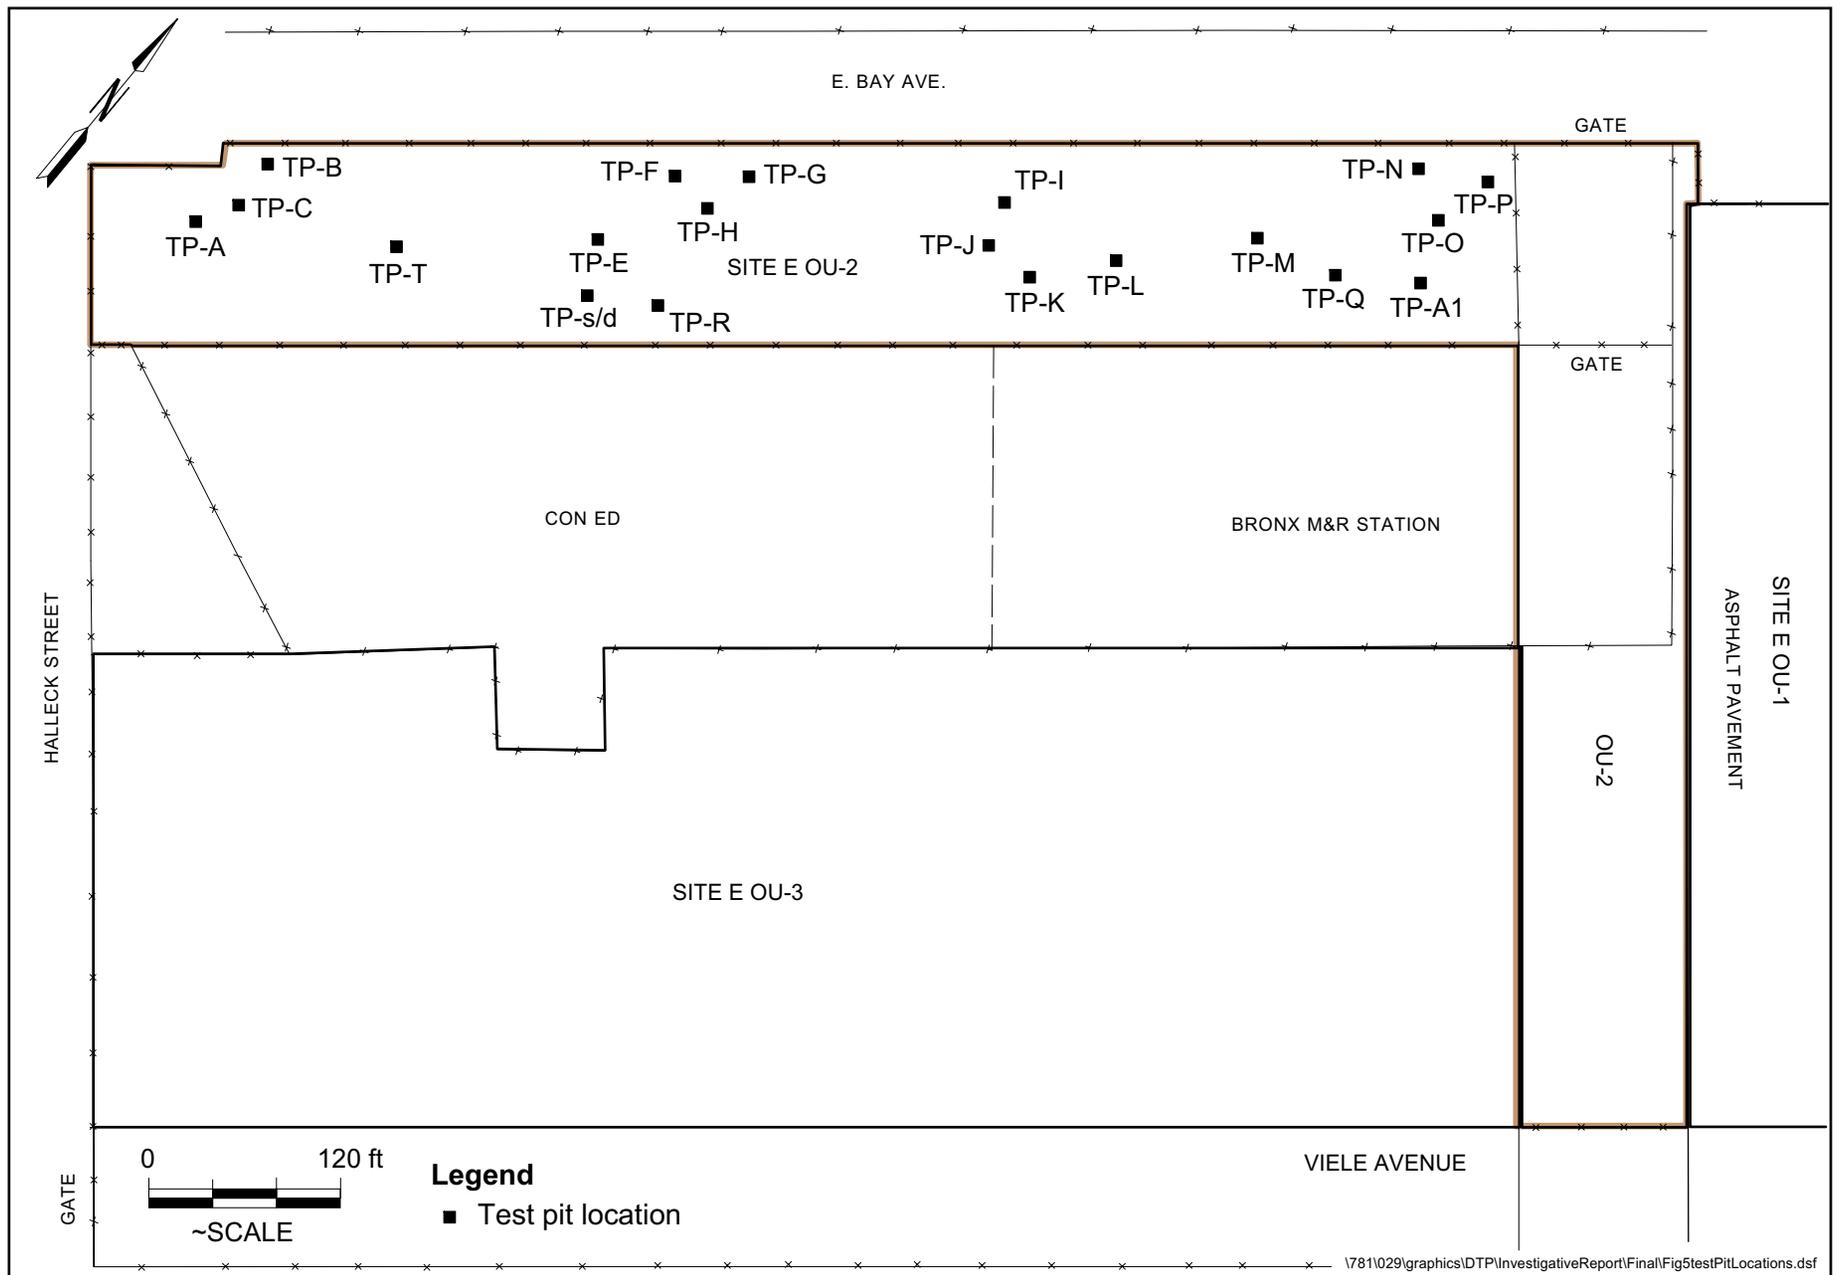
**Figure**  
**5**

The excavation of twenty (20) test pits was completed on site E OU-2 between April 12<sup>th</sup> and 13<sup>th</sup> 2005. A tire mounted backhoe was used to excavate small areas throughout the site to visually inspect the subsurface material and conditions of the site. The pits were generally 3 or 4 ft wide and less than 10 ft long depending on the final depth and were extended to the depth of groundwater or to a point where a clay confining layer was encountered (Figure 5).

**Test Pit Locations**  
 Hunts Point • Site E OU-2

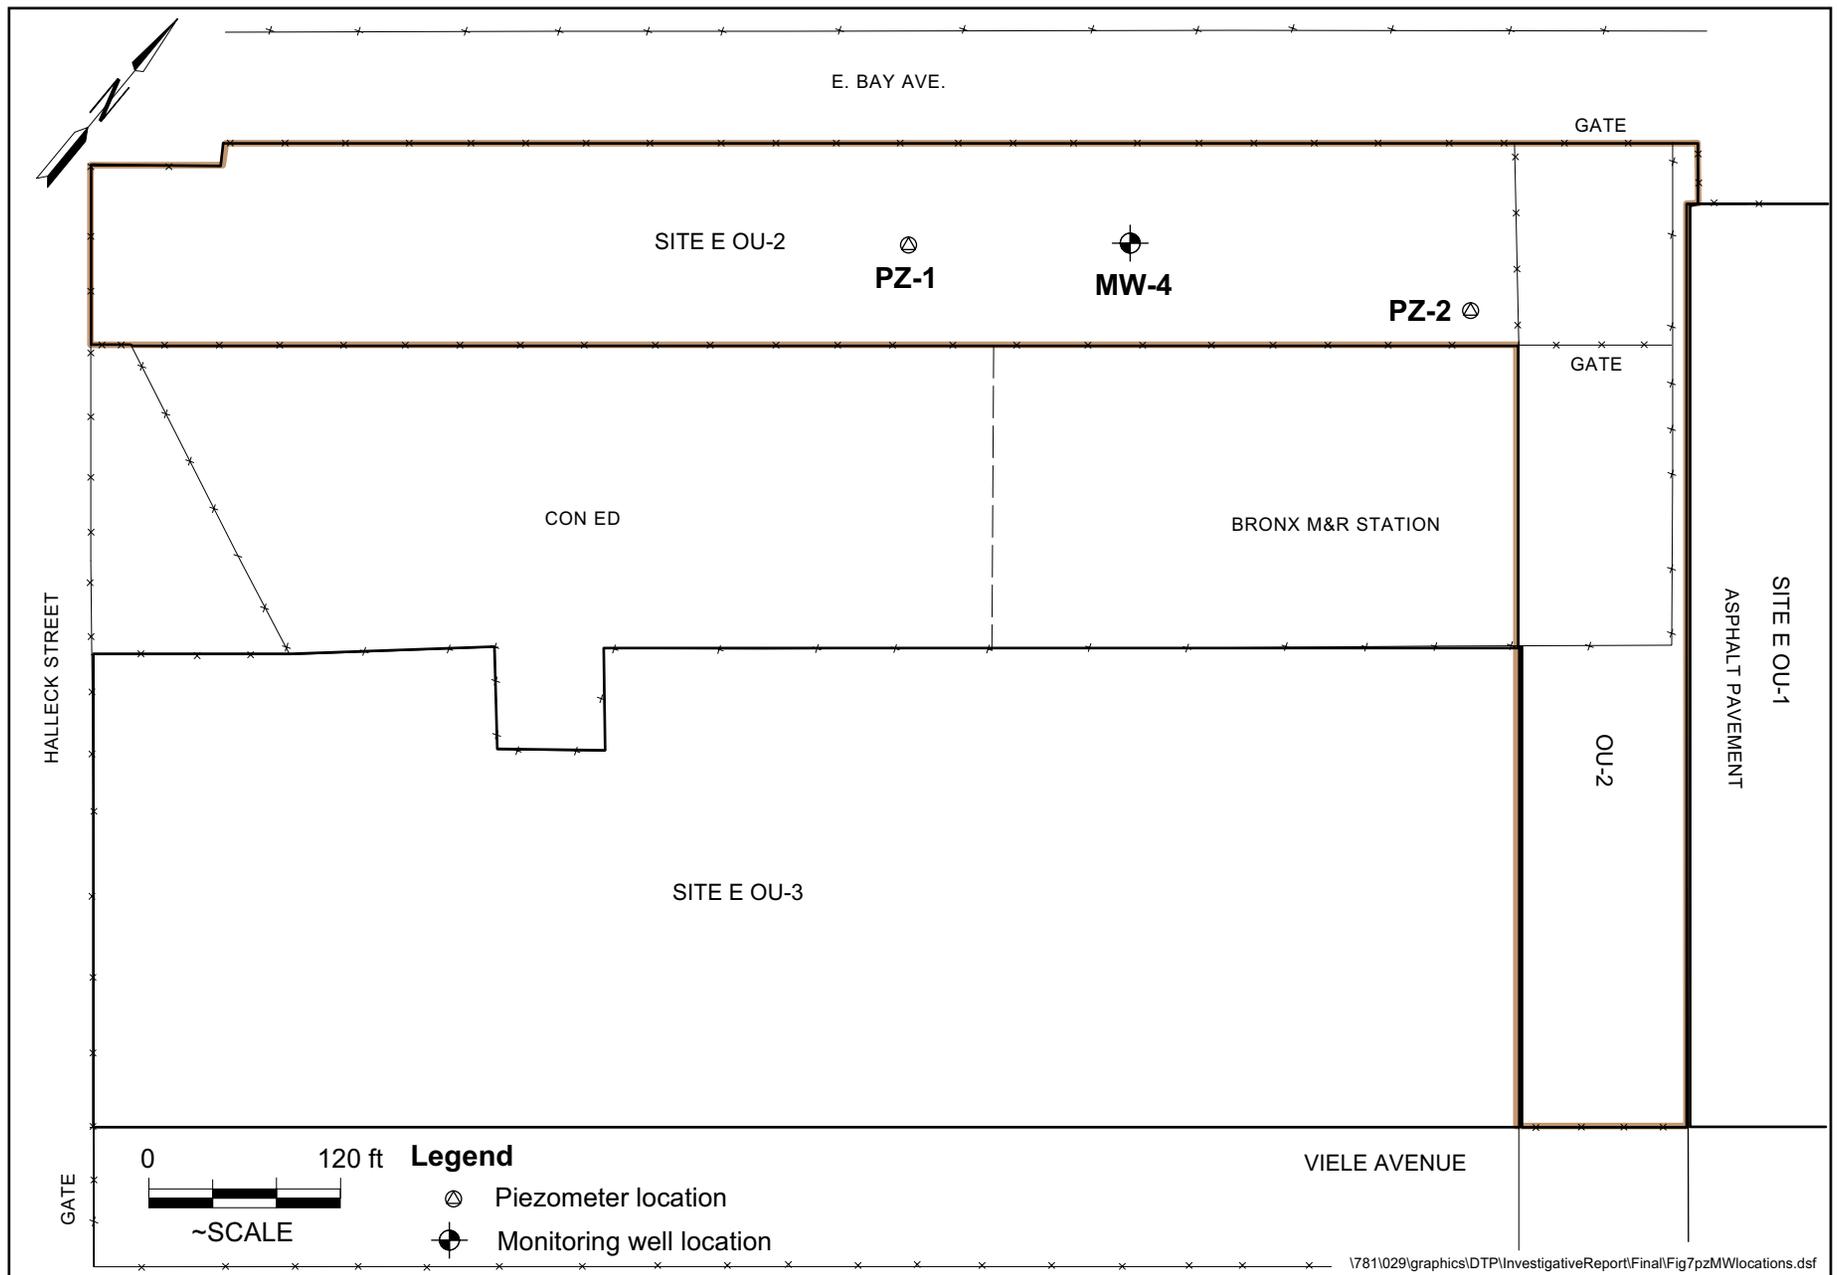
### Piezometer and Monitoring Well Locations

Each piezometer was constructed using 5 ft of 2-in. inside diameter (I.D.) Schedule 40 PVC with 0.010-in. slot screen and solid riser to grade. The piezometers were backfilled using #2 Morie sand to 2 ft above the top of the screen with a 2 ft bentonite seal, the remainder of the annulus of the probe was back filled with cuttings from the probe or clean sand to grade. Each point was then located using GPS and located on the site map prepared (Figure 7).

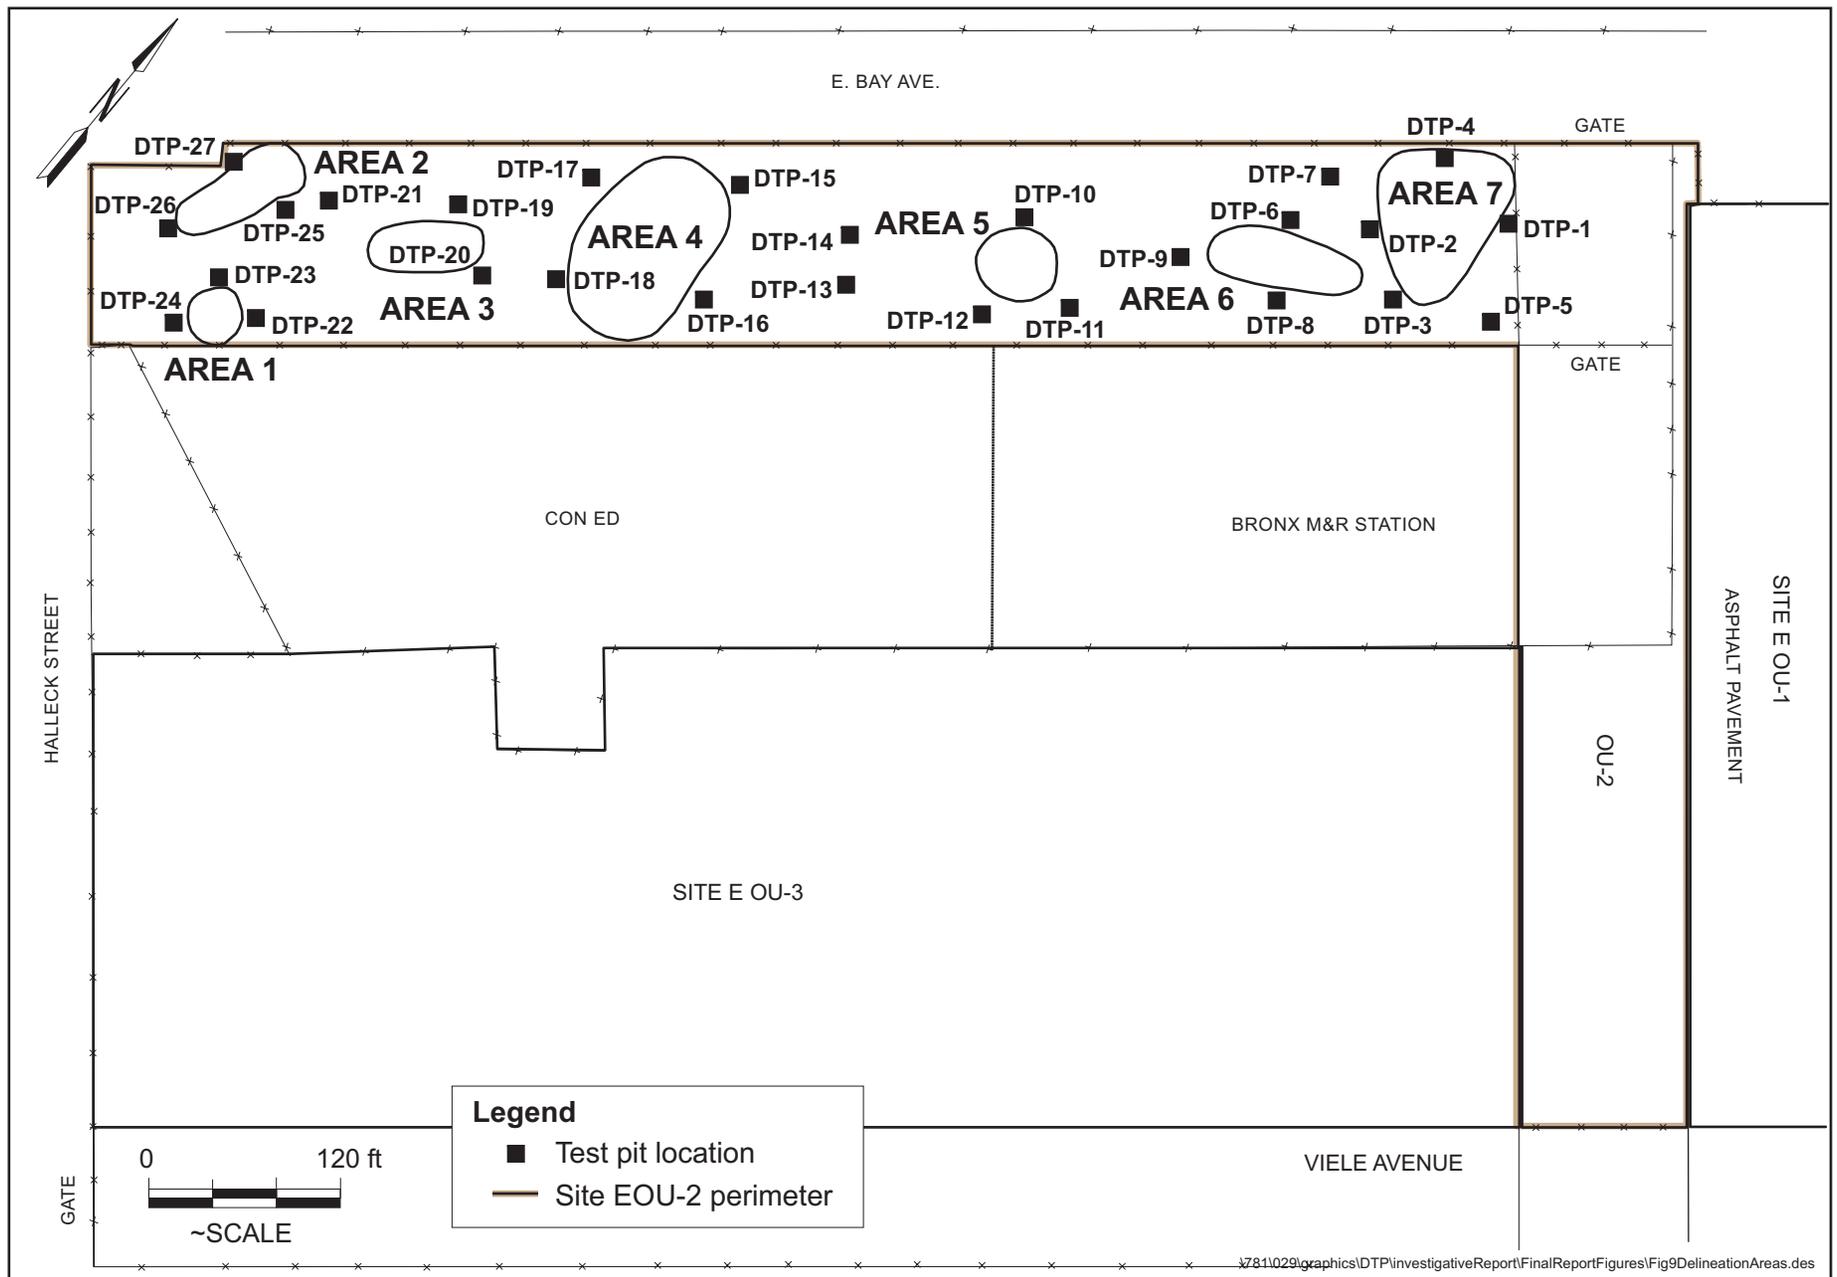
\\7811029\graphics\DTP\InvestigativeReport\FinalReportFigures\Fig9DelineationAreas.des

In order to assess the amount of material that must be removed from the site, HDR|LMS conducted the delineation of areas designated as "hot spots". Seven (7) areas of the site were designated for further delineation. The areas consist of boring, test pit, and soil gas locations where the material observed during installation was characterized as coal tar or petroleum saturated material (Figure 9).

Delineation activities consisted of further test pitting in the seven (7) locations shown on Figure 9, collection of waste characterization soil samples from a sidewall of one to two test pits for each of the seven delineation areas. Following the delineation of each location, each area was remarked using GPS so the material can be found precisely, and be re-excavated and removed at a later date.

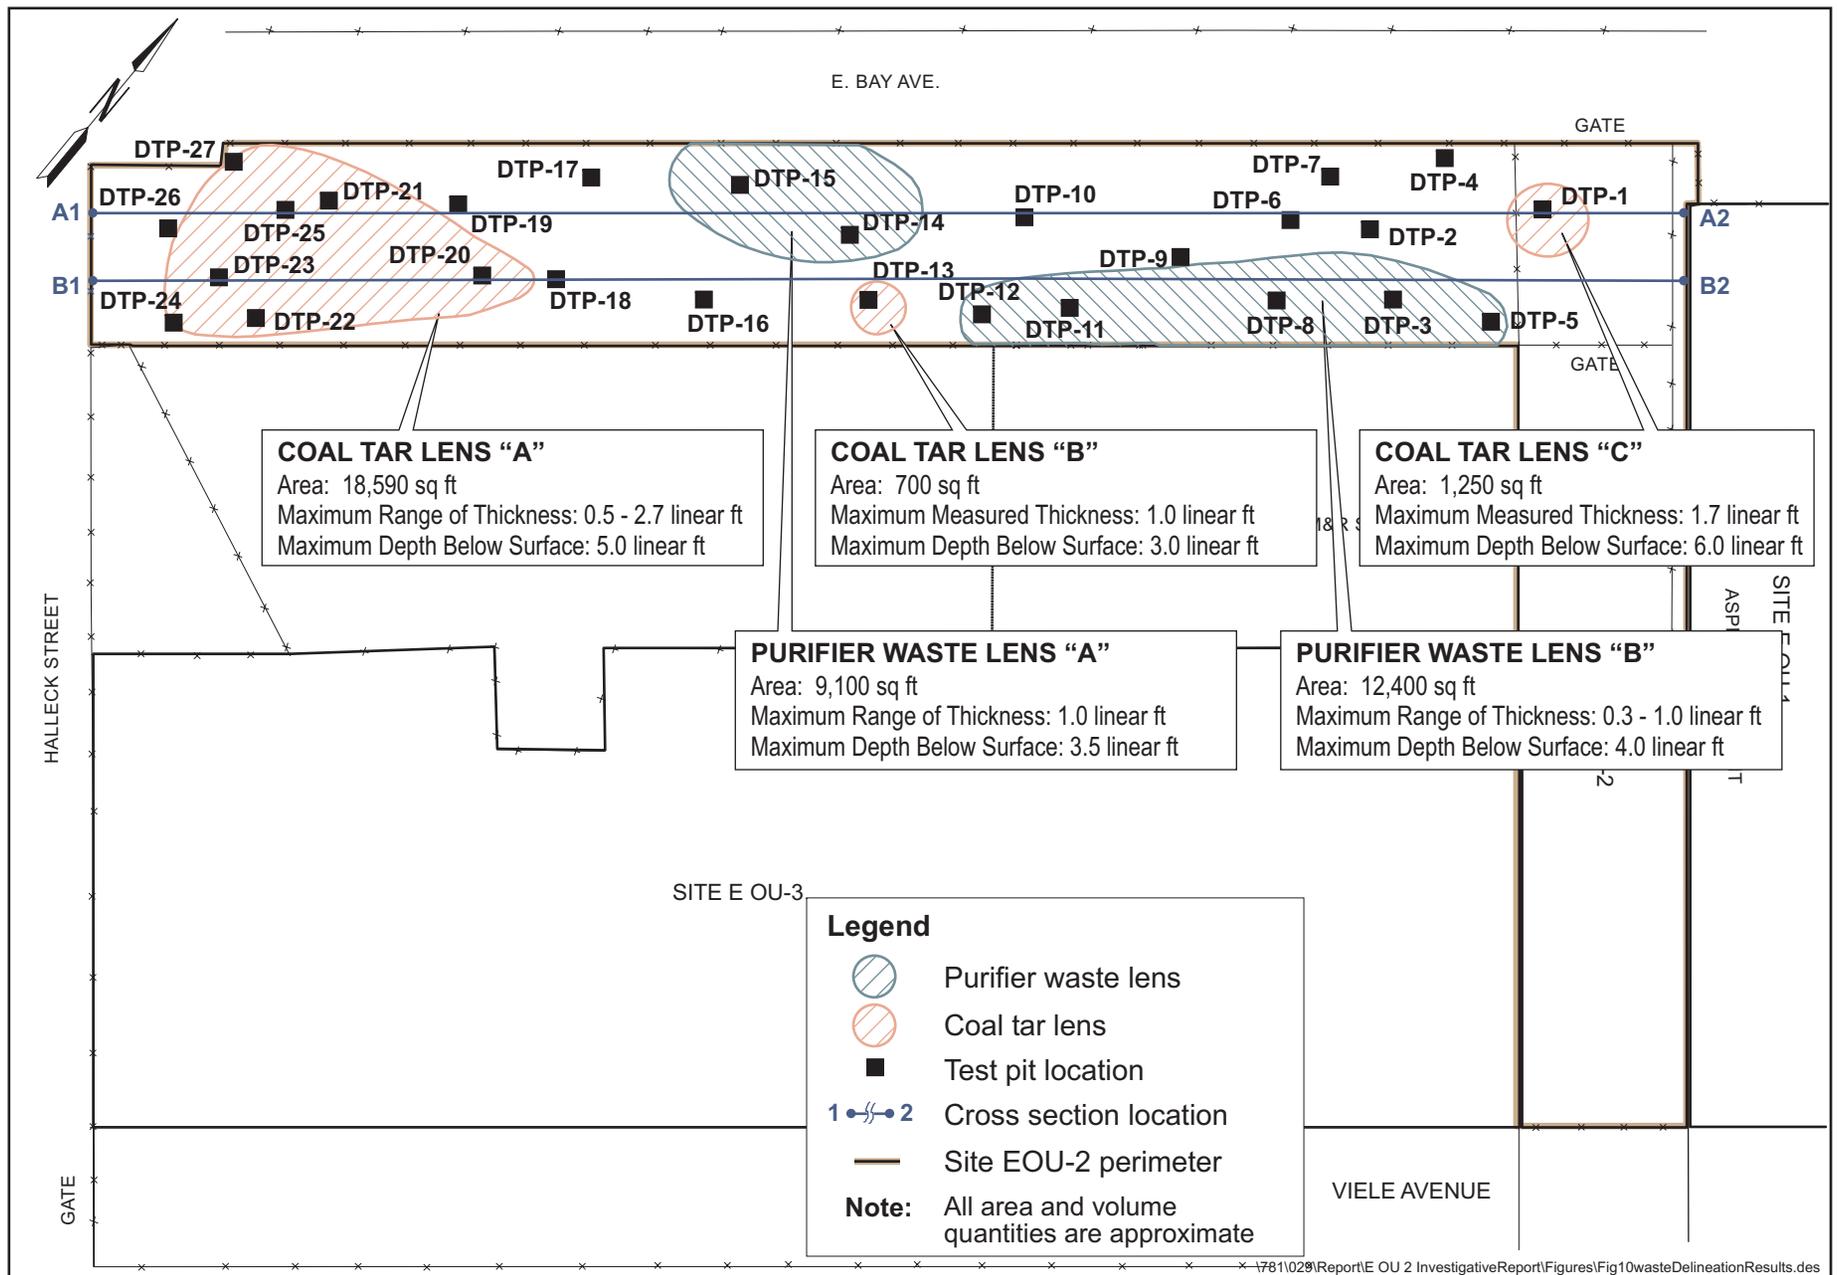
17811029\Report\E OU 2 Investigative\Report\Figures\Fig10wasteDelineationResults.des

The overall results of soil sampling activities during the investigation indicate that the prevalent waste material on-site that may require further remedial action are the coal tar and purifier type waste hot spots.
