Pre-Design Investigation (PDI) Summary Report

Hunts Point 400 Food Center Drive
NYSDEC BCP Site No. C203101

For the Property located at:
400 Food Center Drive, Bronx, New York

August 2024
Project No. 2303627

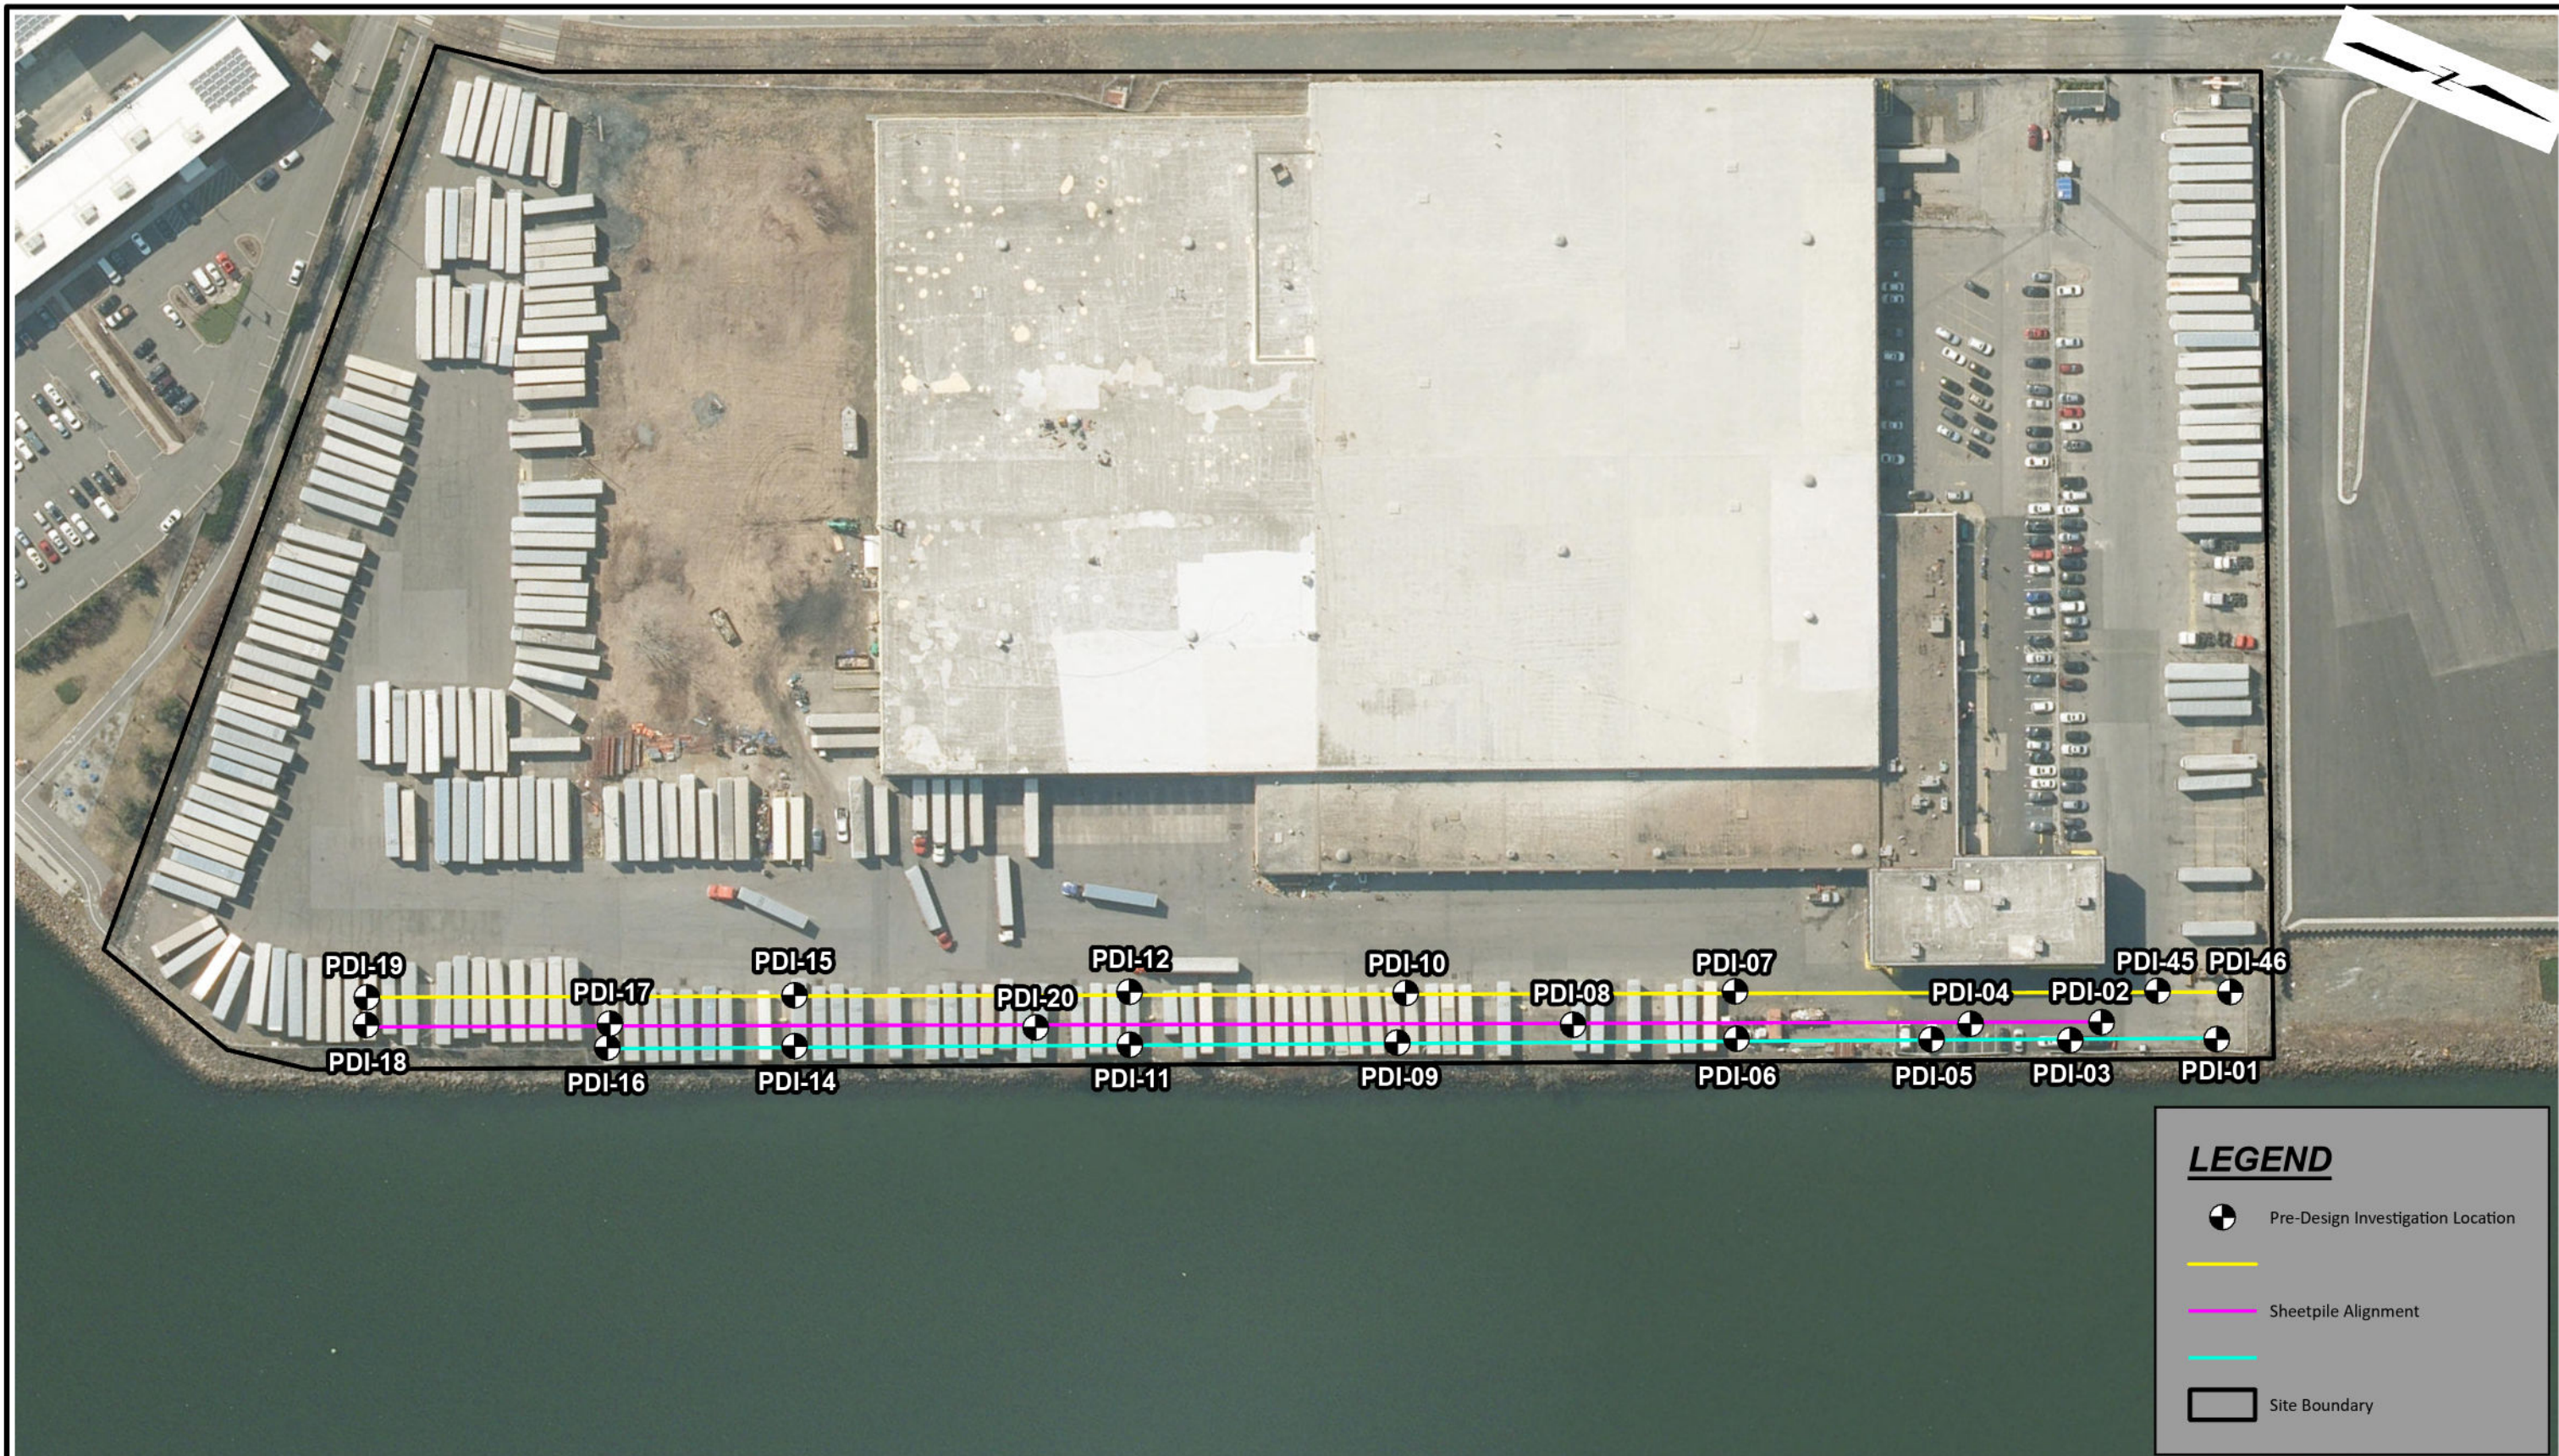
Fig. 1

Boring locations and their respective alignment lines are presented in Fig. 1. Daily field summary reports and air monitoring data are included in Appendix B.

NOTES:
1. EASTERN-MOST ALIGNMENT LINE (GREEN) IS APPROXIMATELY 13 FEET WEST OF THE BULKHEAD.
2. CENTER ALIGNMENT LINE (PINK) IS APPROXIMATELY 20 FEET WEST OF THE BULKHEAD.
3. WESTERN-MOST ALIGNMENT LINE (YELLOW) IS APPROXIMATELY 45 FEET WEST OF THE BULKHEAD.

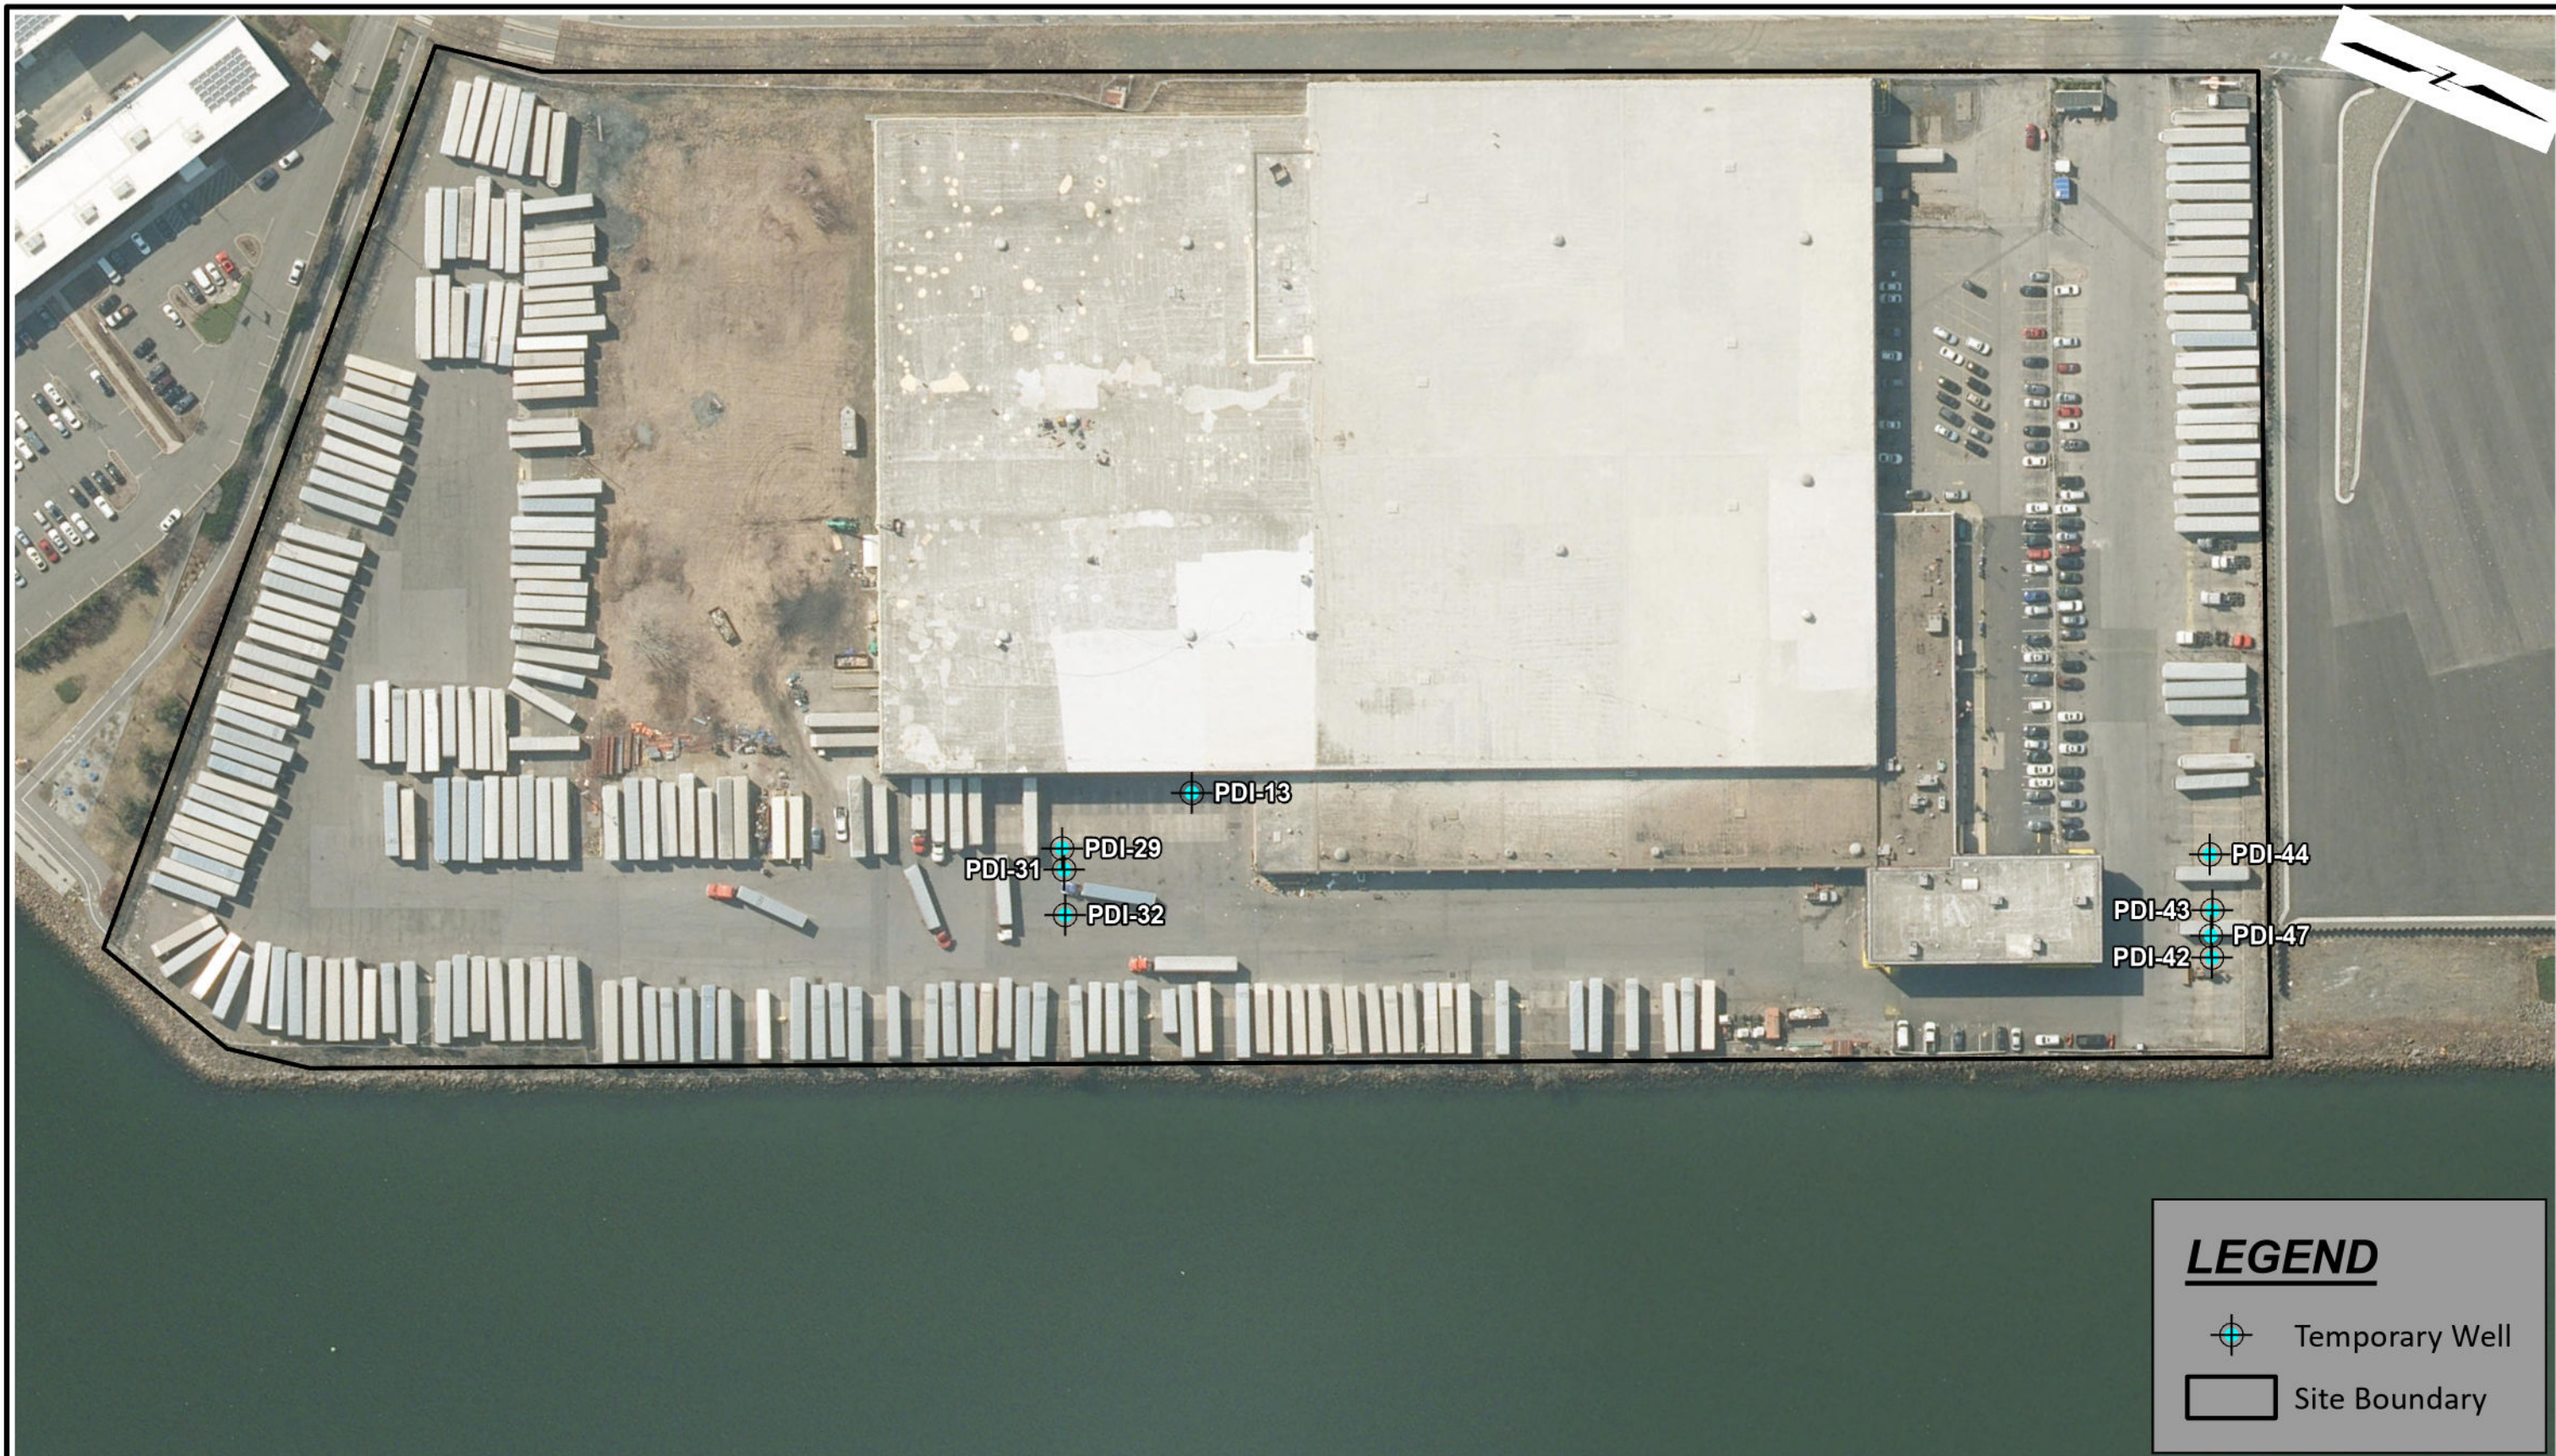
Figure 3. PDI-20 Waste Delineation

PDI-35 through PDI-41 were advanced on March 4, 2024, via direct-push rig to delineate the extent of shallow coal tar impacts near PDI-20. Delineation borings were performed at 5-foot and 10-foot step-outs where possible, none of which encountered any additional coal tar. Material encountered mainly consisted of historic fill material with varying amounts of black coal ash and faint to moderate MGP-like odors, which is typical of the shallow historic fill layer in Hunts Point. The minor amount of solidified coal tar encountered in PDI-20 is considered to be a non-significant amount and not part of a larger deposit requiring remediation. At this time, it is predicted that this material may be removed during installation of the SSP wall, however, no additional action will be recommended. Boring locations are presented in Fig. 3 and boring logs will be provided in the RAWP under a separate cover.

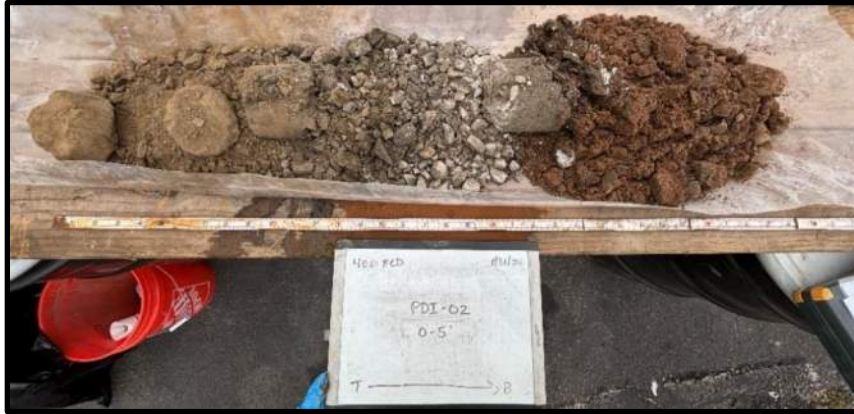
Photo 1: Boring location PDI-02, 0-5-foot interval

PDI-02 was advanced within an area that detected the presence of minor voids at approximately 2-4 ftbgs. As presented in the attached boring log and Photo 1 below, this interval primarily consisted of subangular gravel with silt and sand from 2.1 to 2.9 ftbgs and a dense silty sand with about 30% gravel from 2.9-3.7 ftbgs. Below this, there is a transition to a more loose, homogeneous sand with trace amounts of gravel, which may have contributed to why the GPR scan showed a lower density area. As the boring was advanced, no voids or hollow areas were identified.

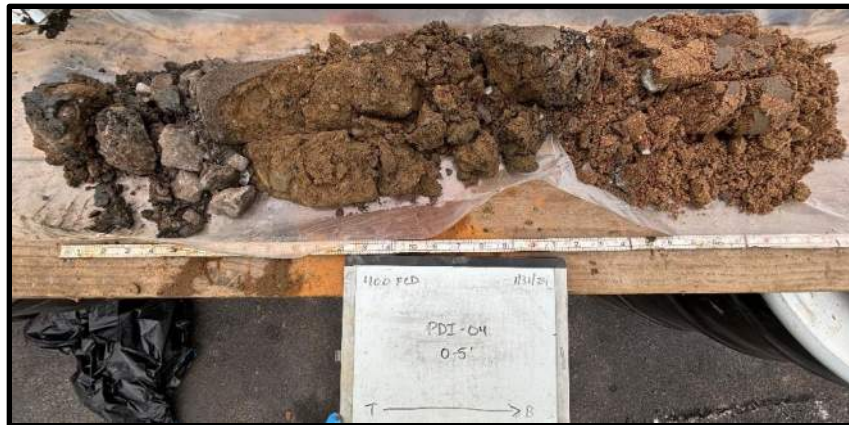
Photo 2: Boring location PDI-04, 0-5-foot interval

PDI-04 was advanced within an area that detected the presence of minor voids at approximately 3-4 ftbgs. As presented in the attached boring log and Photo 2 below, this interval primarily consisted of narrowly graded, homogeneous sand with trace subrounded gravel. At a depth of 3.1 ftbgs, the subsurface transitioned from a more dense silty sand with about 15% gravel to a more loose sand, which may have contributed to why the GPR scan showed a lower density area (similar to PDI-02). As the boring was advanced, no voids or hollow areas were identified.

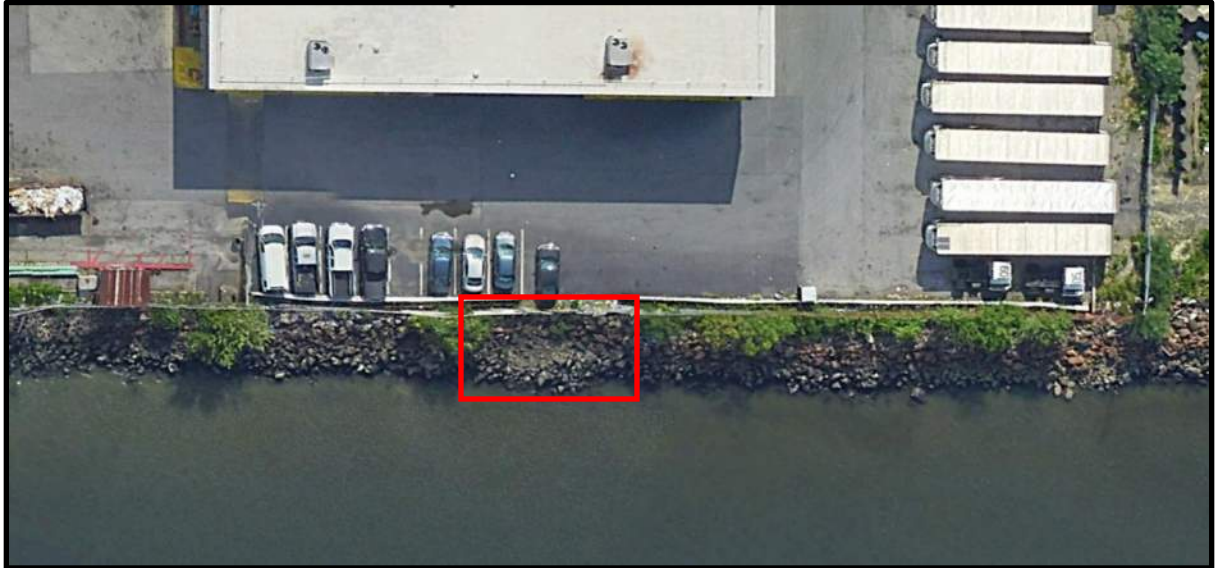
An area of concern was also identified along the stone riprap adjacent to a gate opening in the eastern fenceline, as depicted in Photo 3 and Photo 4 below. In discussions with the Krasdale management team, it was brought to GEI's attention that when the facility was first constructed in the 1970's, the gate was installed to provide a specific staging area to clear the facility of snow. The routine dumping of large amounts of snow likely contributed to the "flattening" of the rip rap stone in this area.

Photo 3: Area of “flattened” riprap stone adjacent to fence/gate opening.

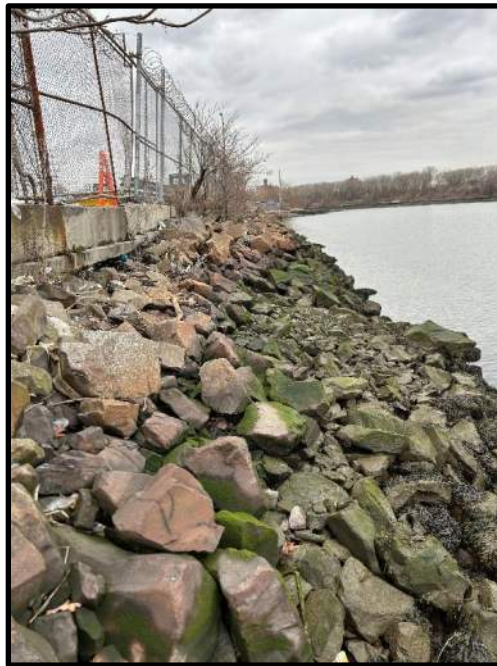
Photo 4: Stone riprap adjacent to fence/gate opening.

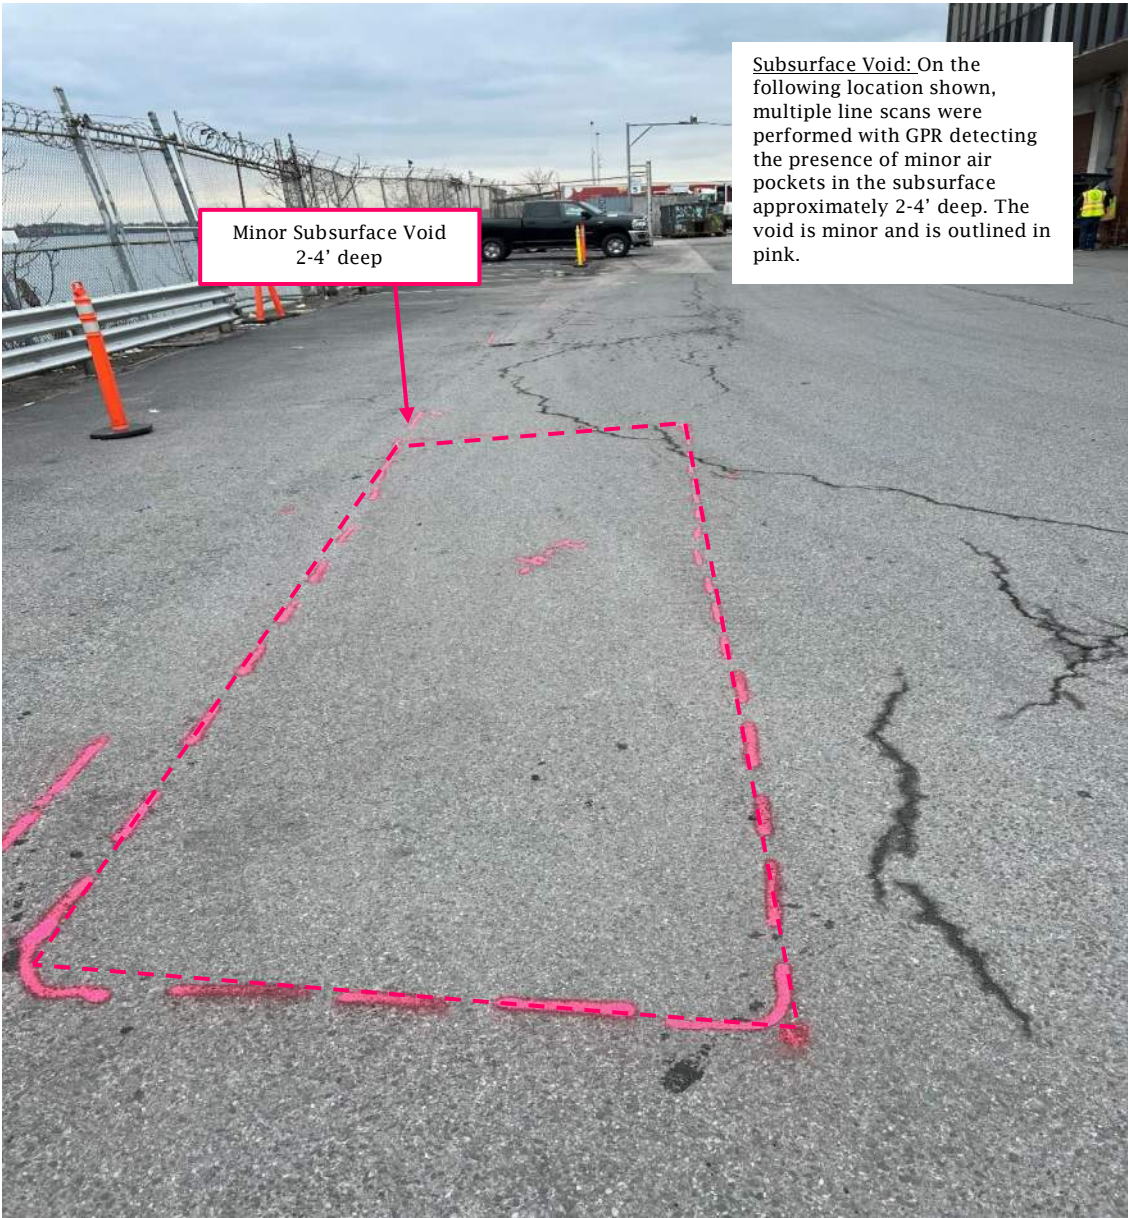
Subsurface Voids

Hunts Point Market 355 Food Center Drive Bronx NY 10474 Results: On the following project summary report images taken on-site, GPR data collected from the property will be shown, and brief description findings will be provided. The objective for this project was to investigate for a water line, to determine if there are subsurface voids in the pre-determined area, and to possibly detect abnormal subsurface features such as cribbing. The water line was detected using EM Detection conductive locating methods. GPR technology was used to investigate for subsurface voids and cribbing. The area that was investigated for cribbing, GPR data collection was limited due to truck trailers in the parking lot. All findings were marked in paint.
