# **Hunts Point Food Distribution Center E OU-3 Extension & Viele Avenue Extension**

## **Site Investigation Report Bronx, New York**

### **Final**

**April 2010**

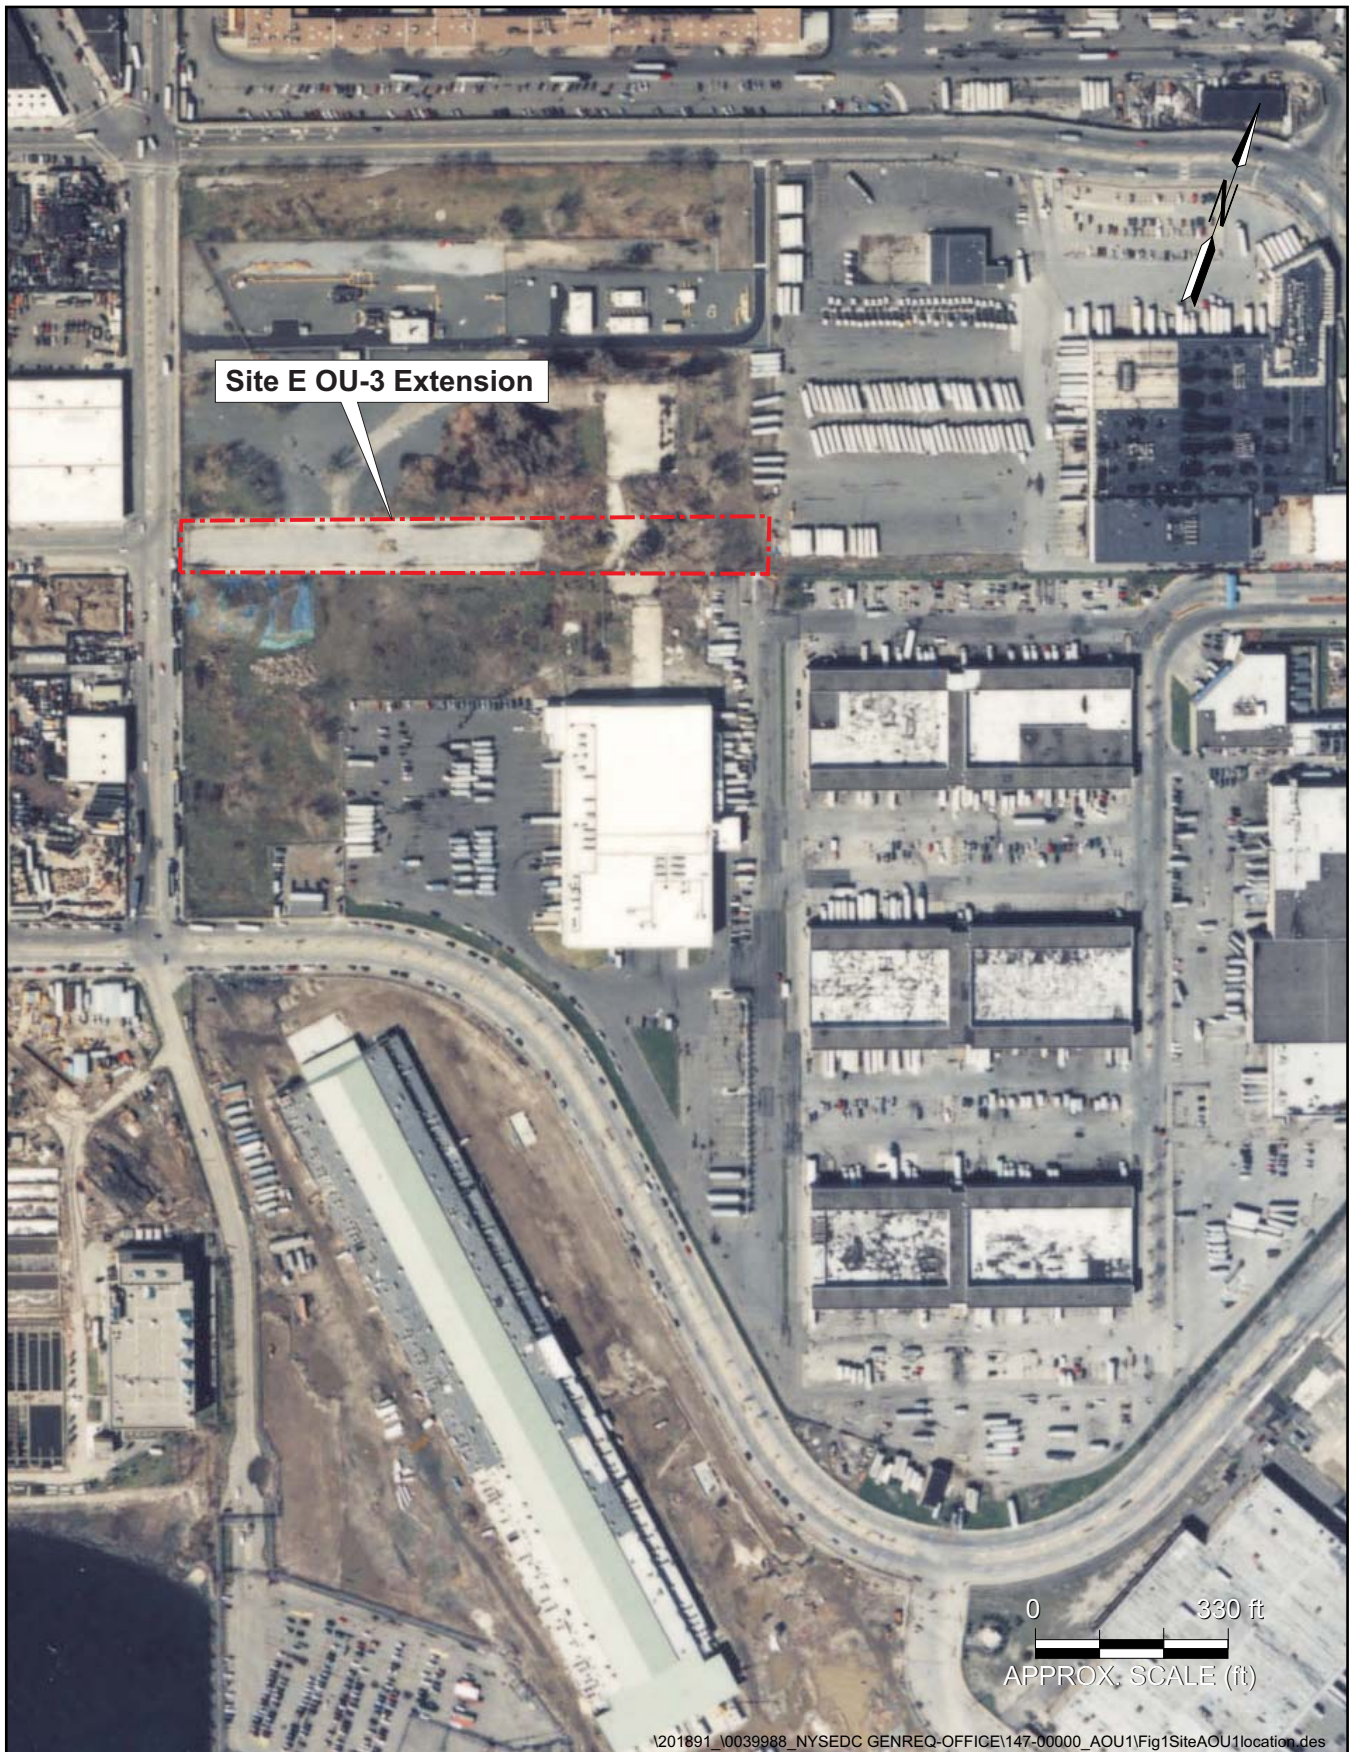
Figure  
4

Between 1966 and 1975, the western portion of the Site was developed as Viele Avenue (refer to Figure 4). Viele Avenue has been demapped but the Site E OU-3 Extension and Viele Avenue Extension still contain multiple utilities including a drainage easement (refer to Figure 2) leading to a combined sewer overflow (CSO) located on the southern edge of the Hunts Point Peninsula. Between 1975 and 1984, concrete foundations were installed along the eastern boundary of the Site. The foundations were intended for the development and relocation of a fish market that was operating in lower Manhattan. The relocation plans were never realized and in 2005 the Fulton Fish Market was relocated to a parcel in the southern end of the Hunts Point peninsula. Several of the foundations were used by the Nebraskaland development as an expansion of the current Meat Market Cooperative. The remaining slabs are unused.

## Site Aerial Photograph

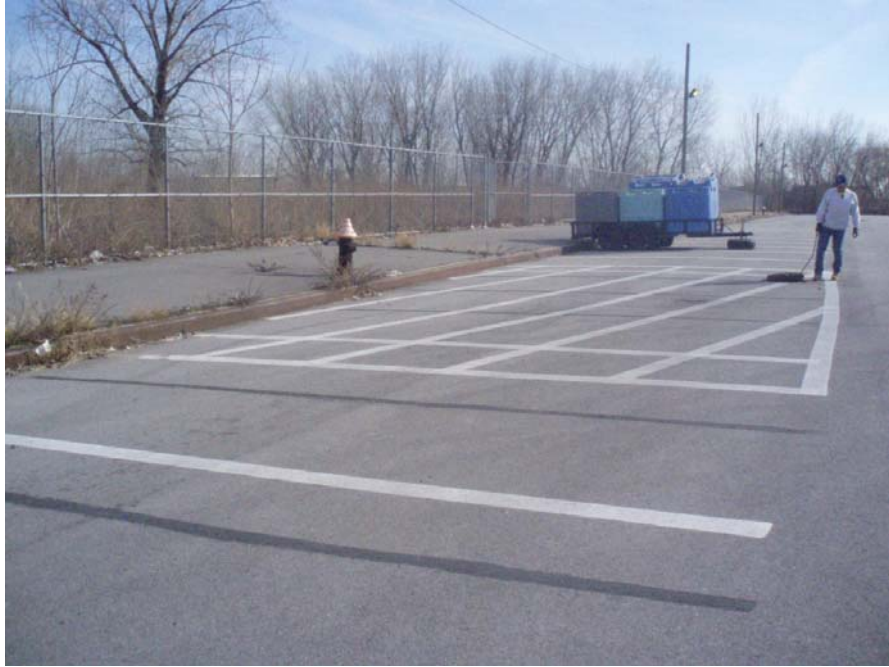
On March 10, 2010, HDR commenced field activities with the location of Site utilities by Diversified Geophysics. Each borehole location was cleared for drilling using electromagnetic and ground penetrating radar instruments, including the borings installed through the abandoned foundation slab. Diversified Geophysics also attempted to confirm the location of utilities shown on the Viele Avenue Investigation Area Survey (see Appendix B).

**Photograph 1: Geophysical Survey**

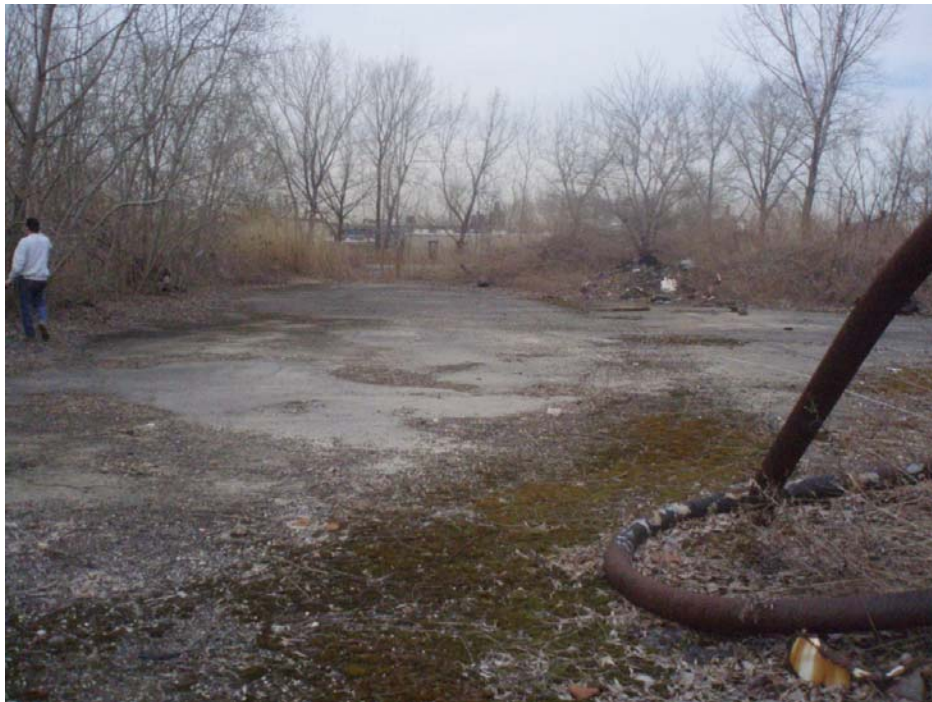
Sample locations were distributed across the Site to provide information for future planning and design efforts for the entire Site. The Site is divided by a fence into two sections: the former Viele Avenue and the eastern portion which is vegetated and partially covered by an abandoned concrete foundation slab.

**Photograph 2: Abandoned Concrete Foundation Slab**

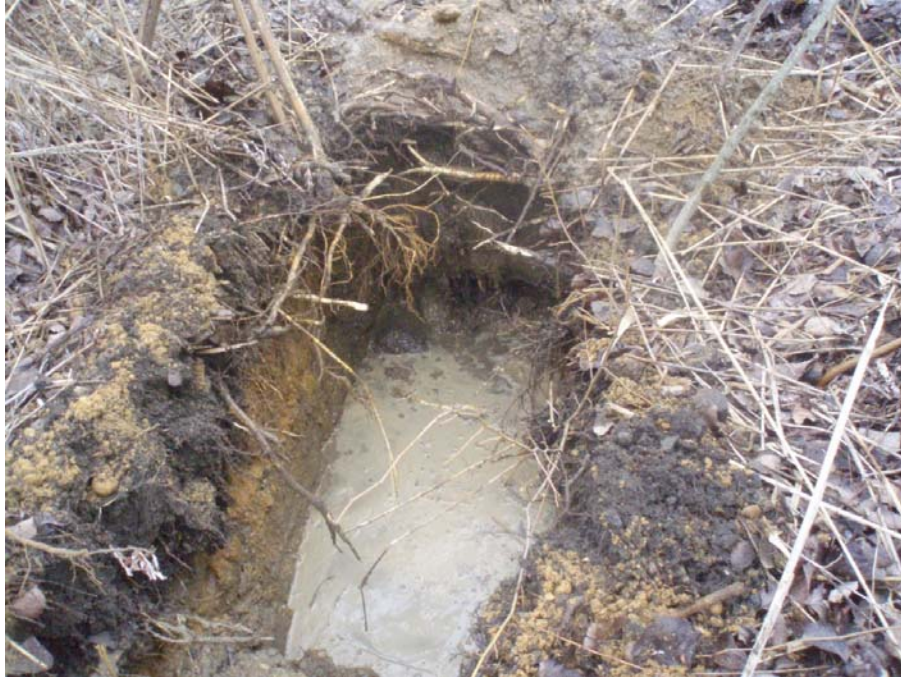
In addition to the borings, four test pits were advanced in the area surrounding the concrete foundations on March 15, 2010. A detailed log was prepared for each test pit and included: material type, composition, color, grain size and distribution, and visual or olfactory evidence of contamination, as well as any other distinctive characteristics. The test pit logs are included in this report as Appendix D. Each test pit was advanced to a depth of approximately 10 feet. The materials encountered in each test pit were very similar. The surface materials consisted of either topsoil or metal and rubber tire debris. The topsoil or debris was underlain by fill described as a yellow to brown coarse to fine sand, underlain by a brown very fine sand and silt layer. Groundwater was encountered at 4 to 5 feet below the surface, roughly two feet below the concrete pad. While advancing the test pits along the foundation slabs an odor similar to coal tar was noted. There was, however, no sign in the excavation of any source of the contamination, nor were any readings recorded on the meters above background. An inspection of the groundwater in the excavation did not reveal any sheen or other sign of impact from MGP material. Small isolated pockets of MGP material have been identified on other development sites within Hunts Point and it is believed that this may be the case in this area. An example of this was the very small sign of coal tar noted at 7ft in boring B-11, on a layer of concrete (this boring is discussed in detail below). Once completed, the test pits were backfilled with the excavated materials from the same location.

**Photograph 3: Test Pit (along west edge of concrete slab)**

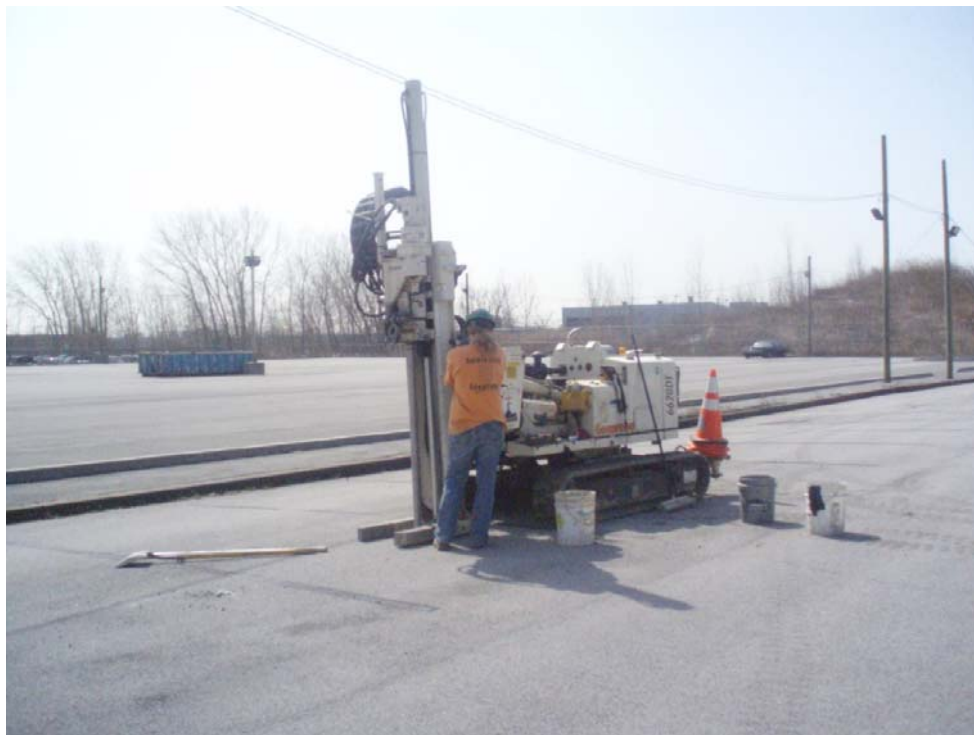
On March 16, 2010, ADT mobilized a Geoprobe<sup>®</sup> 6610 track mounted direct-push rig to advance 20 soil borings (B-1 through B-20). Samples were collected continuously in dedicated acetate liners from the ground surface to the depth of a native clay confining layer, approximately 20 feet below grade or refusal, whichever was encountered first.

**Photograph 4: Drilling Boring B18.**

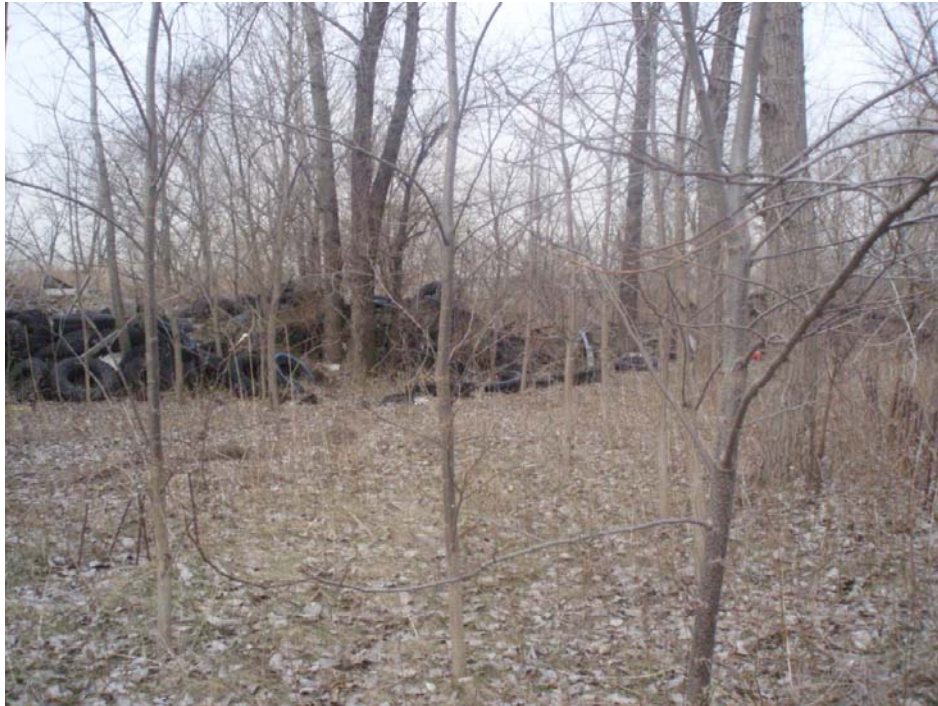
**Photograph 5: Large Debris Pile**

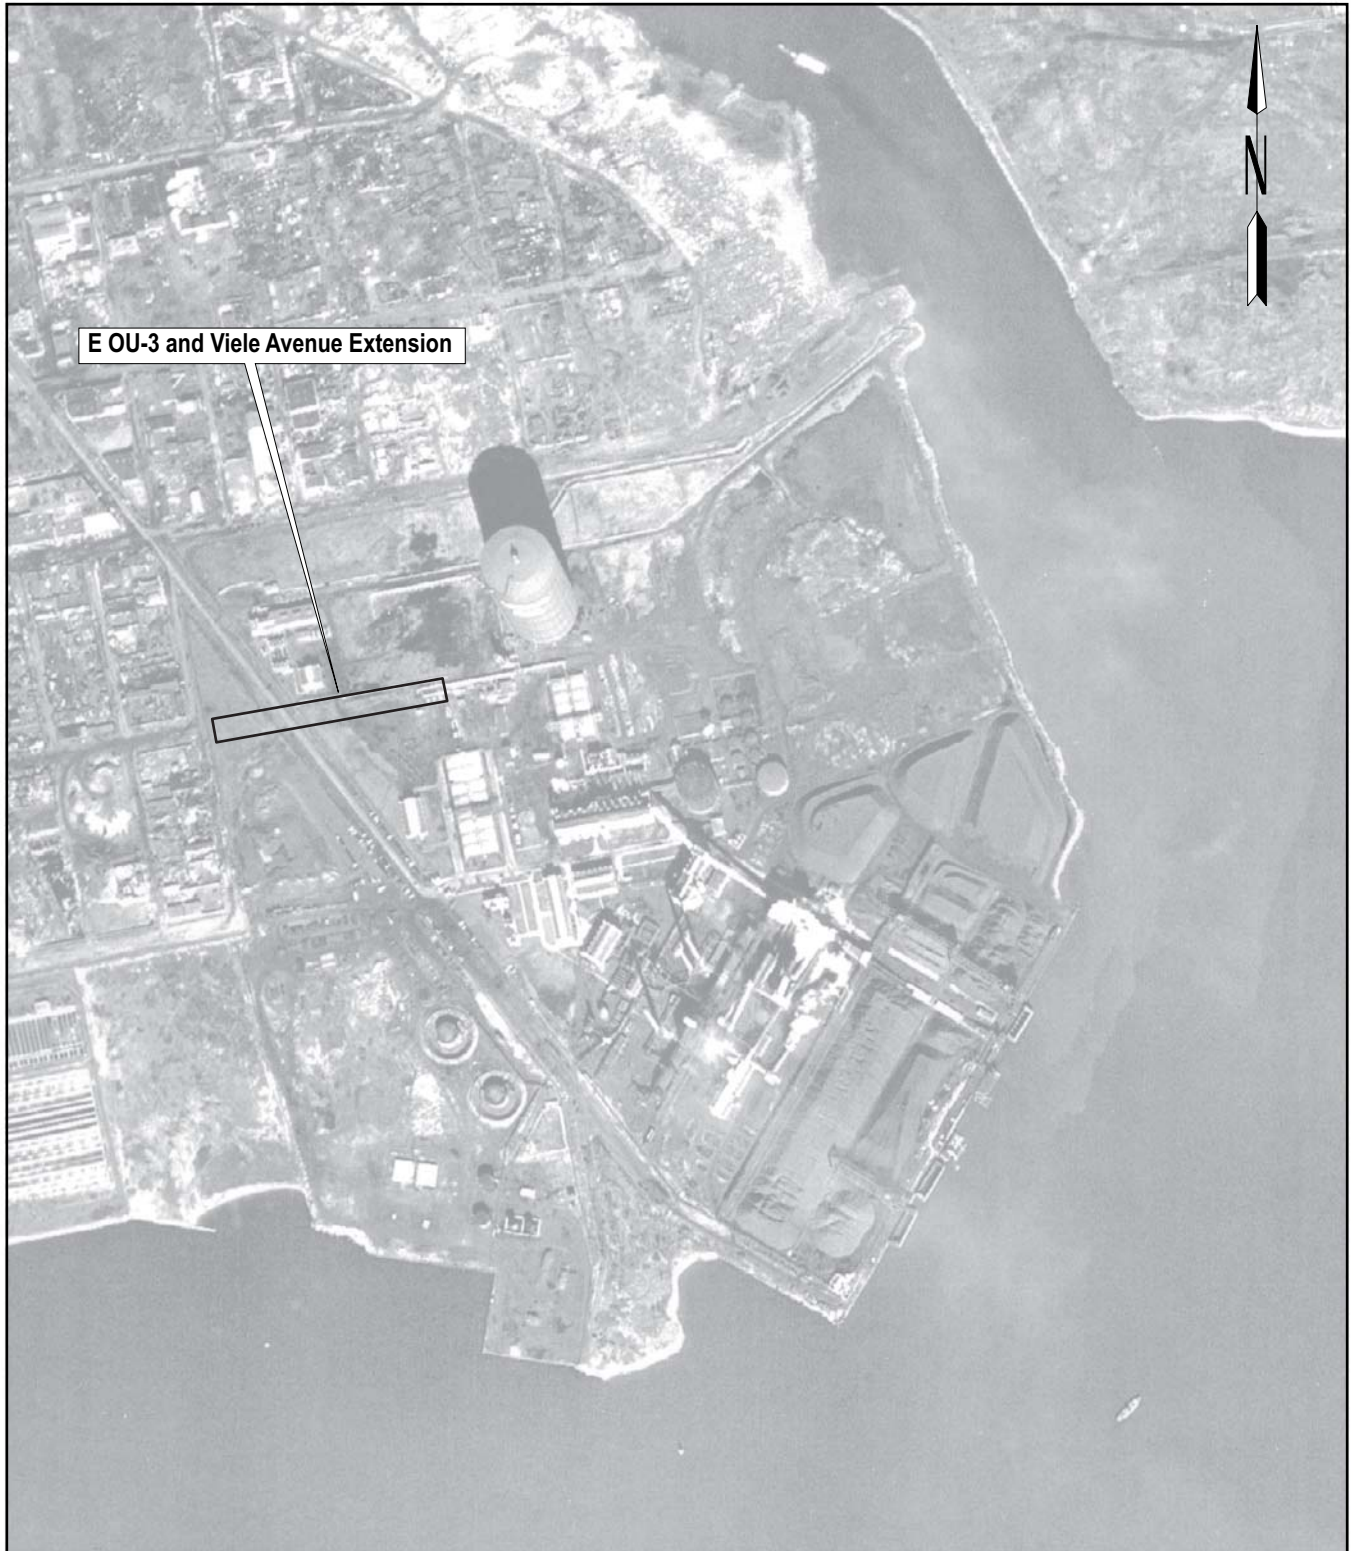
Aerial  
Photo  
1

The SI was based on historic information and aerial photographs (see Appendix A) showing that the area was formerly occupied by a Manufactured Gas Plant (MGP). The MGP site was operated by Consolidated Edison Company of New York, Inc. (Con Edison) from 1926 to approximately 1960. The land was subsequently sold to the City of New York. The facility occupied 206.4 acres, bounded on the north by East Bay Avenue, on the east by the Bronx River, on the south by the East River, and on the west by Halleck Street. Plant operations included the manufacturing, storage, and distribution of coal gas.

### 1954 Aerial Photograph
