# SITE MANAGEMENT PLAN

**2455 Third Avenue  
Bronx County, Bronx, New York**

**NYSDEC Site Number: C203125**

**DECEMBER 2022**

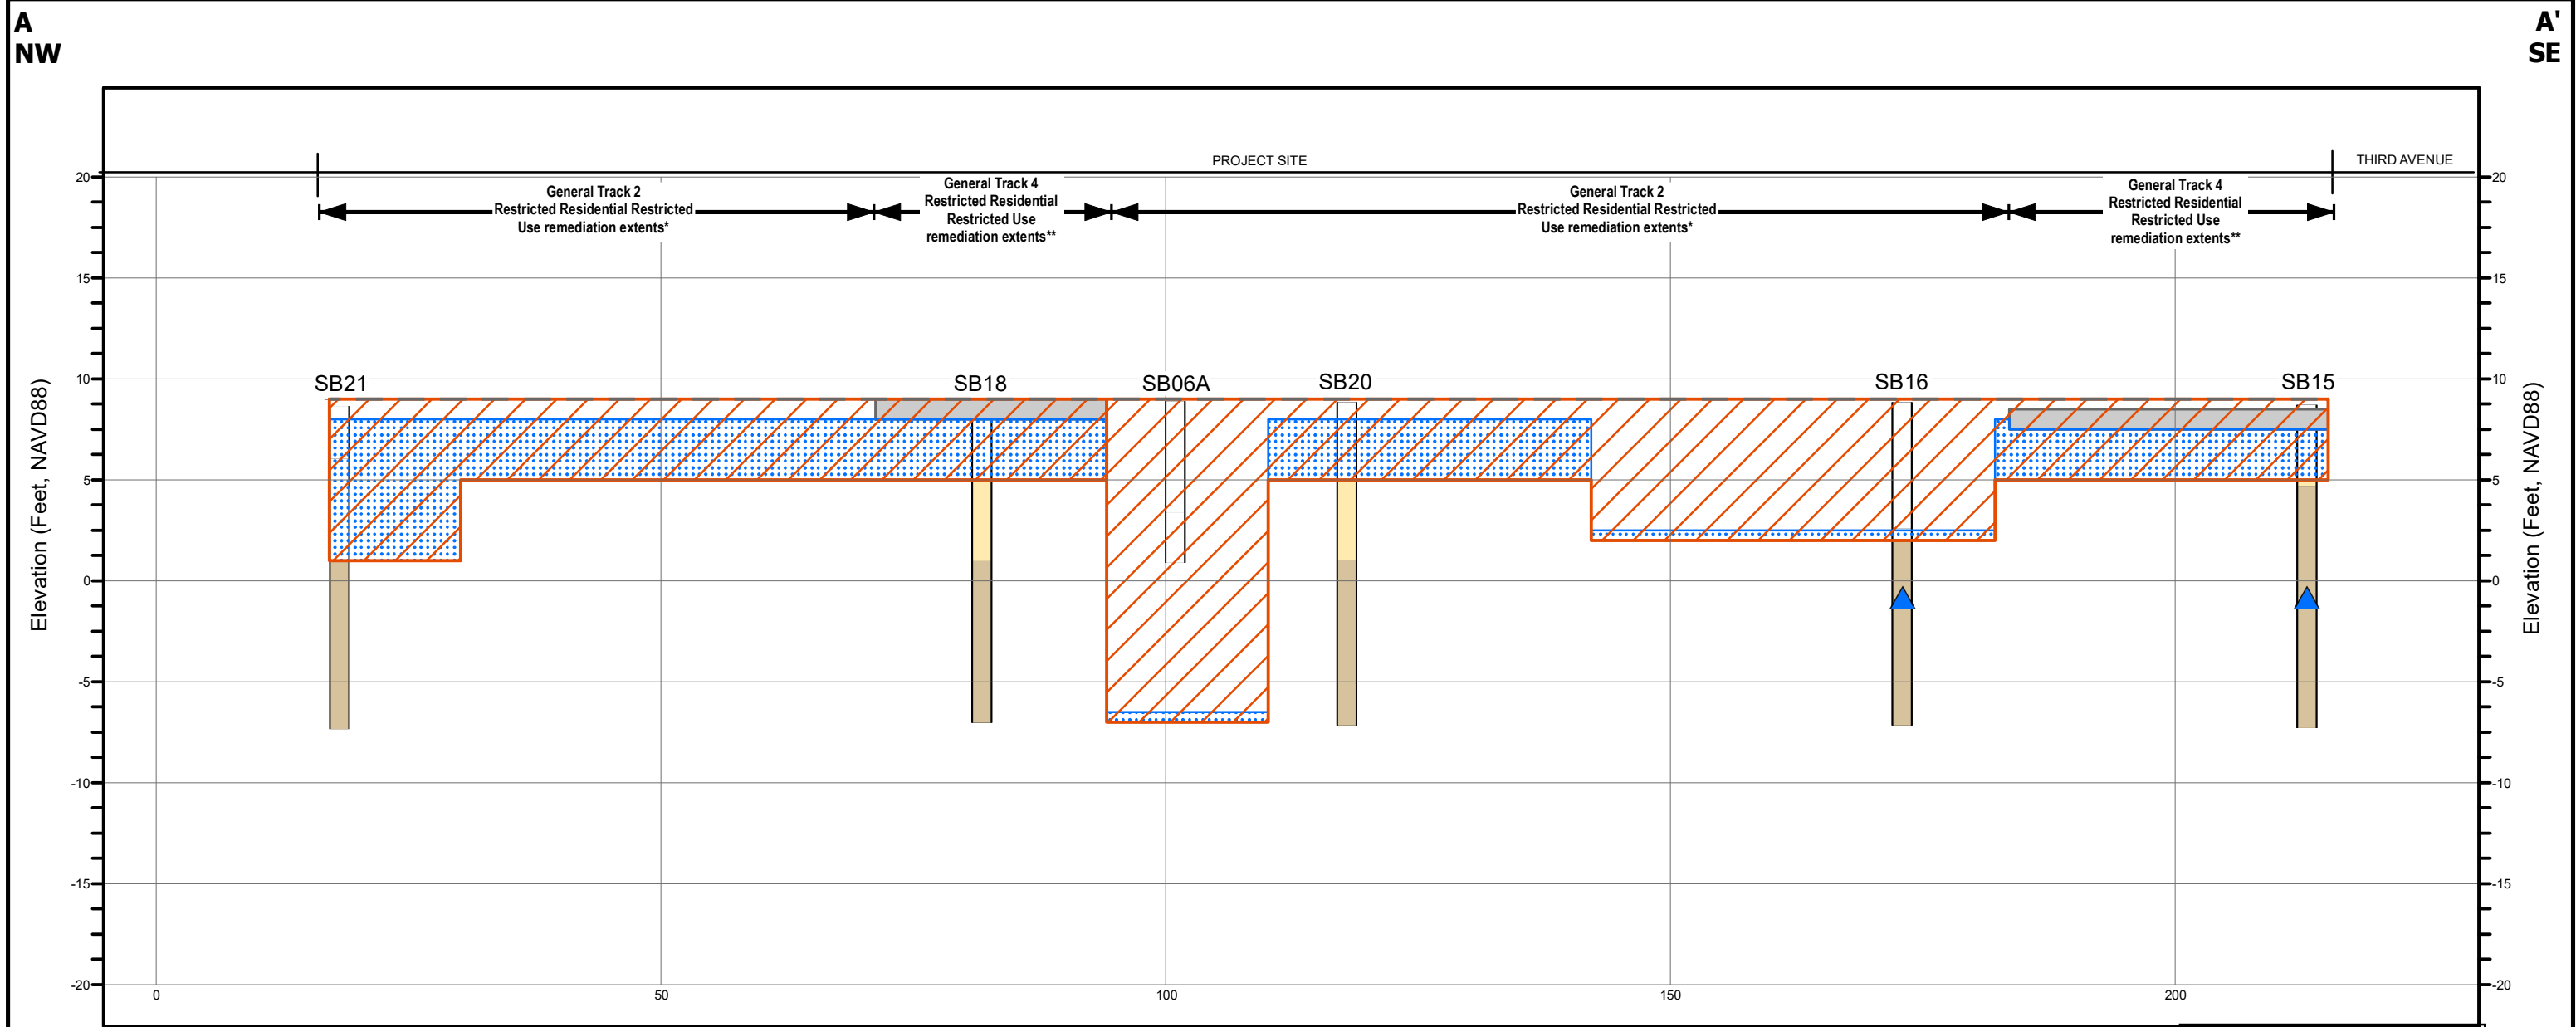
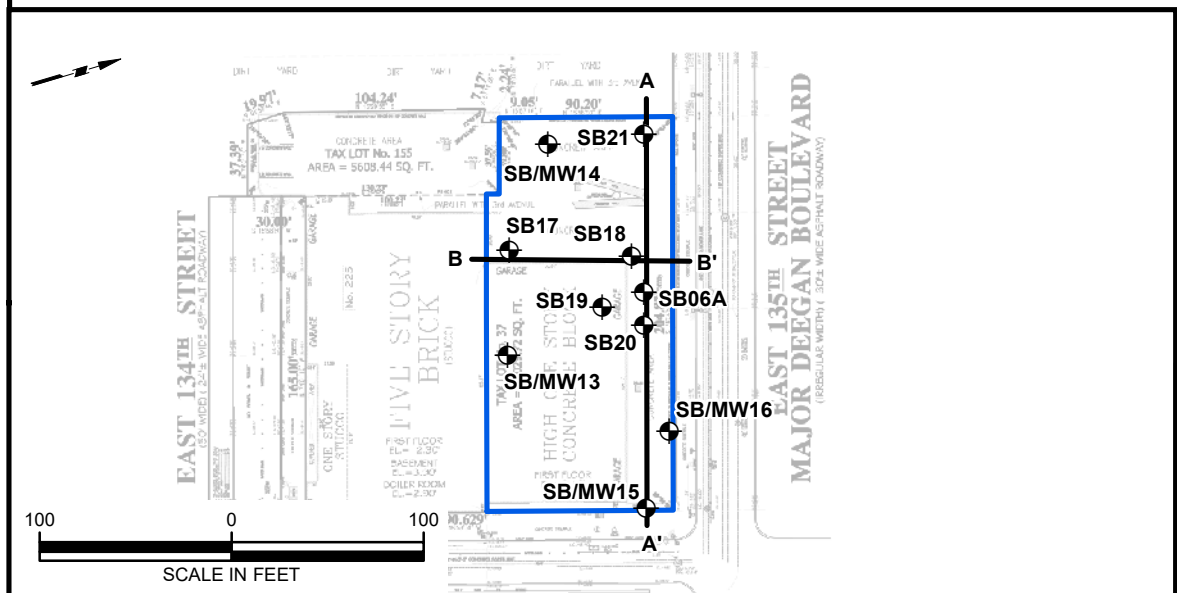
Drawing Title  
**SUBSURFACE  
 PROFILE  
 A-A'**

\*No cover system required.  
 \*\*Cover system is comprised of a 1- to 4- foot-thick concrete slab.

- FILL
- CONCRETE SLAB COVER SYSTEM
- SAND
- EXCAVATION EXTENTS
- GROUNDWATER ELEVATION
- NYSDEC-APPROVED BACKFILL CONSISTING OF #57 BLUE STONE, MANUFACTURED STONE, RECYCLED STONE, SAND, OR RCA.

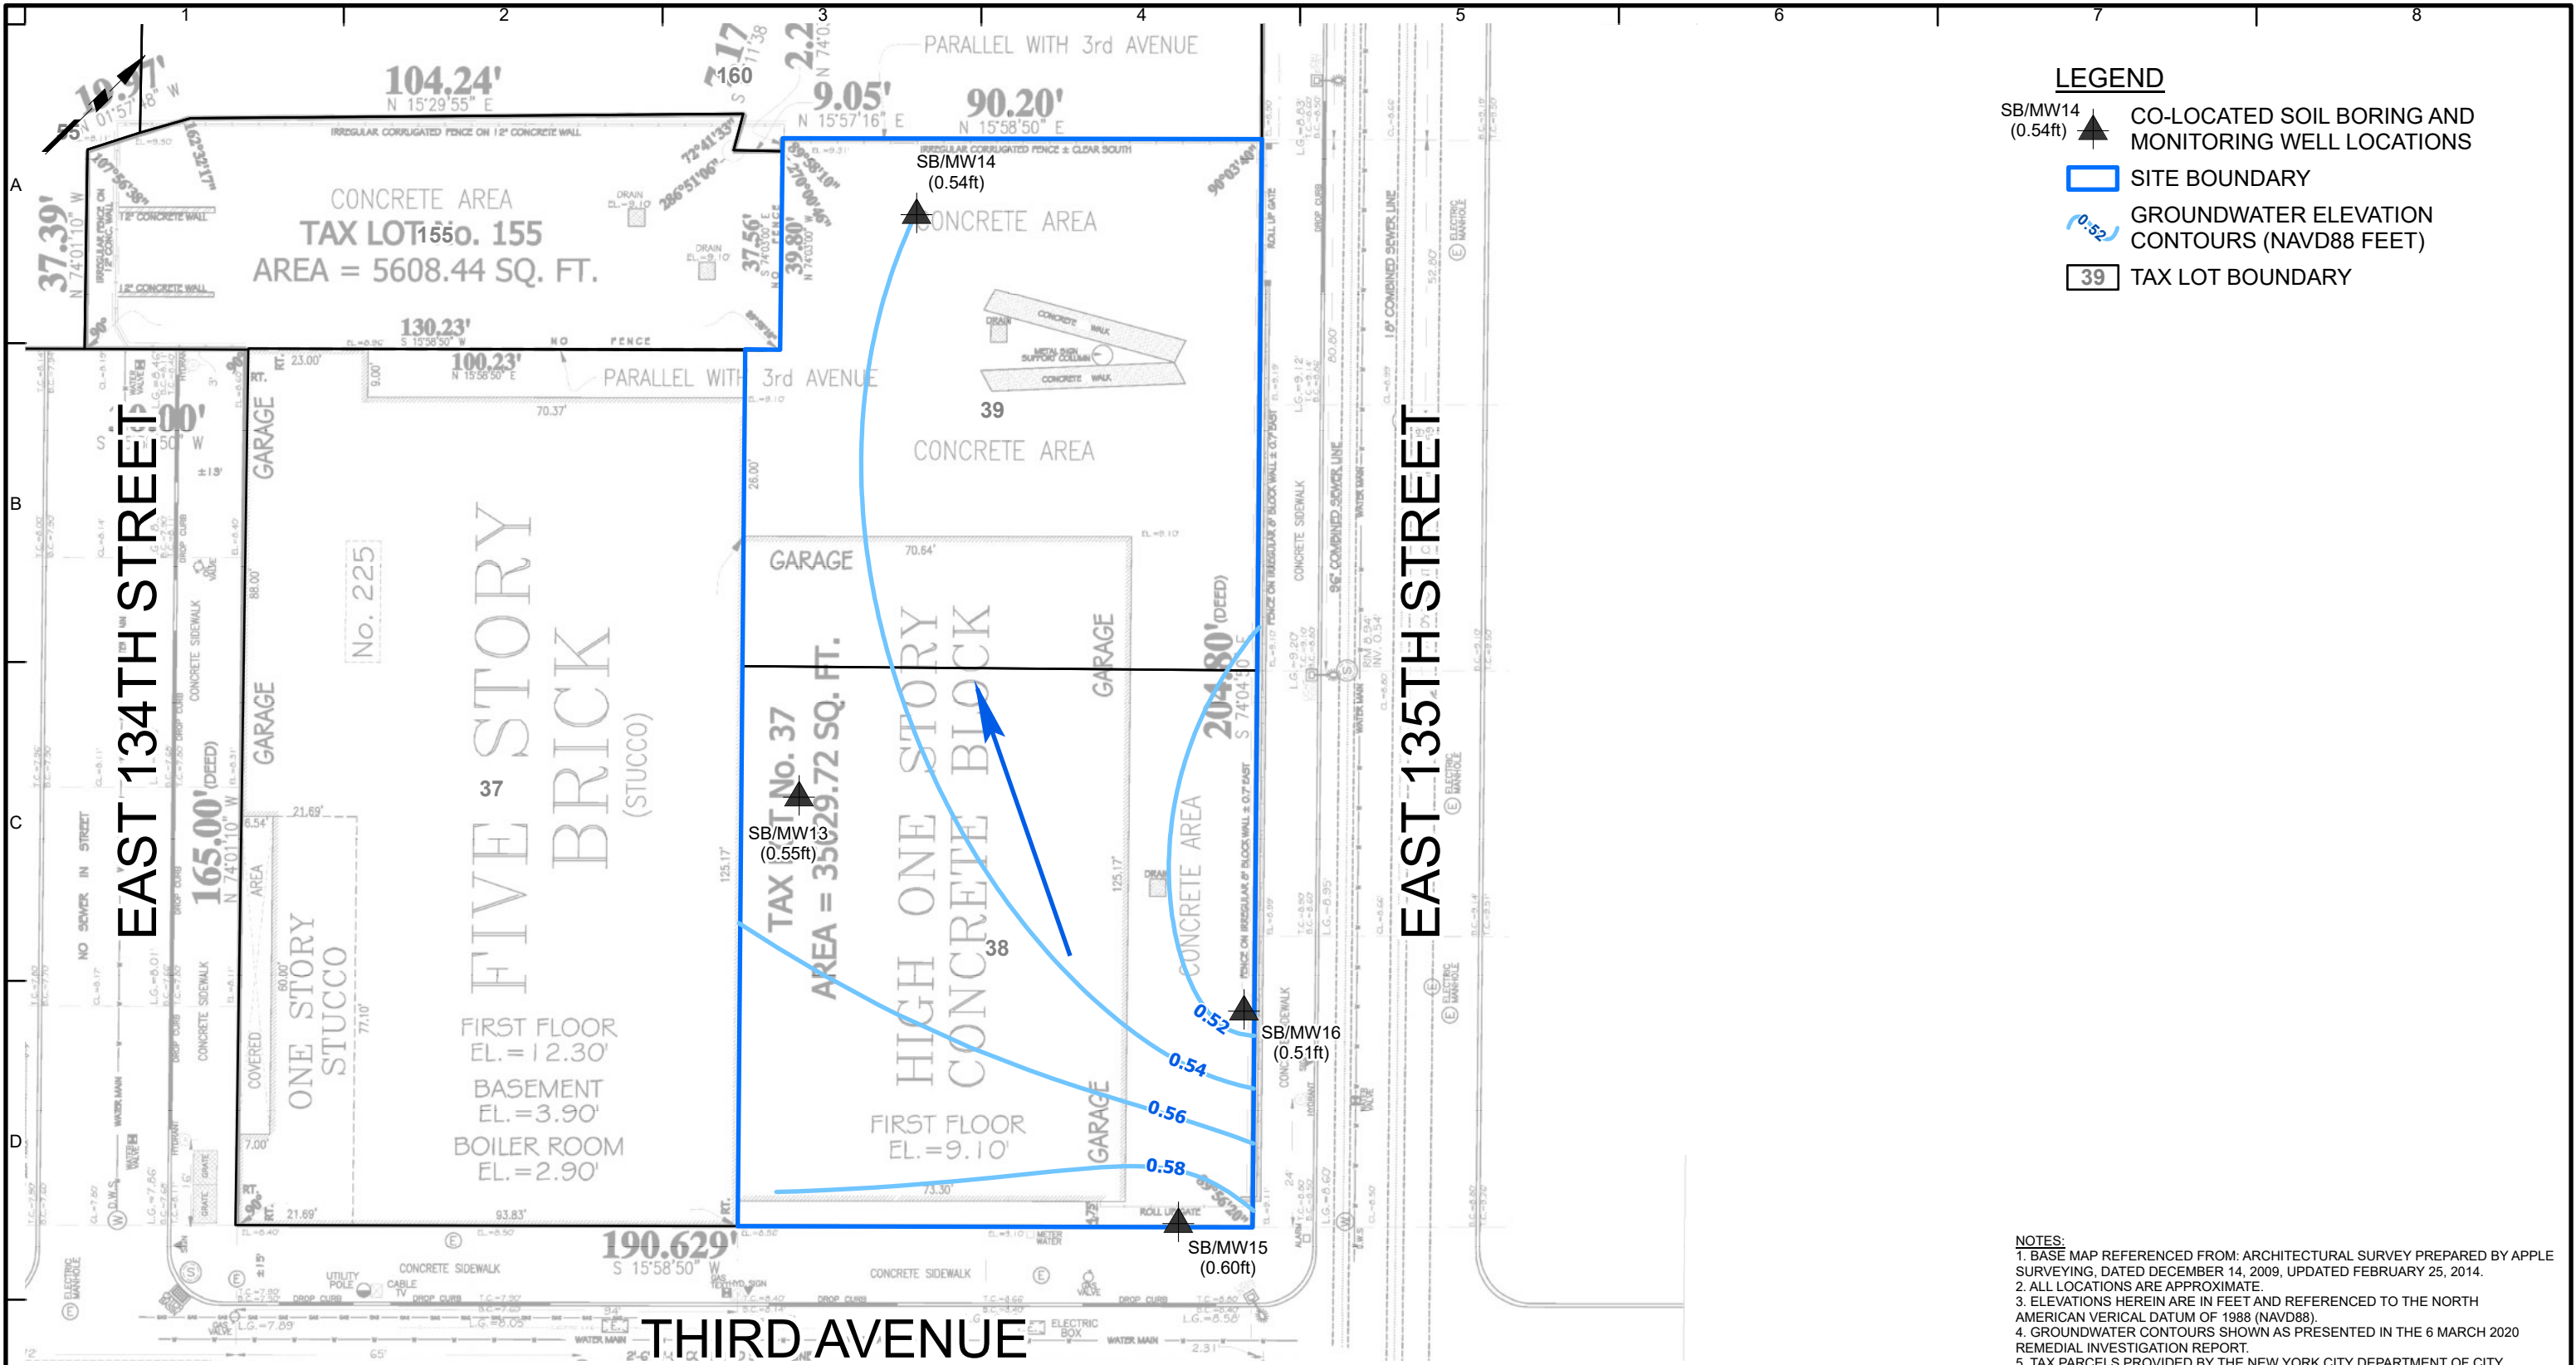
- SB/MW14 (0.54ft) CO-LOCATED SOIL BORING AND MONITORING WELL LOCATIONS
- SITE BOUNDARY
- GROUNDWATER ELEVATION CONTOURS (NAVD88 FEET)
- TAX LOT BOUNDARY

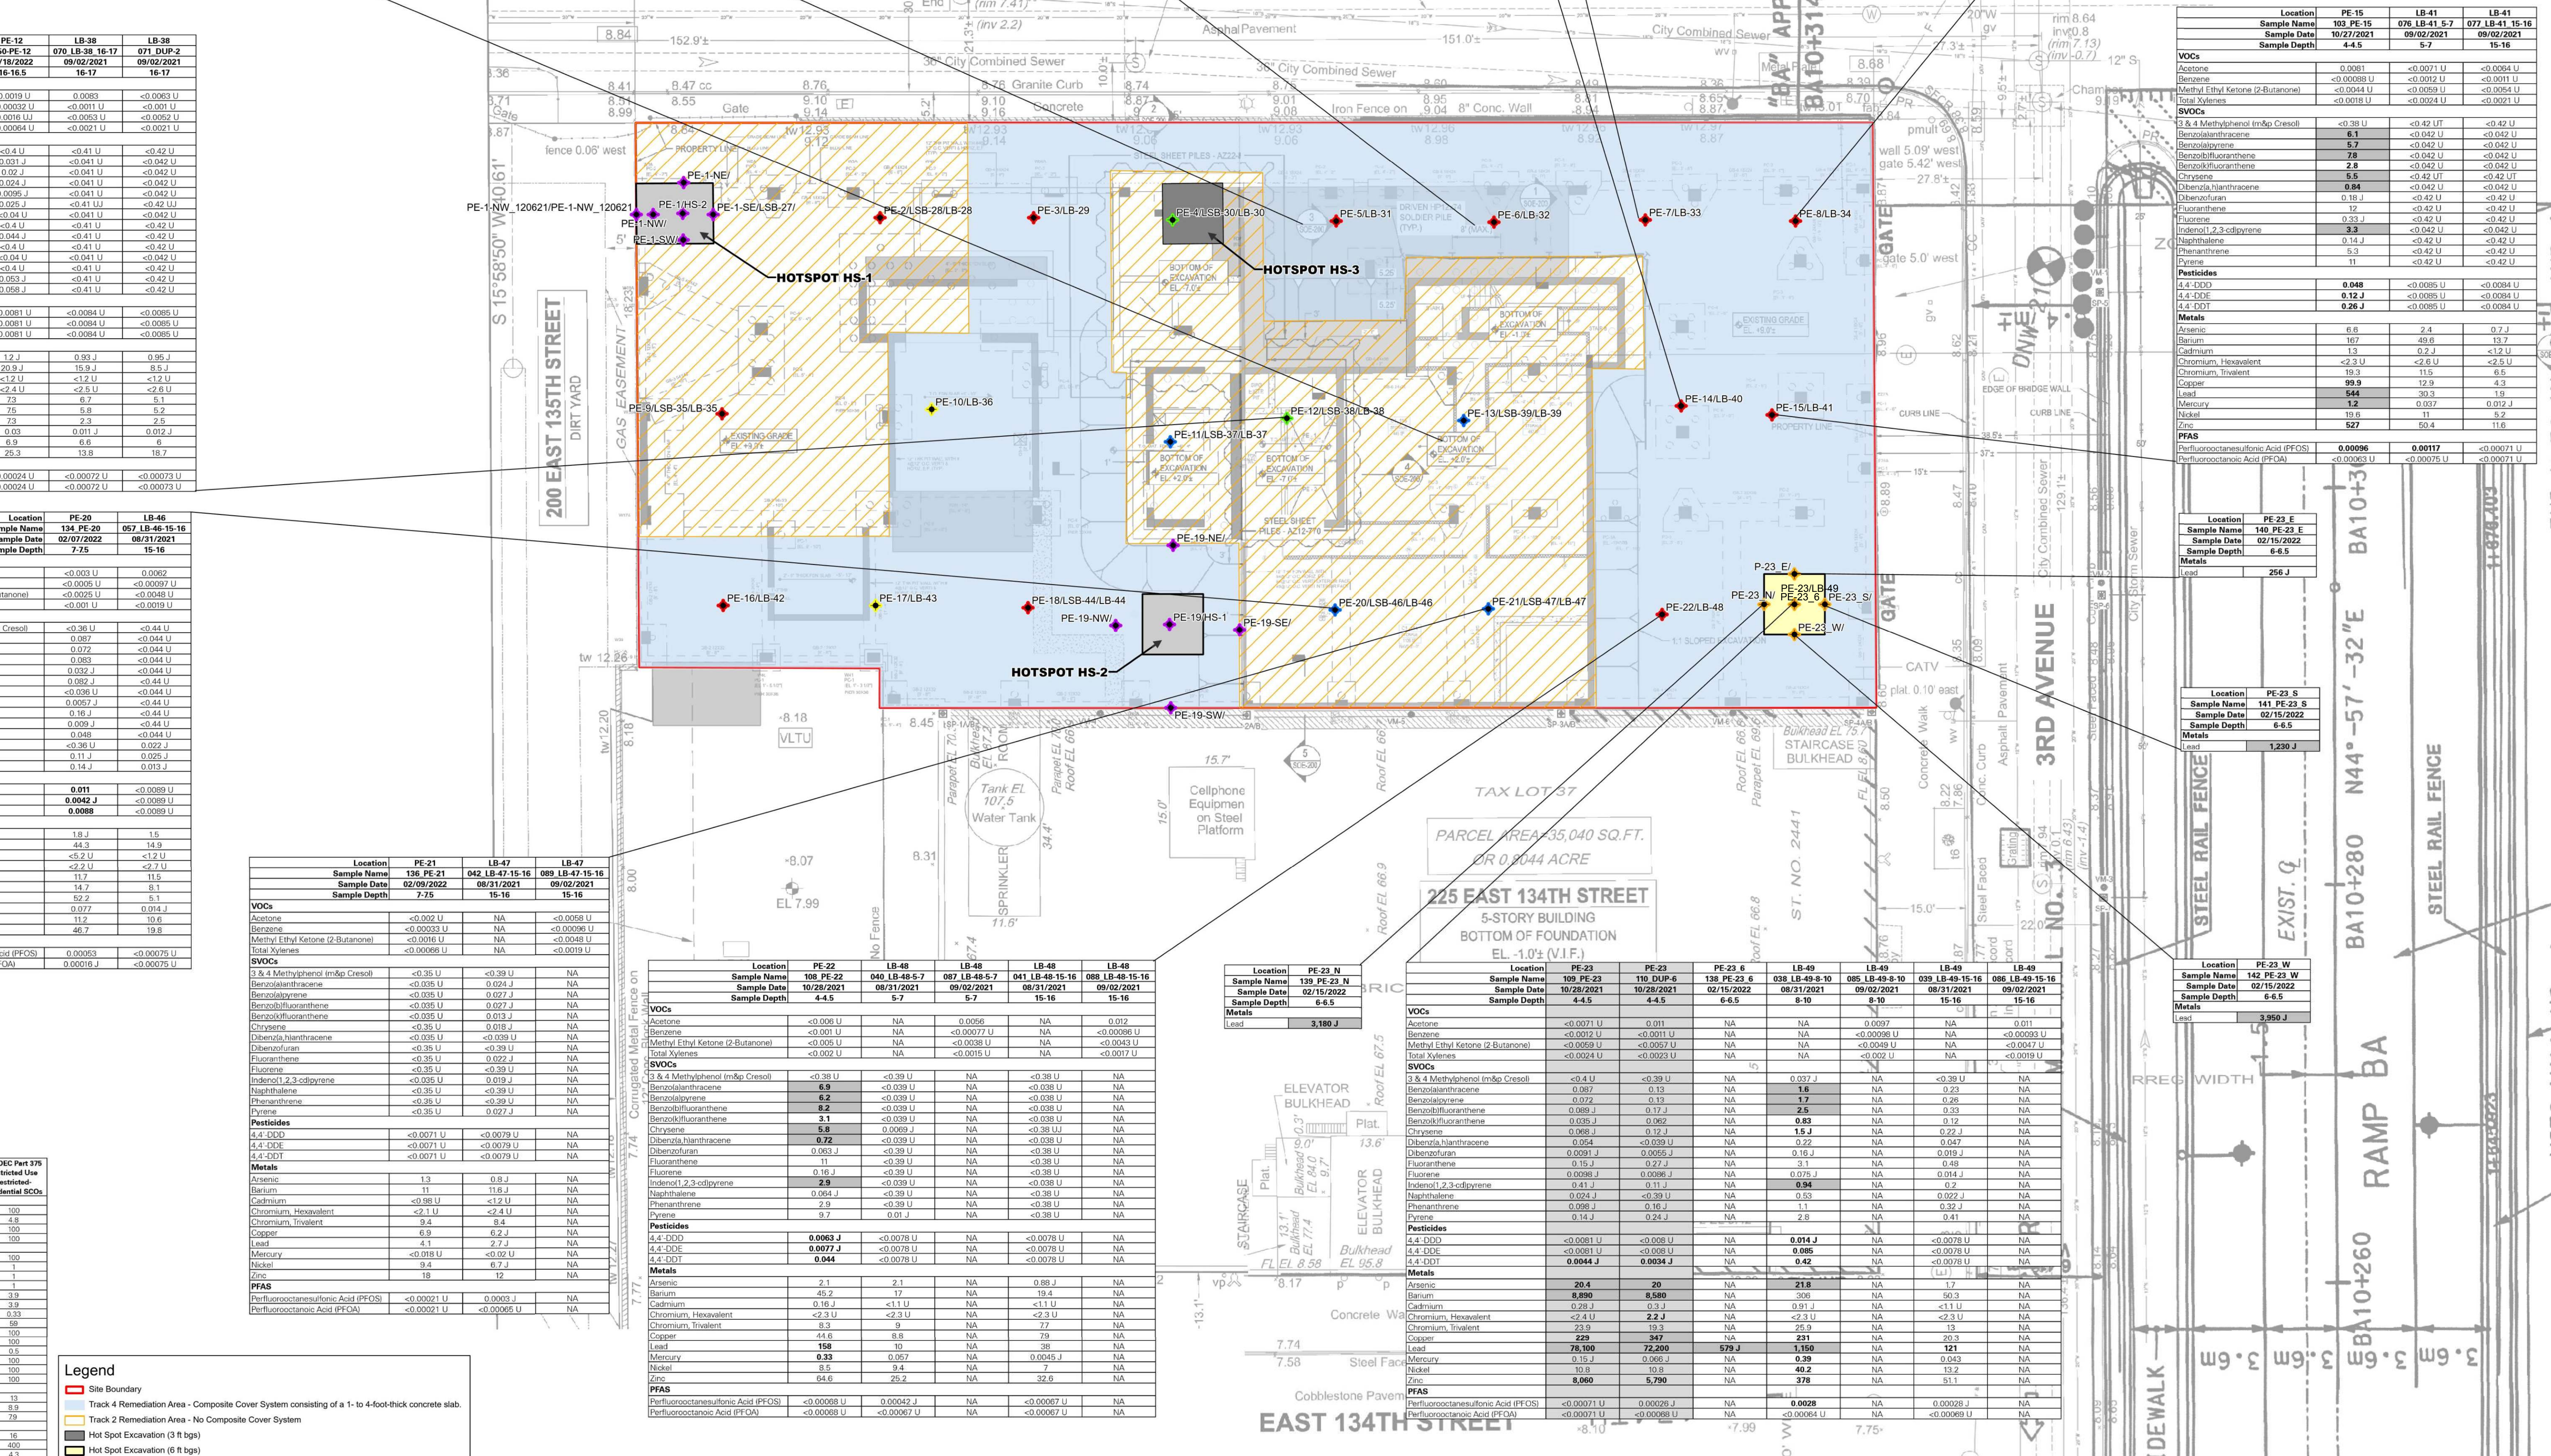
LANGAN logo and project information. Project: 2455 THIRD AVENUE. Drawing Title: DOCUMENTATION ENDPOINT SAMPLE LOCATION AND ANALYTICAL RESULTS MAP - EAST. Project No: 190051701. Date: 9/23/2022. Scale: 1"=10'. Drawn by: IHS.

Legend and Post Excavation Sample Locations. Legend includes symbols for Site Boundary, Track 4 Remediation Area, Hot Spot Excavation, etc. Post Excavation Sample Locations list various sample types and their corresponding locations.
