**VOLUME 1 OF 4**  
**FINAL ENGINEERING REPORT**  
**FORMER MILL SANITARY WIPING CLOTH SITE**  
**40 BRUCKNER BOULEVARD**  
**BRONX, NEW YORK**  
**NYSDEC SITE #C203146**

by  
H & A of New York LLP  
d/b/a Haley & Aldrich of New York

File No. 0200734  
21 December 2022

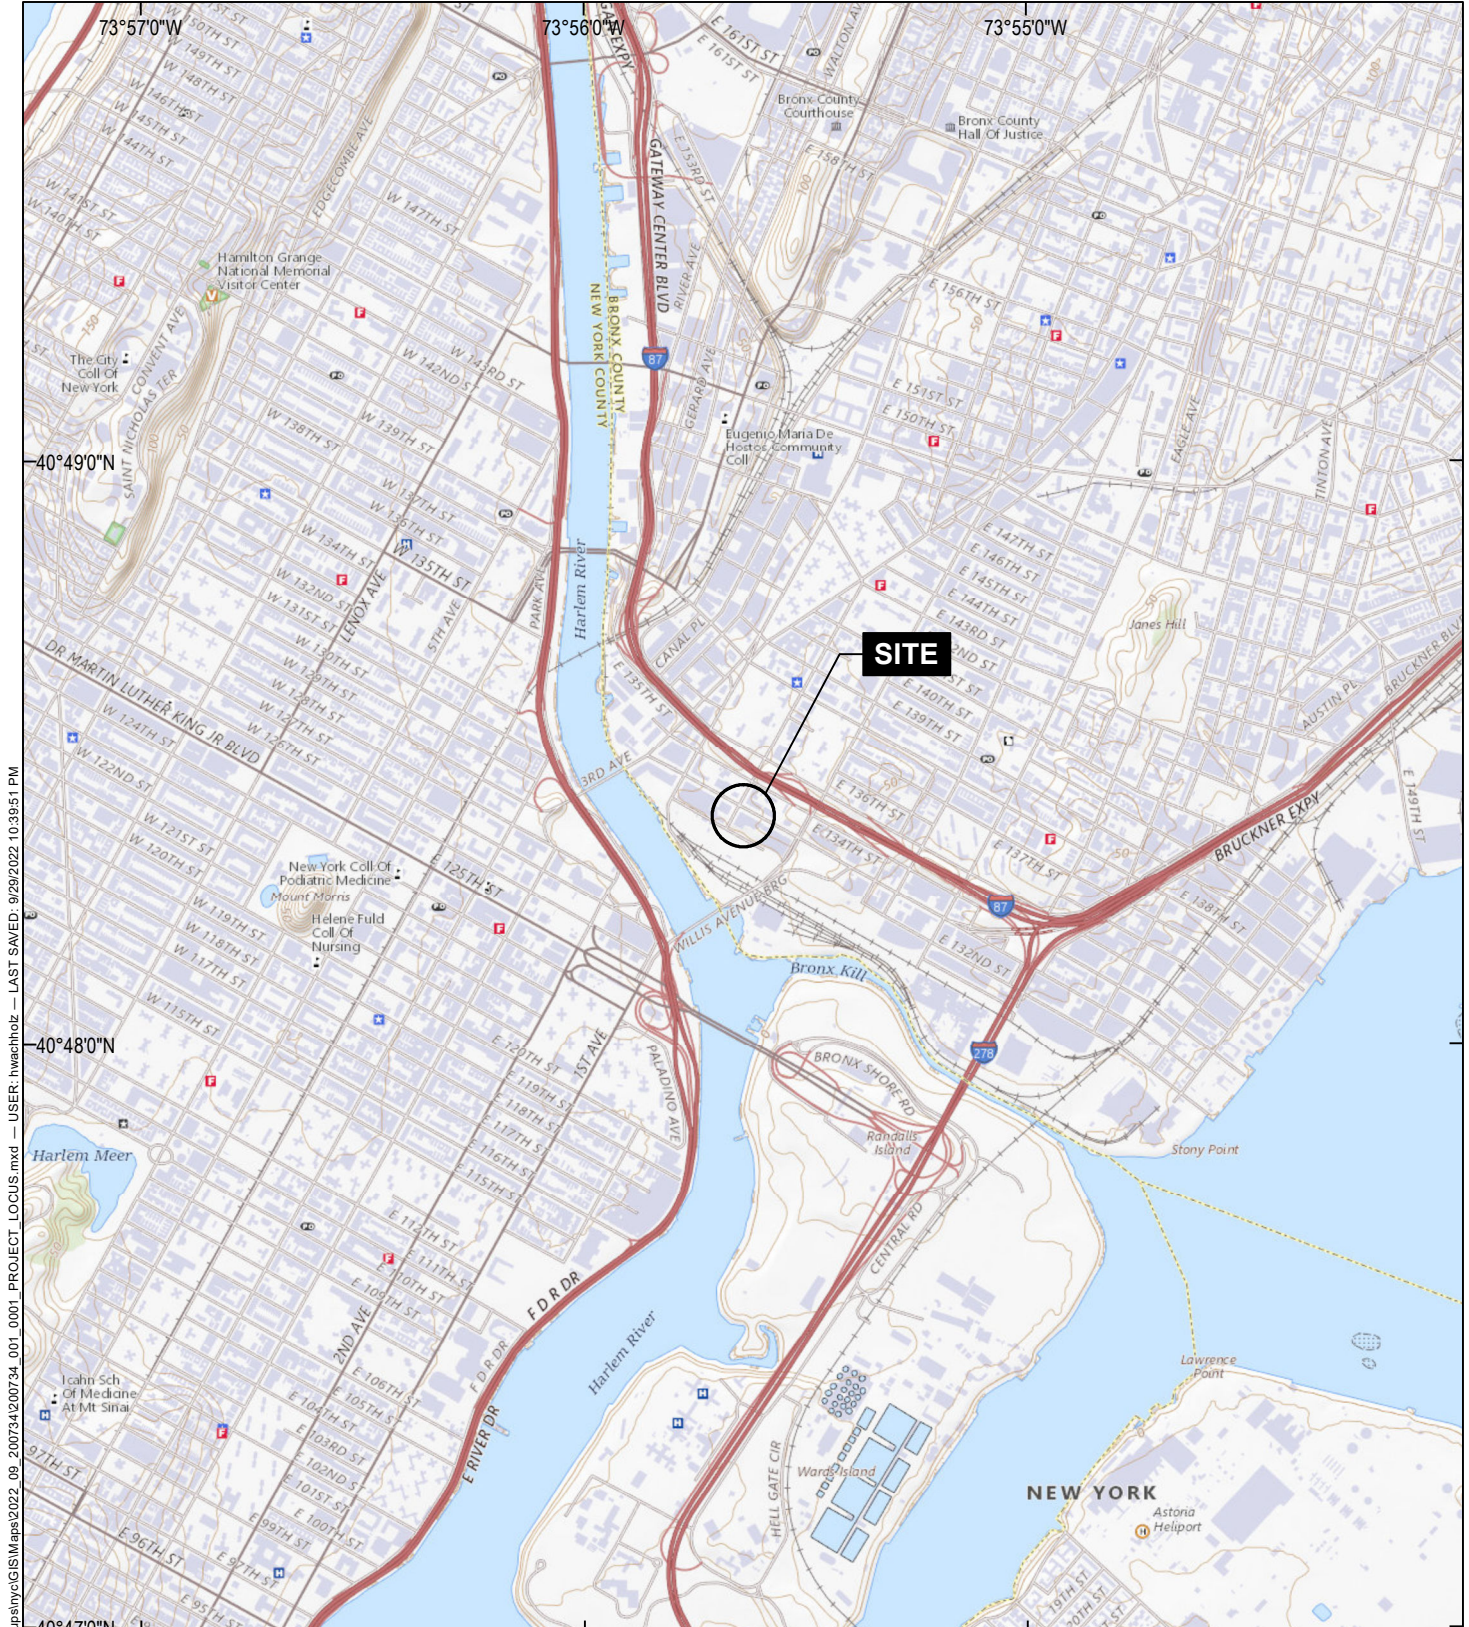
**FIGURE 1**

The site is located in the County of Bronx, New York and is identified as Block 2295 and Lot 51 on the Bronx Tax Map # 6a ("Site"). A Project Locus is provided as Figure 1. The Site is situated on an approximately 0.95-acre area bounded by Bruckner Boulevard to the north, East 132<sup>nd</sup> Street to the south, Lots 40 and 67 to the east, and Alexander Avenue to the west (see Figure 2). The boundaries of the Site are fully described in Appendix A: Survey Map, Metes and Bounds.

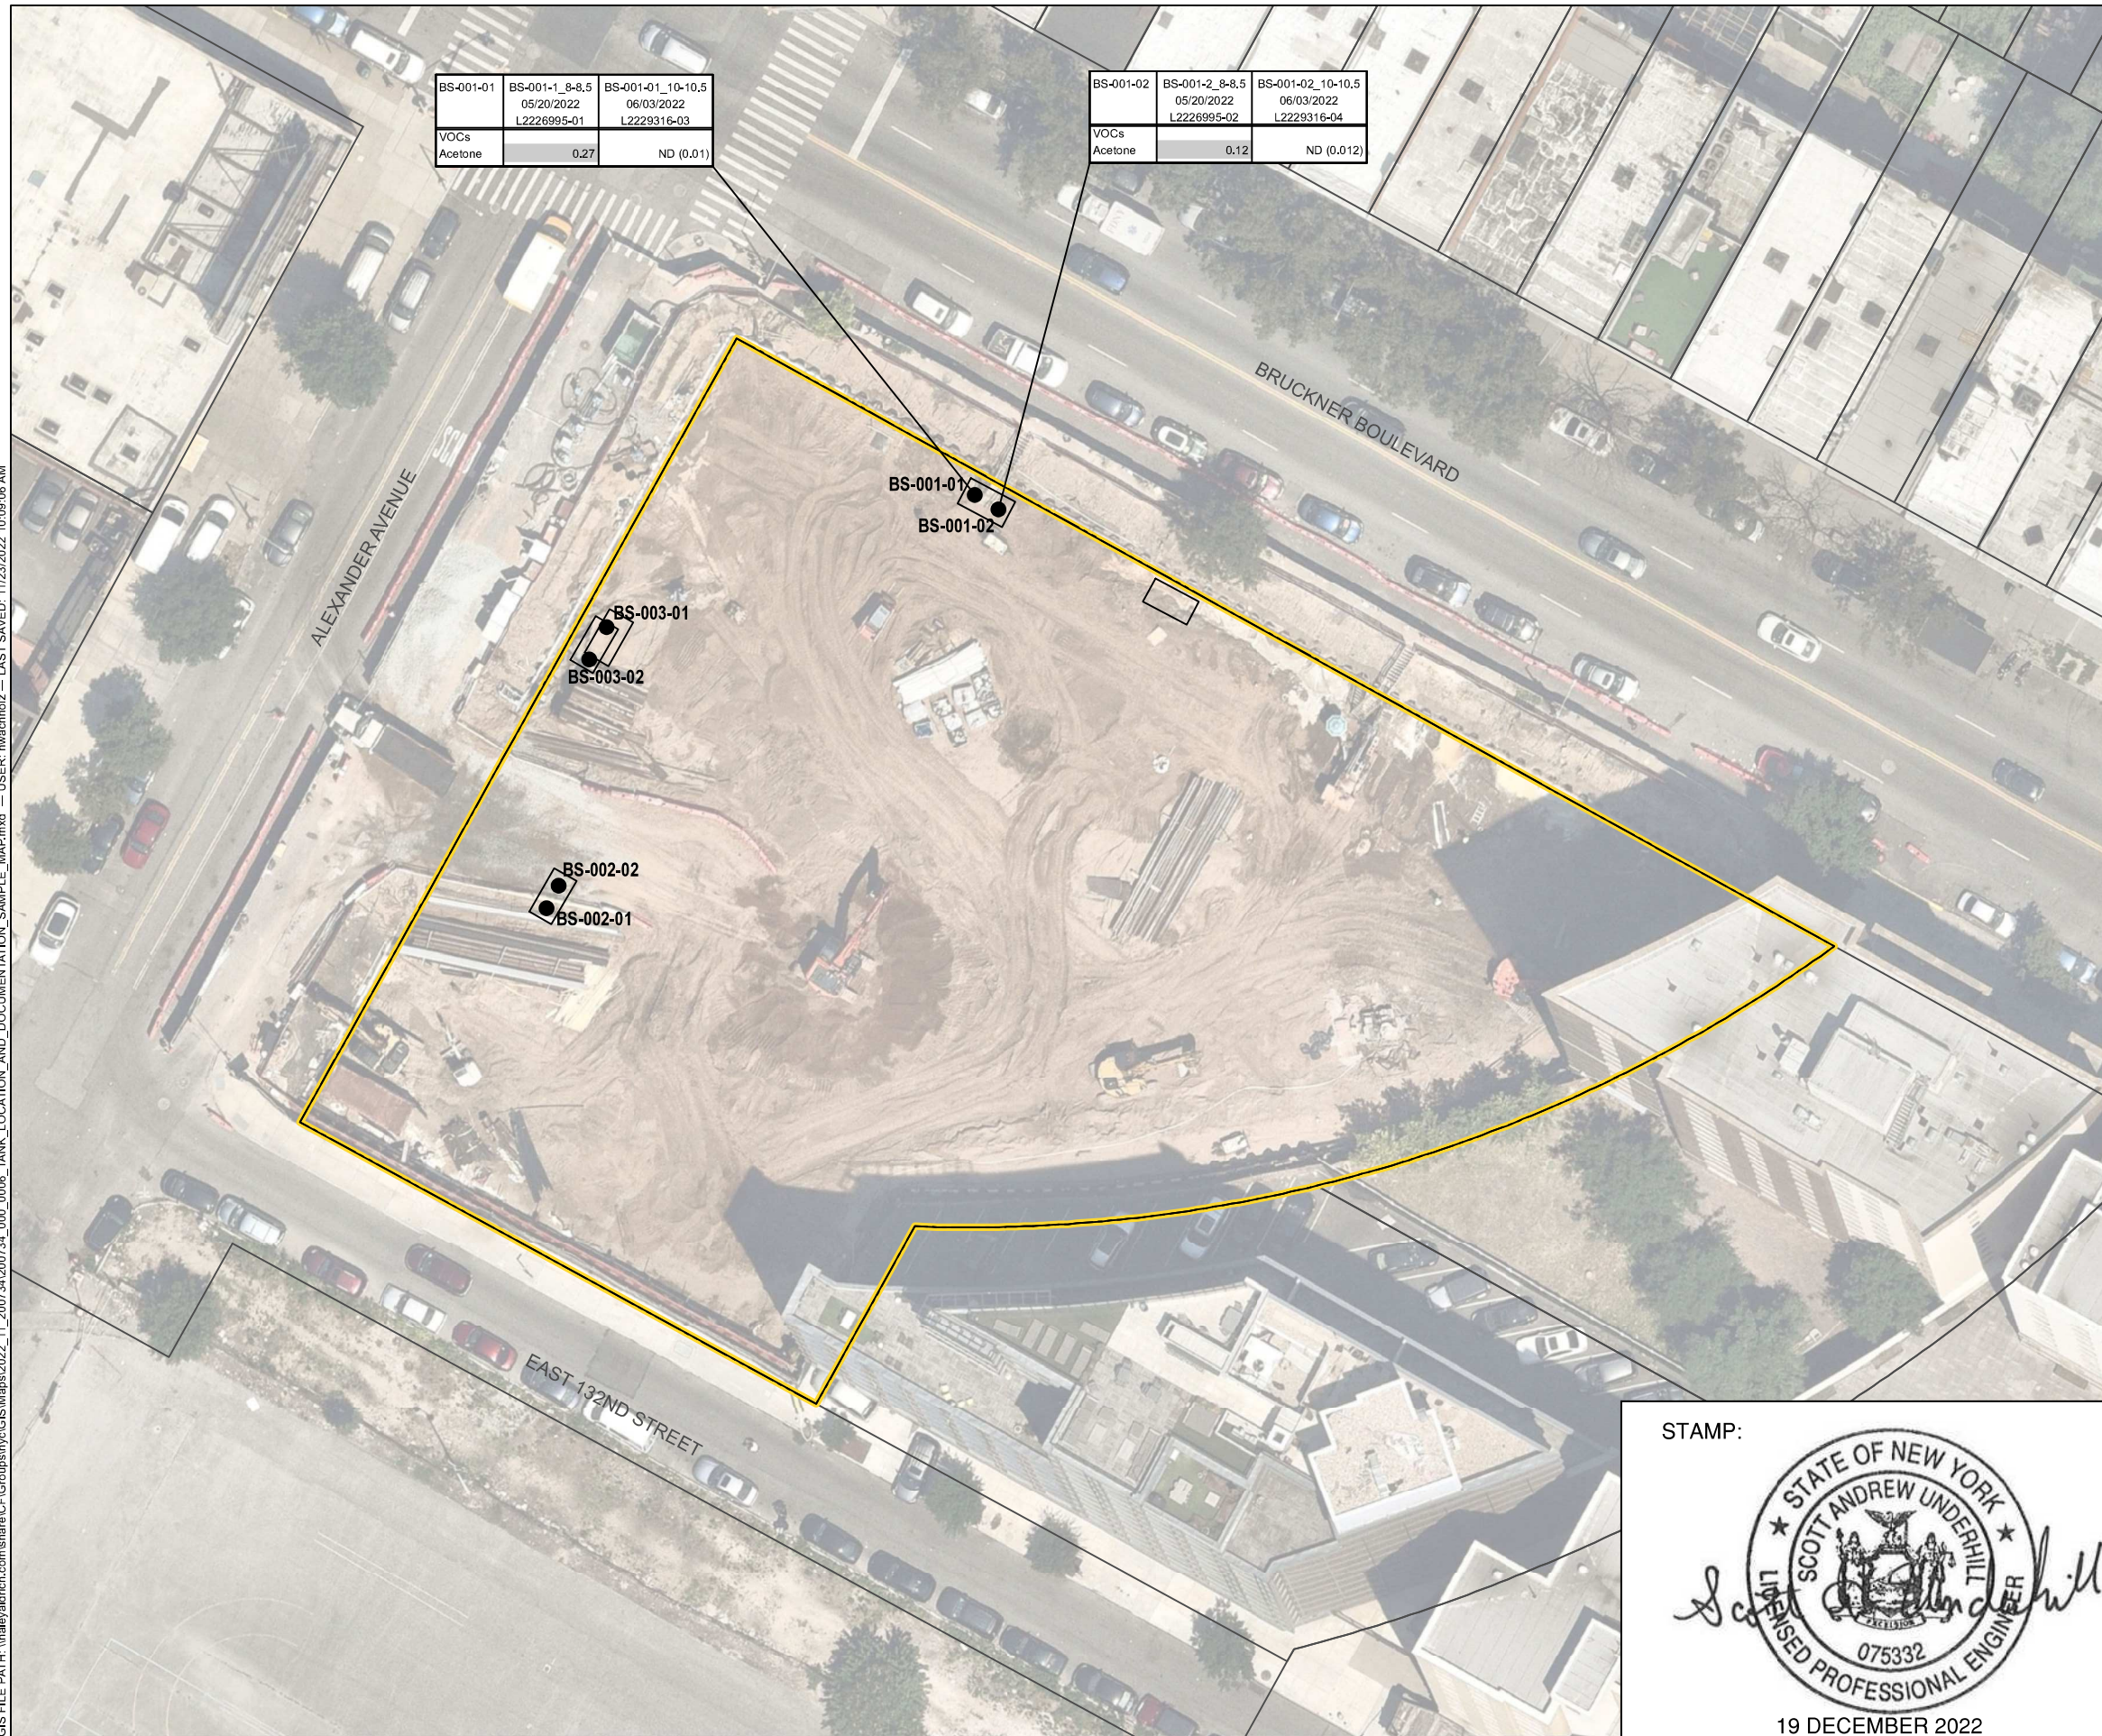
FIGURE 6

BS-001-01	BS-001-1_8-8.5 05/20/2022 L2226995-01	BS-001-01_10-10.5 06/03/2022 L2229316-03
VOCs		
Acetone	0.27	ND (0.01)

BS-001-02	BS-001-2_8-8.5 05/20/2022 L2226995-02	BS-001-02_10-10.5 06/03/2022 L2229316-04
VOCs		
Acetone	0.12	ND (0.012)

TANK LOCATION AND DOCUMENTATION SAMPLE MAP

A total of five 550-gallon storage tanks, one aboveground and four underground, were encountered during remediation activities at the Site. The AST was found in the former structure located along the northern boundary of the Site. A total of approximately 50 gallons of fuel oil, fuel oil/water mixture, or hydraulic oil was removed from the USTs and disposed of at GFL Environmental Inc in Chambly, Quebec. The tanks were cleaned, cut, removed by Eastern Environmental and recycled at Gershow Recycling in Medford, New York. Table VI summarizes the details of the tanks including volume, contents, date encountered, and date removed from the Site. An affidavit from Eastern Environmental for tank removal and certificate of destructions is provided in Appendix H. Registration paperwork was submitted to the NYSDEC Petroleum Bulk Storage (PBS) program on 03 November 2022. NYSDEC PBS Unit processed the application on 09 November 2022 and indicated Tanks # AST-001 & UST-001 through UST-004 were added to the registration and updated to Closed-Removed as requested (Appendix H).

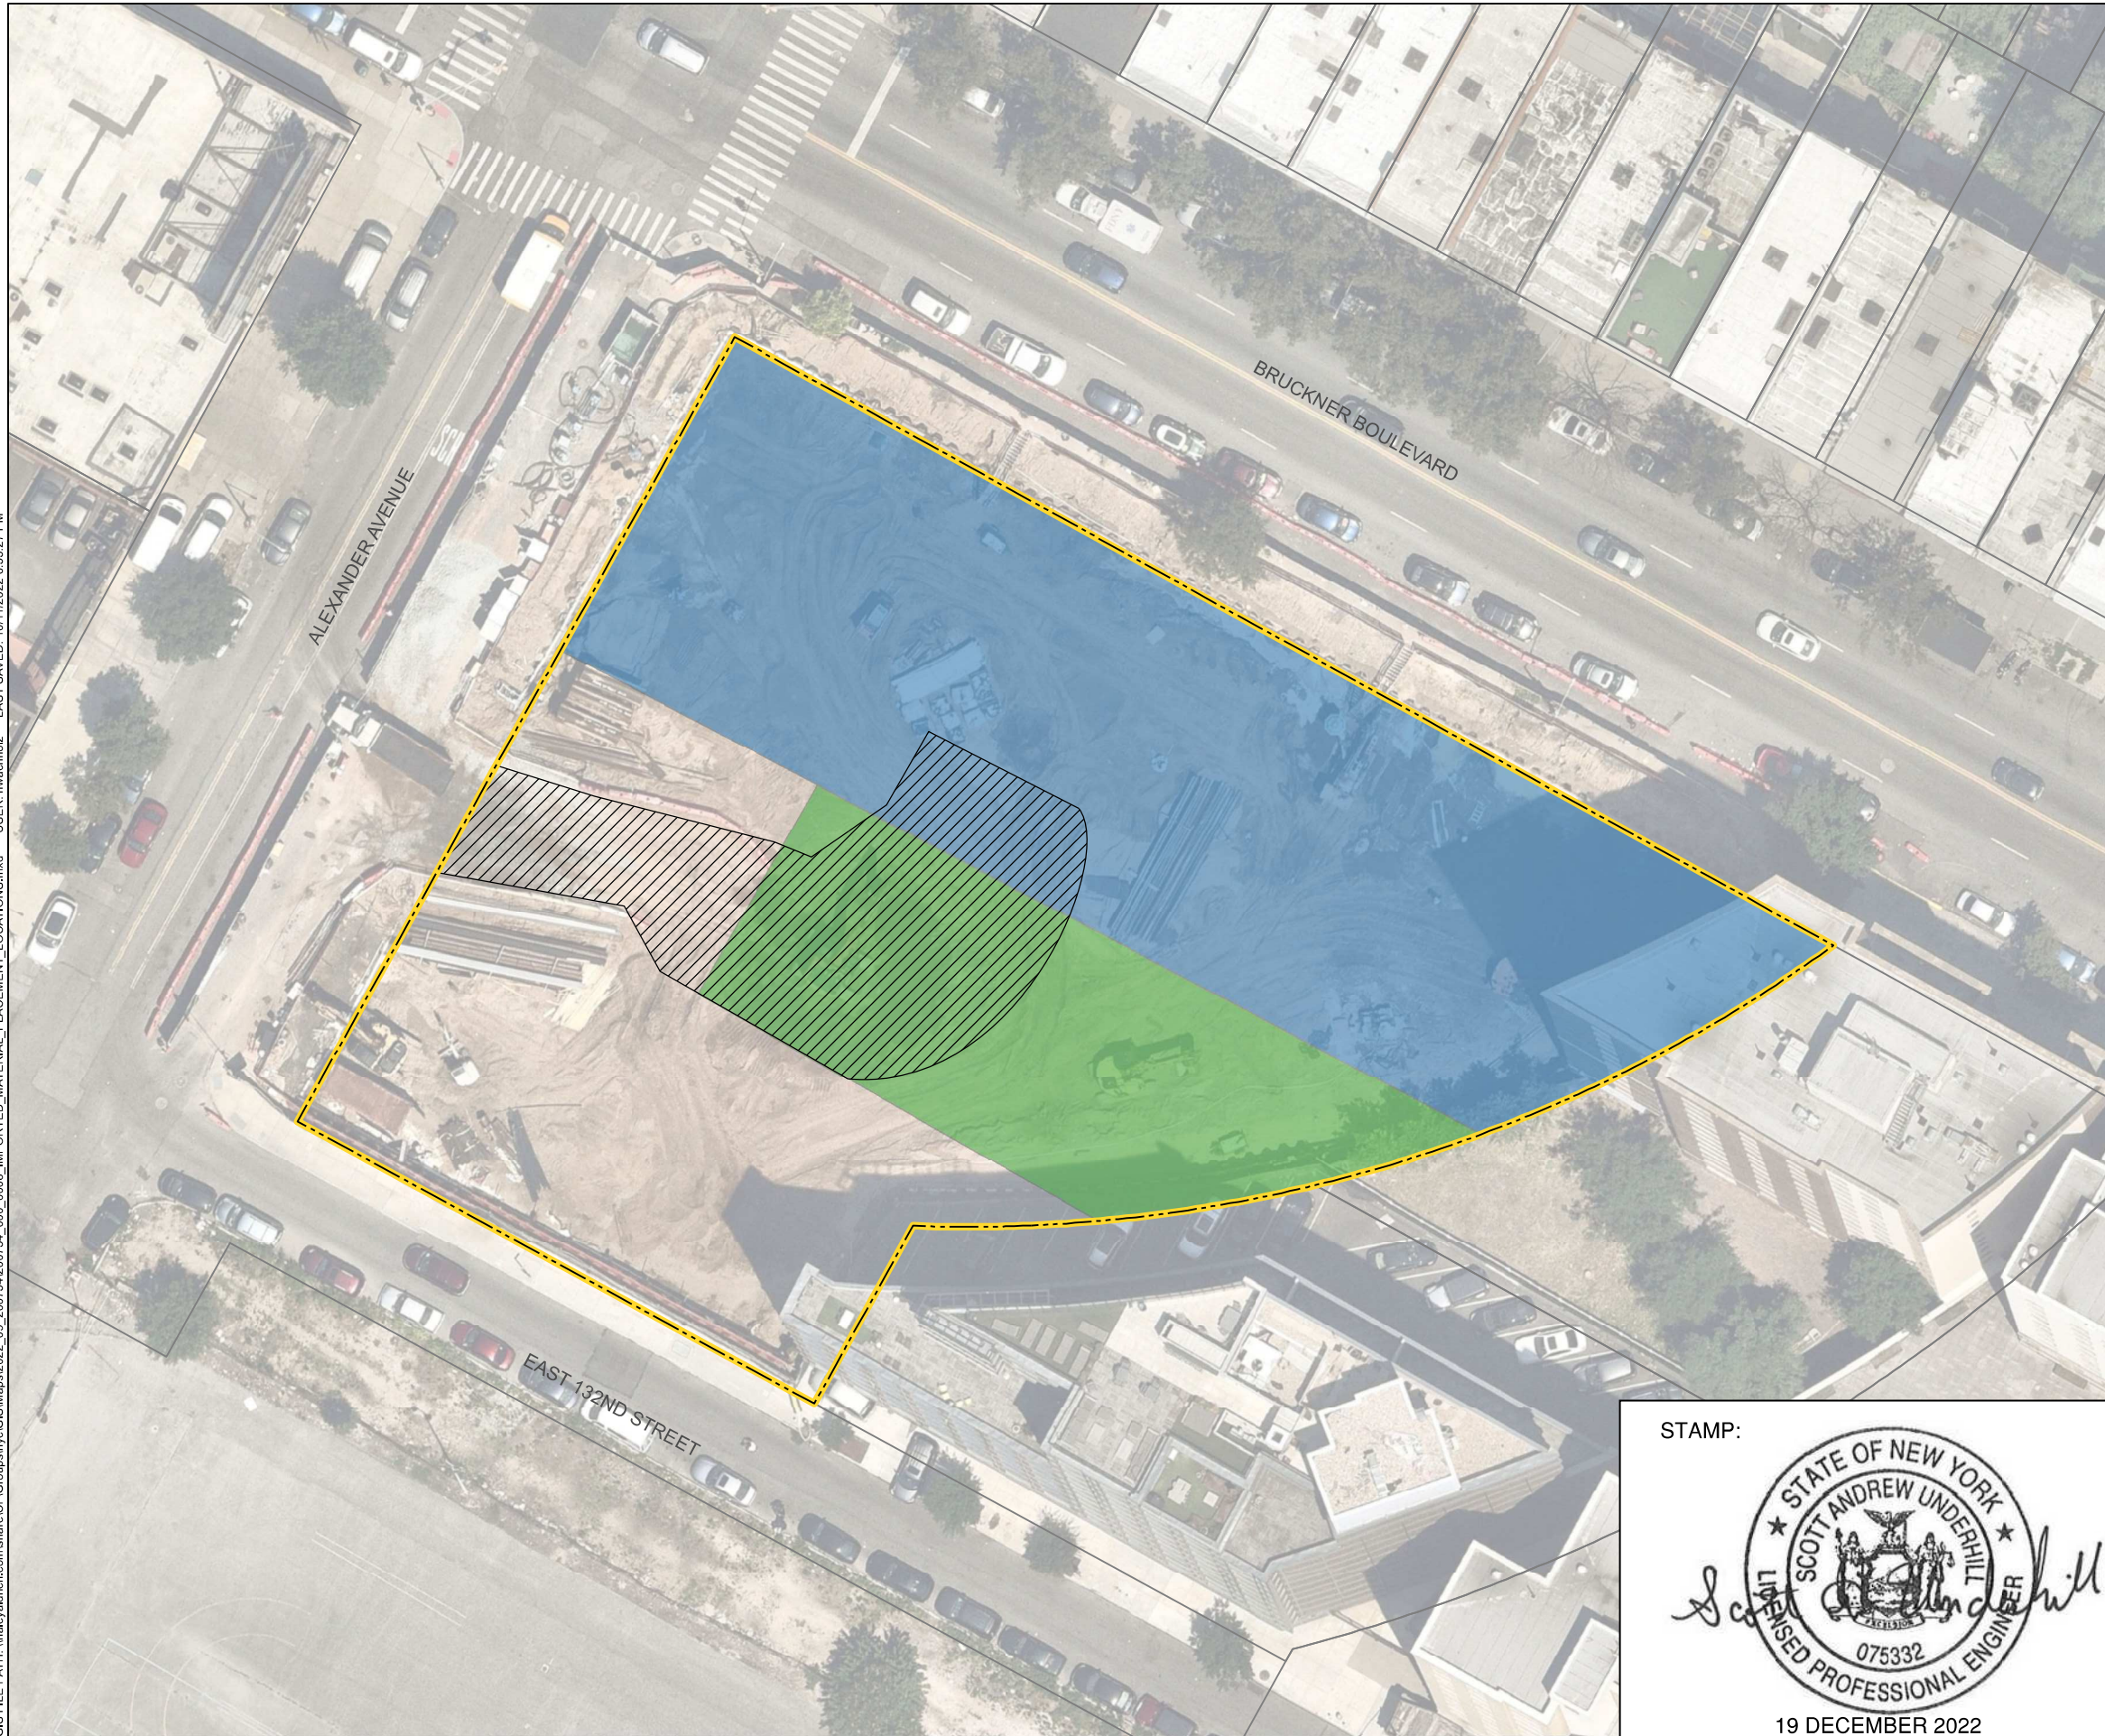
IMPORTED MATERIAL  
PLACEMENT LOCATIONS

A total of 575.62 tons of clean stone was imported to the Site for use as the construction ramp, construction entrances, and foundation subbase. Imported backfill included ¾-inch clean stone (377.17 tons), ⅝-inch clean stone (24.60 tons), and 2-1/2-inch clean stone (173.85 tons) from the Mount Hope Quarry located at 625 Mt Hope Road in Wharton, New Jersey. A table of all sources of imported backfill with quantities for each source is shown in Table VIII. A figure showing the Site locations where backfill was used at the Site is shown in Figure 8.
