REMEDIATION ACTION WORK PLAN
FORMER MILL SANITARY WIPING CLOTH SITE
NYSDEC SITE C203146
40 BRUCKNER BOULEVARD
BRONX, NY

File No. 0200734-002
March 2022

Subject: Remedial Action Work Plan
Former Mill Sanitary Wiping Cloth Site
40 Bruckner Boulevard
Bronx, New York
BCP Site C203146

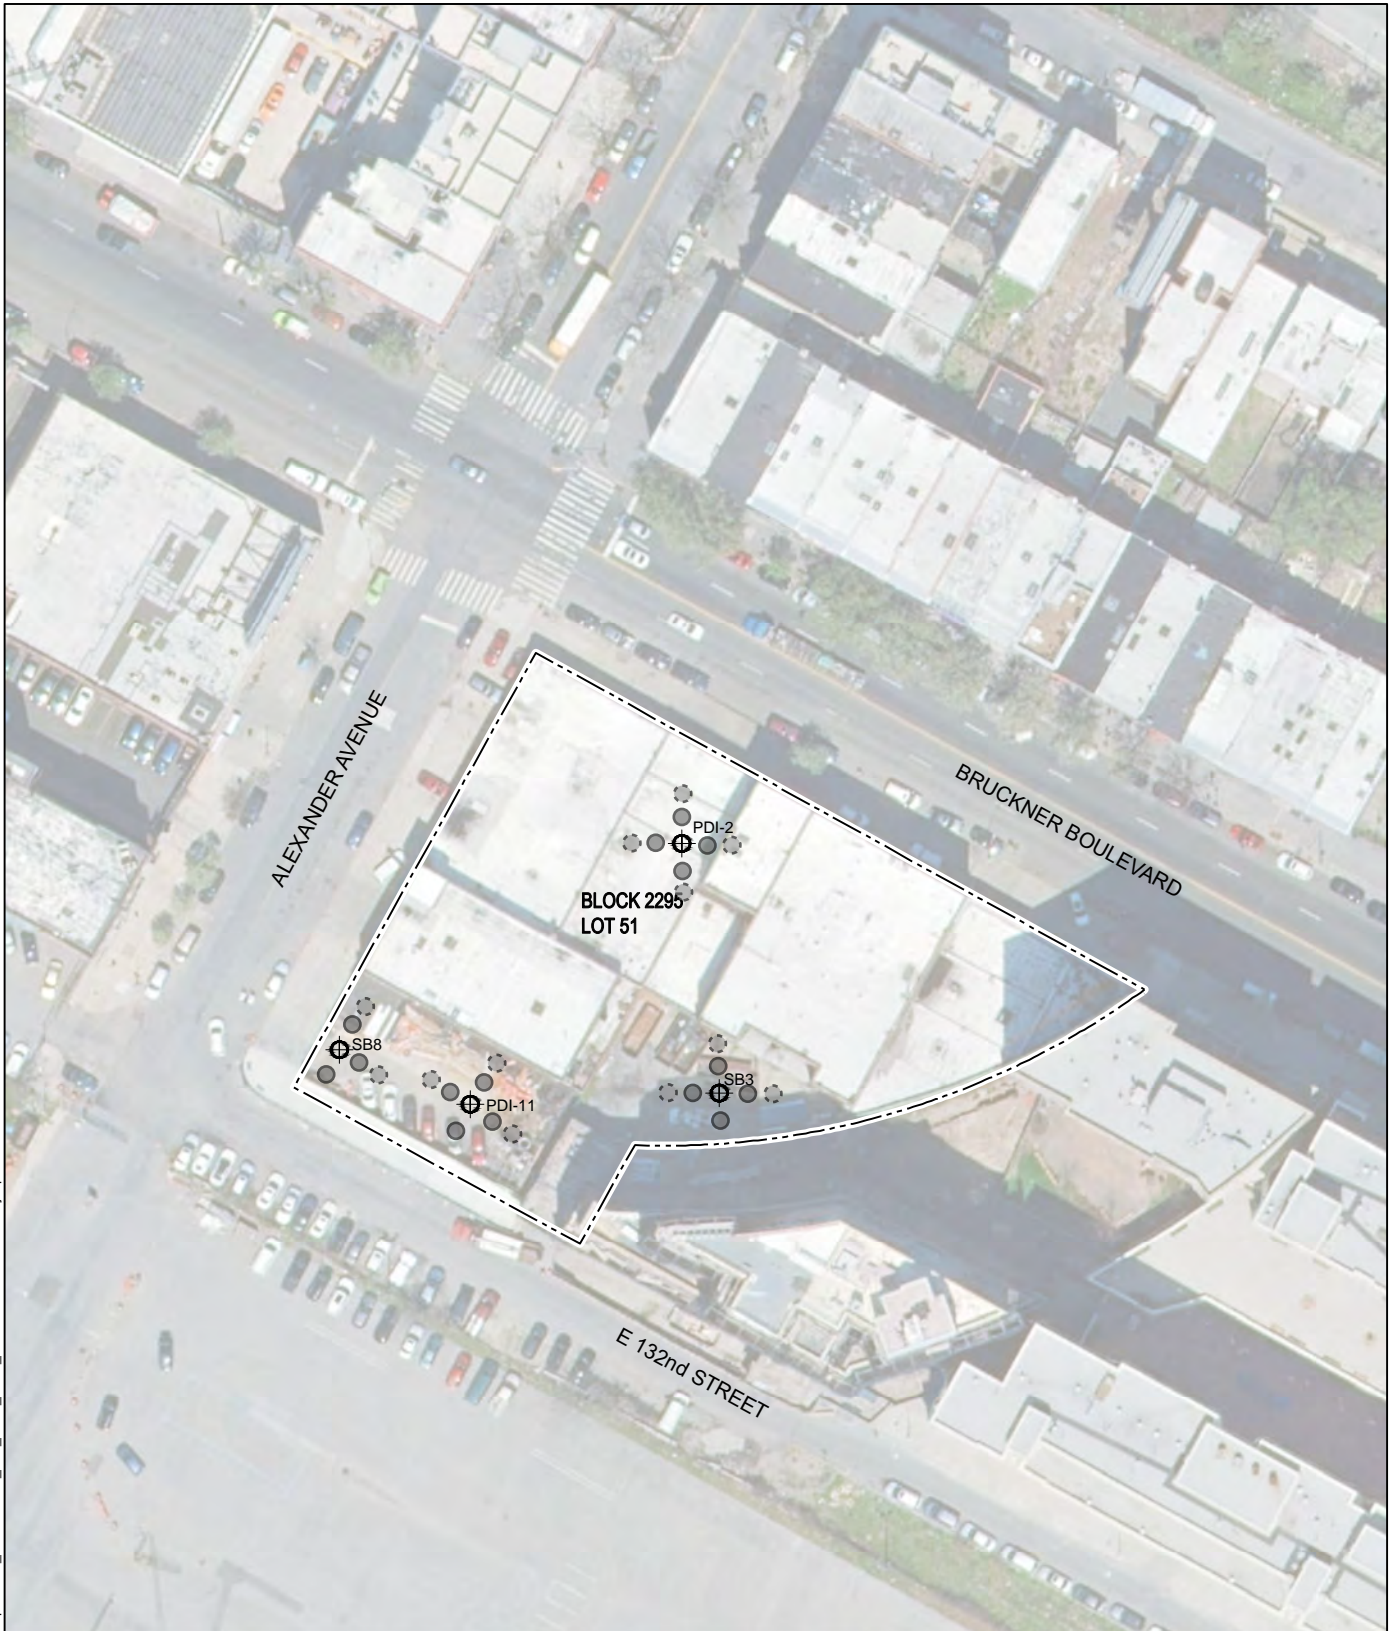
FIGURE 9

- APPROXIMATE SITE BOUNDARY
- PRE-DESIGN INVESTIGATION SOIL BORING LOCATION
- PROPOSED 8 FT BGS REMEDIAL EXCAVATION
- PROPOSED 4 FT BGS REMEDIAL EXCAVATION
- PROPOSED 10 FT BGS REMEDIAL EXCAVATION

Elevated lead total concentrations, above 1,000 mg/kg, were detected in shallow soil collected from 0 to 2 inches at SB8 and SB3 during the September 2021 RI. During the January 2022 PDI, elevated lead concentrations, above 1,000 mg/kg, were detected in PDI-2 at 6 to 8 ft bgs and in PDI-11 at 2 to 4 ft bgs. Analysis for toxicity characteristics leachate procedure (TCLP) and total lead will be conducted at the above referenced locations along with delineation of potentially hazardous lead material followed by subsequent excavation and disposal of potentially hazardous lead-impacted historic fill material. Delineation areas are shown in Figure 9.

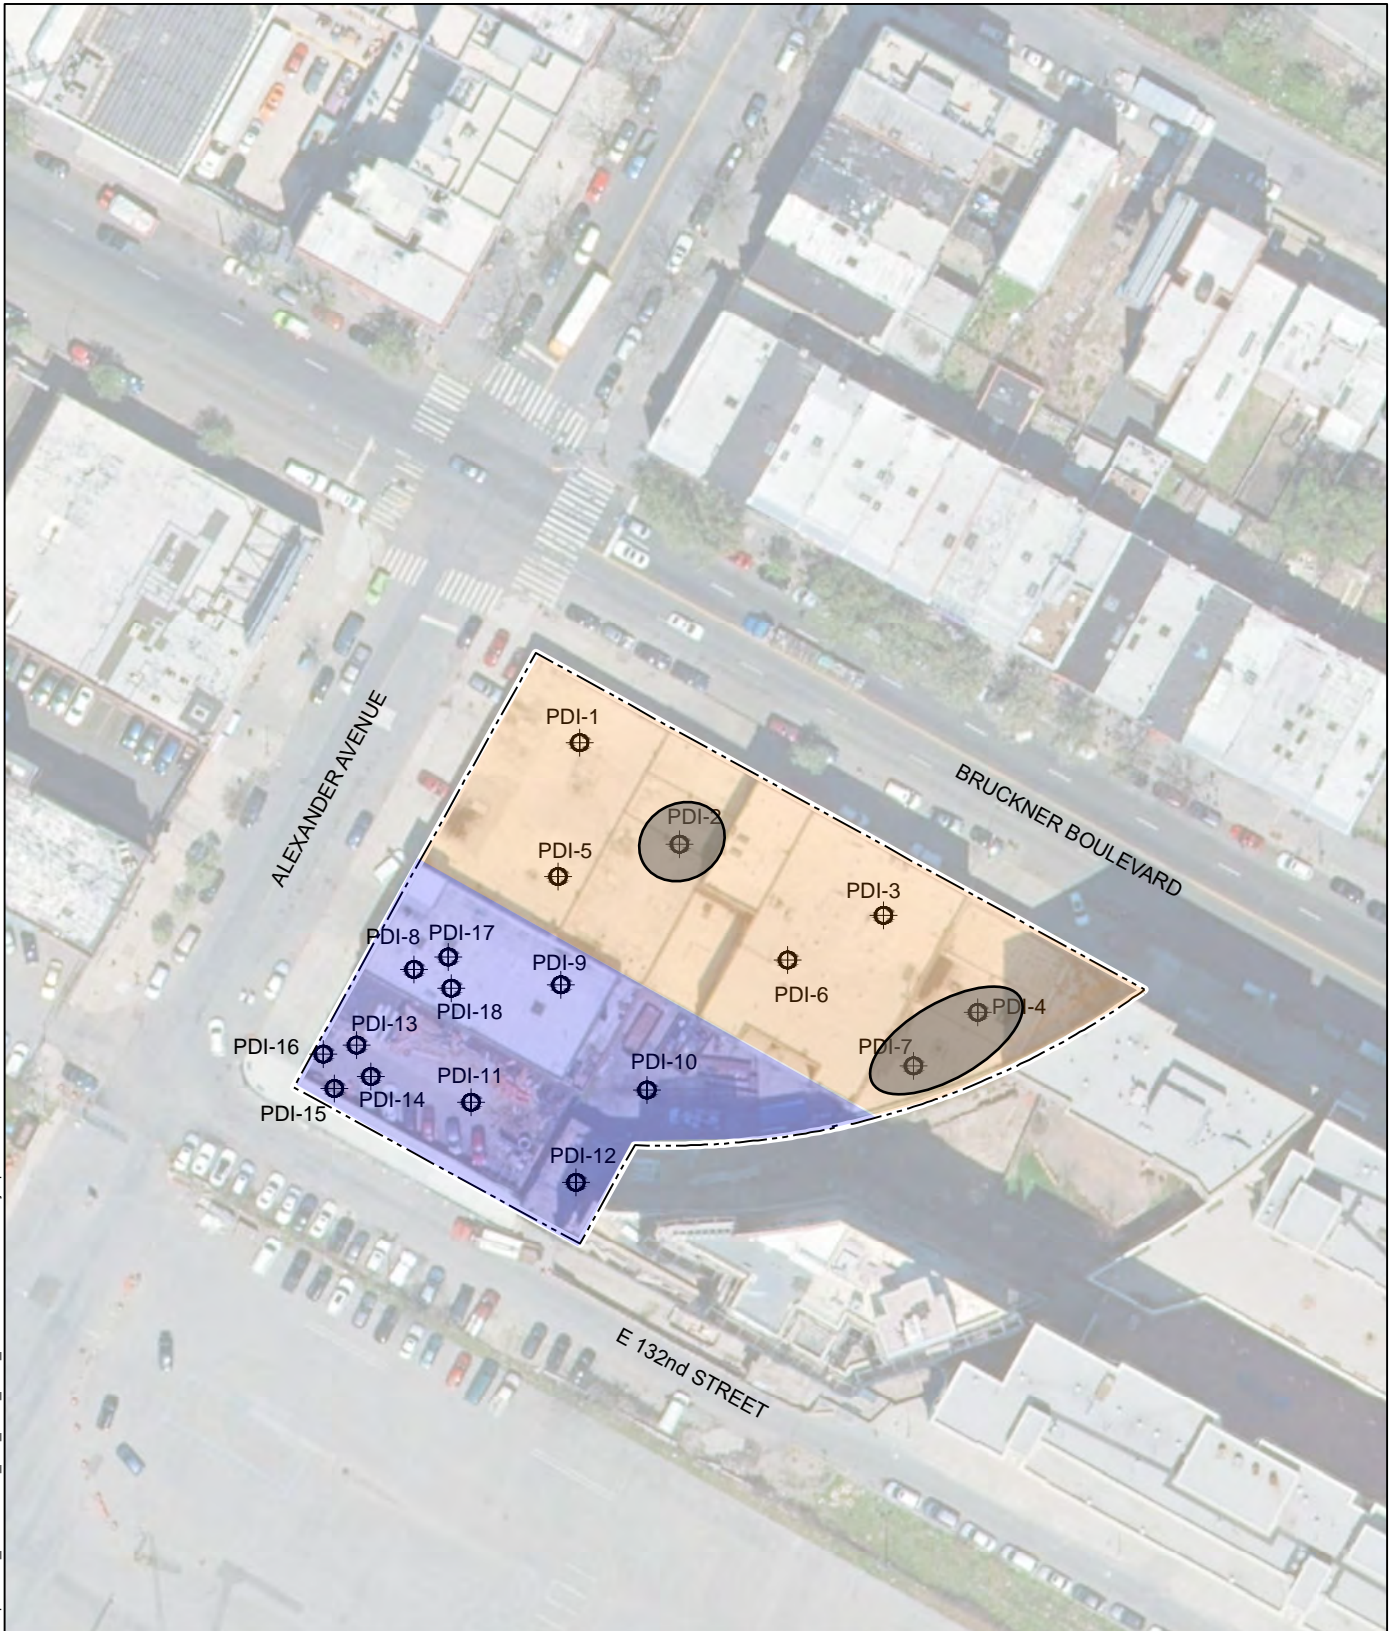
FIGURE 10

- APPROXIMATE SITE BOUNDARY
- PRE-DESIGN INVESTIGATION SOIL BORING LOCATION
- PROPOSED 6 FT BGS REMEDIAL EXCAVATION
- PROPOSED 4 FT BGS REMEDIAL EXCAVATION

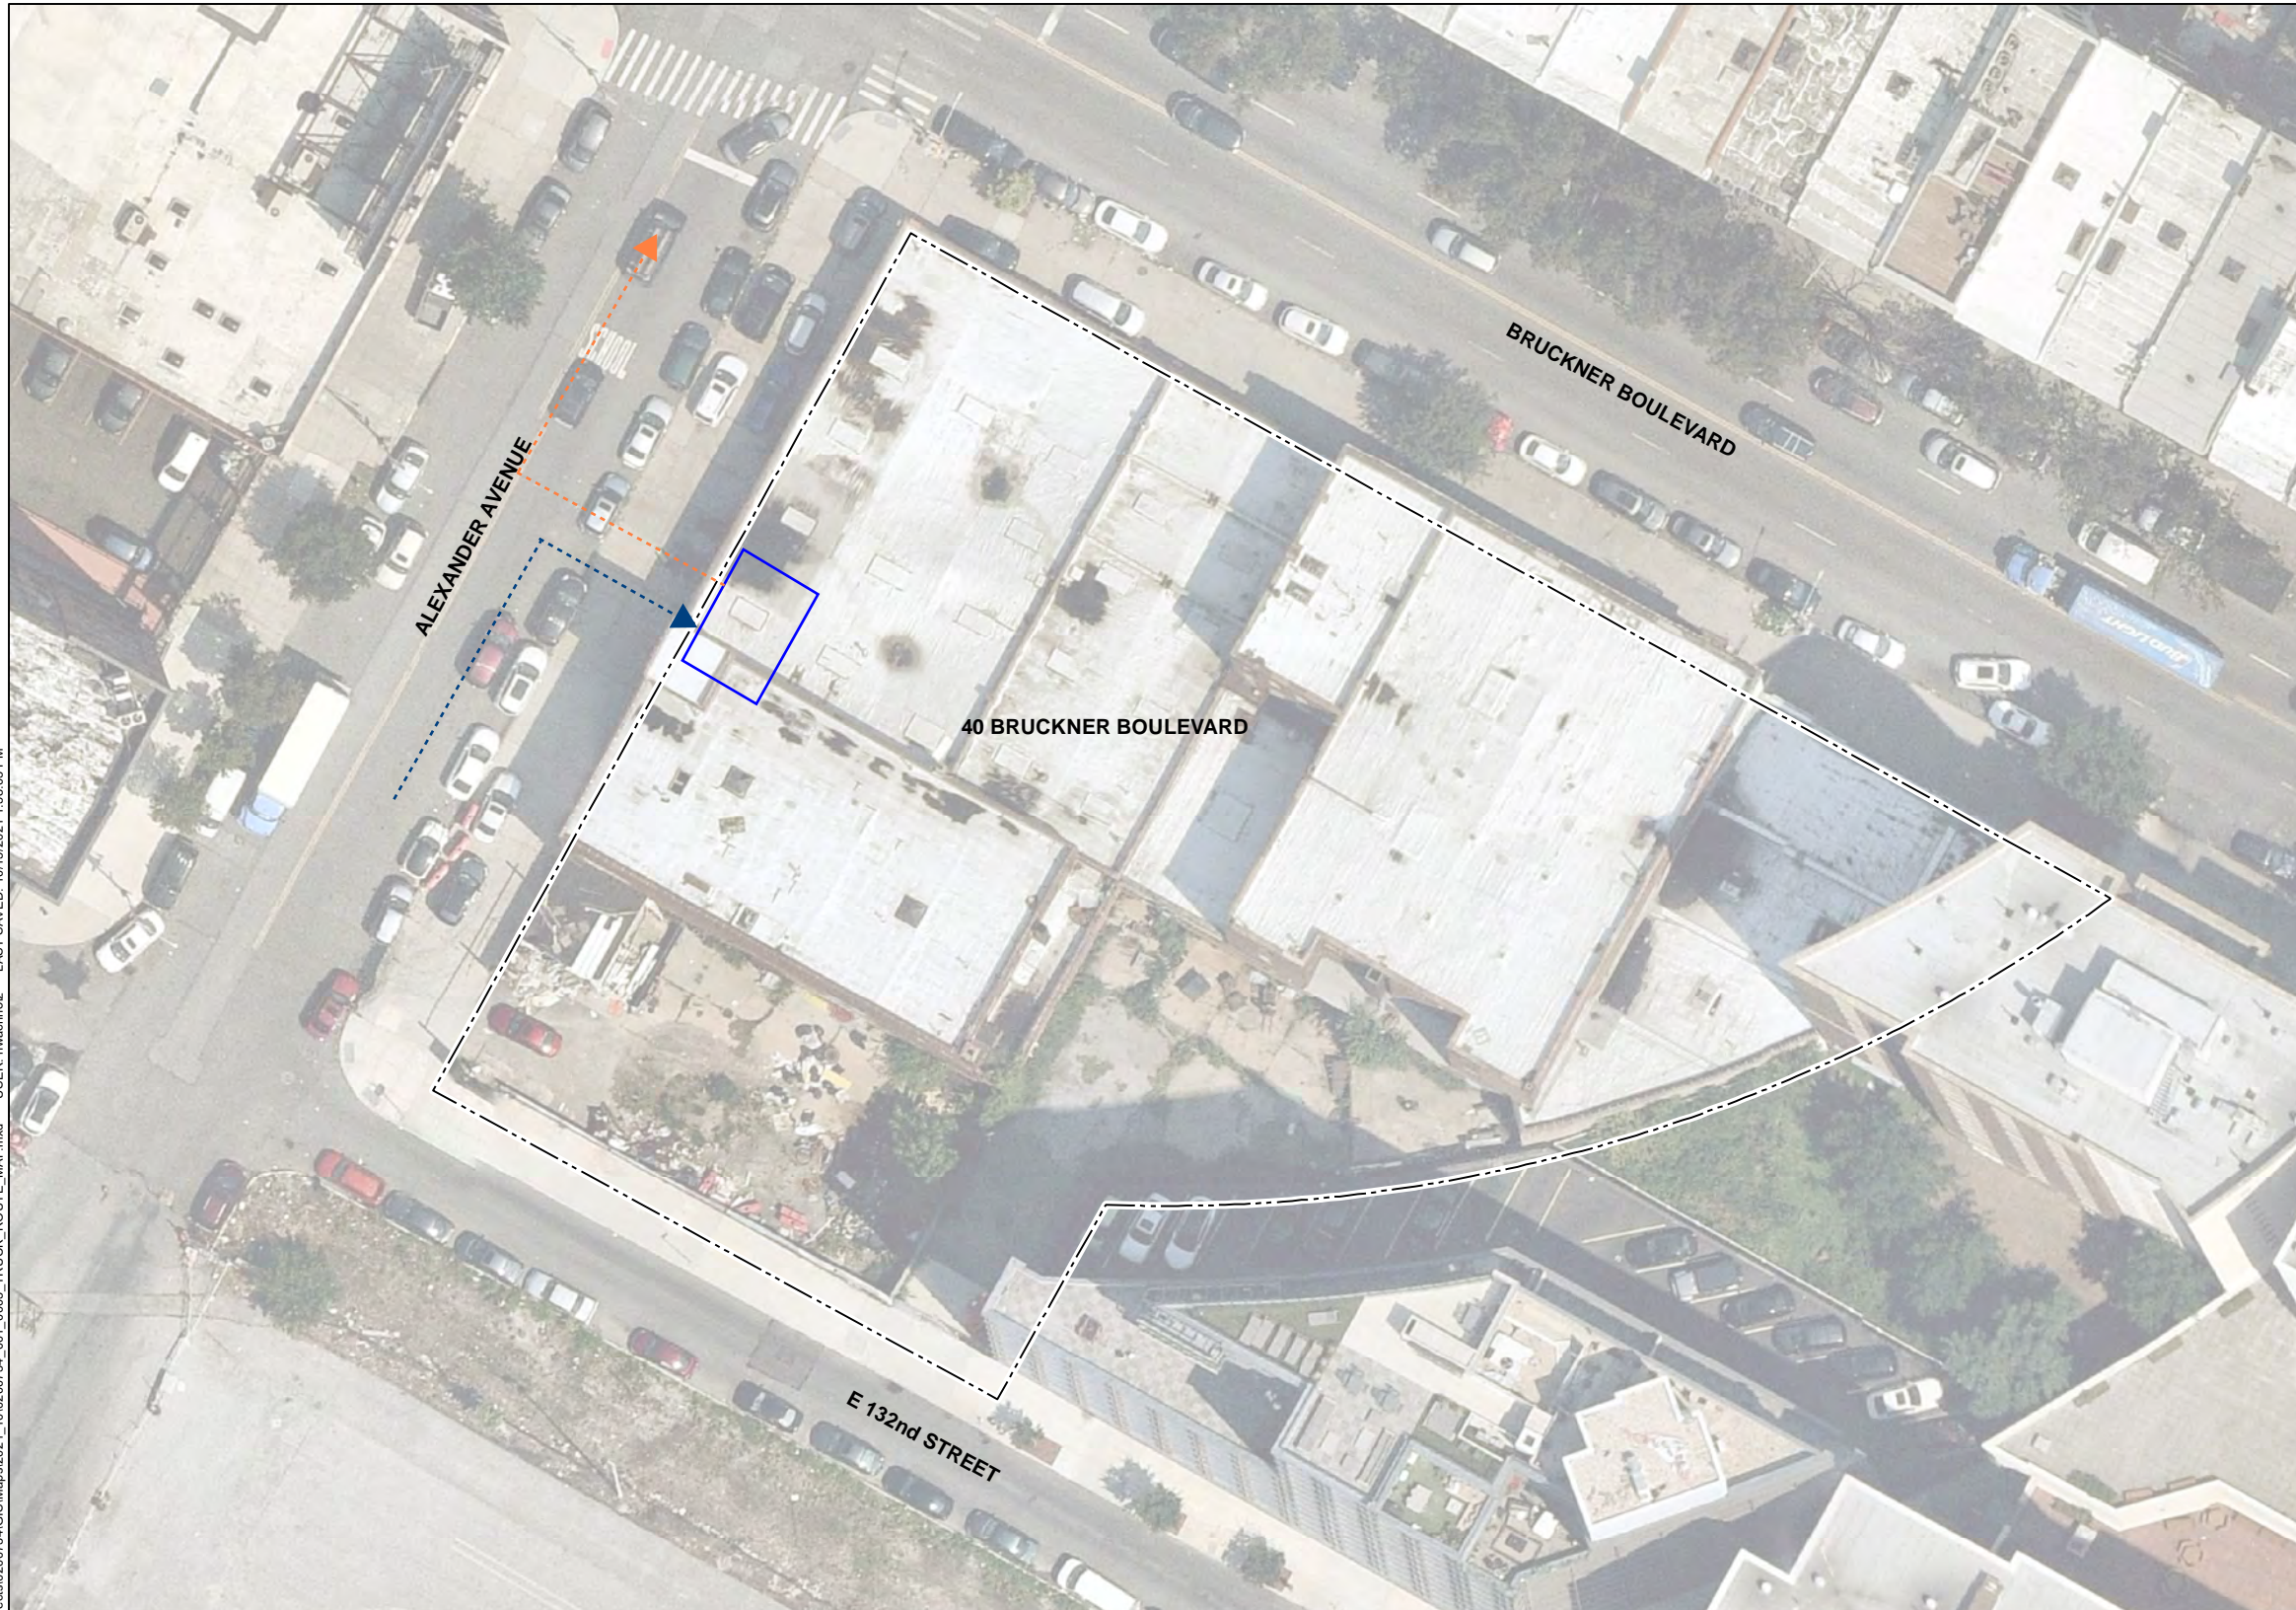
FIGURE 14

- SITE BOUNDARY
- TRUCK ENTRANCE
- TRUCK EGRESS
- TRUCK INGRESS
- TRUCK ROUTE

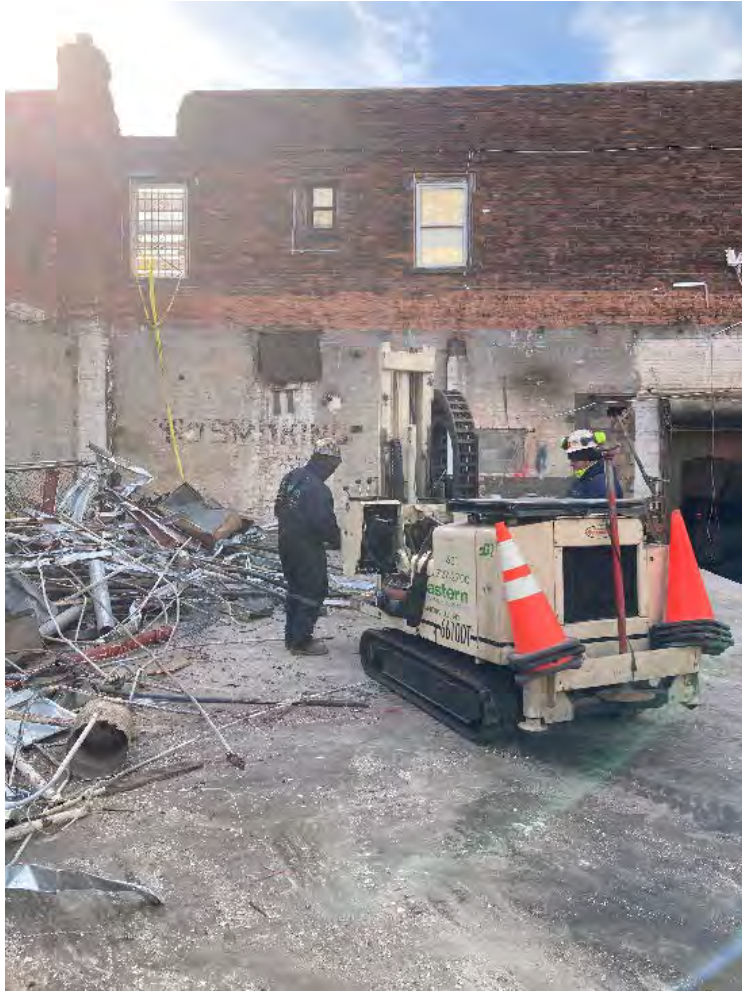
Photo 1: View of soil boring installation at location PDI-5.

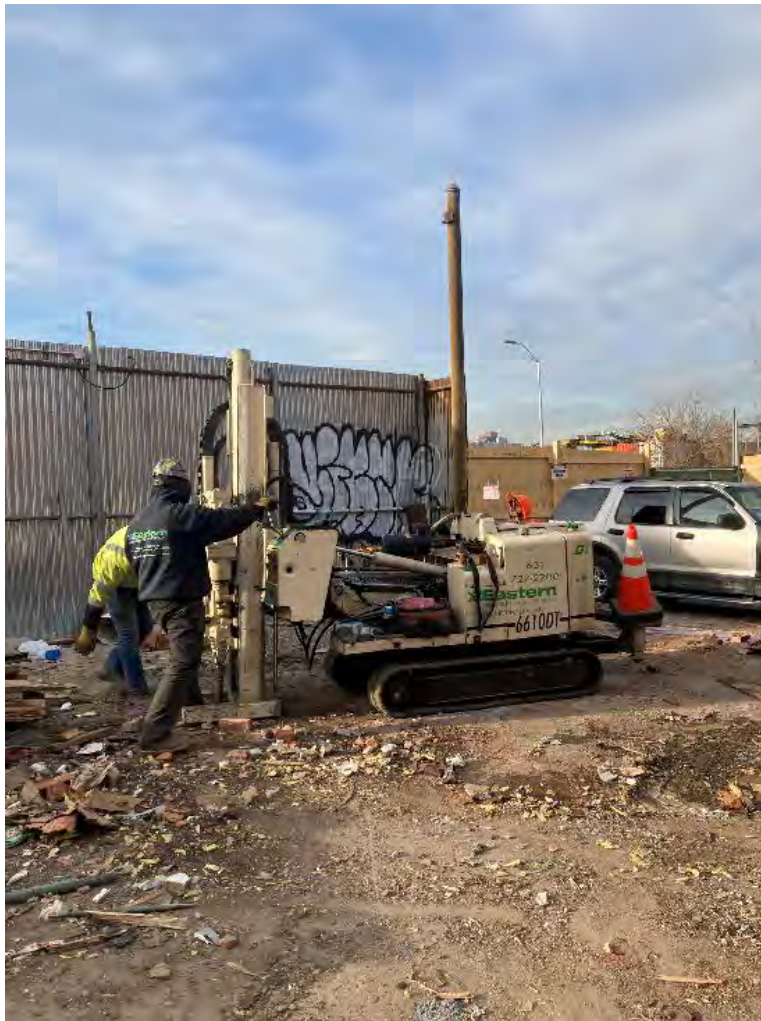
Photo 1: View of soil boring installation at location PDI-14.
