FORMER SEARS AUTO CENTER
4720 THIRD AVENUE
BRONX, NEW YORK 10458
NYSDEC BCP ID: C203147

FINAL ENGINEERING REPORT

NYSDEC SITE NUMBER: C203147

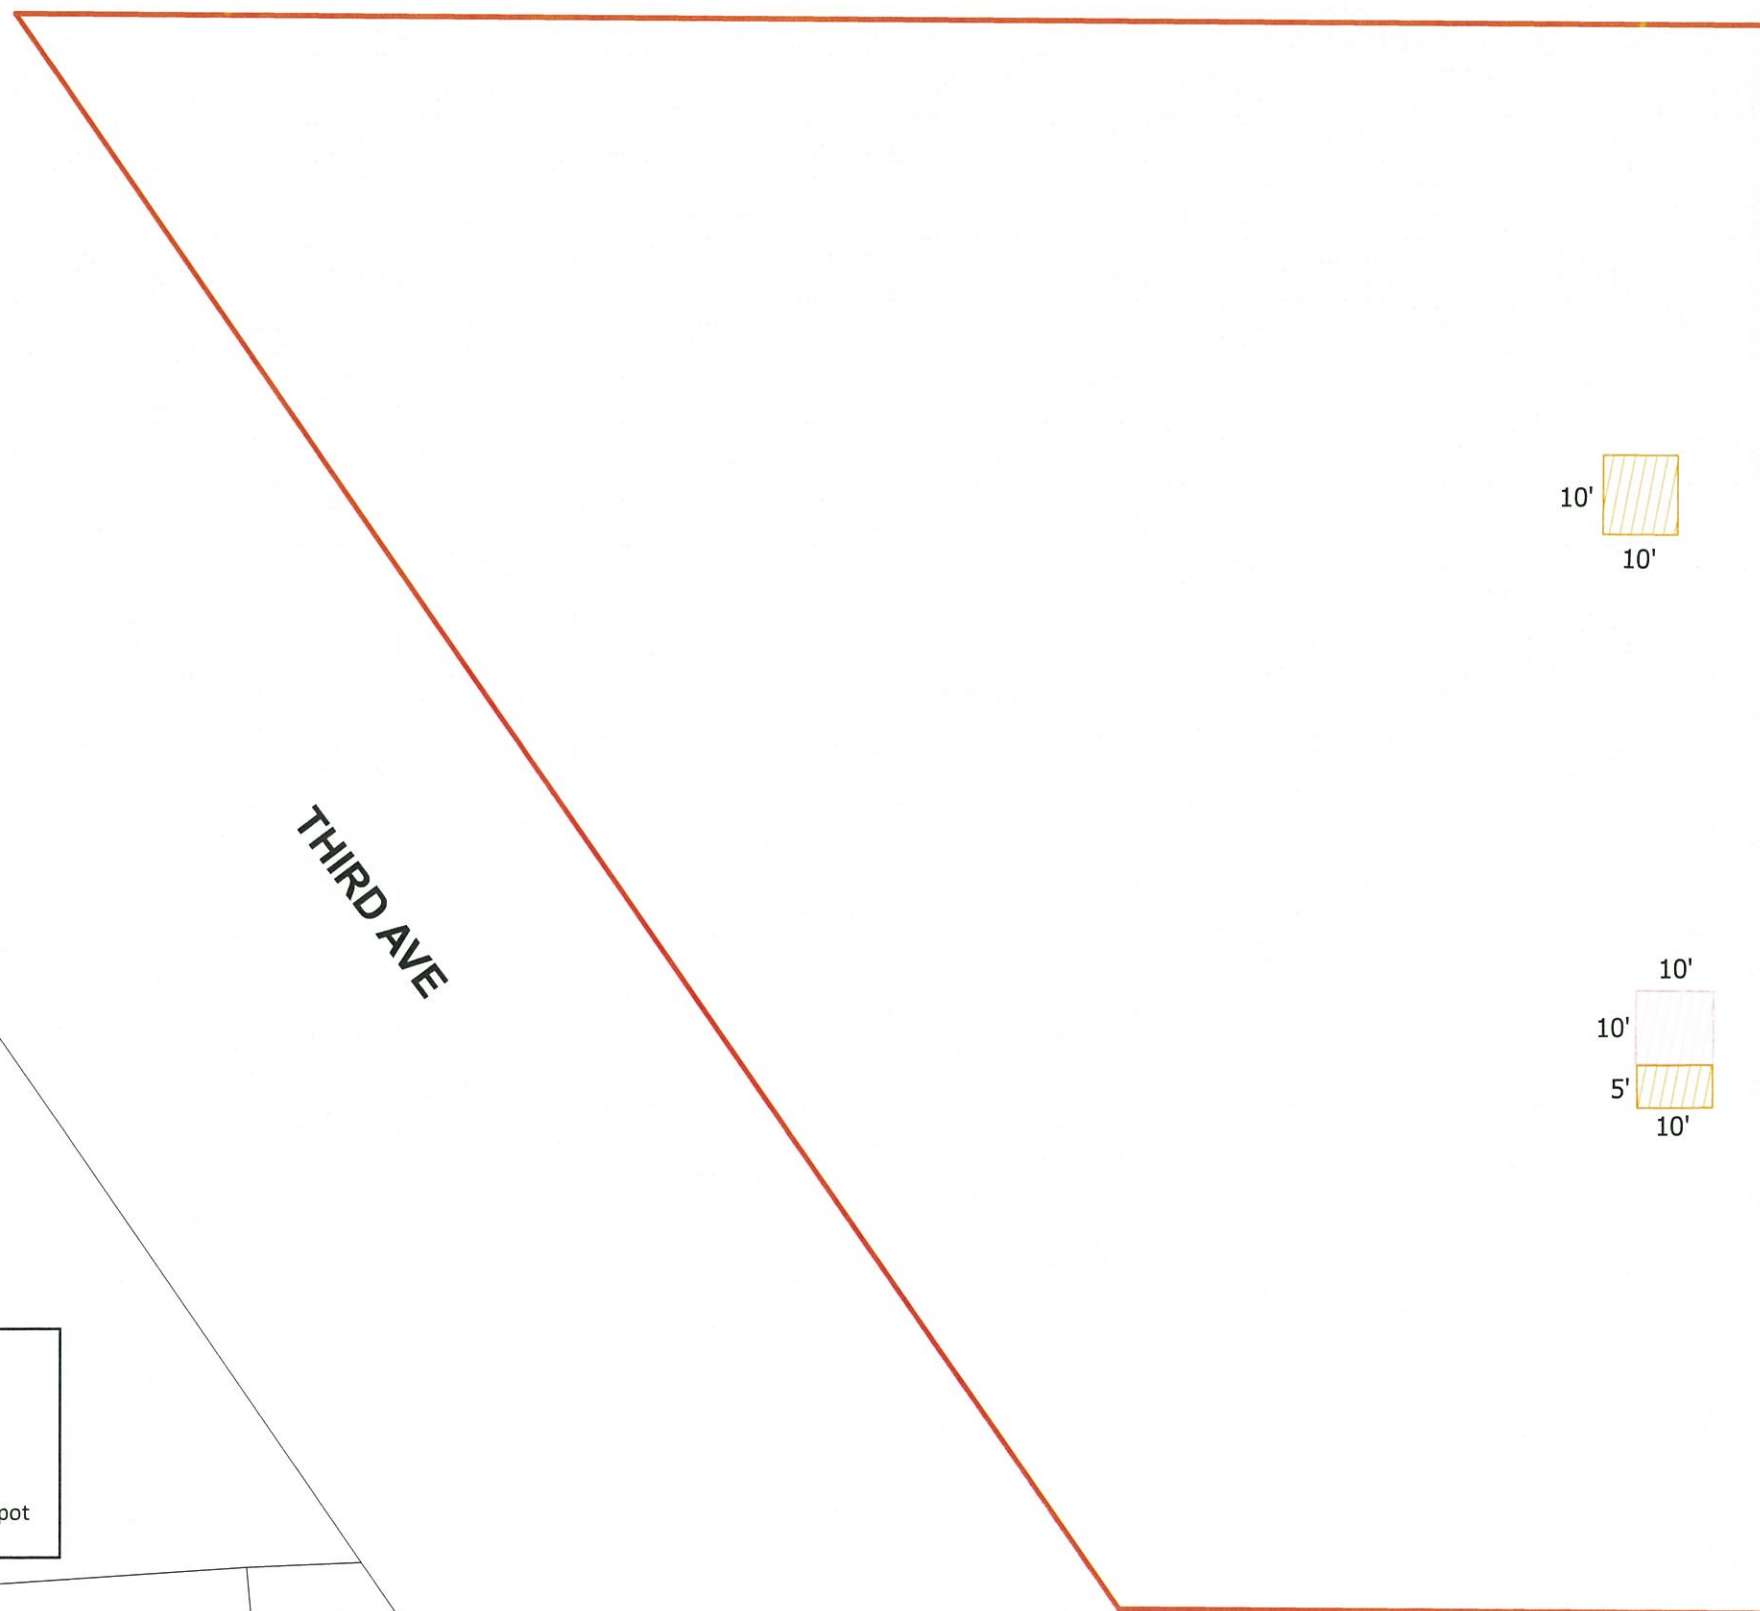
A ten foot wide by ten foot long by five foot deep hazardous lead hotspot was delineated and characterized on December 1, 2021 and December 16, 2021 during the IRM phase of this project. An USEPA Resource Conservation and Recovery Act (RCRA) Generator ID was assigned (NYR000253526) and the hotspot was removed during the IRM. The excavated hazardous hotspot material was sent to the Clean Earth of North Jersey facility (CENJ) and totaled 54.6 tons of material. Two additional non-hazardous lead hotspots were also delineated during this time period. The excavated non-hazardous hotspot material was also sent to CENJ and totaled 53.48 tons of material. The delineated hotspot locations are identified in **Figure 4**.

- Site Boundary
- Lot Boundary
- Hazardous Lead Hotspot
- Non-Hazardous Lead Hotspot

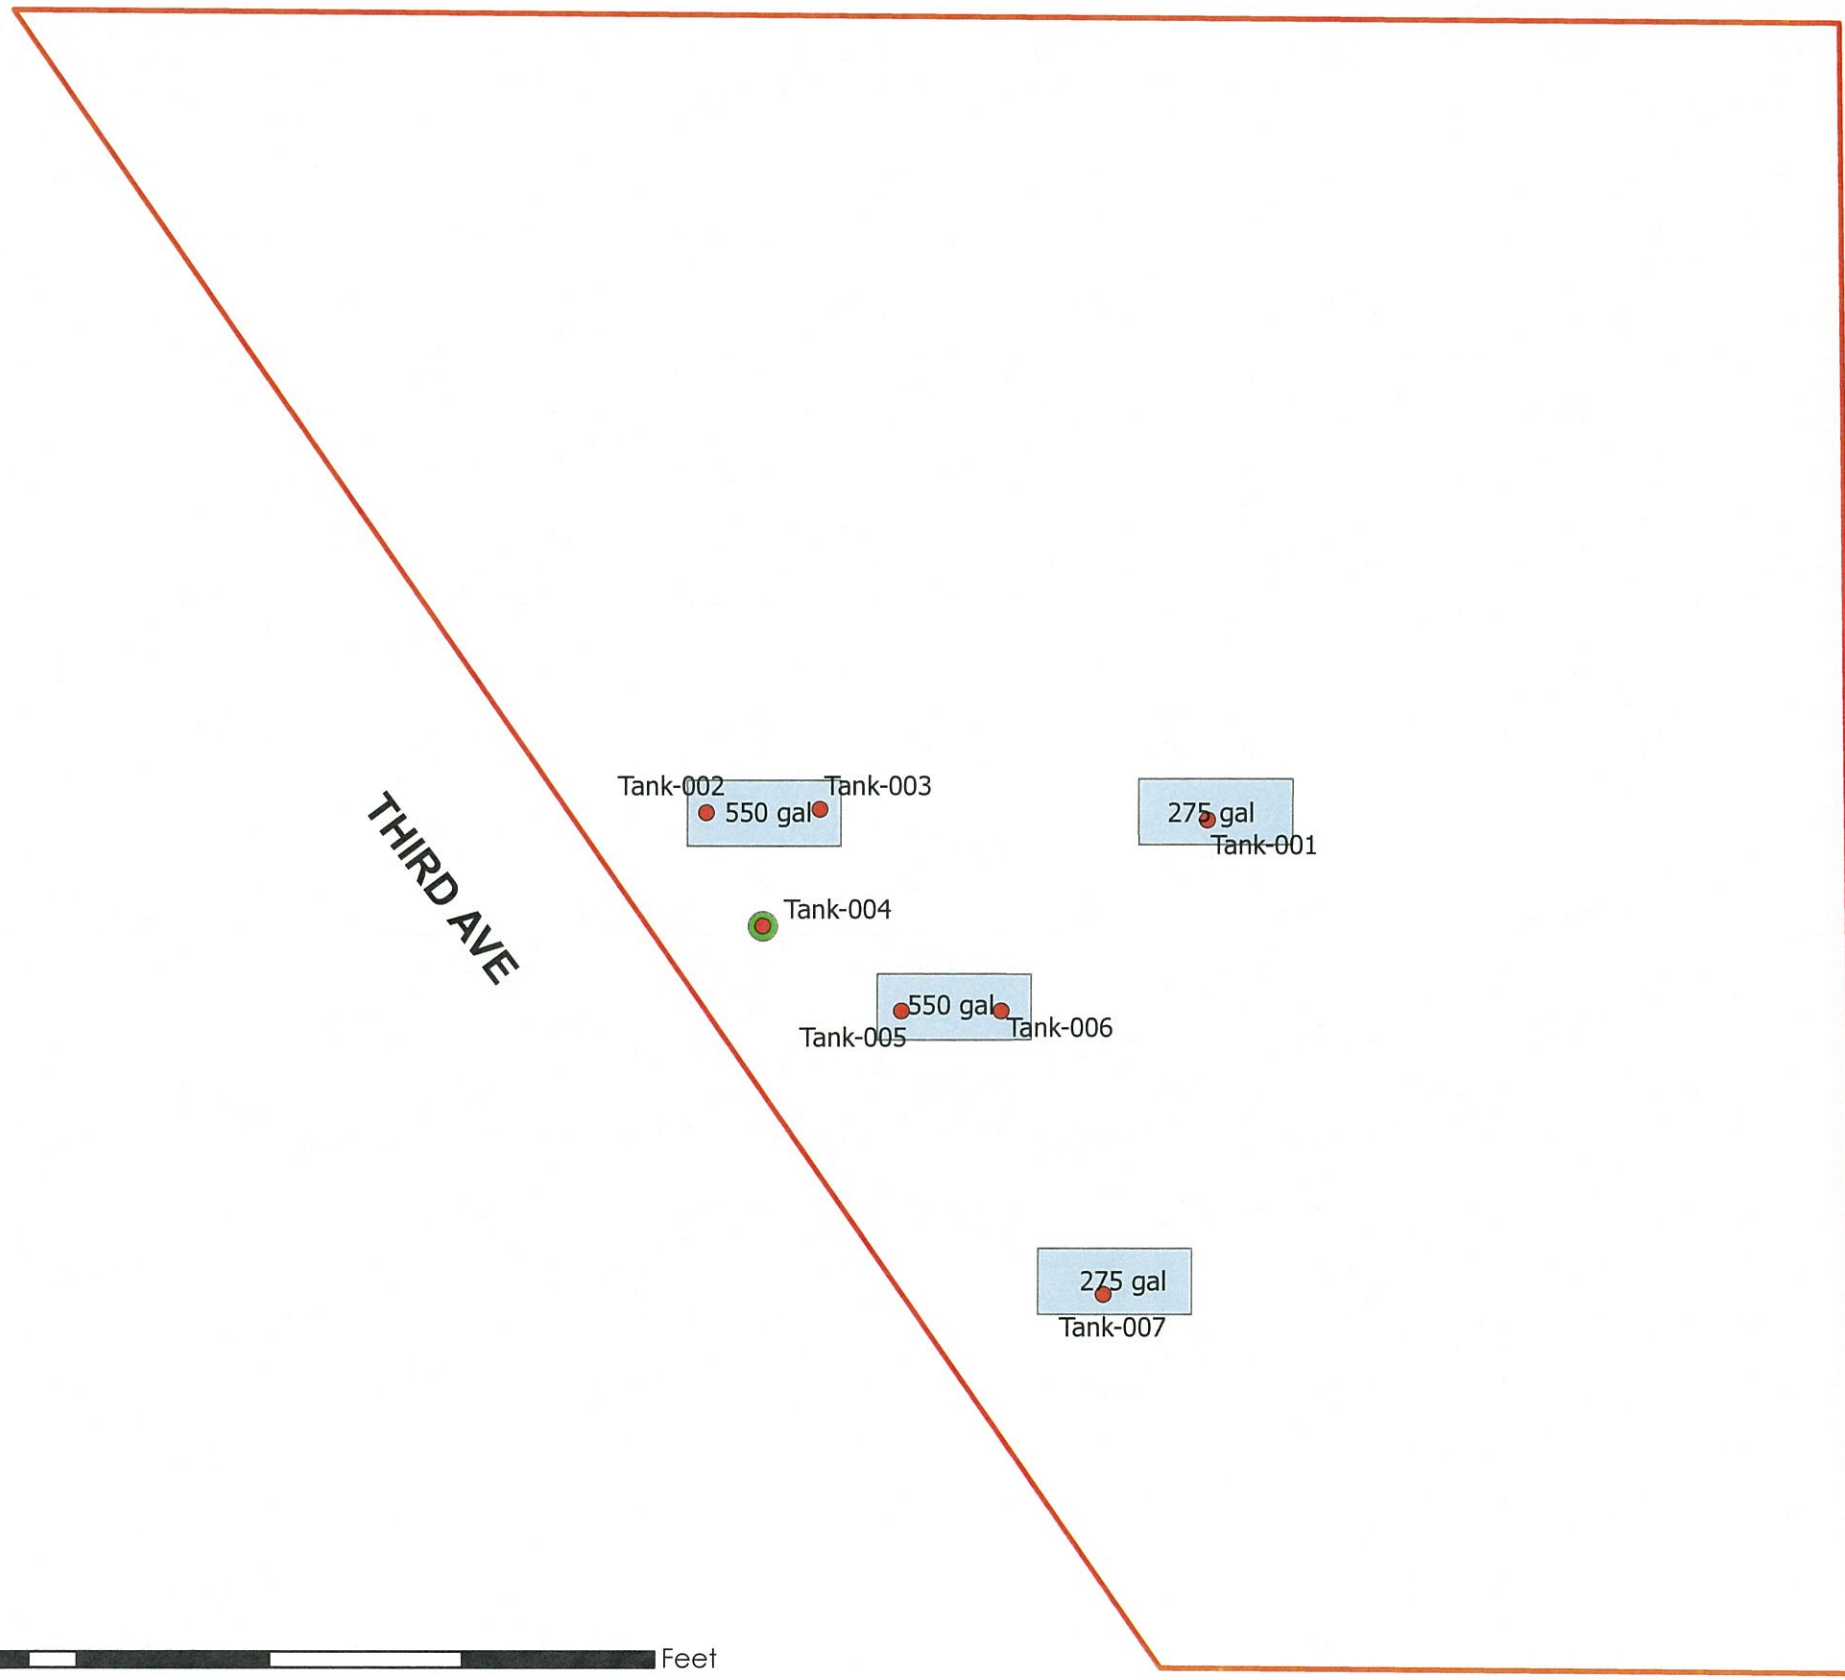
Tank Bottom Confirmation Samples

Prior to removal, remaining liquids were pumped out utilizing a vacuum powered pump truck. Following liquid removal, the tanks were removed from the excavation, cut open, and cleaned. A total of approximately 731 gallons of residual liquids (oily water) and 1,700 pounds of non-hazardous, non-RCRA sludges were generated and properly disposed of at the following facilities:

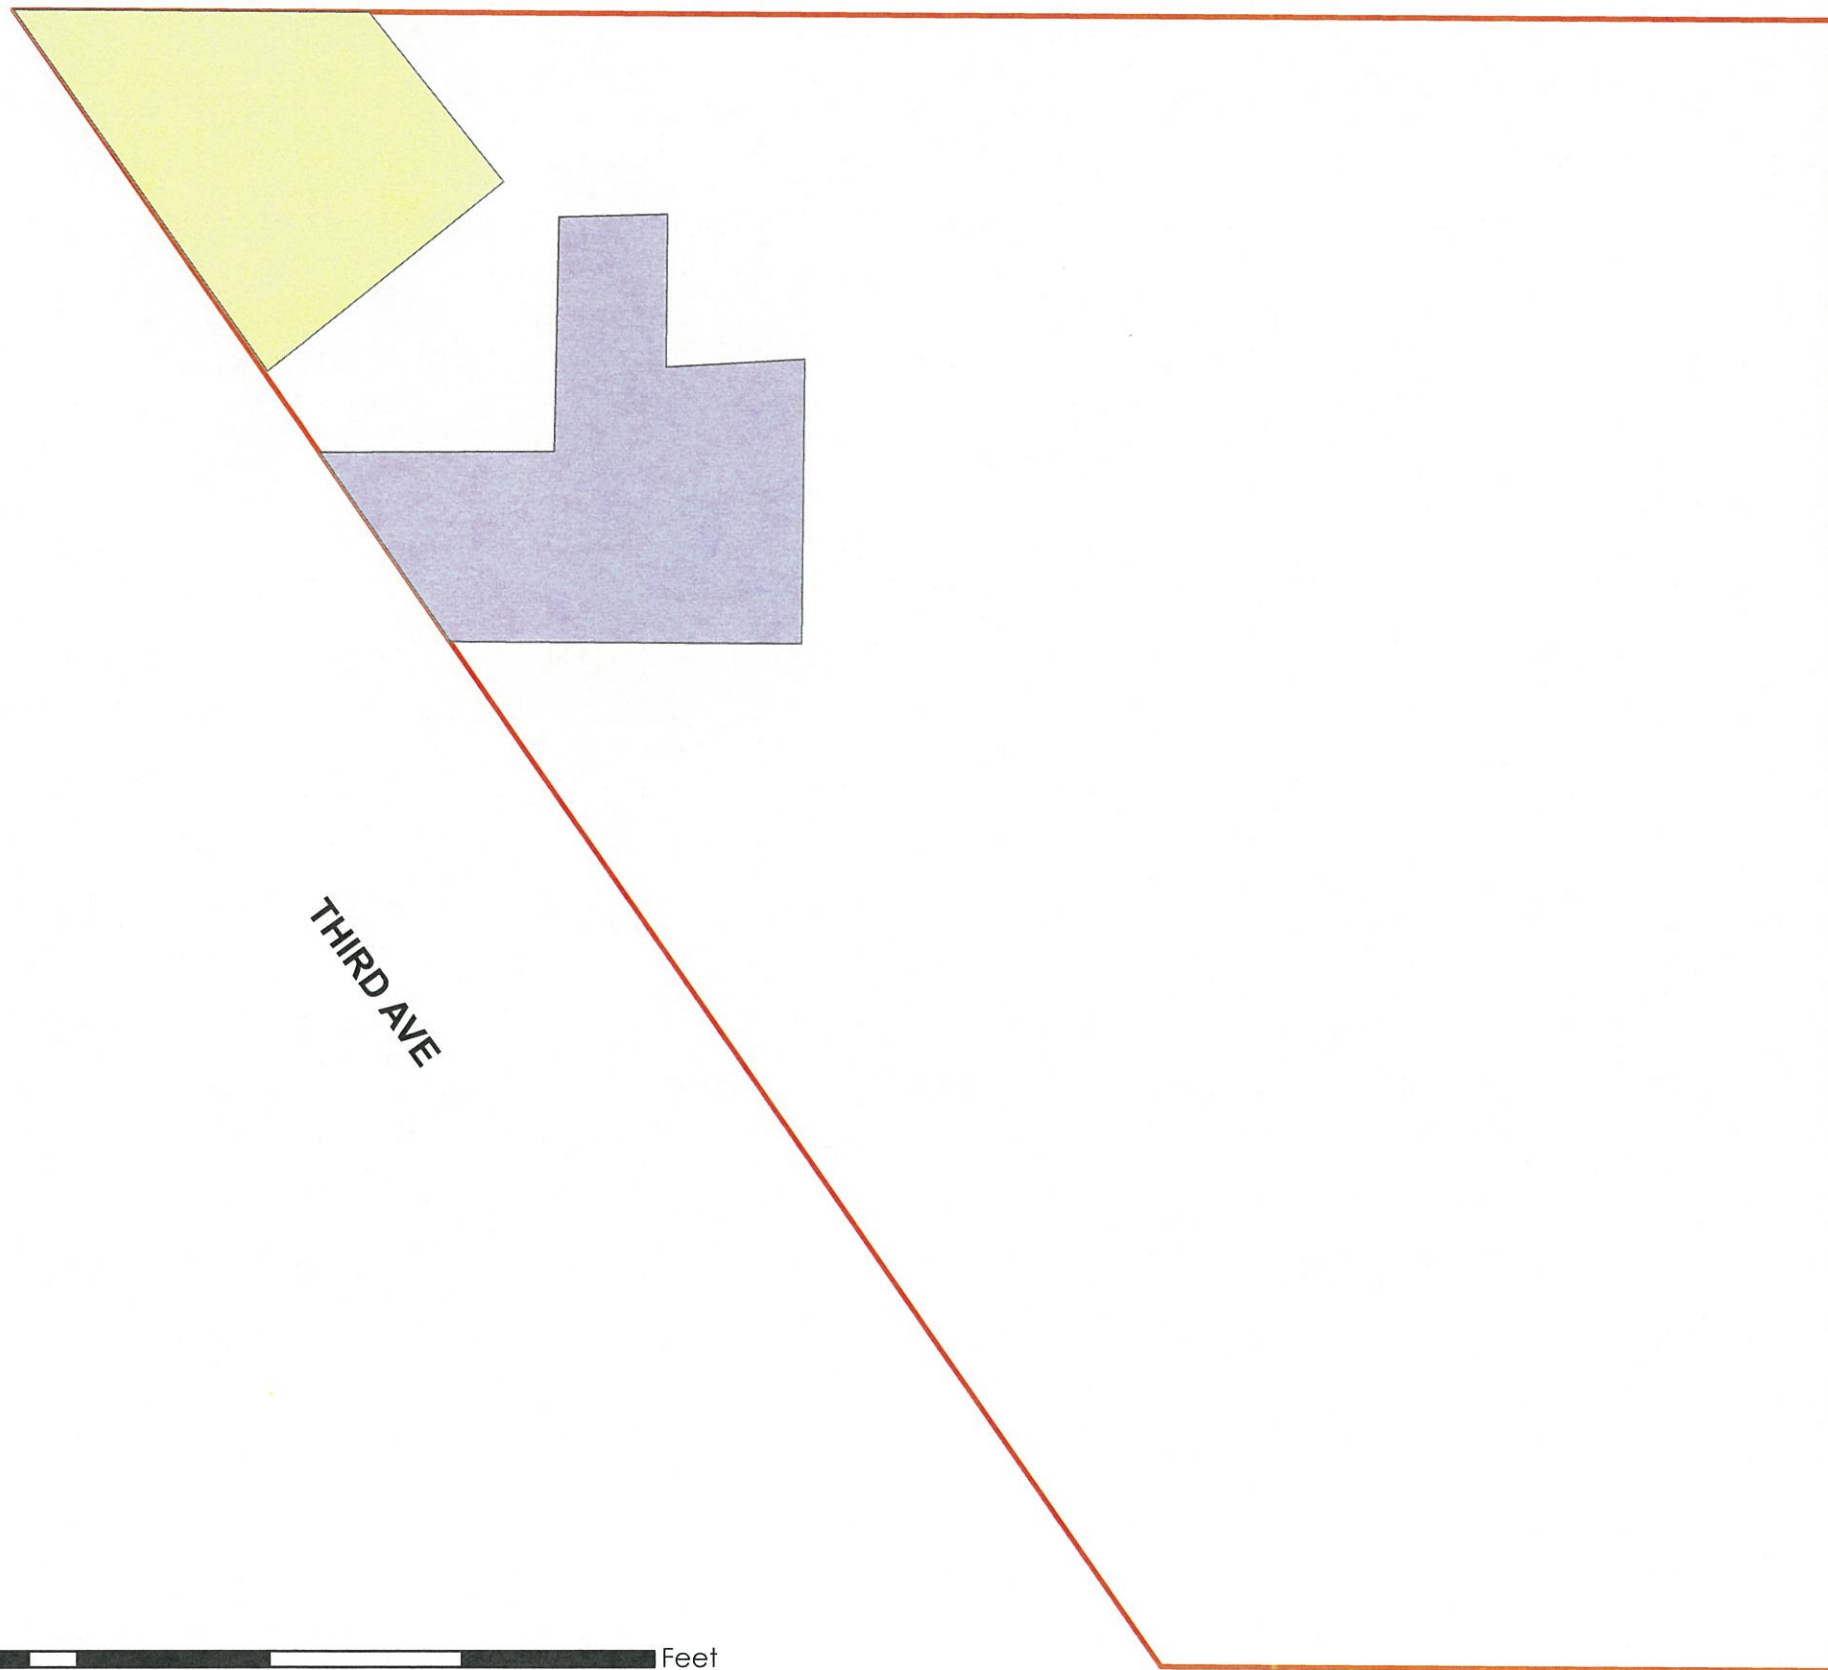
Soil Reuse Origin- Soil from 20-23.5' bgs (~ 250 cubic yards)
