COPYRITE PLASTIC SHEETS
BRONX, NEW YORK

Final Engineering Report

NYSDEC Site Number: C203151

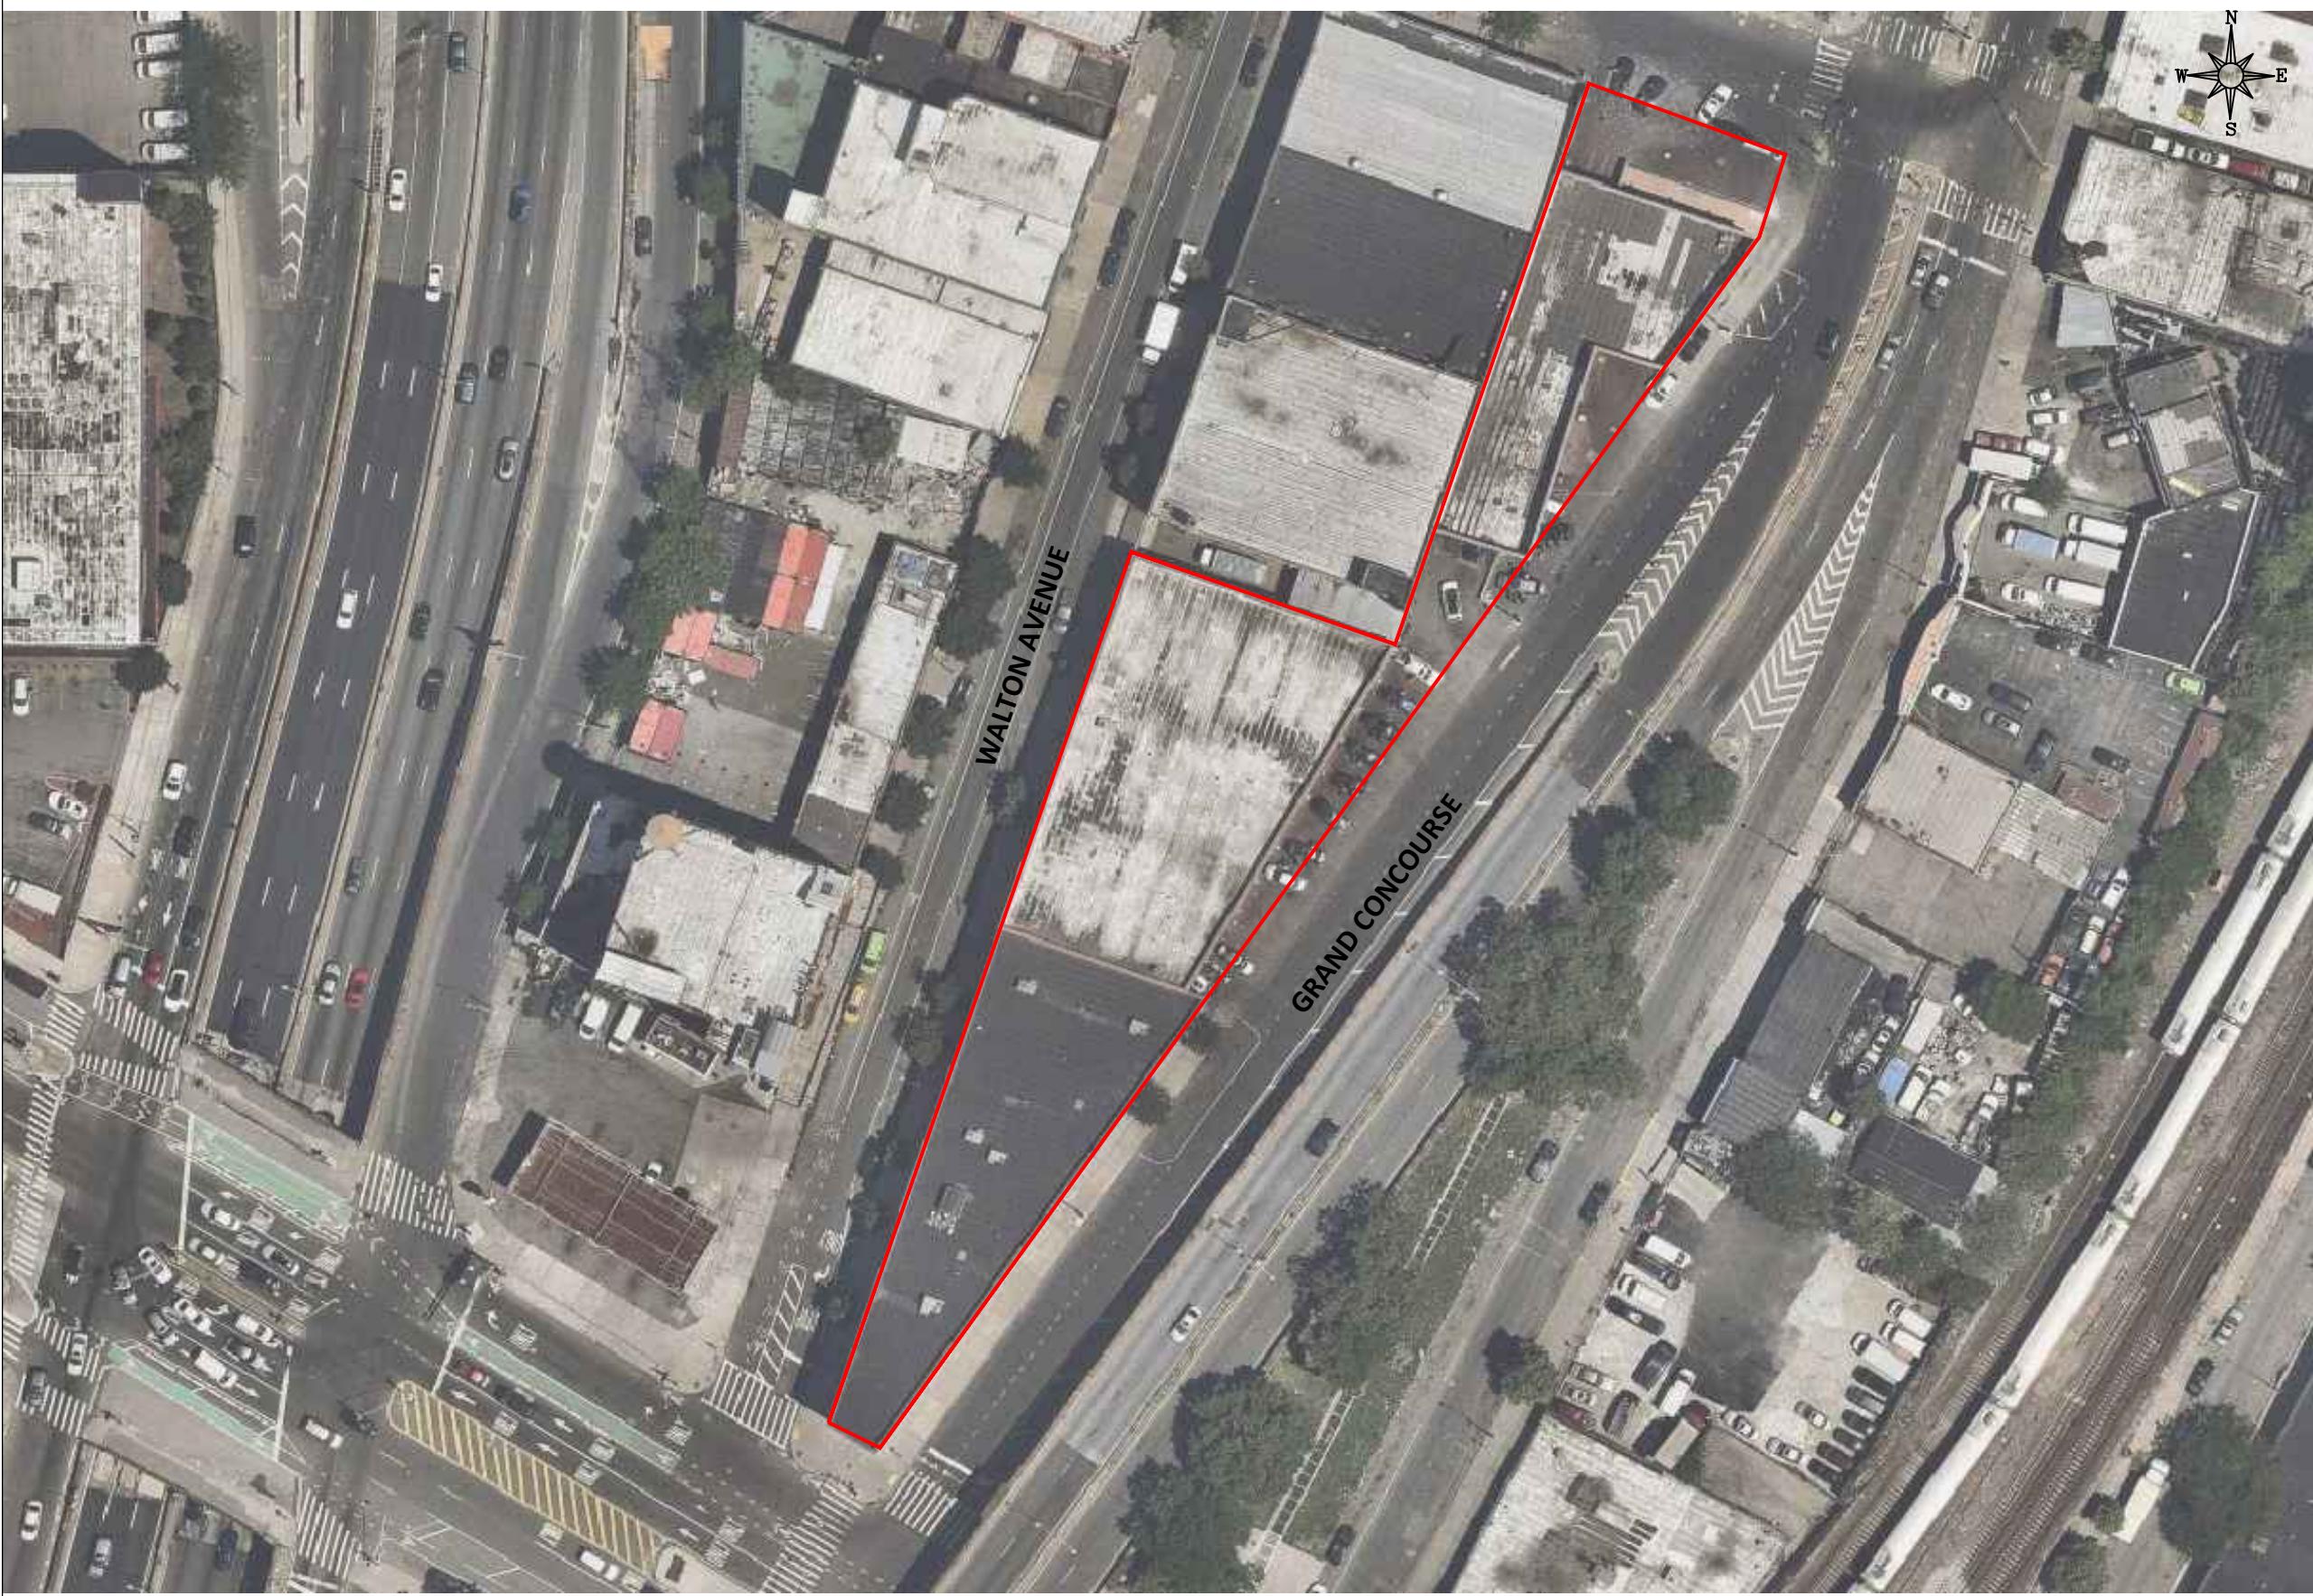
Figure No. 3

A figure of the location of original sources and areas where excavations were performed is shown in Figure 3.

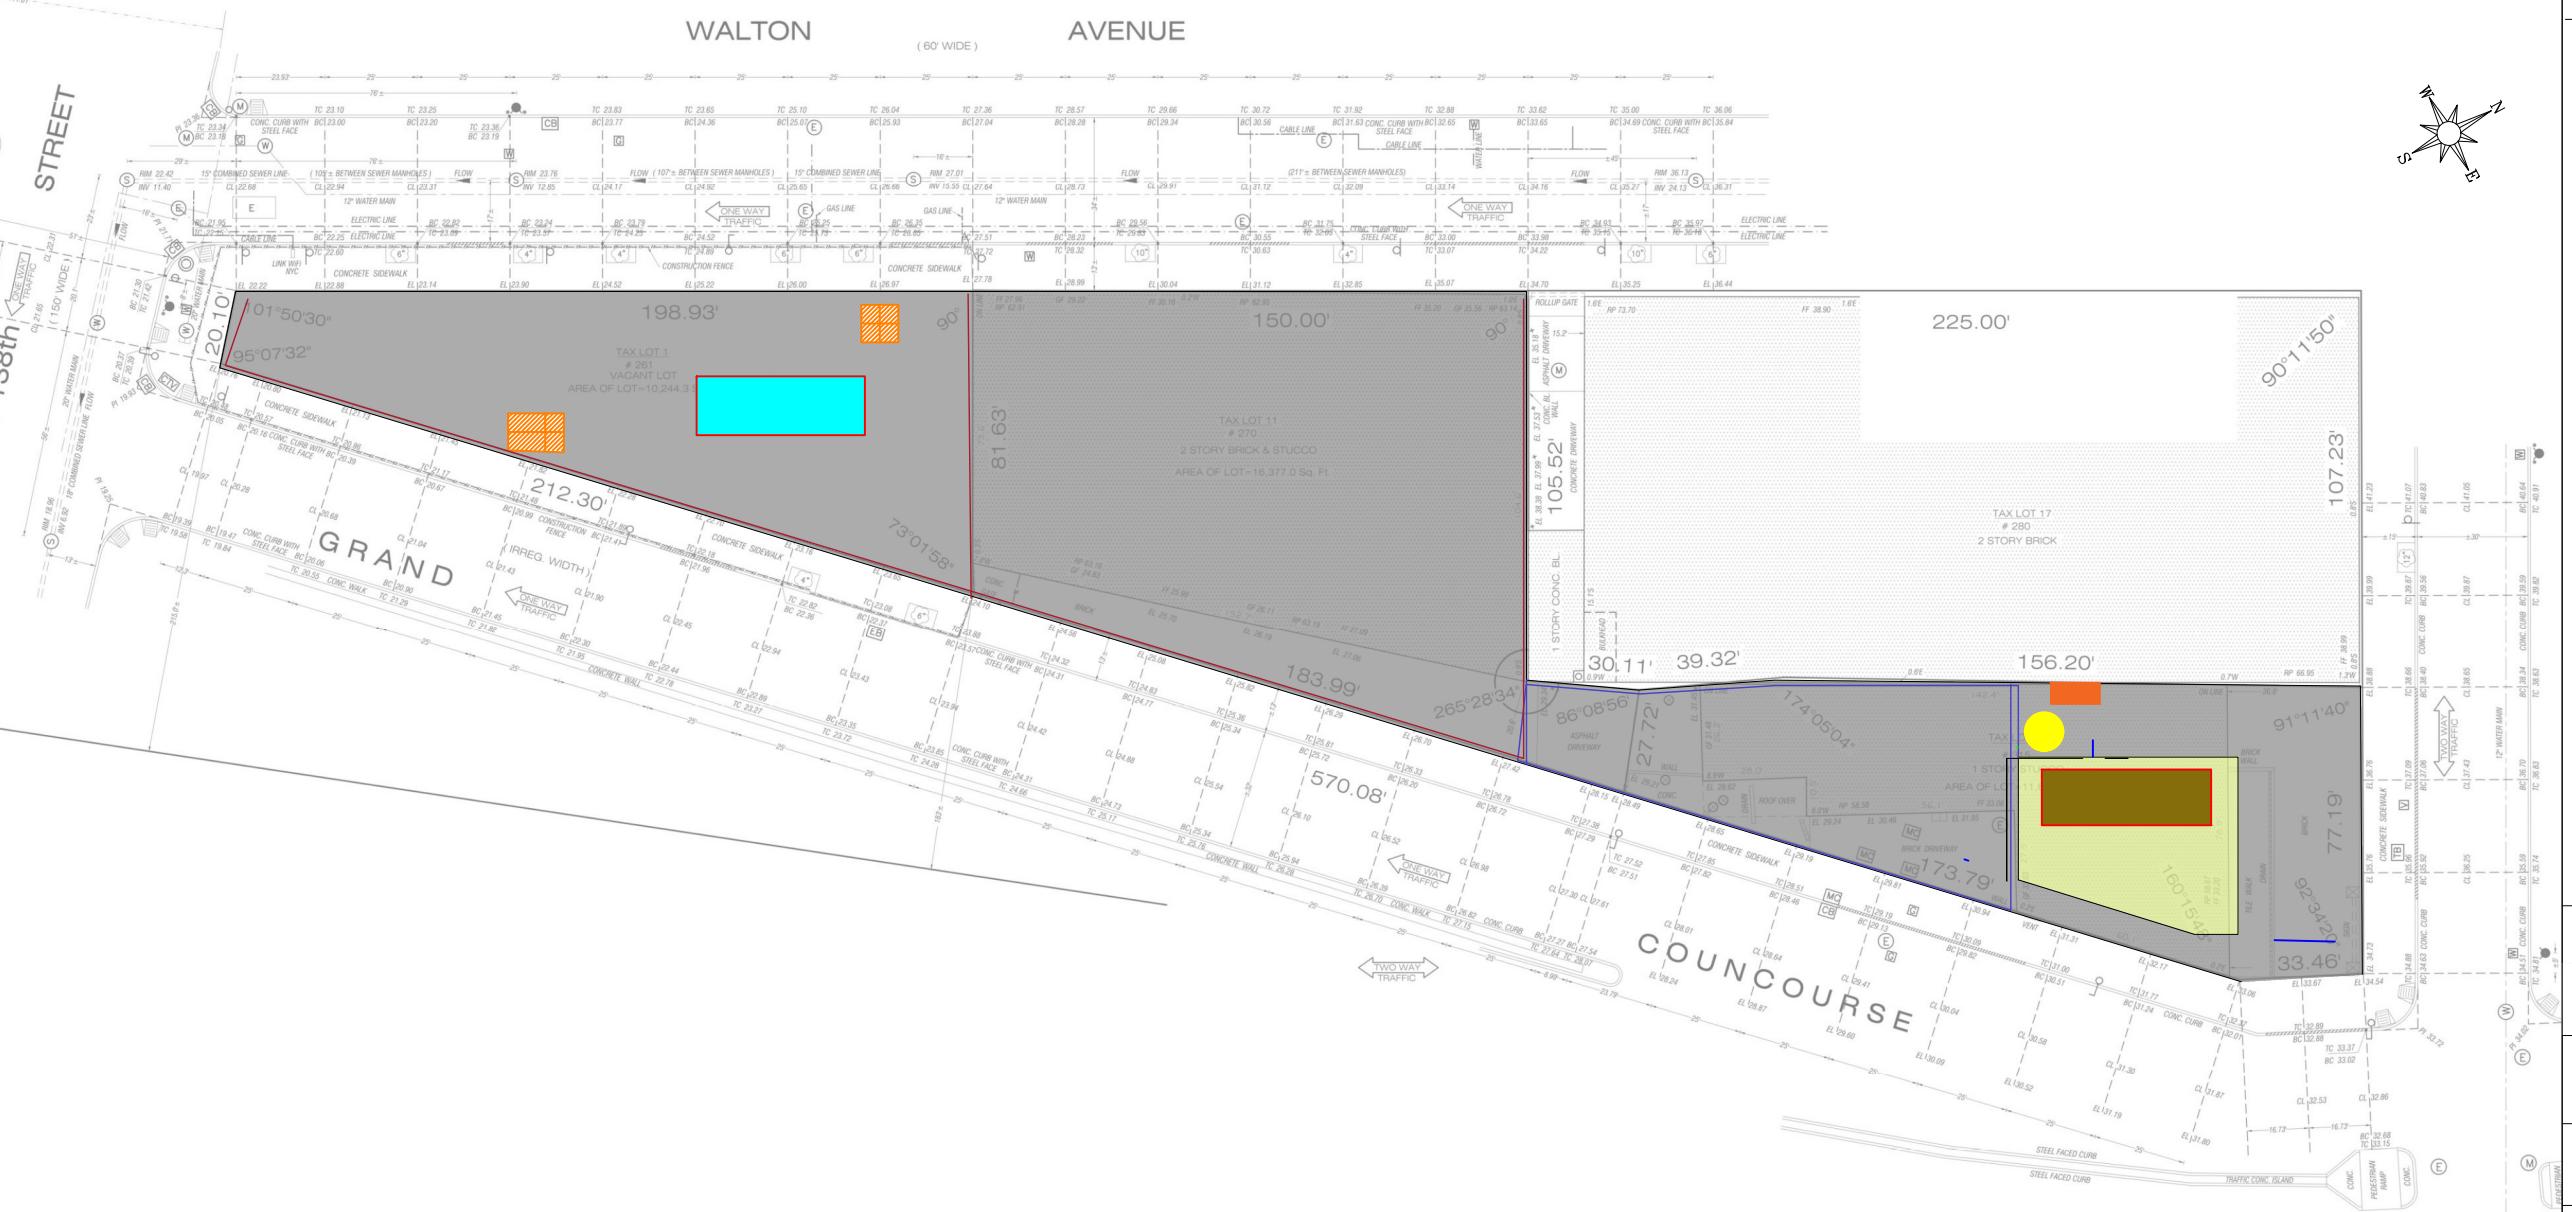
Figure Name: EXTENT OF EXCAVATION

The footprint of the entire site was excavated to bedrock (depths ranging between 1.5 and 5 feet bgs) to achieve Track 1 UUSCOs. The total quantity of material disposed off-site as part of the remedy was approximately 5,253.3 tons. The soil/fill removed was classified as non-hazardous fill; non-hazardous soil/urban fill; and hazardous RCRA D008 (lead). Other materials removed included C&D debris (7,288.46 tons) and bedrock (1,156.43 tons)

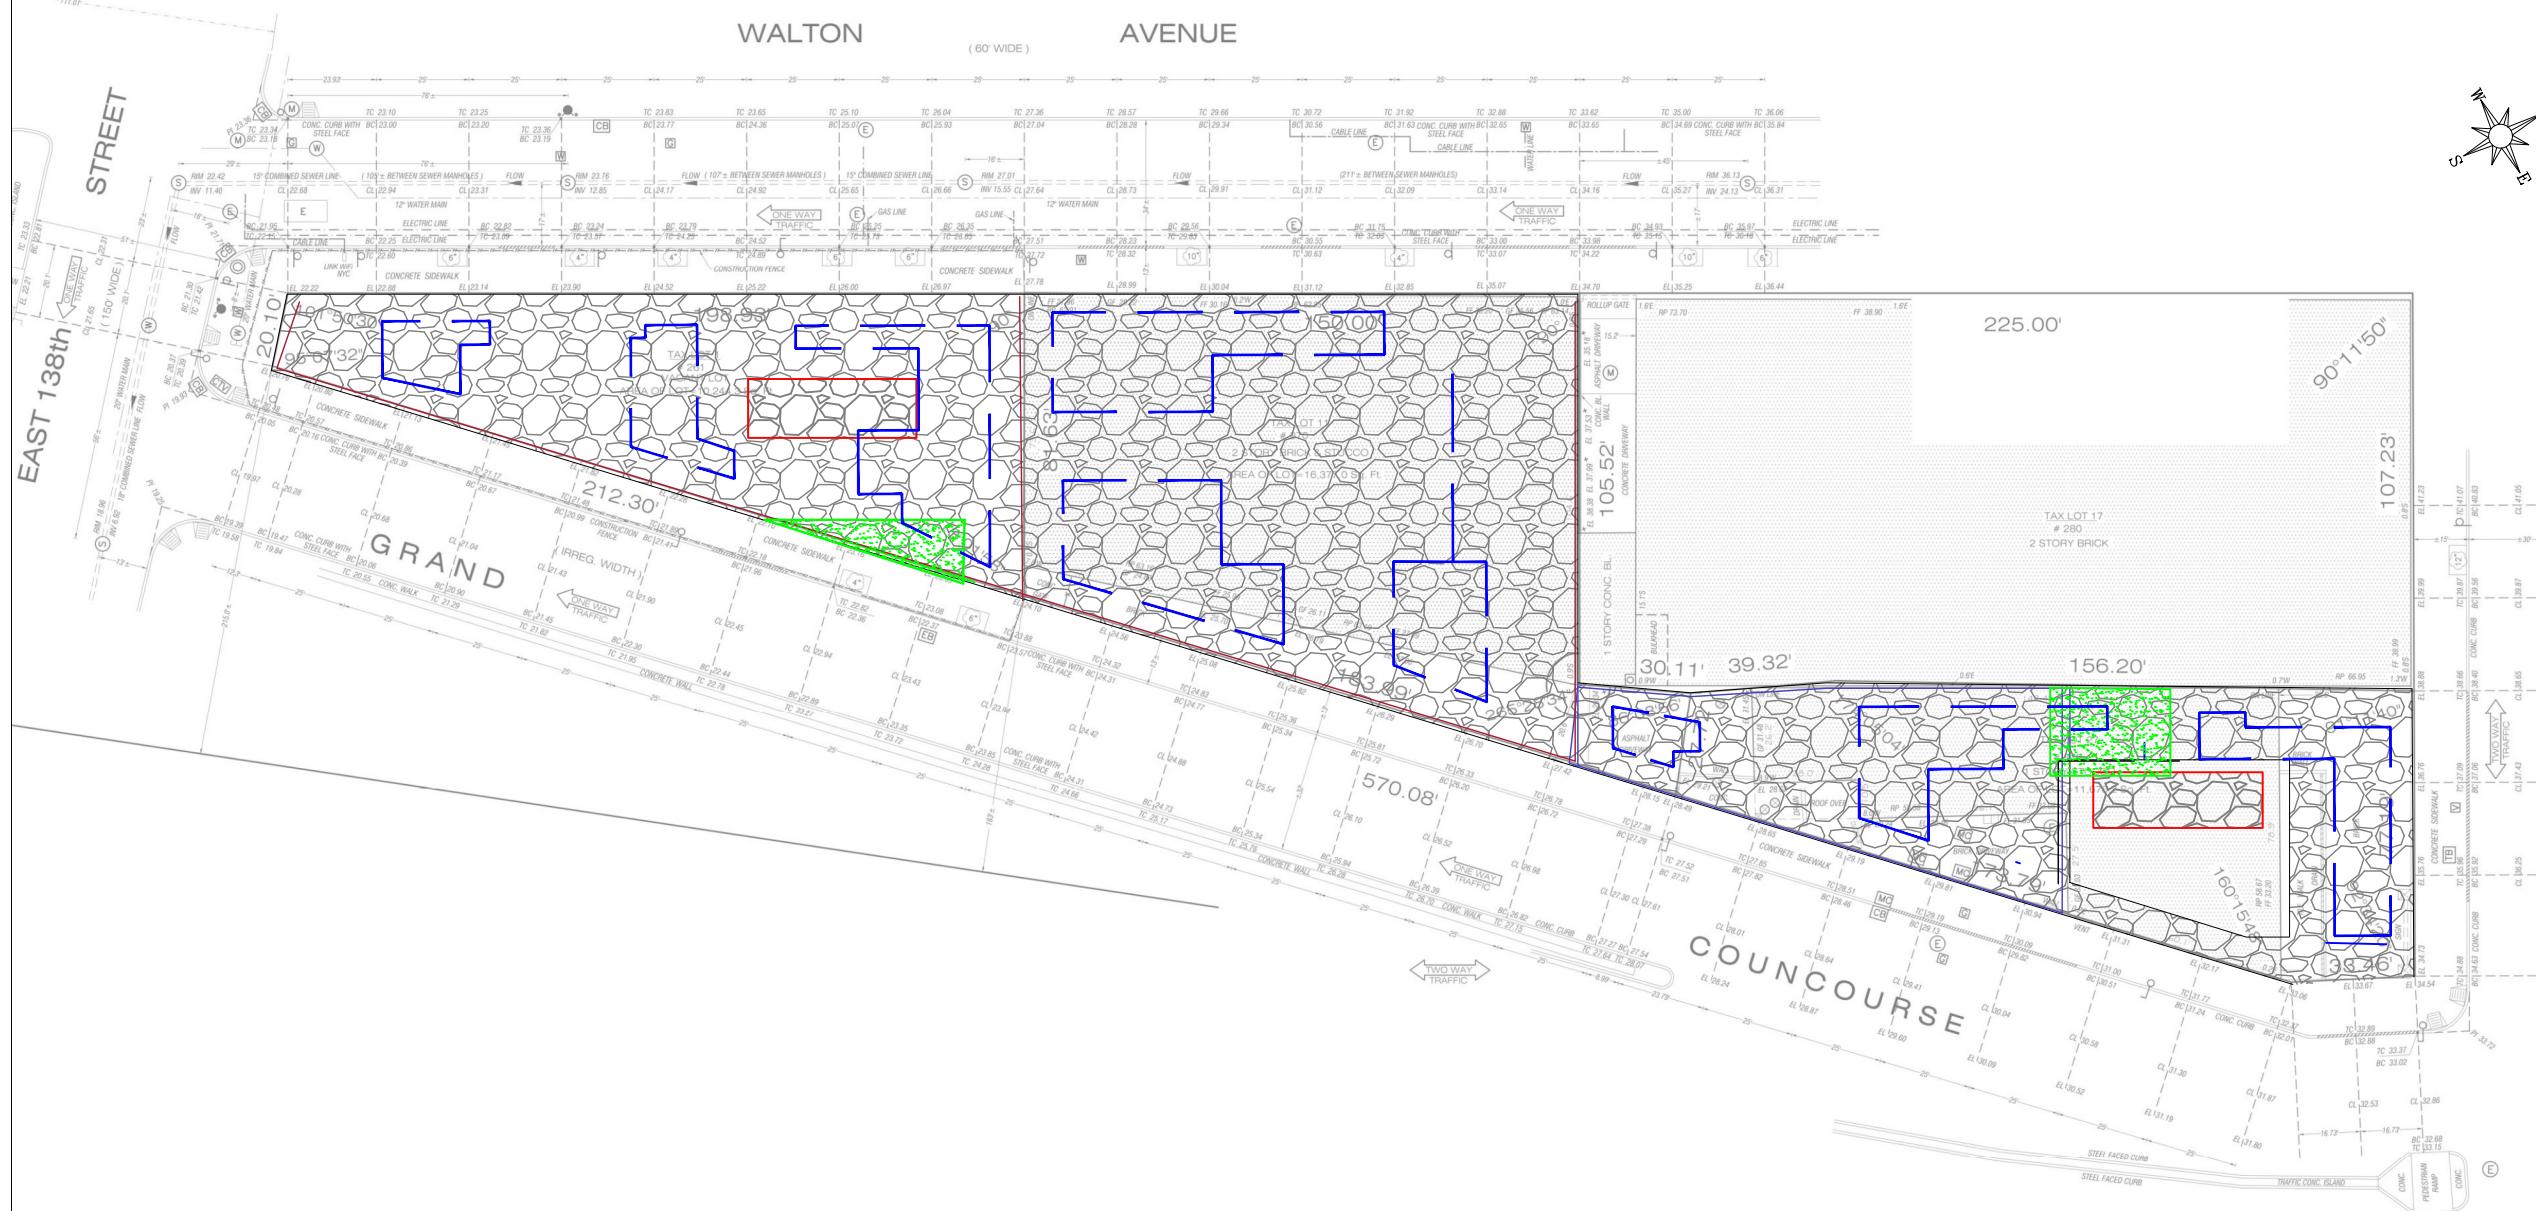
12" Topsoil

3/4" ASTM #57 Gravel

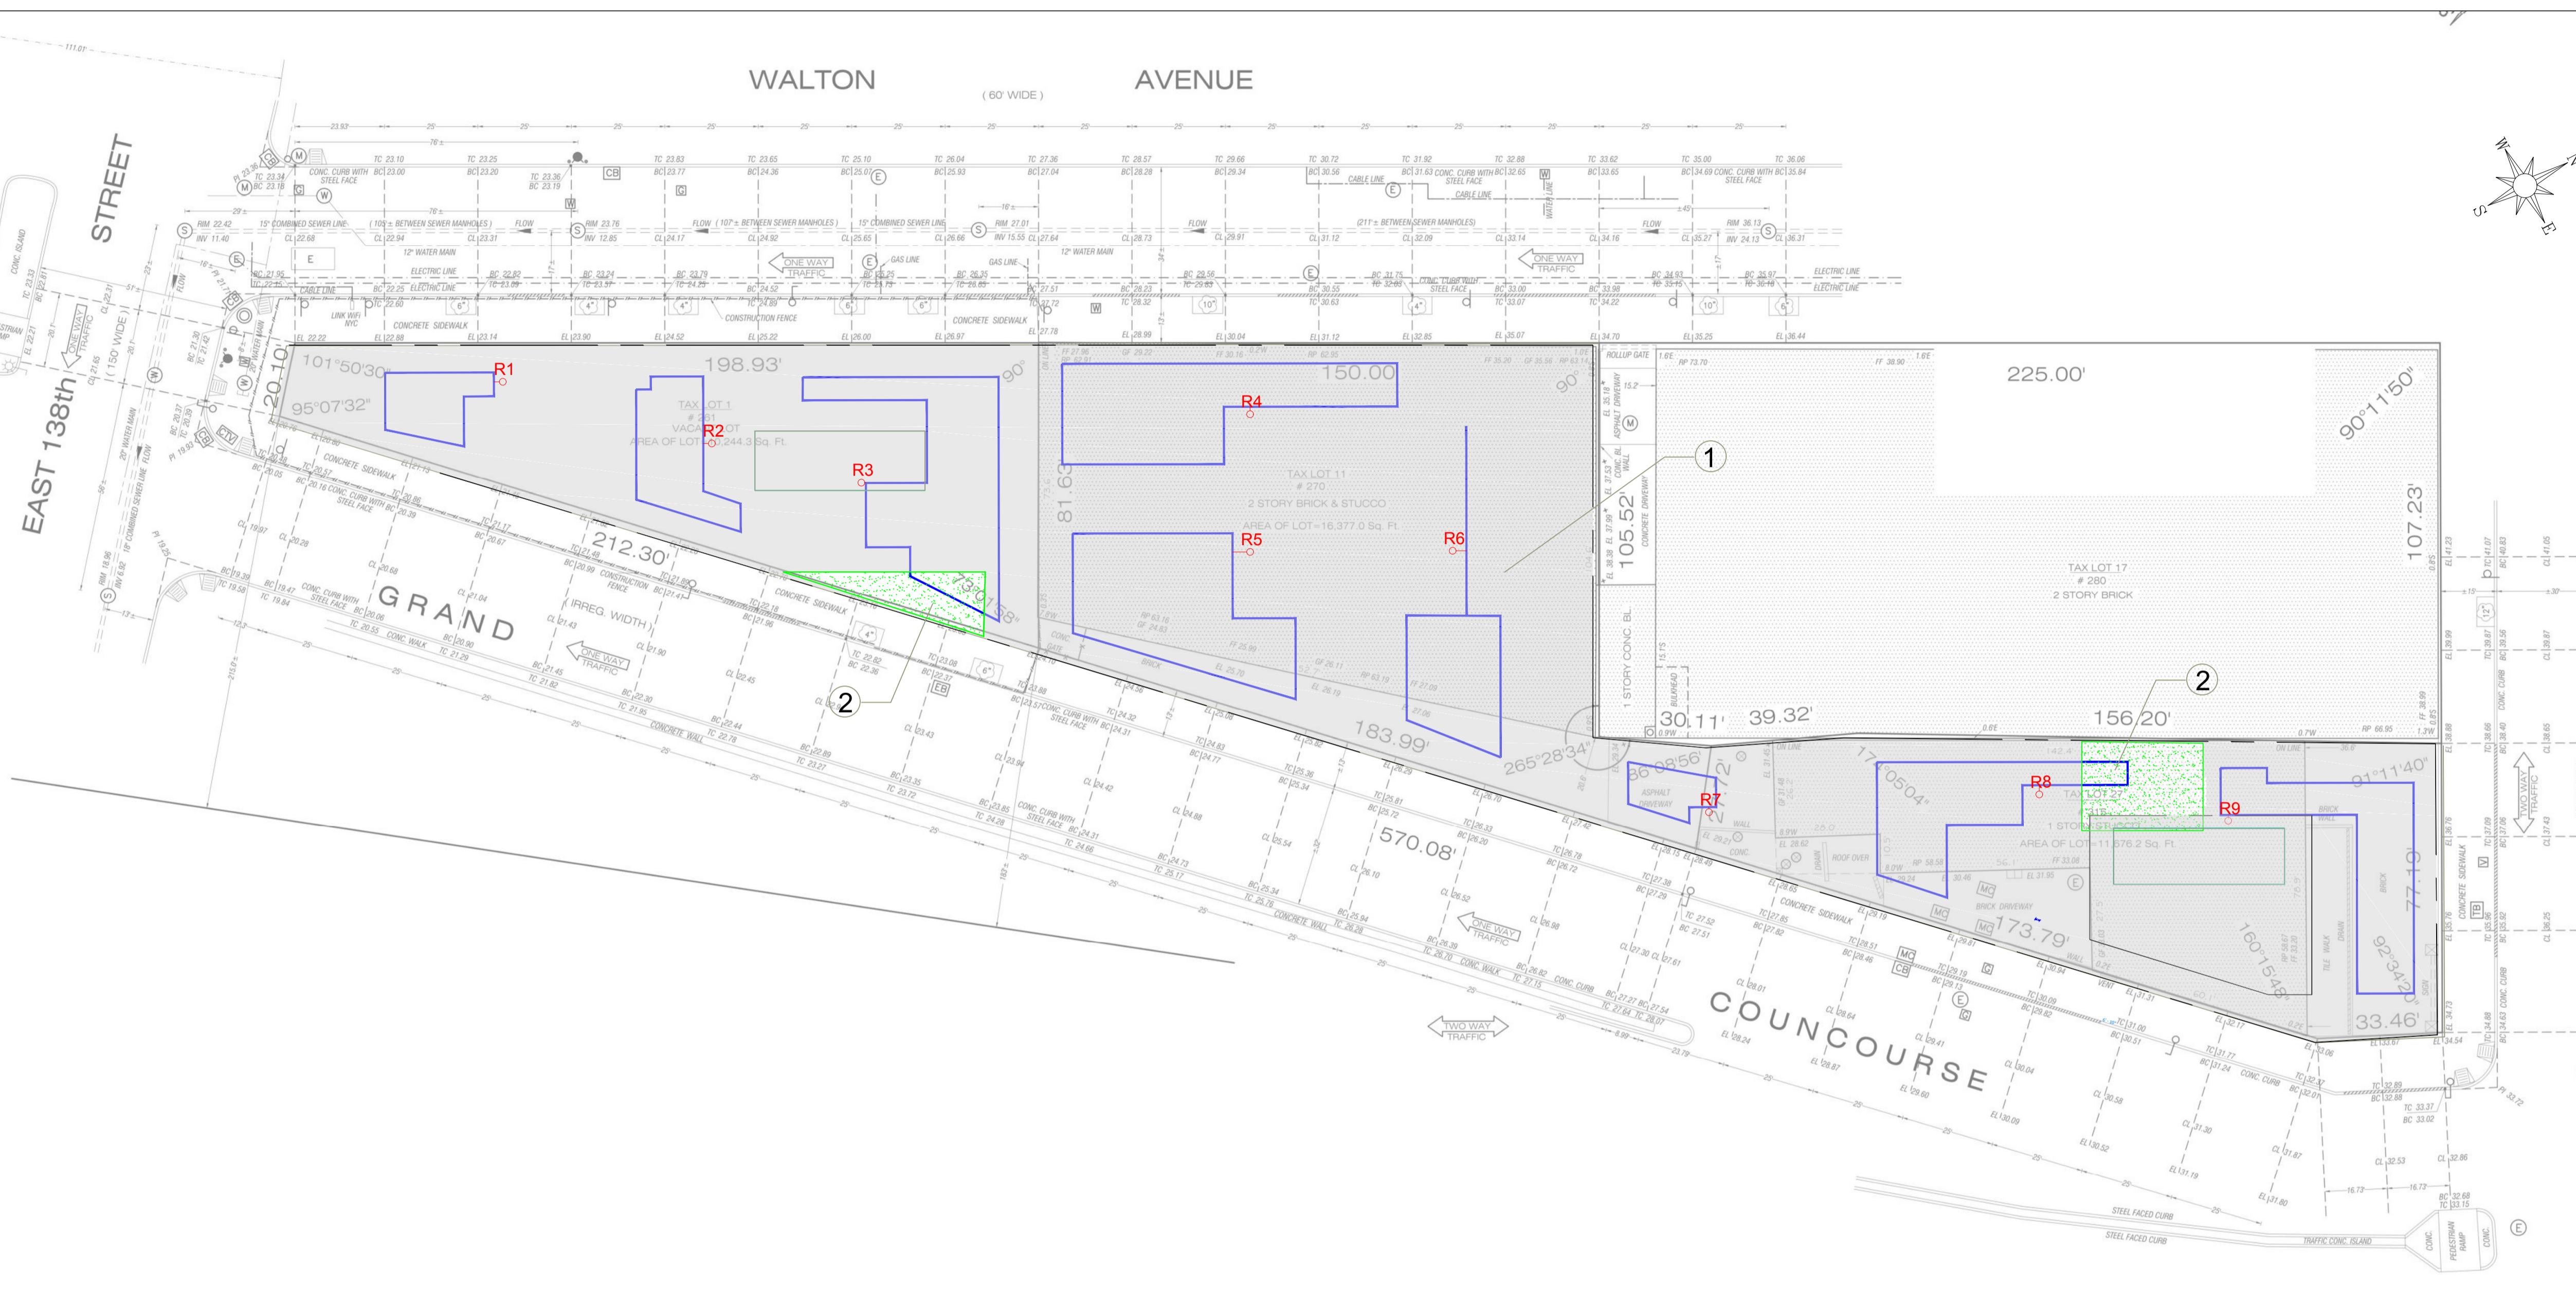
The SSDS consists of a network of horizontal pipe set in the middle of a gas permeable layer approximately 6-inches in depth and immediately beneath the concrete building slab and vapor barrier system, respectively. The SSDS consists of nine loops installed underneath both buildings' foundations. The horizontal piping consists of 4-inch Schedule 40 perforated, corrugated PVC pipes connected to a 6-inch cast iron riser pipe that penetrates the slab and travels vertically through the building to the roof. The gas permeable layer consists of a 6-inch-thick layer of $\frac{3}{4}$ -inch gravel located beneath the entire building slabs and surrounding the perforated pipe. A vapor barrier system was installed over the SSDS and below the buildings' concrete slabs. Each individual SSDS loop has a stub rising above the first-floor slab. After penetrating through the slab, Loops 1 and 2, Loops 5 and 6, and Loops 7 and 8 were manifolded on the first floor. Loops 3, 4, and 9 were not manifolded. Seventeen (17) pressure/monitoring points were installed throughout the buildings' slab on the ground floor to confirm the efficacy of the system and for future sampling. Six RadonAway (model RP265) fans were installed and hardwired on the roof line. The vertical risers include a rain cap on the roof to prevent water infiltration. The pressure gauge and alarm consist of Magnehelic Pressure Gauges and RadonAway alarms located on the first floor. The PE for the Remedial Action inspected the system and confirmed that the effluent discharge point is a minimum of 10 feet from any operable window or air intake for any building as per the NYC Mechanical Code. Figure 7A provides the as-built layout of the SSDS, and Figure 7B provides the as-built exhaust detail of the SSDS.

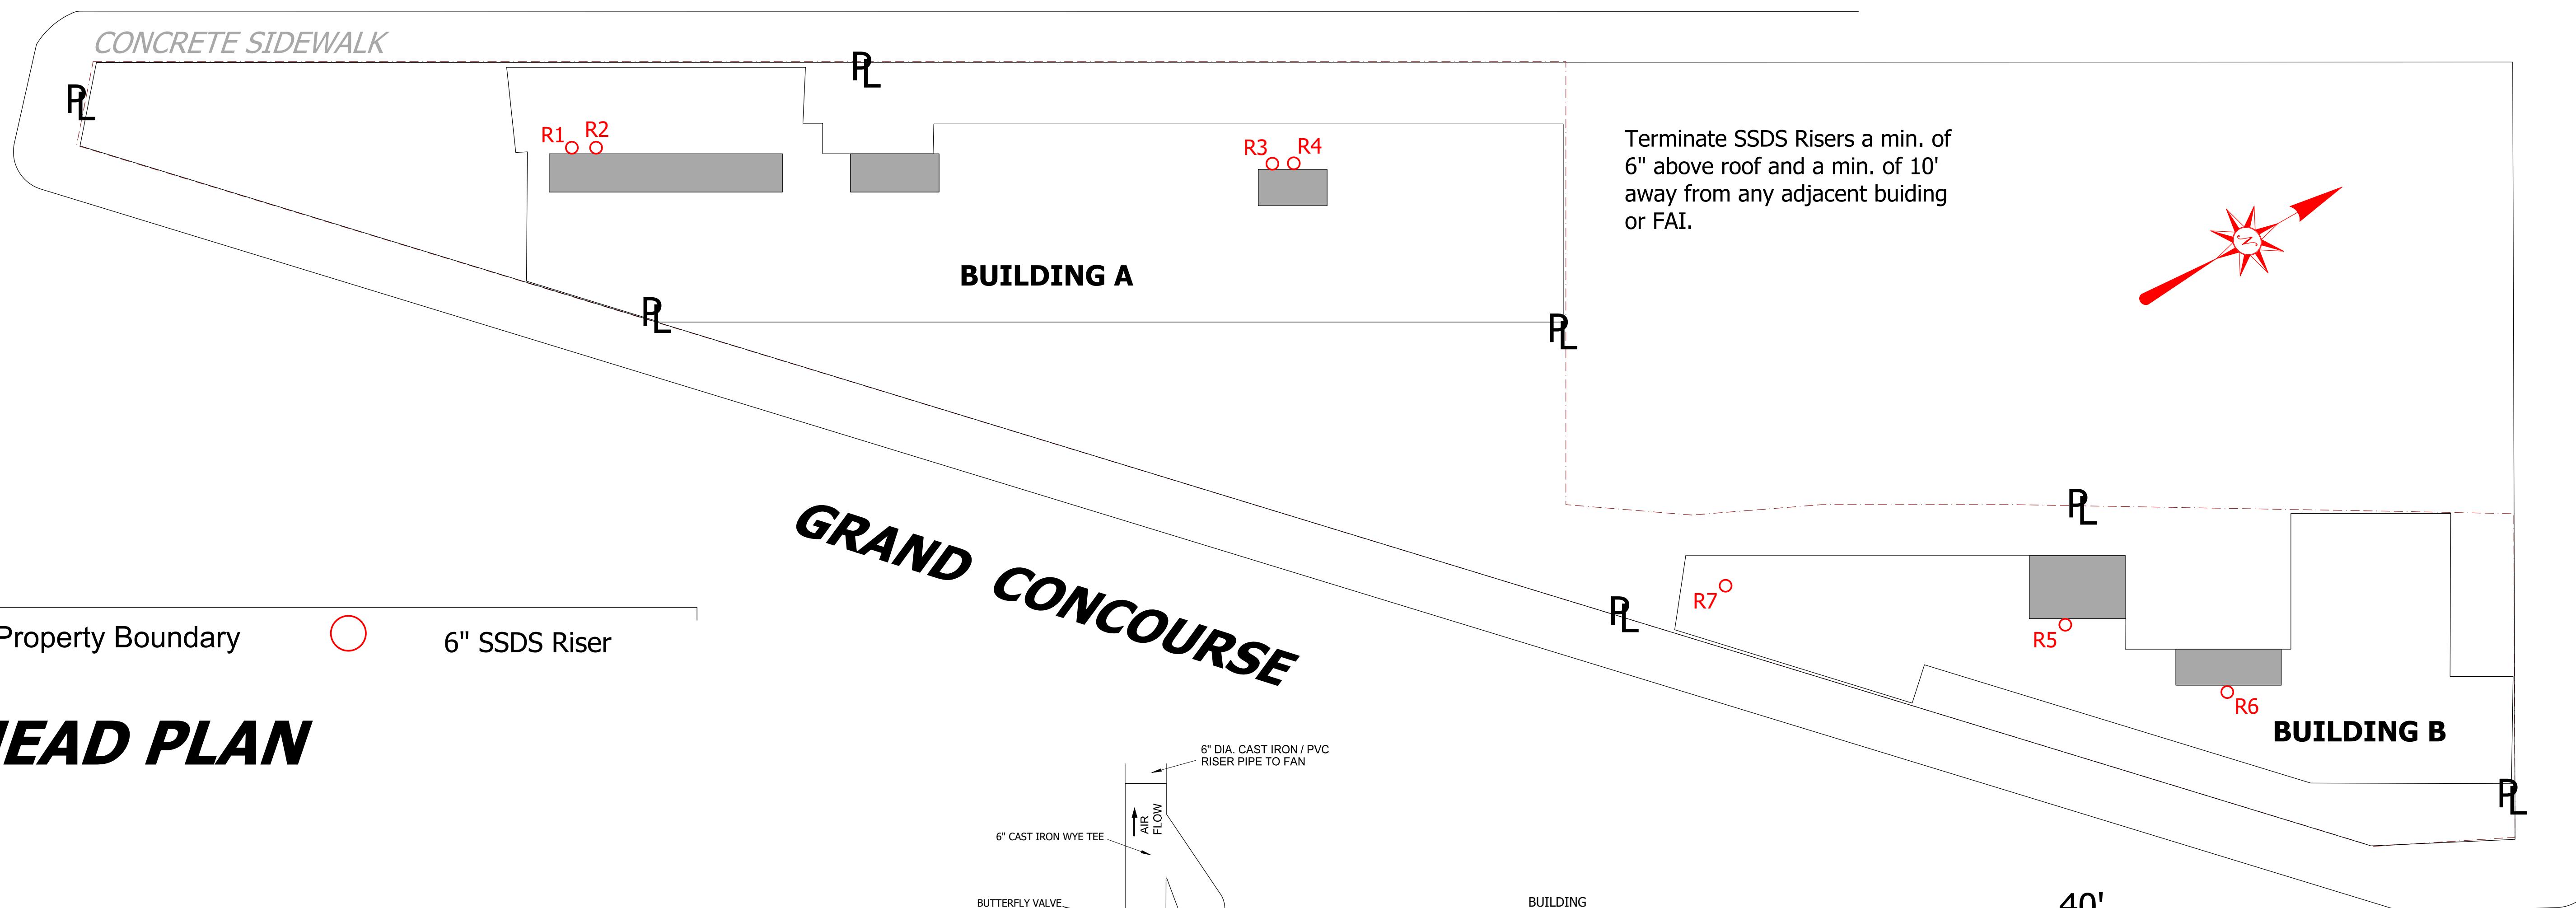
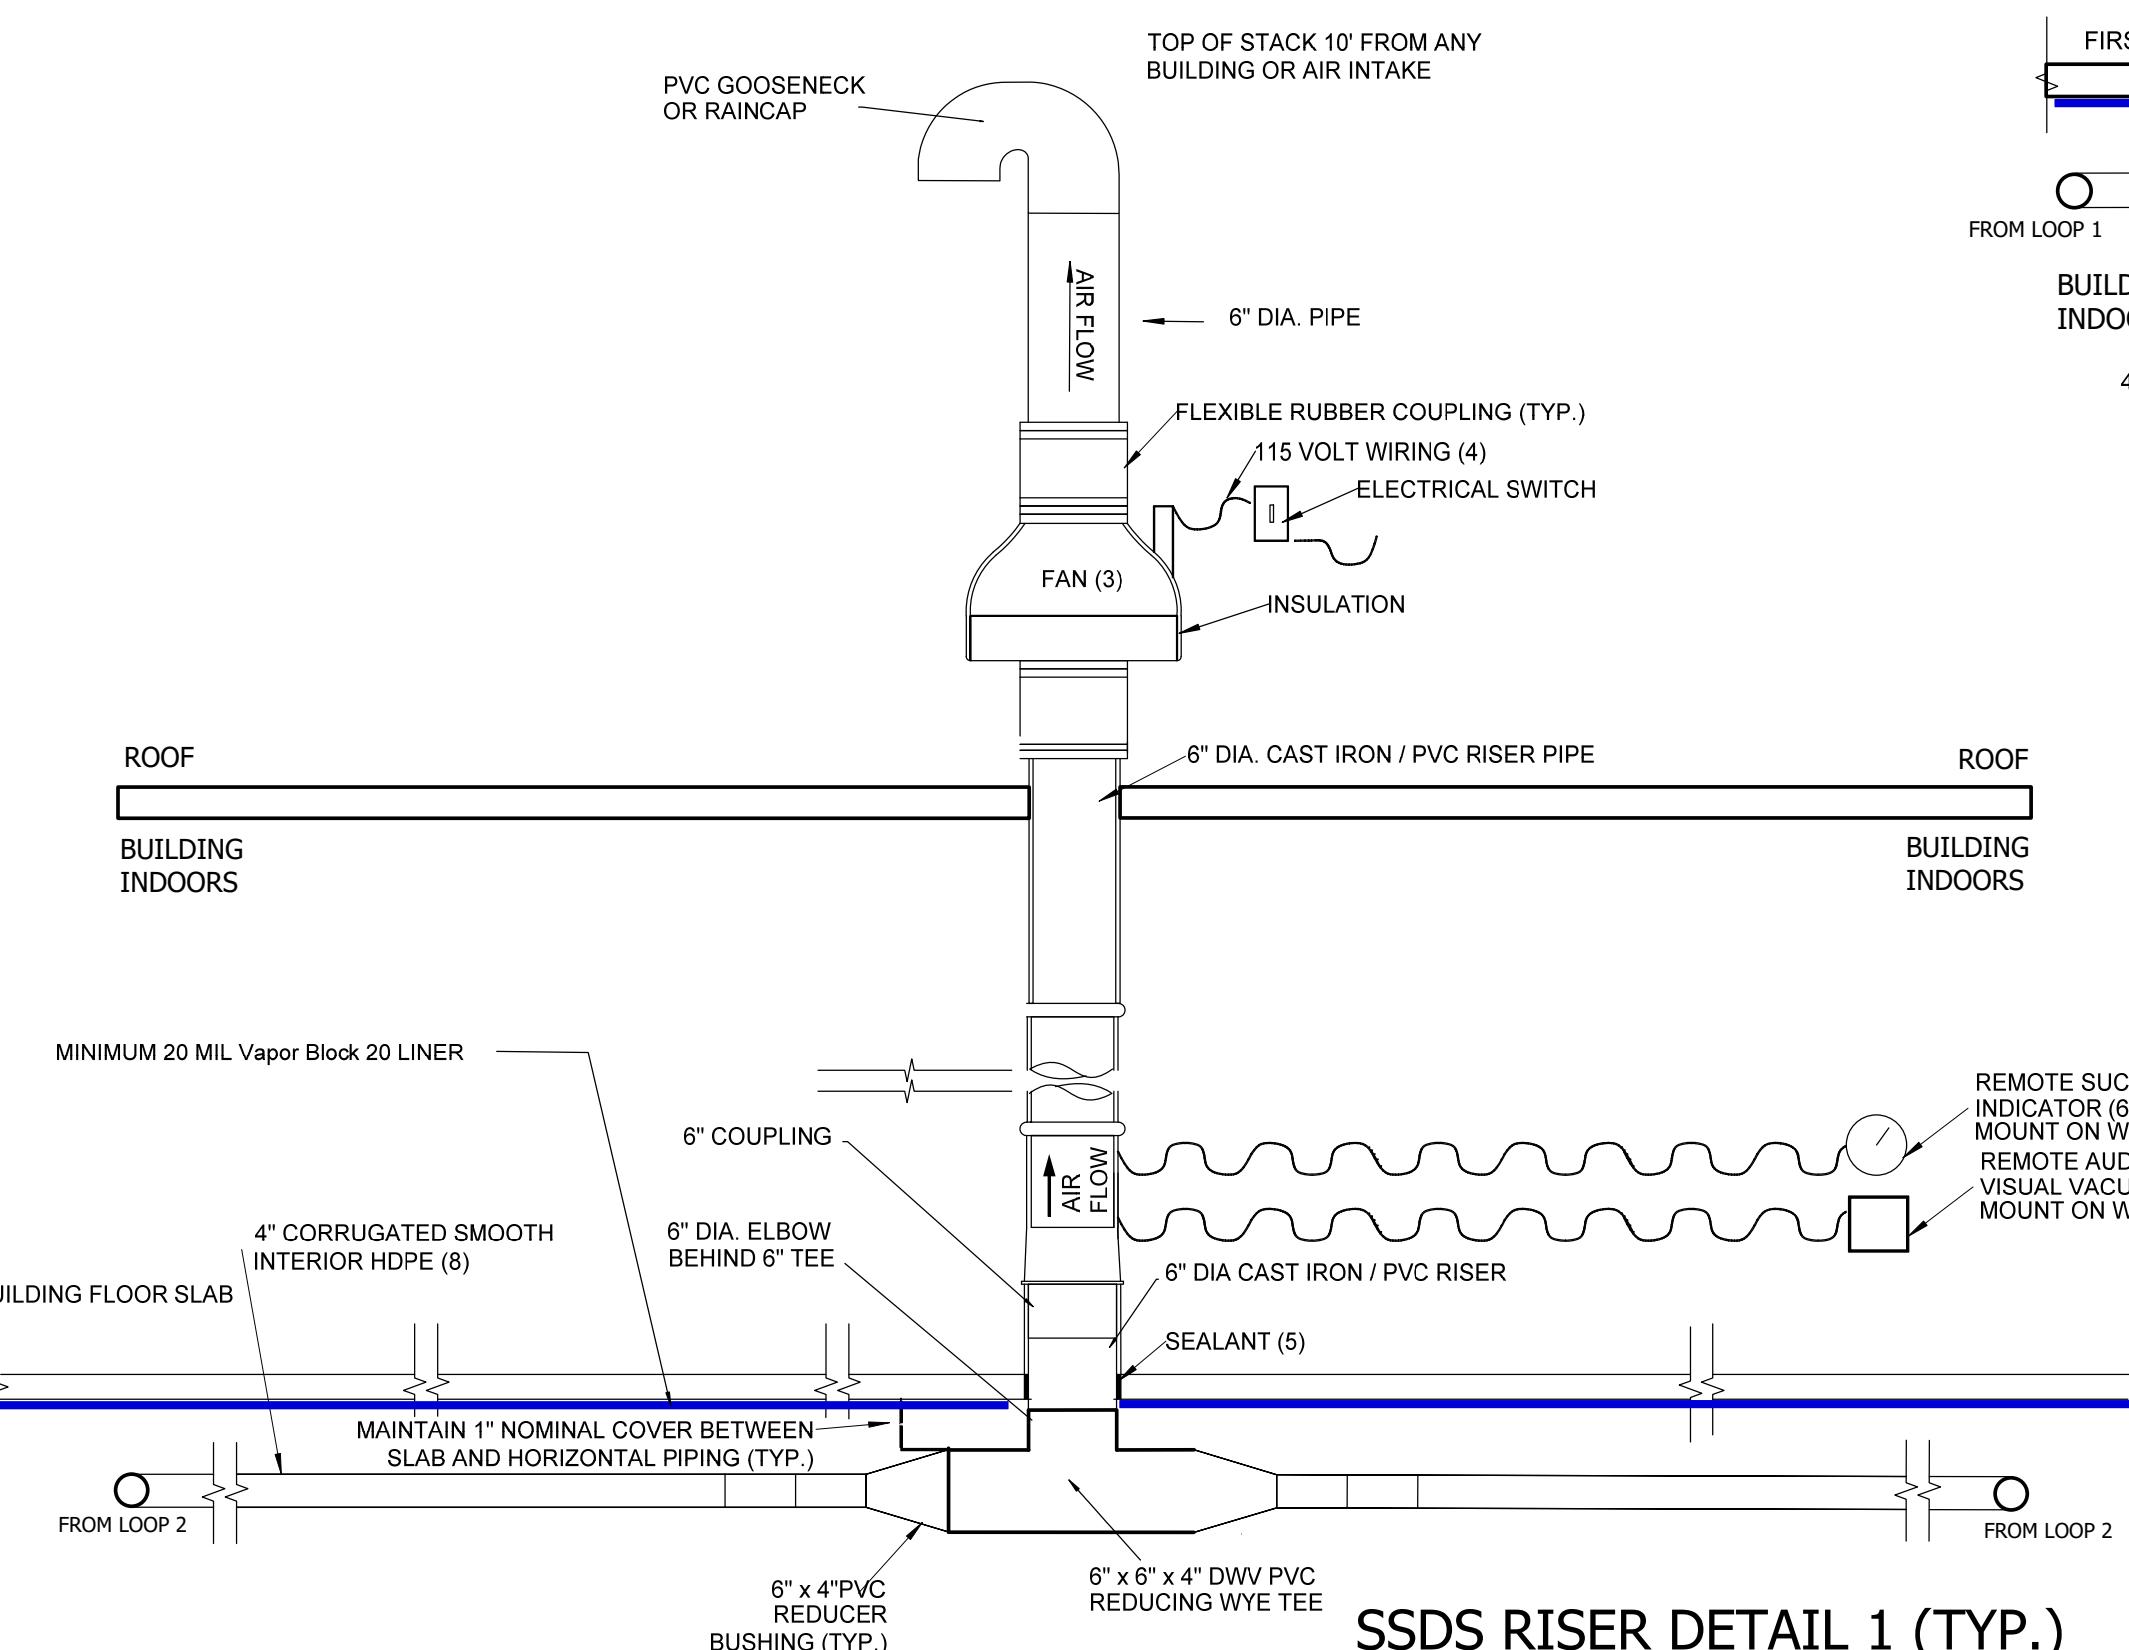
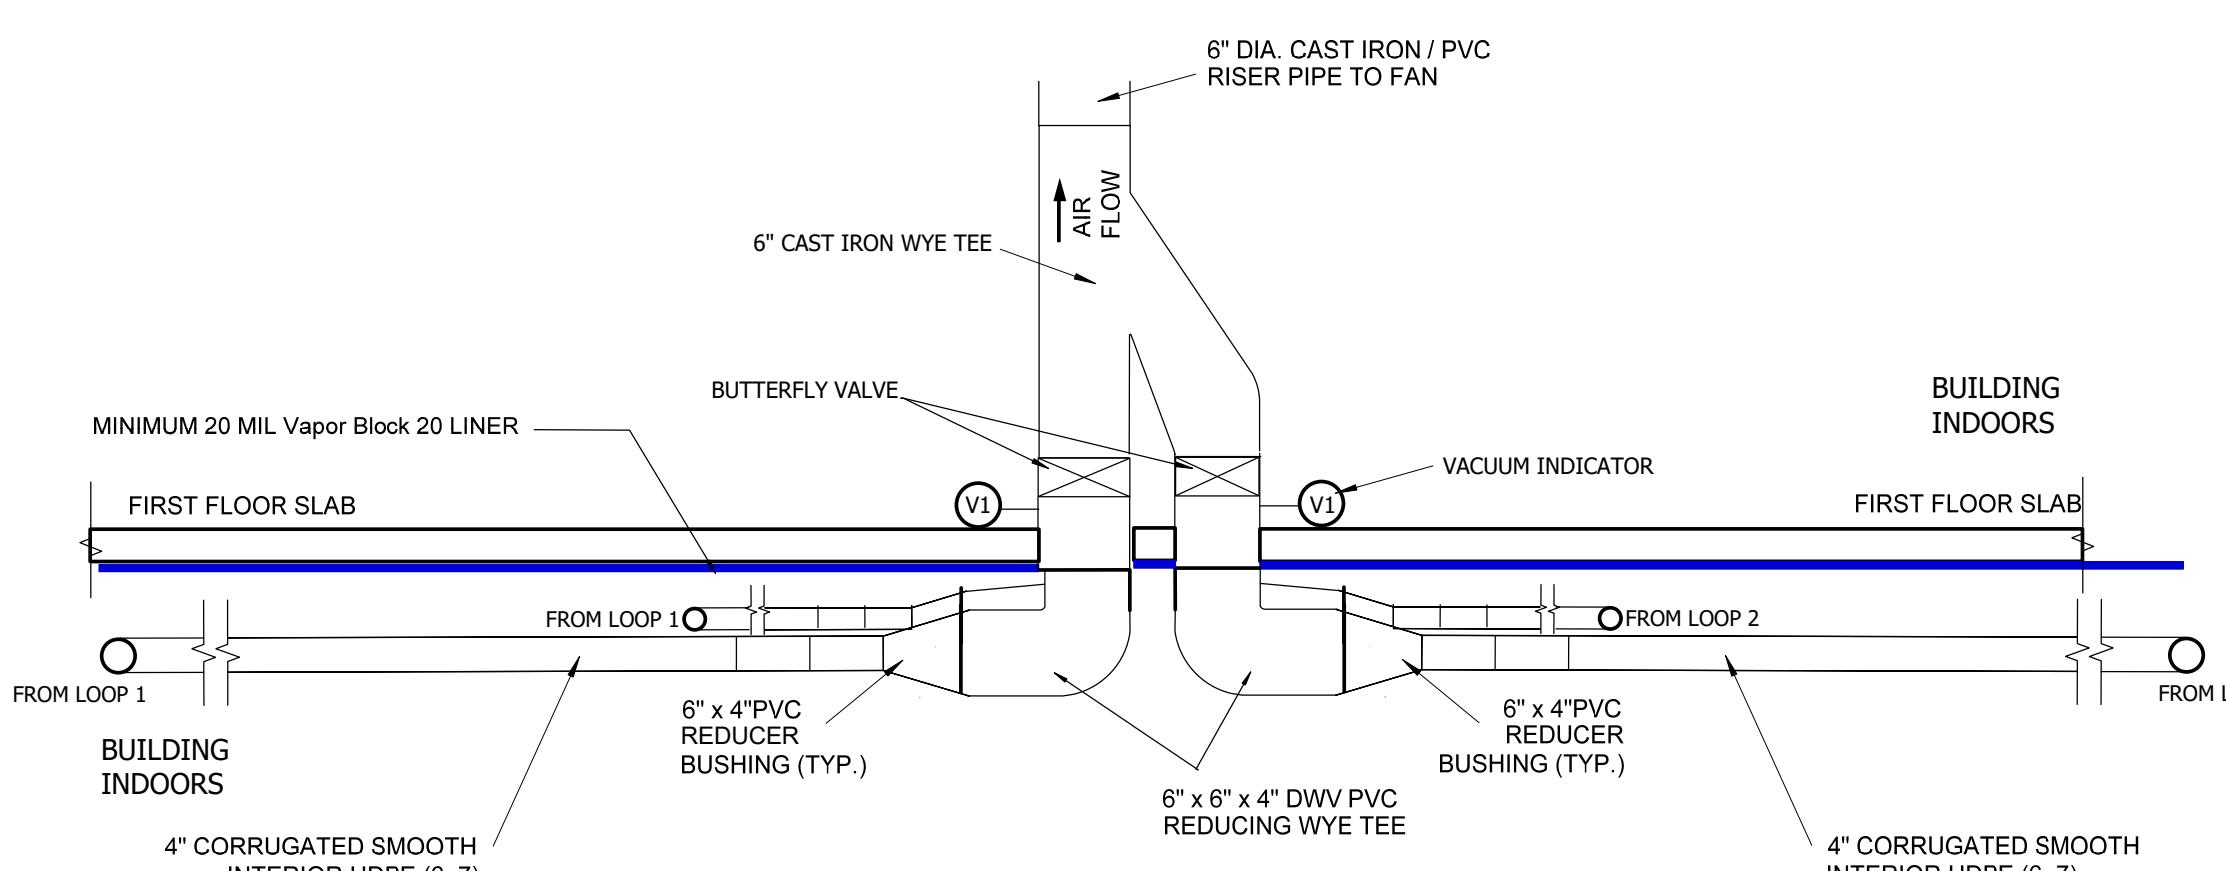
FIGURE 7A - SSDS LAYOUT

6" SSDS Riser

1. REFER TO ARCHITECTURAL PLANS FOR WATERPROOFING REQUIREMENTS.
2. FOUNDATION WALL BELOW GRADE SHALL BE PROTECTED WITH VAPOR BARRIER.
3. FAN TO BE RADONAWAY HIGH FLOW INLINE FAN, MODEL RP-265 OR APPROVED EQUAL.

- The SSDS design included in the RAWP was slightly amended due to revisions to the foundation plan (i.e., installation of large mat slabs). The amended layout still encompasses the footprint of both buildings and ensures sufficient vacuum is achieved across the entire site.
