**Final Engineering Report**

BCP Site No. C203154

101 East 150<sup>th</sup> Street, Bronx, NY

**APPENDIX F – DAILY, WEEKLY, MONTHLY FIELD REPORTS**

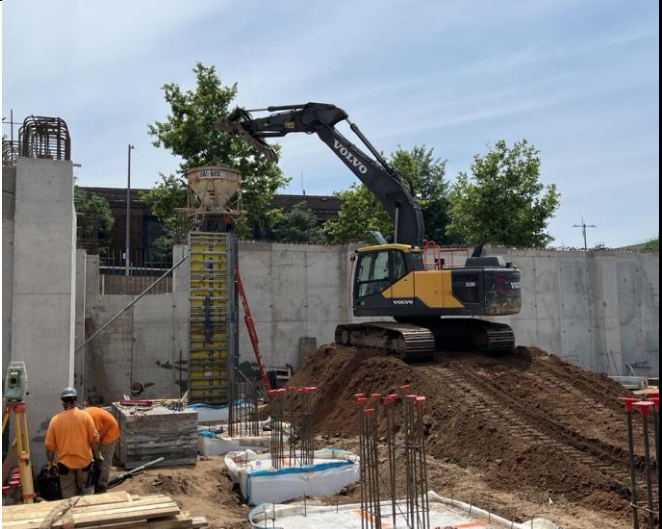
<b>Description:</b> View of Site at the beginning of the day.		<b>Description:</b> J&A pouring concrete for a column in grid B10.	
Photo No. 3	Direction Photo Taken: Northwest	Photo No. 4	Direction Photo Taken Southwest

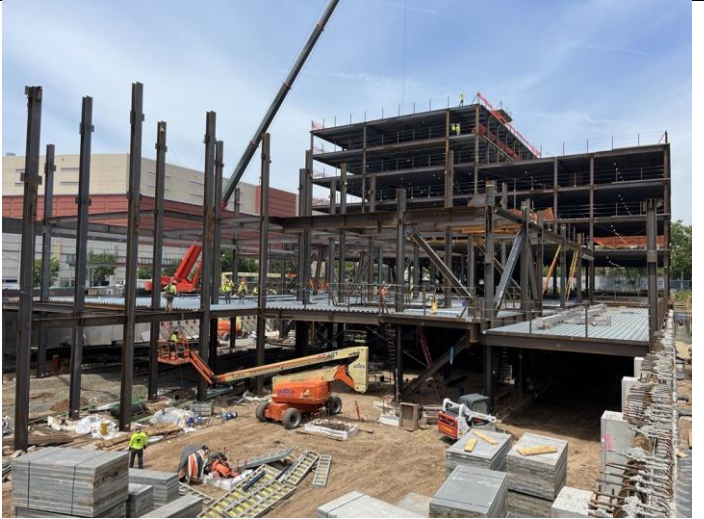
<b>Description:</b> Steel erection in grids C4, C5, and C6.		<b>Description:</b> View of the southern portion of Site at the end of the day.

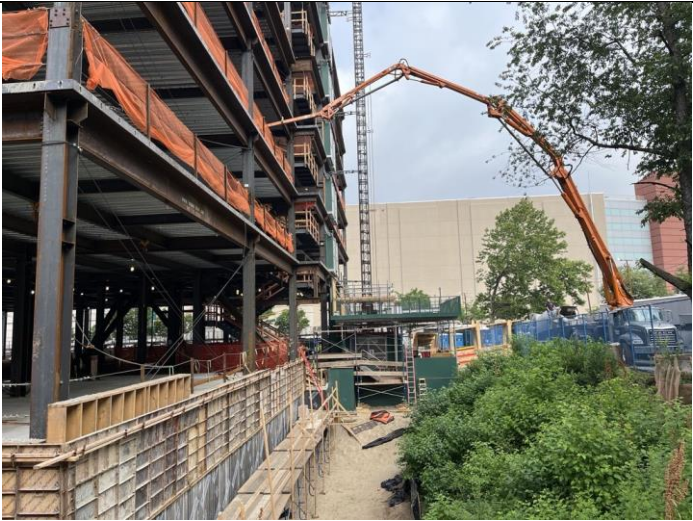
<b>Description:</b> J&A pouring concrete for the third story slab-on-deck.		<b>Description:</b> J&A performing housekeeping on the southern portion of the Site.	
Photo No. 3	Direction Photo Taken: South	Photo No. 4	Direction Photo Taken Northwest

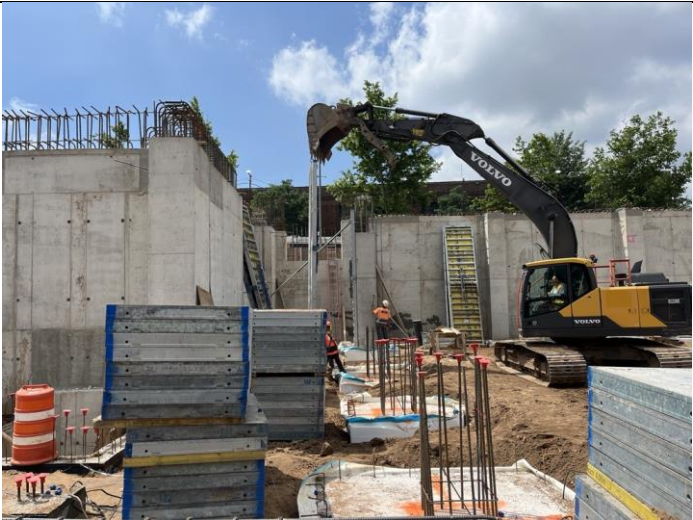
<b>Description:</b> J&A removing formwork from the column in grid B10.		<b>Description:</b> Steel erection on the northern portion of Site.

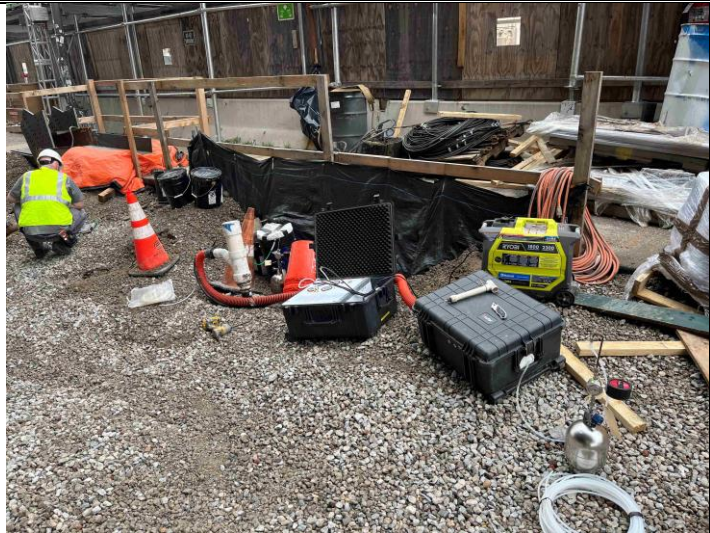
<b>Description:</b> Obar Systems performing Soil Vapor Extraction system pilot test. GZA is collecting air samples from vacuum influent and effluent of GAC filter.		<b>Description:</b> J&A cleaning the dewatering frac tank in grid A10 in preparation for demobilization.	
Photo No. 3	Direction Photo Taken: Southeast	Photo No. 4	Direction Photo Taken Southwest

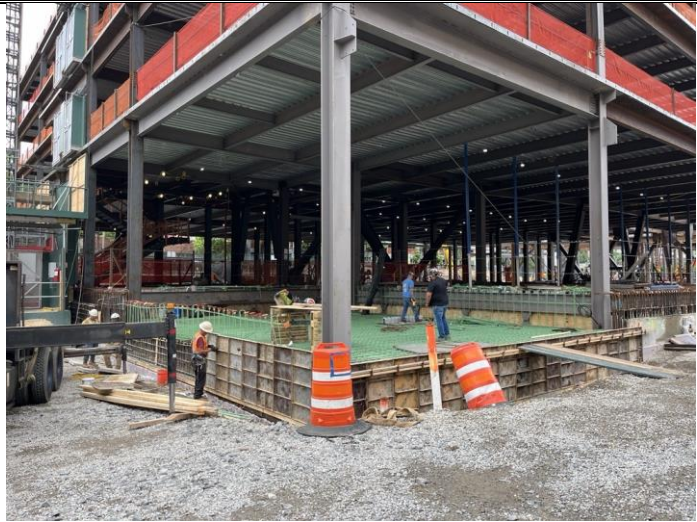
<b>Description:</b> J&A installing rebar and formwork for the loading dock slab-on-deck in grid A1.		<b>Description:</b> Excavation around piles and in the SSDS area in grids A9, A10, B9, and B10.

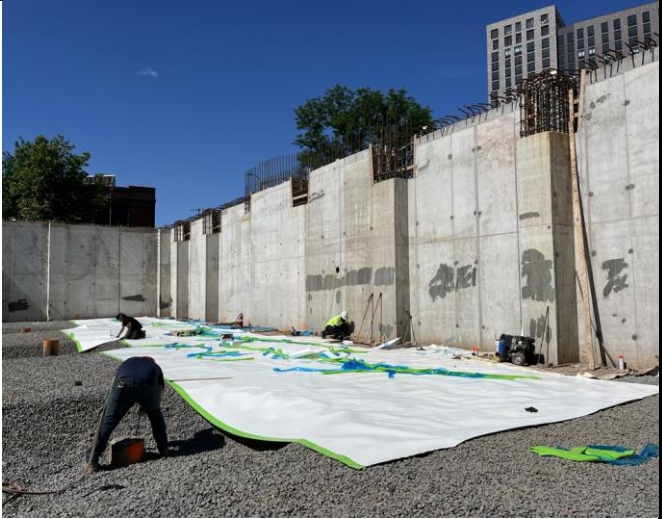
<b>Description:</b> J&A performing housekeeping at the beginning of the day.		<b>Description:</b> Crown installing PREPRUFE 300R Plus waterproofing/vapor barrier at the slab-on-grade locations in grids A8, A9, and A10.	
Photo No. 3	Direction Photo Taken: Northwest	Photo No. 4	Direction Photo Taken North

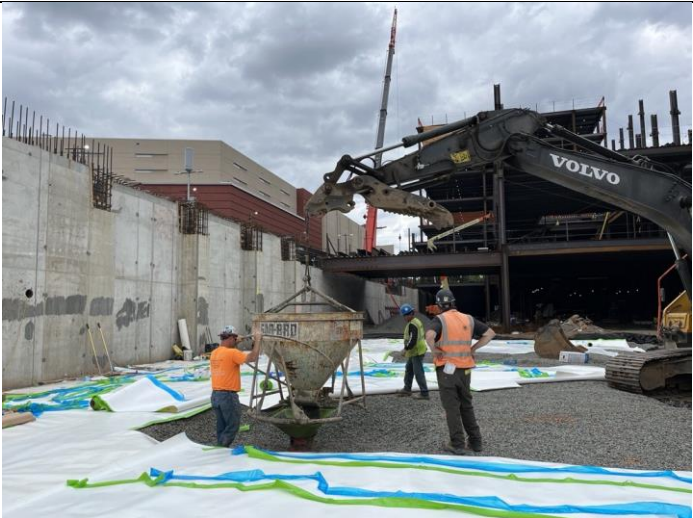
<b>Description:</b> J&A pouring concrete into a pile in grid B8.		<b>Description:</b> SSDS piping installed at SSD-01 in grid B9.

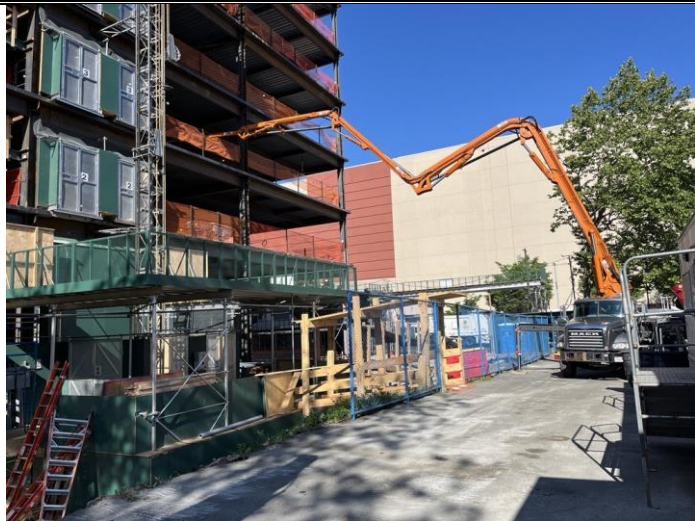
<b>Description:</b> J&A pouring concrete for the third story slab-on-deck in grids A1, A2, A3, B1, B2, and B3.		<b>Description:</b> PREPRUFE 300R Plus waterproofing/vapor barrier installed at the slab-on-grade locations in grids A8, A9, A10, B8, B9, and B10.	
Photo No. 3	Direction Photo Taken: Northeast	Photo No. 4	Direction Photo Taken West

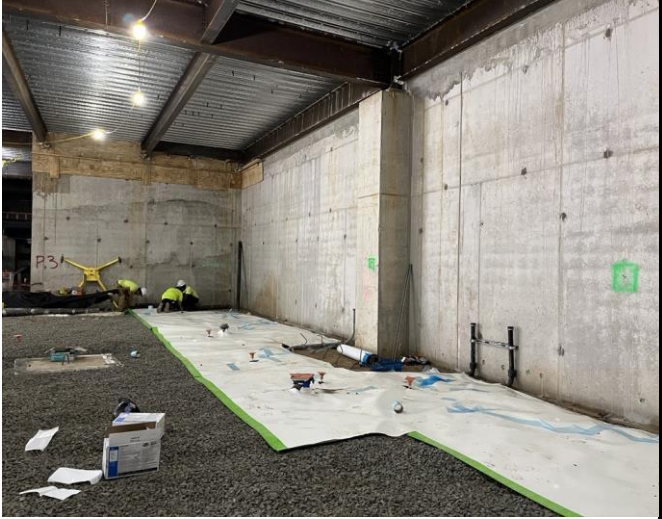
<b>Description:</b> Munoz Trucking Inc. delivering pipe sand from NAA - Weeks Marine, Inc., to the area north of grid C1.		<b>Description:</b> PREPRUFE 300R Plus waterproofing/vapor barrier installed at the slab-on-grade locations in grids A1 and A2.	
Photo No. 3	Direction Photo Taken: Southwest	Photo No. 4	Direction Photo Taken West

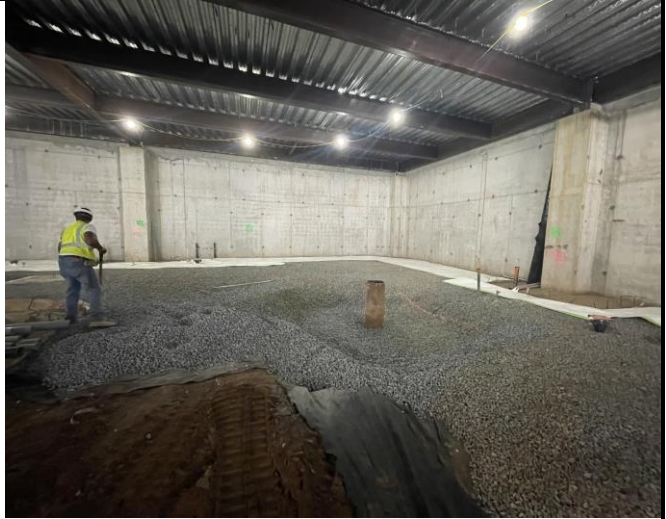
<b>Description:</b> Delivery of gas permeable aggregate to grid D8 by Shamrock Materials, LLC.		<b>Description:</b> J&A spreading layer of gas permeable aggregate throughout grids C1, C2, D1 and D2.	
Photo No. 3	Direction Photo Taken: East	Photo No. 4	Direction Photo Taken Southwest

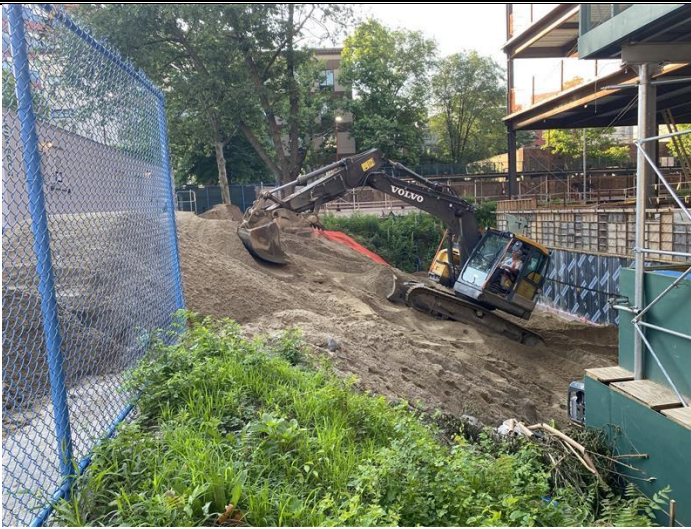
<b>Description:</b> J&A spreading layer of imported fill throughout grids B1, C1, and D1.		<b>Description:</b> J&A laid down SSDS piping .

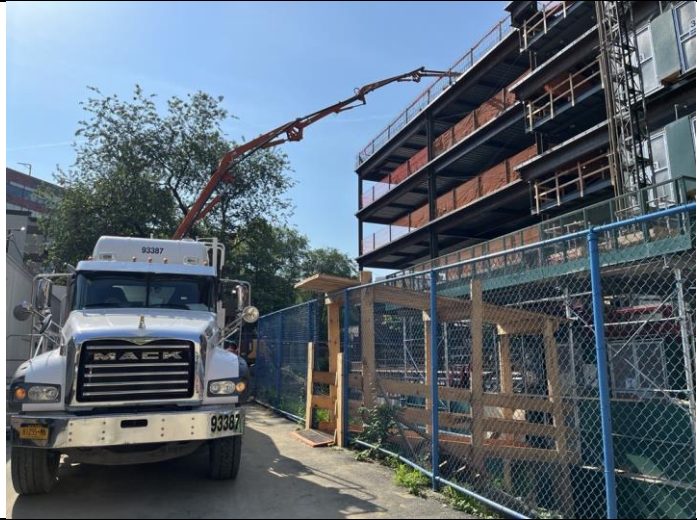
<b>Description:</b> J&A pouring concrete for the slab-on-deck.		<b>Description:</b> Preparation for SSDS area in grid A7.

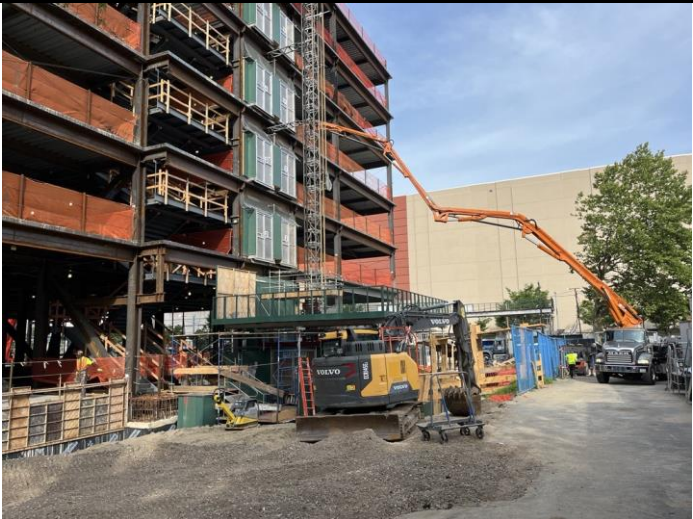
<p>Description: J&amp;A pouring concrete slab on the 4<sup>th</sup> floor deck in grid A1, A2, B1, and B2.</p>		<p>Description: Crown installing PREPRUFE 300R Plus waterproofing/vapor barrier at the slab-on-grade locations in grids C2 and C3.</p>	
<p>Photo No. 3</p>	<p>Direction Photo Taken: Southwest</p>	<p>Photo No. 4</p>	<p>Direction Photo Taken Southeast</p>

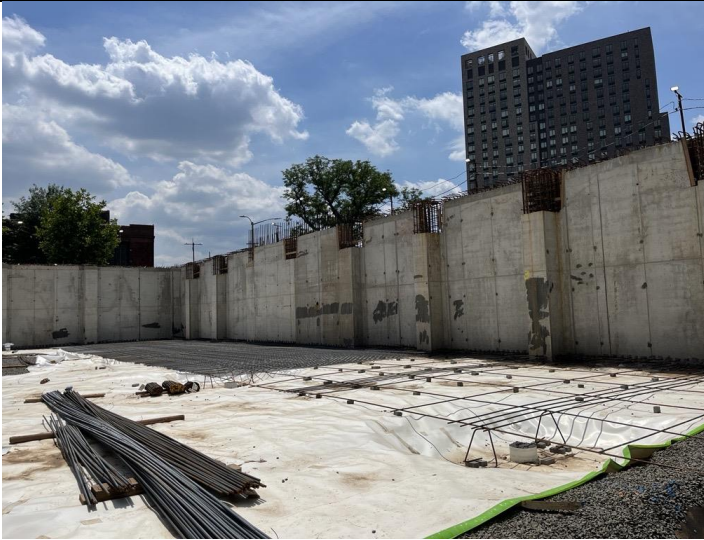
<p>Description: Rebar installed at the slab-on-grade locations in grids A8, A9, and A10.</p>		<p>Description: Excavation for utility conduits in grid A4.</p>

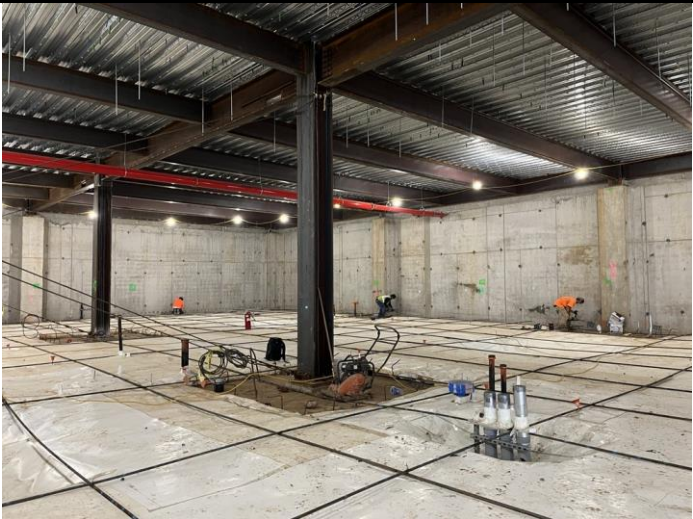
<b>Description:</b> Rebar installed at the slab-on-grade locations in grids C1, C2, C3, D1, D2, and D3.		<b>Description:</b> SSDS piping installed in grid B3.	
<b>Photo No.</b> 3	<b>Direction Photo Taken:</b> West	<b>Photo No.</b> 4	<b>Direction Photo Taken</b> Northeast

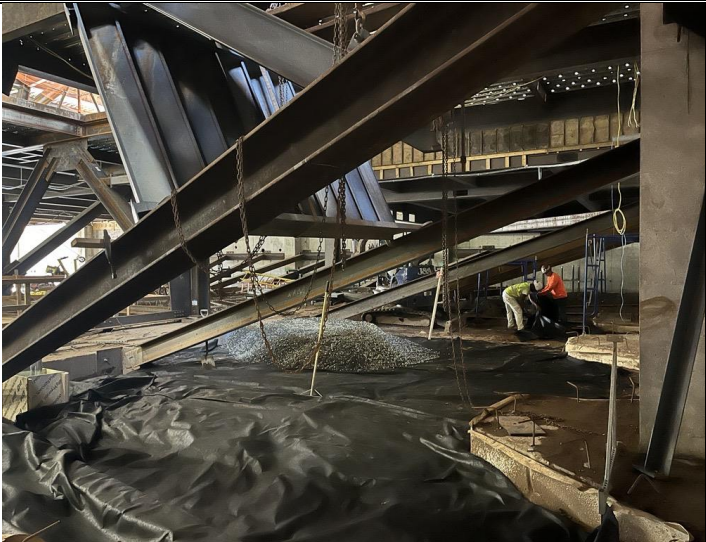
<b>Description:</b> J&A placing Mirafi non-woven Geotextile in grids B1 and B2 and spreading clean stone over geotextile.		<b>Description:</b> The backfilled area in grids B1 and B2 at the end of the day.

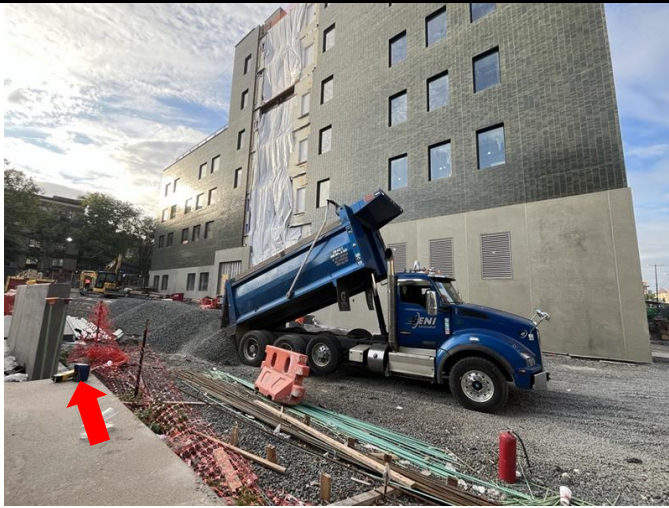
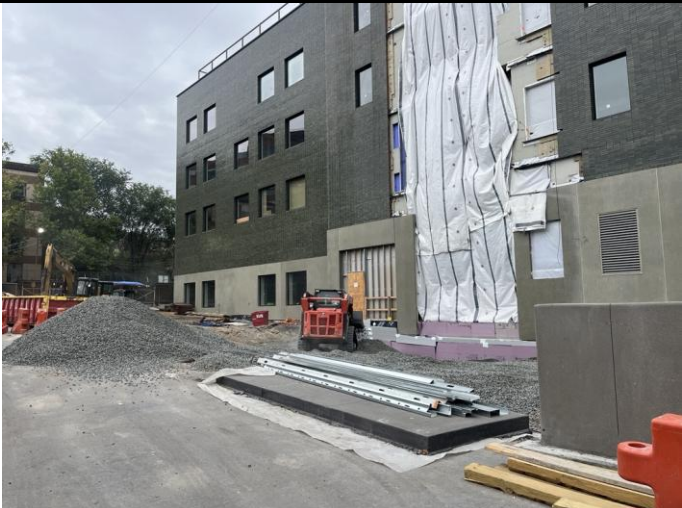
Photo No. 1	Direction Photo Taken: South	Photo No. 2	Direction Photo Taken East

<b>Description:</b> Delivery of Tilcon GPA to the northern portion of the Site. Air monitoring performed using handheld equipment during delivery and backfilling.		<b>Description:</b> DEM backfilling north of the foundation wall with GPA for a stable subgrade.	
Photo No. 3	Direction Photo Taken: East	Photo No. 4	Direction Photo Taken: Southeast

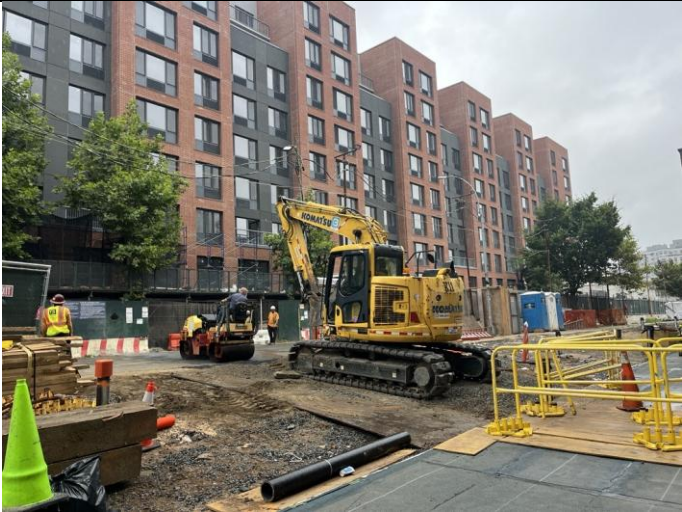
<b>Description:</b> Bancker installing sanitary pipe connection to Gerard Avenue on the eastern portion of the Site.		<b>Description:</b> View of trench excavation area for sanitary connection after backfilling at the end of the day.

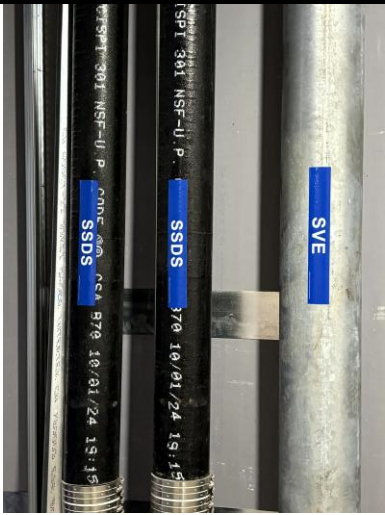
<b>Photo No.</b> 5	<b>Location Photo Taken:</b> 6 <sup>th</sup> Floor Interior	<b>Photo No.</b> 6	<b>Location Photo Taken</b> Cellar

<b>Description:</b> SSDS and SVE System vertical risers		<b>Description:</b> Monitoring Point SS MP-05	
<b>Photo No.</b> 7	<b>Location Photo Taken:</b> Cellar	<b>Photo No.</b> 8	<b>Location Photo Taken:</b> 1 <sup>st</sup> Floor Interior

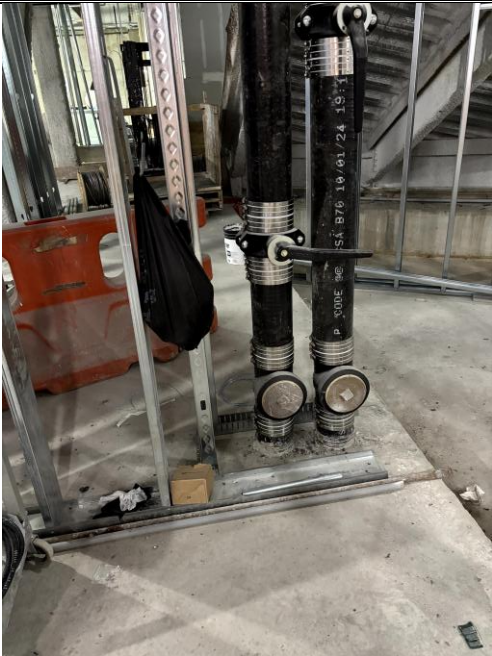
<b>Description:</b> SSDS Vertical riser showing cleanouts		<b>Description:</b> SSDS and SVE System risers

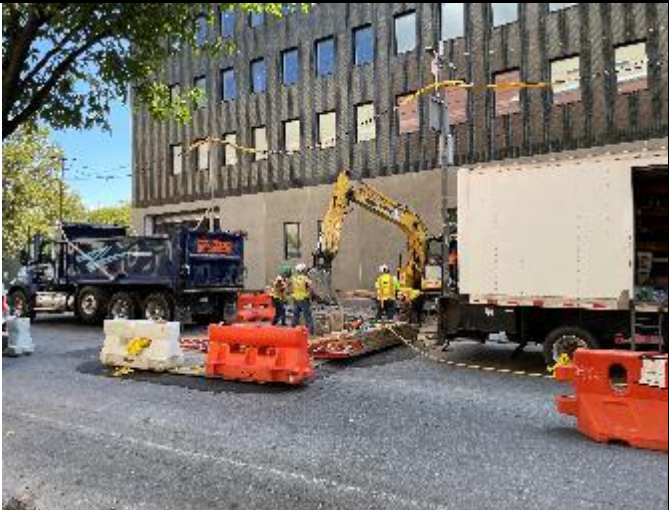
Photo No. 1	Direction Photo Taken: Northeast	Photo No. 2	Direction Photo Taken East

Description: Bancker using excavator to remove material from off-site trench on River Avenue.		Description: Bancker hand excavating around piping in trench.	
Photo No. 3	Direction Photo Taken: West	Photo No. 4	Direction Photo Taken: South

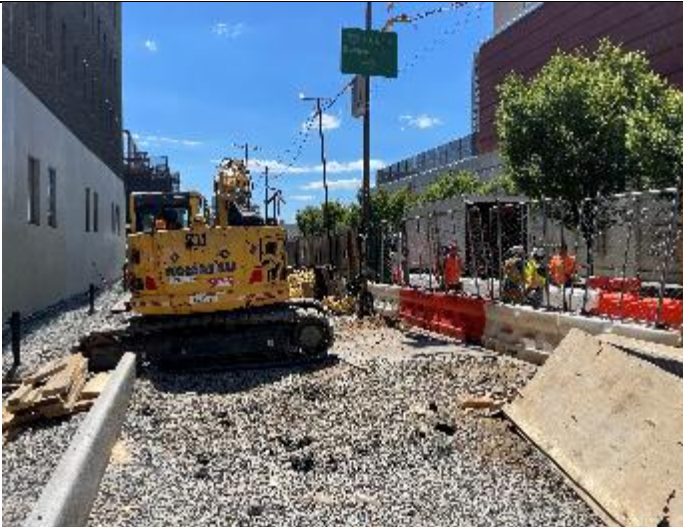
Description: Bancker continues hand excavation in trench.		Description: View of on-site area where excavation will continue.

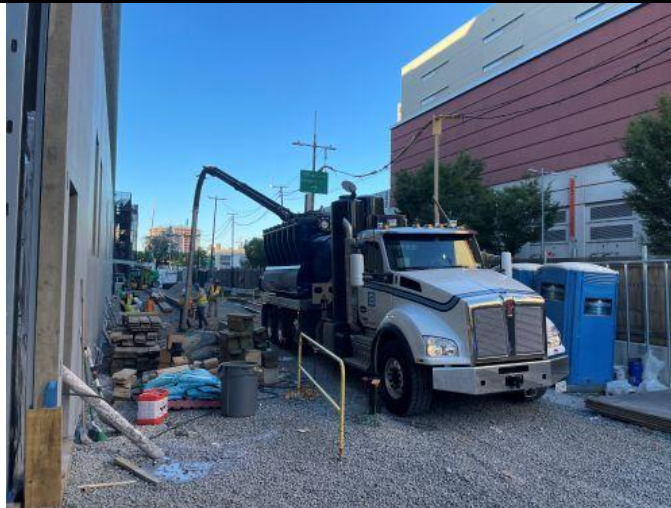
Photo No. 1	Direction Photo Taken: South	Photo No. 2	Direction Photo Taken South

<b>Description:</b> Bancker using vacuum truck to remove GPA from the SVE system trench in northwest portion of the Site.		<b>Description:</b> Bancker exposing existing SVE system piping in trench with GPA removal.	
Photo No. 3	Direction Photo Taken: East	Photo No. 4	Direction Photo Taken: South

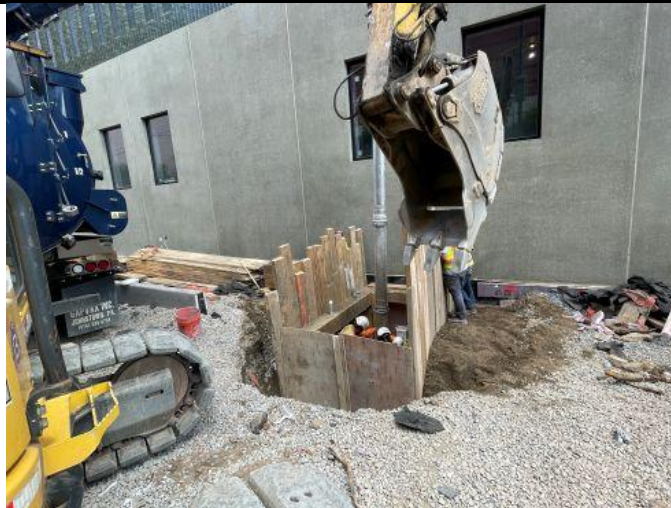
<b>Description:</b> Bancker driving support of excavation timber into the subgrade.		<b>Description:</b> Northwest portion of Site (work area) at end of day.

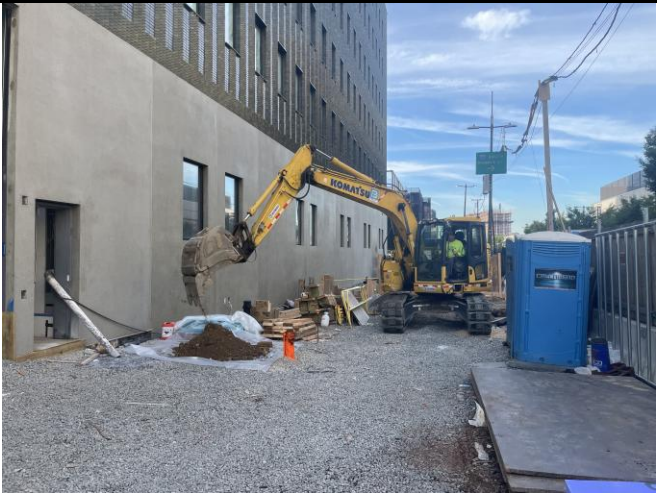
<p>Photo No. 1</p>	<p>Direction Photo Taken: East</p>	<p>Photo No. 2</p>	<p>Direction Photo Taken Southeast</p>

<p><b>Description:</b> Bancker continued trench excavation at the northwestern portion of the Site. The excavated material was placed on top of polysheeting.</p>		<p><b>Description:</b> Bancker placing layer of GPA at the base of trench for pipe bedding.</p>	
<p>Photo No. 3</p>	<p>Direction Photo Taken: Southwest</p>	<p>Photo No. 4</p>	<p>Direction Photo Taken: South</p>

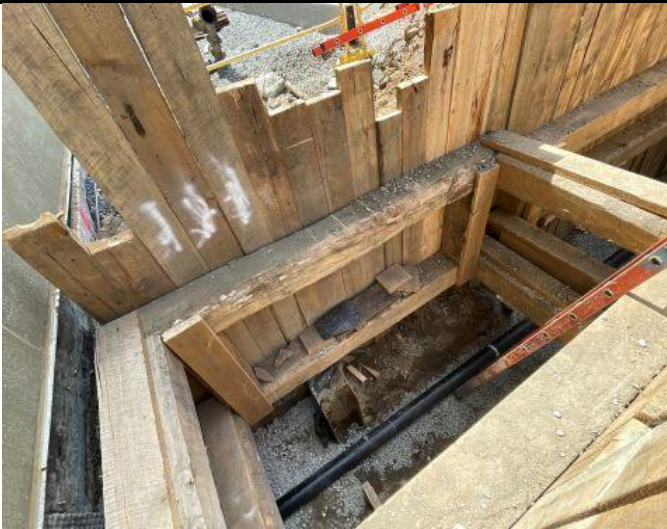
<p><b>Description:</b> Sanitary pipe placed on top of GPA pipe bedding.</p>		<p><b>Description:</b> Work area at end of day.</p>

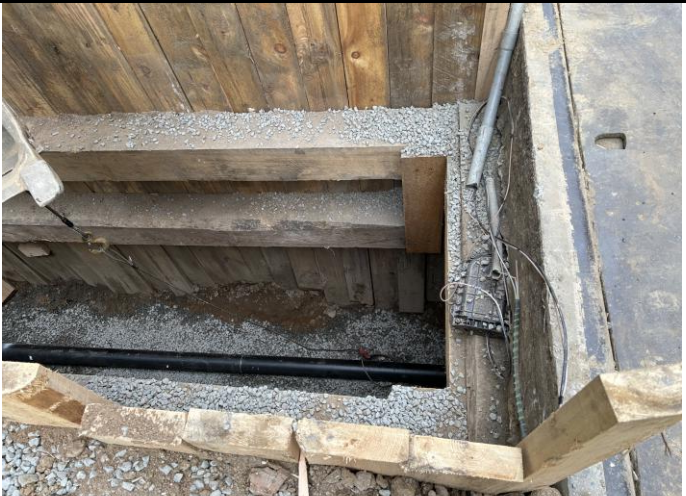
<b>Description:</b> Bancker continued sewer utility line installation outside the northwestern portion off-Site on River Avenue.		<b>Description:</b> View of utility pipe connection and trench located inside property boundary near northwestern portion of Site.	
Photo No. 3	Direction Photo Taken: East	Photo No. 4	Direction Photo Taken: North

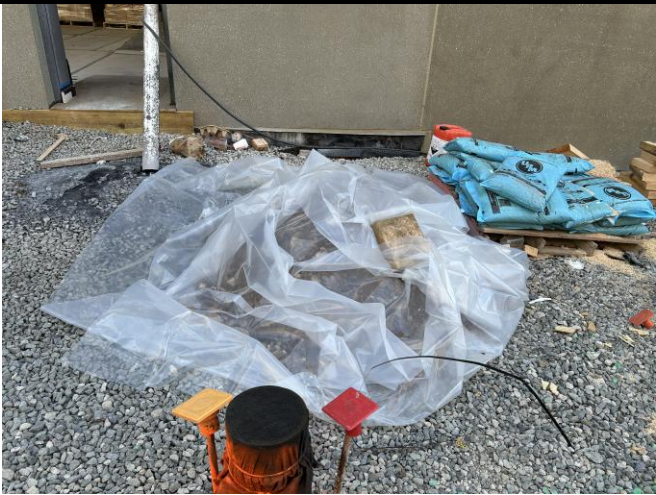
<b>Description:</b> Stockpiled soil covered with poly-sheeting located north of trench.		<b>Description:</b> Stockpiled soil covered with poly-sheeting located south of trench.

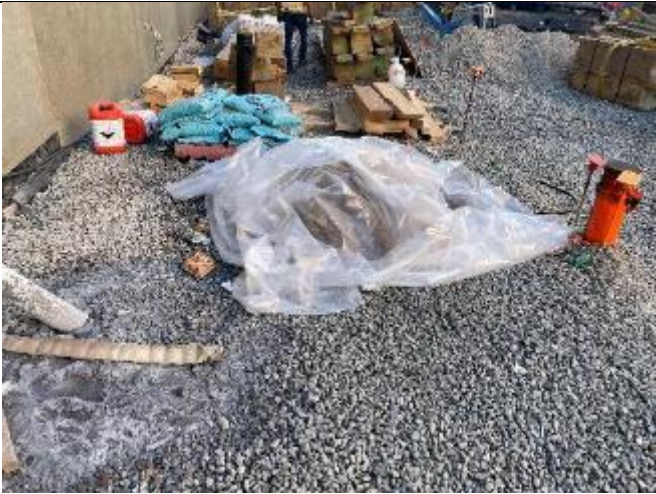
Description: Excavated material from the trench excavation cover with polysheeting. Note the NYSDEC-approved GPA stockpiled in the background.		Description: SSDS riser pipe with gauges.

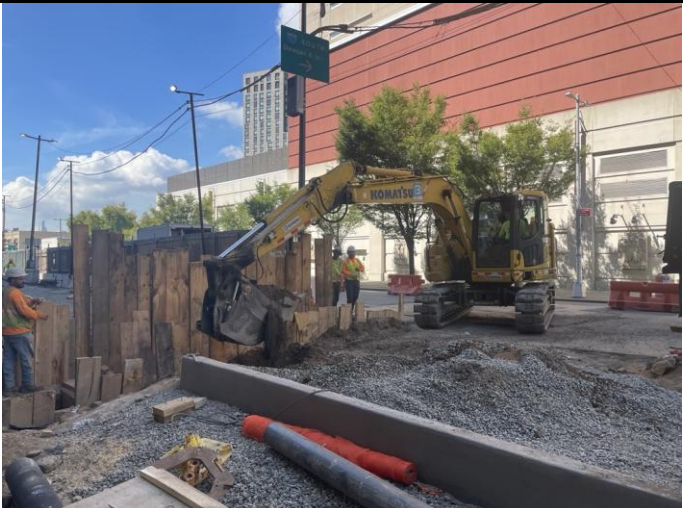
Description: Bancker backfilling trench outside of property line.		Description: Bancker excavating for removal of timber SOE.	
Photo No. 3	Direction Photo Taken: South	Photo No. 4	Direction Photo Taken: Southeast

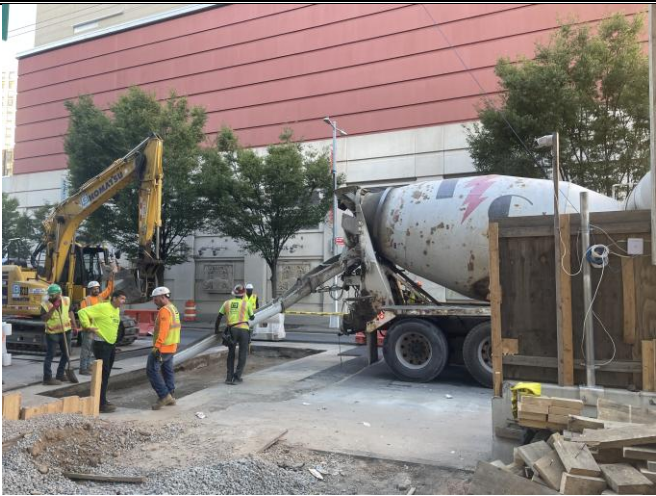
Description: Bancker pouring concrete along River Avenue.		Description: Excavated material from the trench moved to northern portion of Site and covered with poly sheeting.

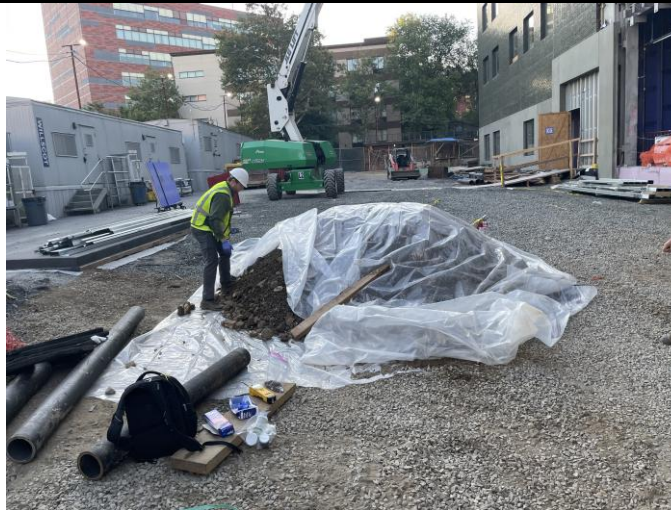
Photo No. 1	Direction Photo Taken: East	Photo No. 2	Direction Photo Taken Southeast

<b>Description:</b> Factor Group collecting soil sample from soil stockpile for waste characterization.		<b>Description:</b> GPA from Tilcon was delivered and stockpiled at northern portion of the Site.	
Photo No. 3	Direction Photo Taken: N/A	Photo No. 4	Direction Photo Taken: South

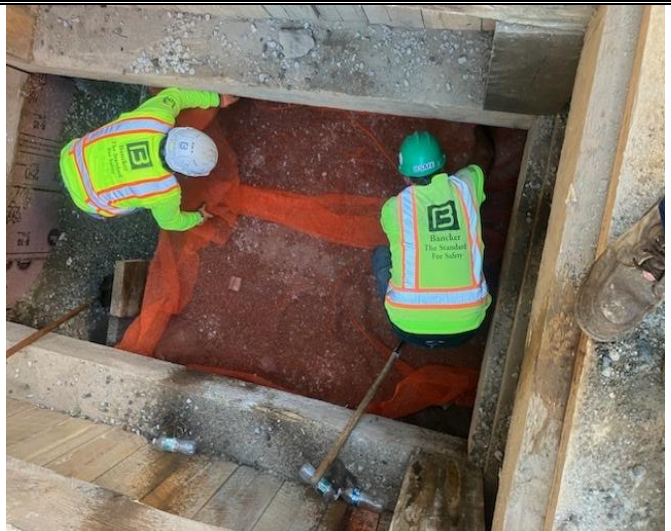
<b>Description:</b> Bancker placing demarcation layer at base of trench prior to backfill.		<b>Description:</b> Bancker backfilling trench with GPA.

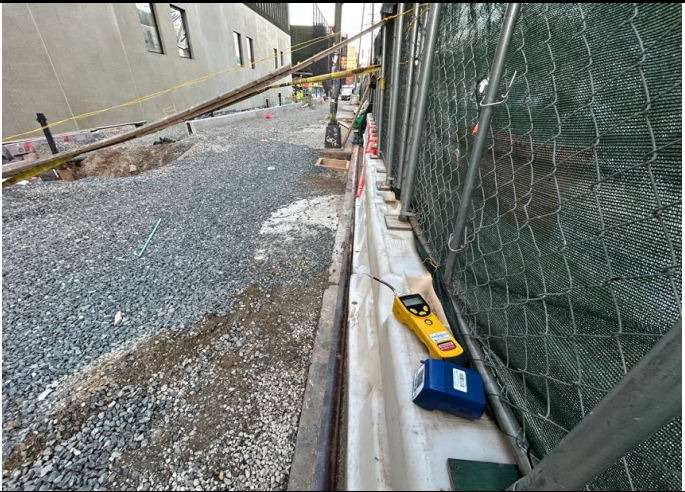
<b>Description:</b> Stasi Brothers installing wall and hardscaping .		<b>Description:</b> Handheld CAMP equipment setup.	
<b>Photo No.</b> 3	<b>Direction Photo Taken:</b> Southwest	<b>Photo No.</b> 4	<b>Direction Photo Taken:</b> Southwest

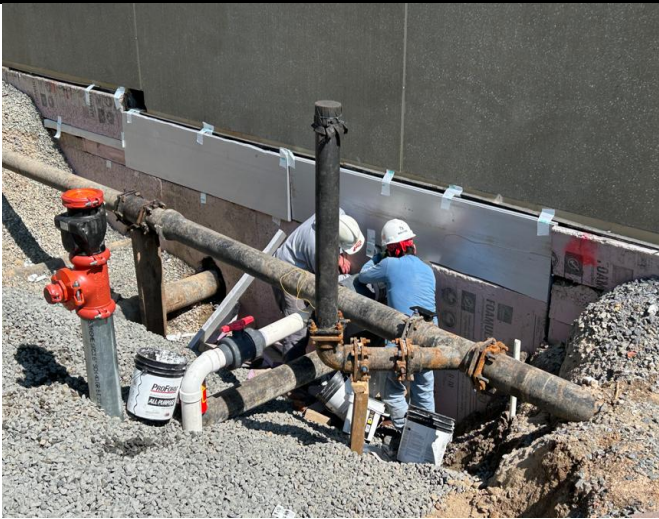
<b>Description:</b> AWS Plumbing continues SVE pipe install.		<b>Description:</b> Work area at end of day.

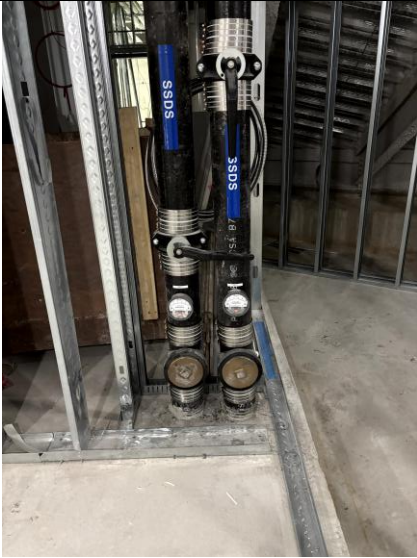
Description: SSDS VR-1 and VR-2.		Description: SSDS VR-3 and VR-4.	
Photo No. 3	Direction Photo Taken: N/A	Photo No. 4	Direction Photo Taken: MP-1

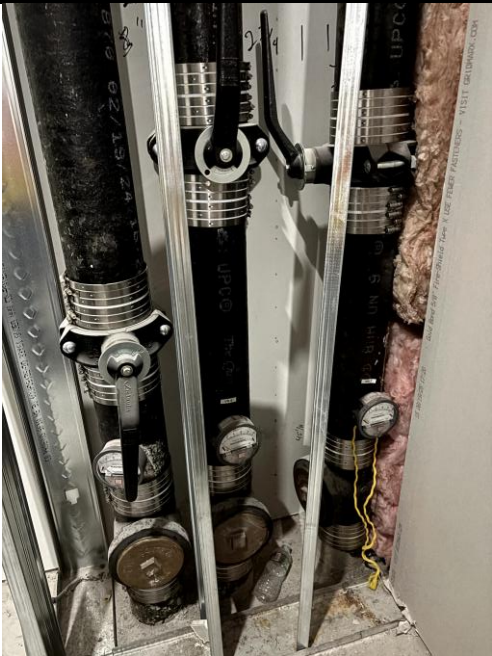
Description: SSDS VR-5, VR-6 and VR-7.		Description: Monitoring Point MP-1, typical installation.

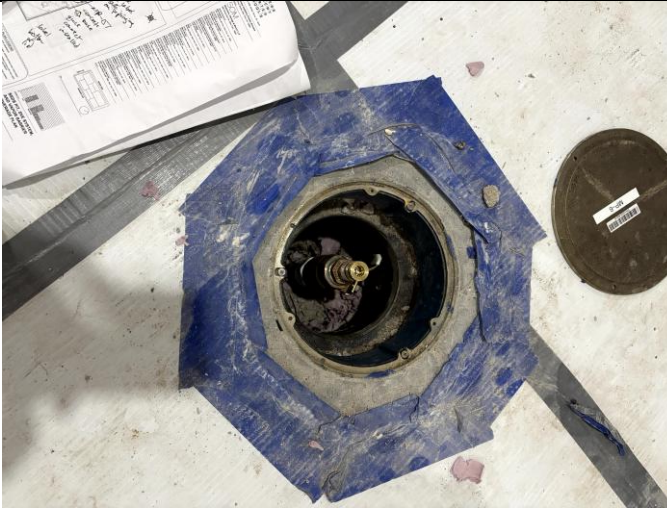
<b>Description:</b> Monitoring Point MP-5, typical installation.		<b>Description:</b> SVE system connection within the building.	
Photo No. 7	Direction Photo Taken: SF-1	Photo No. 8	Direction Photo Taken: North

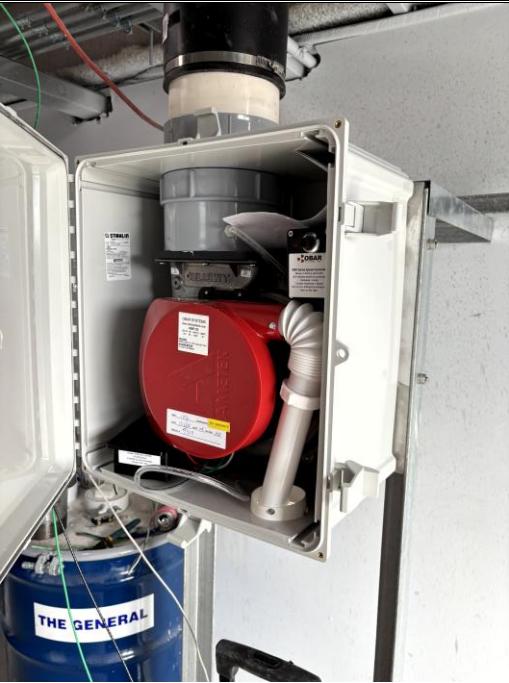
<b>Description:</b> SF-1 internal components. Vapor phase carbon drum present behind SF-1.		<b>Description:</b> SVE exhaust stack installation ongoing.

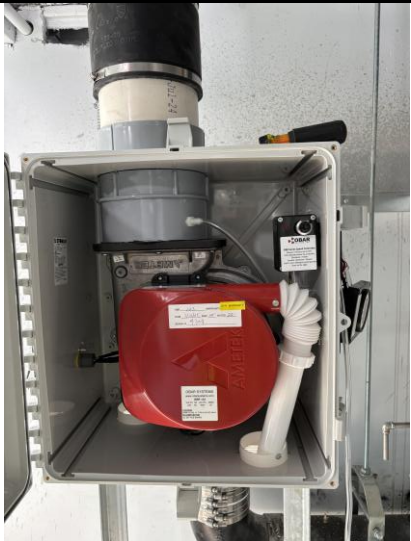
<b>Description:</b> SSDS fan, SF-1.		<b>Description:</b> SVE treatment setup, with SVE fan enclosure, carbon drums, vacuum gauges, and samples taps	
Photo No. 3	Direction Photo Taken: Roof Level Fan room	Photo No. 4	Direction Photo Taken: 1 <sup>st</sup> Floor Elevator Foyer

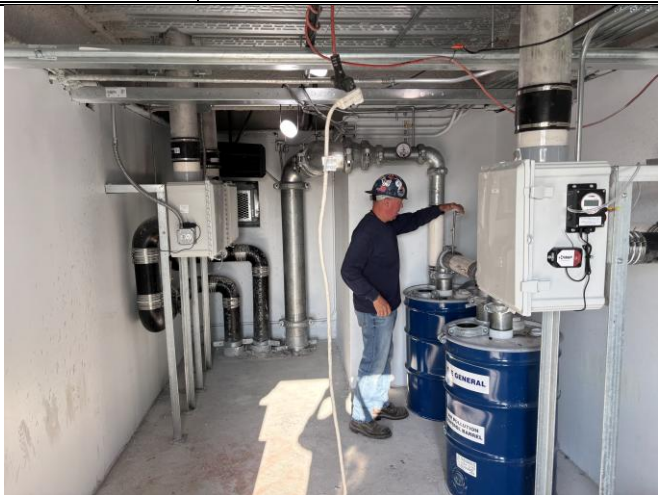
<b>Description:</b> General view of the SSDS/SVE equipment room.		<b>Description:</b> Vertical risers manifolded behind the first floor access door.

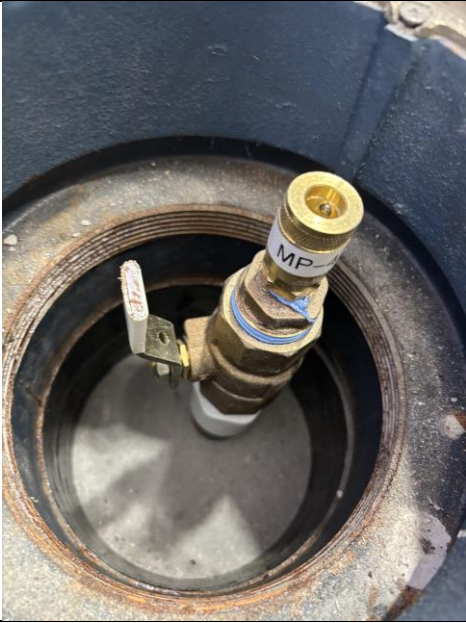
Description: SSDS vapor monitoring point, MP-4.		Description: Vacuum gauge on VR-3 at the cellar grade.	
Photo No. 7	Direction Photo Taken: Cellar Level	Photo No. 8	Direction Photo Taken: North

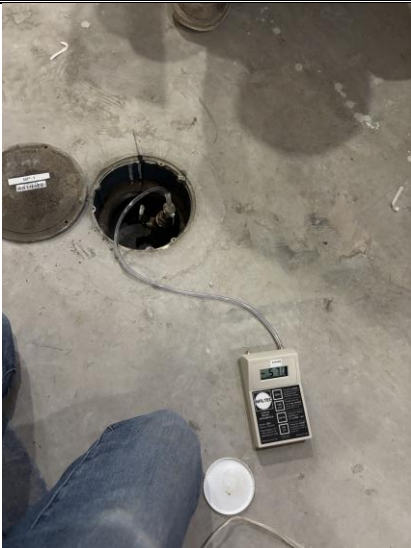
Description: GZA collecting vacuum readings at the SSDS monitoring points with a digital micromanometer.		Description: SVE monitoring point. As shown, gravel is currently set to grade level along the SVE treatment area.
