**608 AND 610 EAST FORDHAM ROAD
BRONX, NEW YORK 10458
BLOCK 3078, LOT 16**

**PHASE II
ENVIRONMENTAL SITE ASSESSMENT
(ASTM 1903-19)**

PWGC Project Number: BLU2201

AUGUST 2022

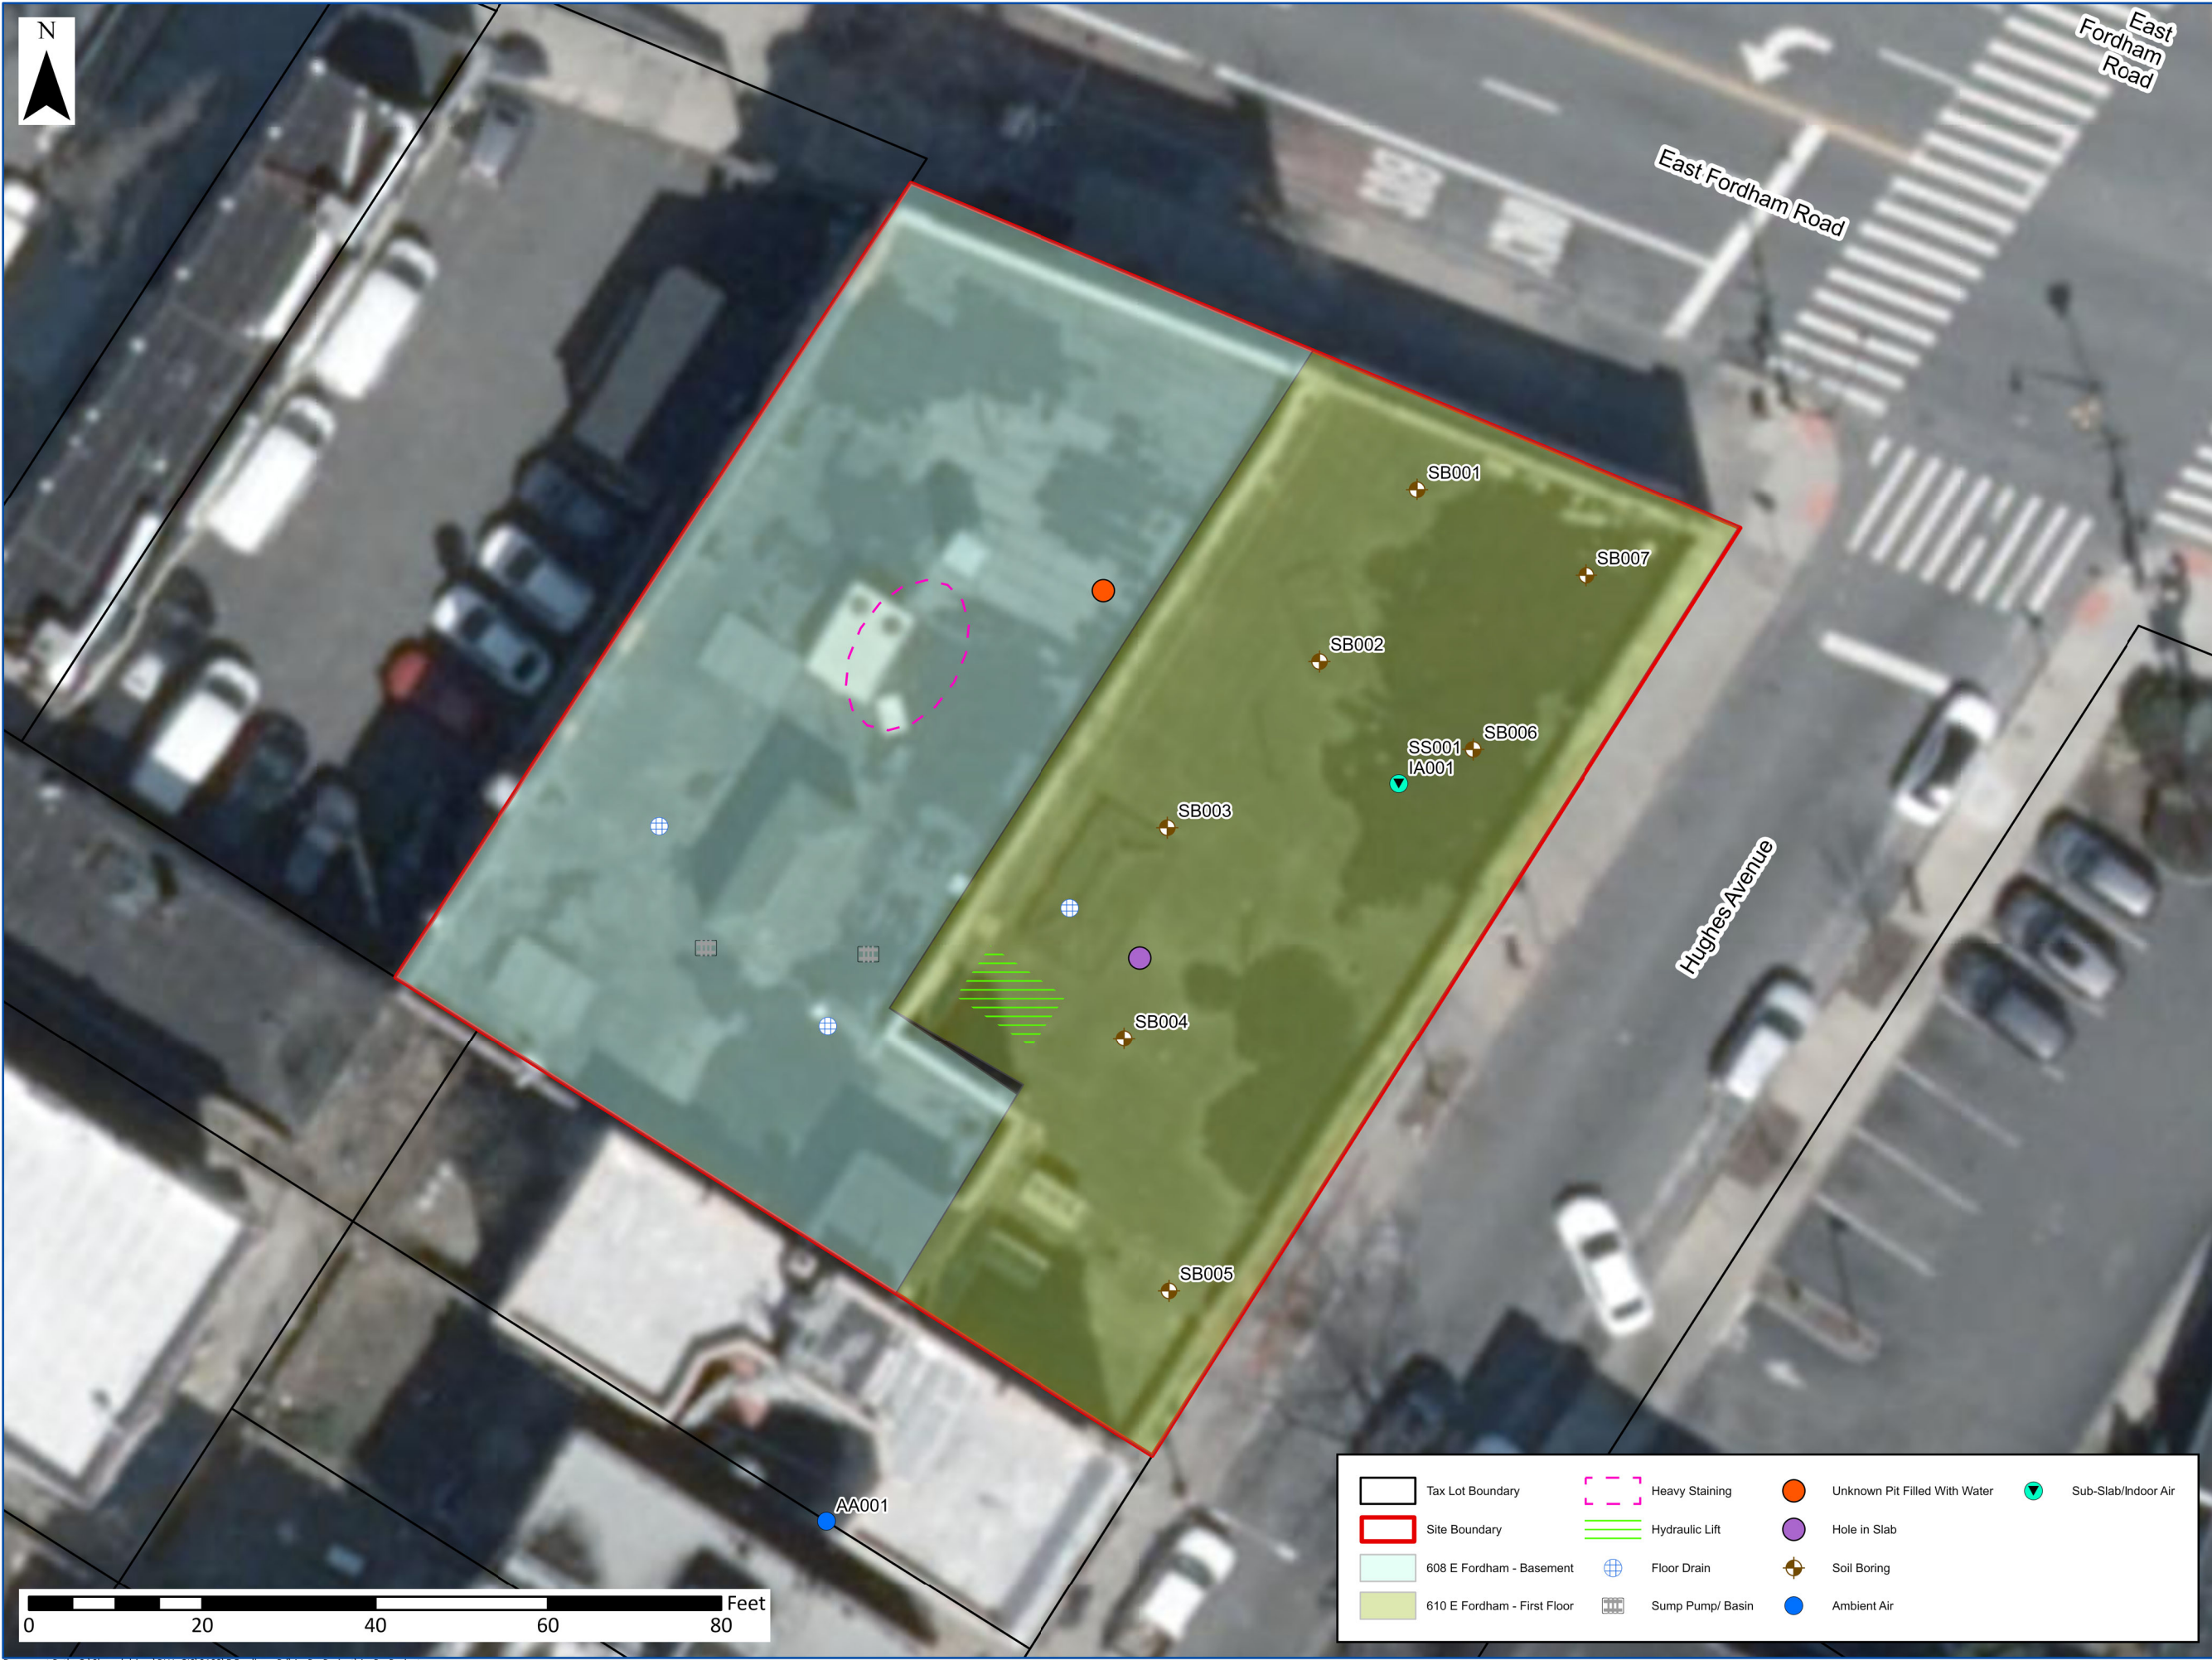
A Site Location Map is included as **Figure 1** and a Site Plan is included as **Figure 2**

To characterize soil quality at the subject property, soil borings were installed throughout the subject property. A total of seven soil borings were installed during the Phase II ESA investigation. Soil boring locations are illustrated in **Figure 2**.

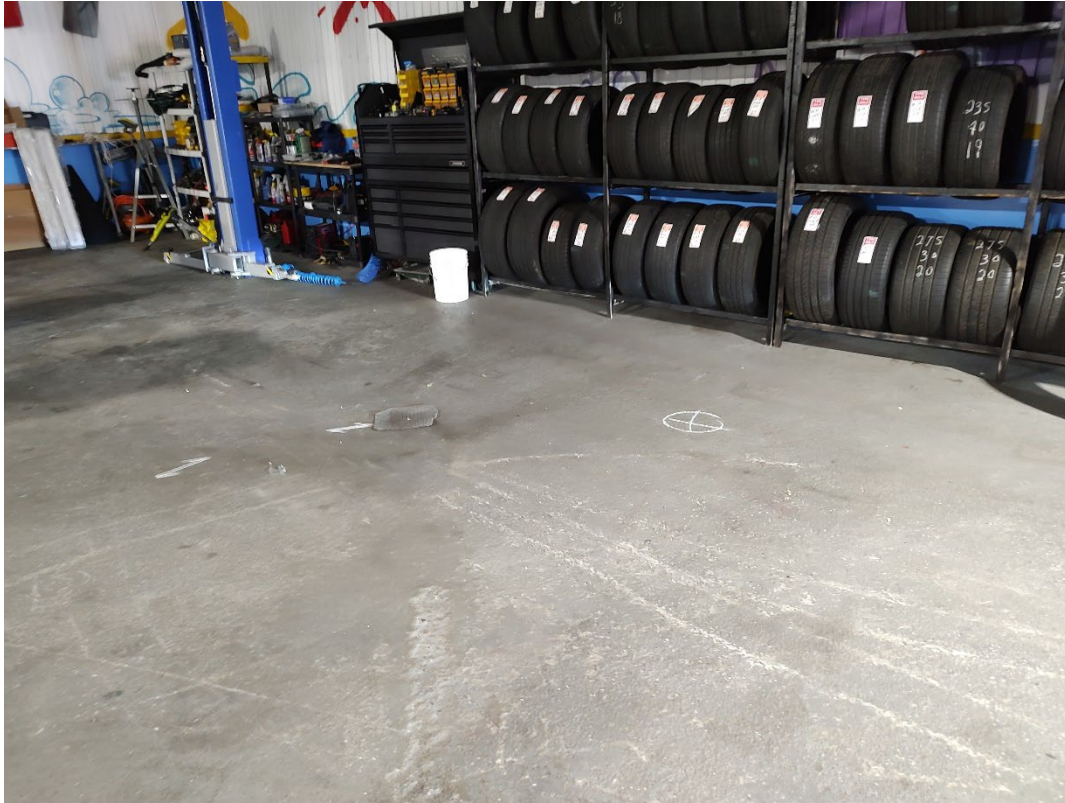
Photo 1 and GPR Screenshot 1 – Photo of one of the proposed soil borings located in the westmost corner of the building. The drain lines detected within the area were identified in the above photo and GPR screenshot (pink arrow).

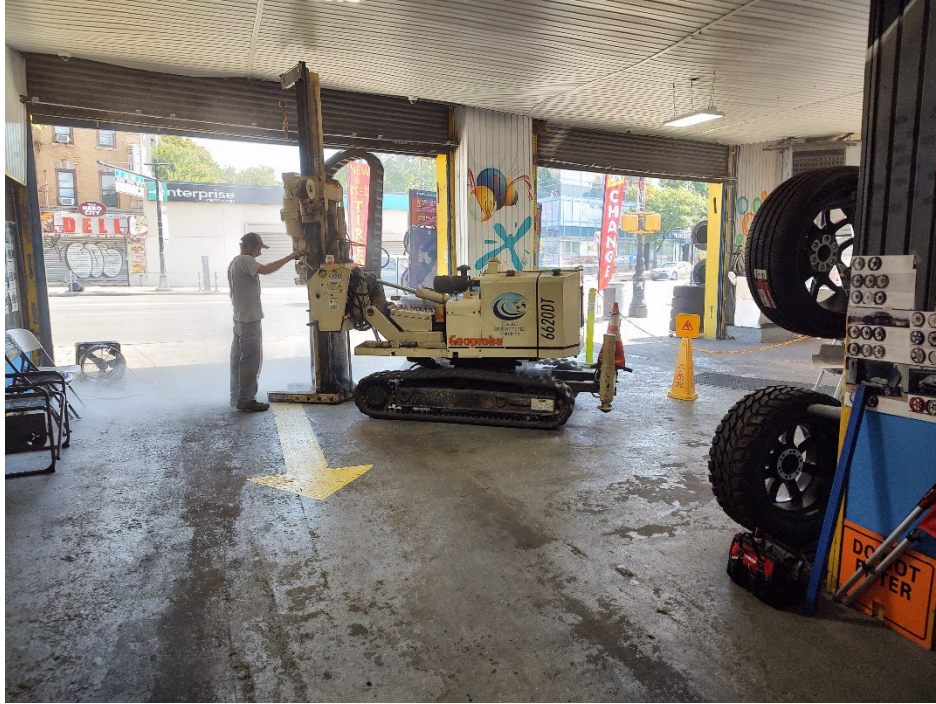
Photo 2 – View of the front of the building during drilling activities.

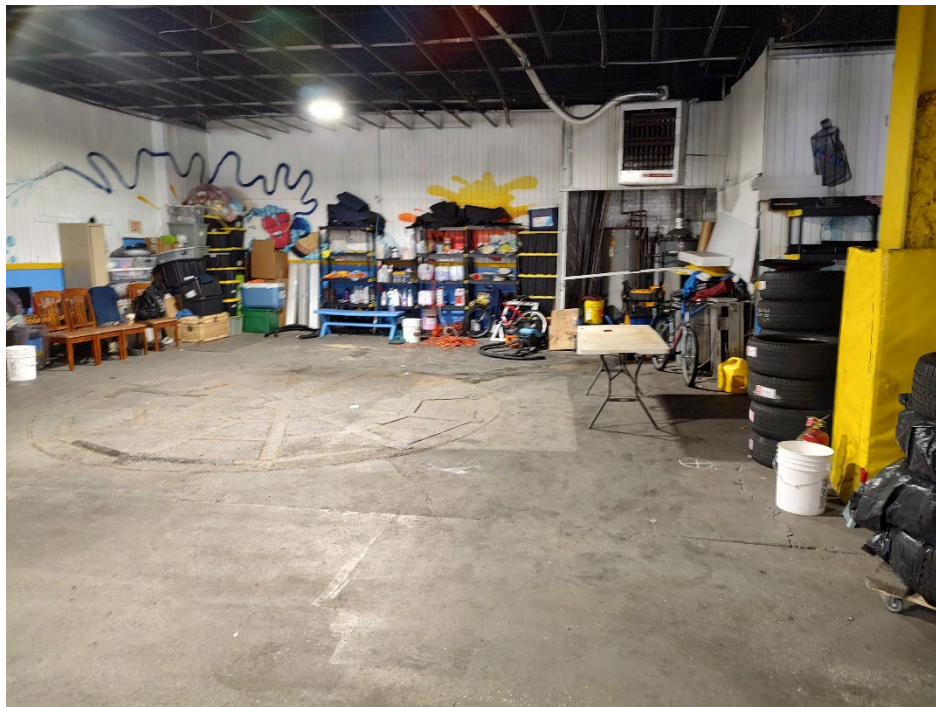
Photo 3 – View of the rear of the building showing two additional proposed boring locations.
