FOCUSED SUBSURFACE SITE INVESTIGATION (FSSI)

**1301-1321 WEBSTER AVENUE
BRONX, NEW YORK 10456**

MECC PROJECT NO. M19720A

MERRITT ENVIRONMENTAL CONSULTING CORP.

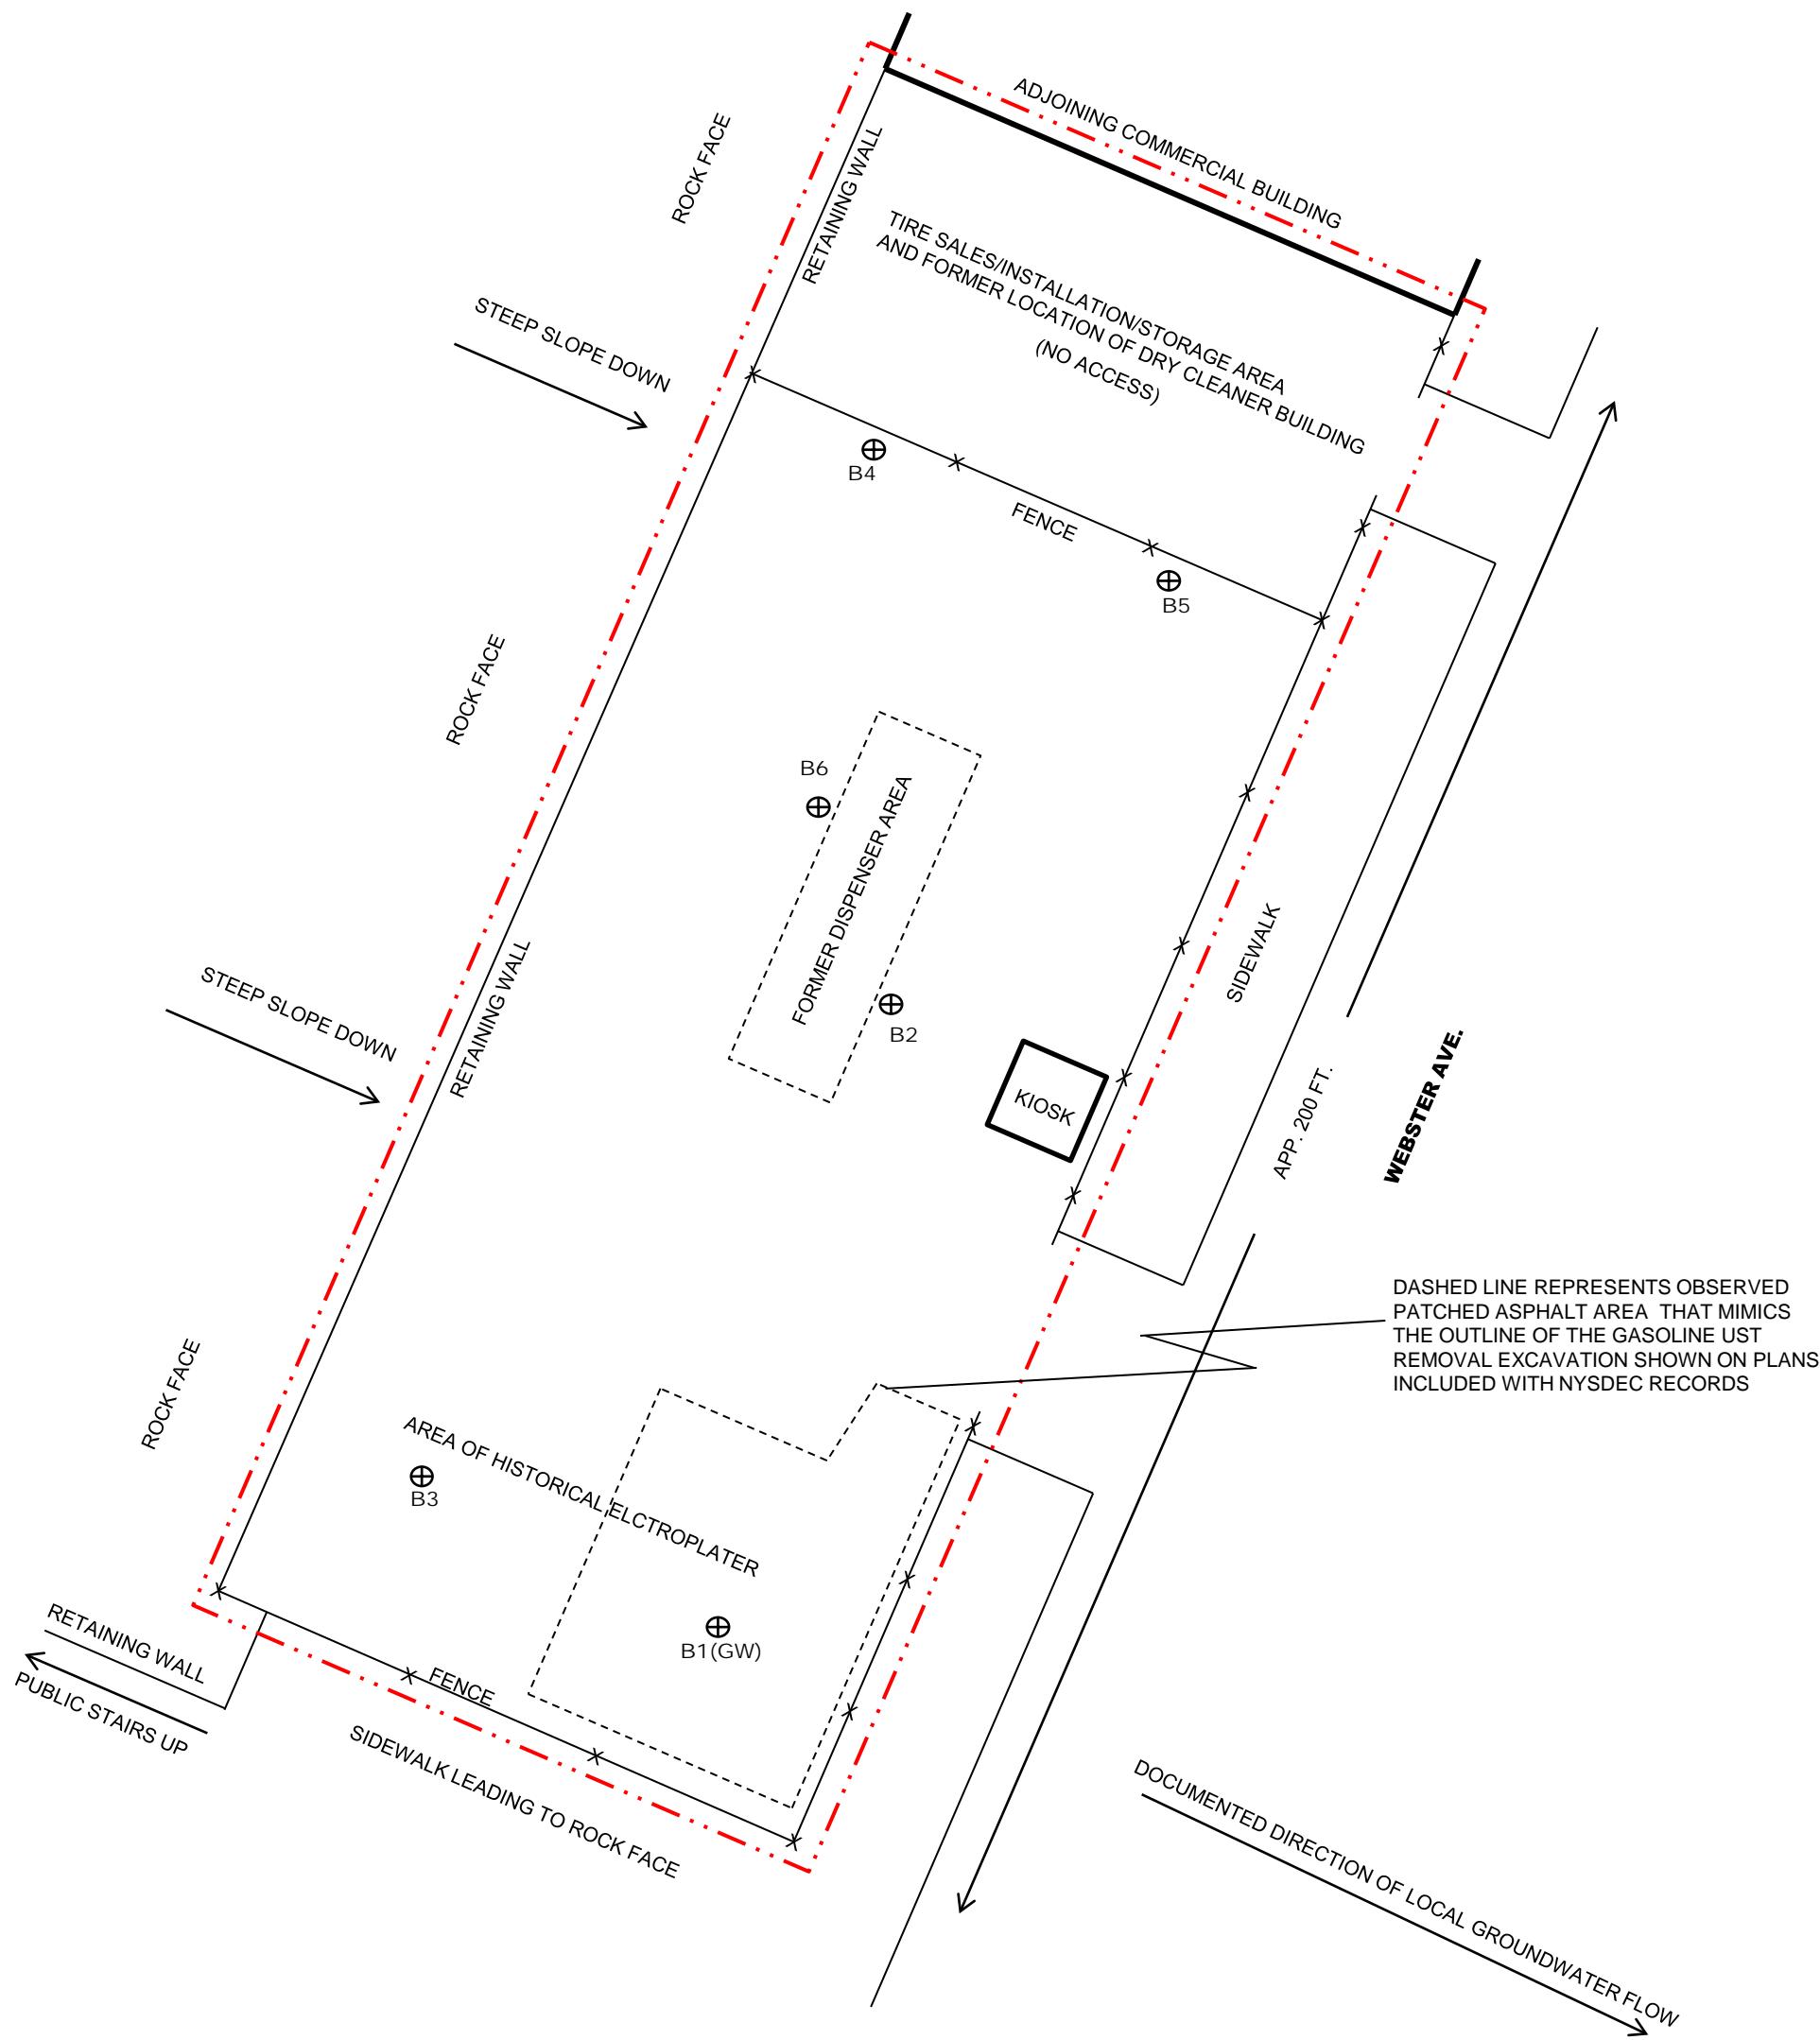
SITE SKETCH: 1301 TO 1321 WEBSTER AVE.
NOT TO SCALE BRONX, NY

NOTES:
 DETAILS ARE BASED ON SITE OBSERVATIONS AND REVIEW OF SITE PLANS INCLUDED IN NYSDEC RECORDS
 NO WATER-BEARING DEPOSITS ABOVE BEDROCK EXCEPT AT B1

⊕ DENOTES SOIL BORING LOCATIONS ("GW" NOTATION IDENTIFIES GROUNDWATER SAMPLE LOCATION)
 RED-PATTERNED LINES ENCLOSE THE SITE

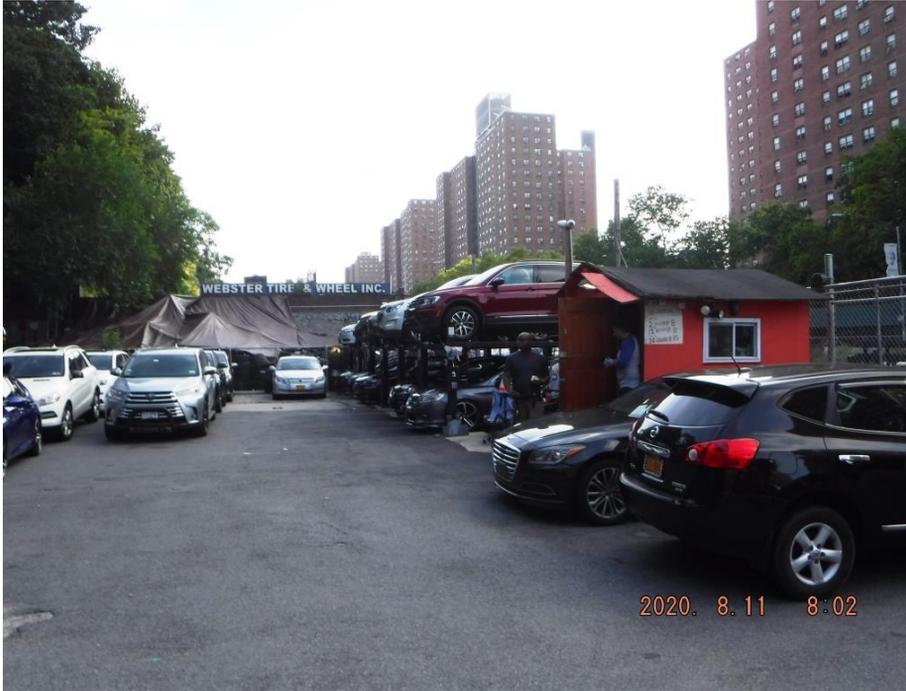
Photograph 1: View of the Site looking north. Tire sales/installation operation at background.

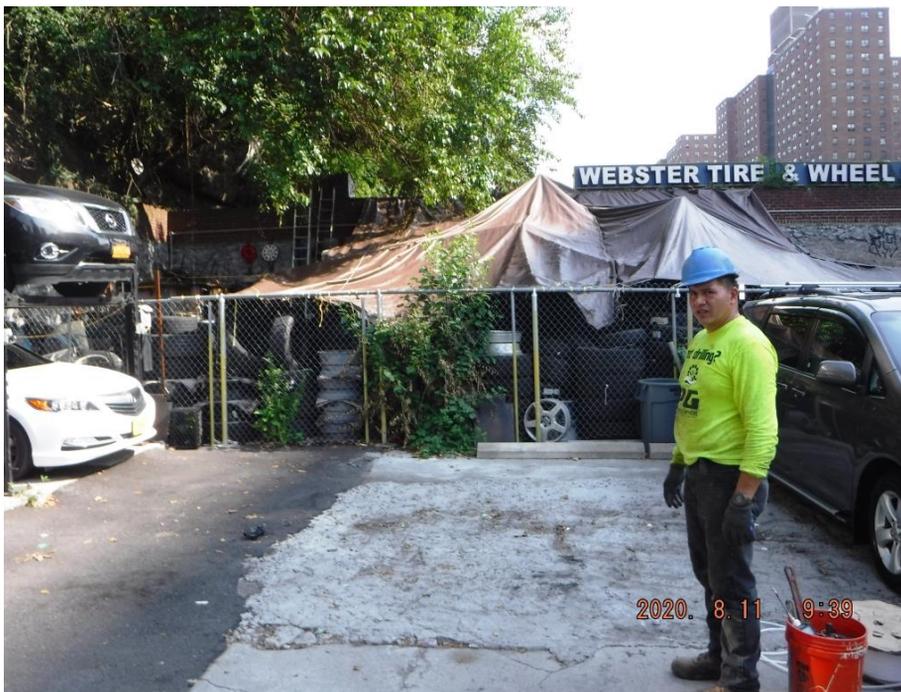
That portion of the Site occupied by the tire sales and installation operation was not accessible during this study. This entire section of the Site was filled with stacked tires (this portion of the Site was historically occupied by a building containing a dry cleaner). However, MECC was able to install two (2) soil borings at the south edge of this area and at the edge of the building perimeter that once occupied the north end of the Site.

Photograph 2: Near view of the north Site section showing tire sales/installation portion.

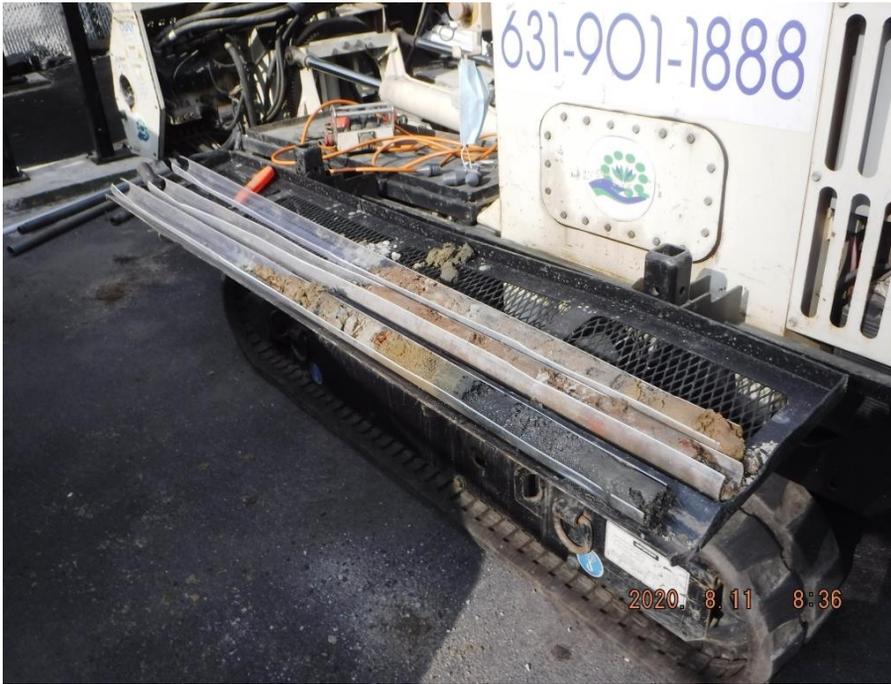
Soil Boring B1, which was installed directly within the former location of three removed gasoline USTs, extended to a water-bearing zone above bedrock. B1 was the deepest boring installed by this study. A groundwater sample was collected for laboratory analysis from B1 by installing a temporary well point. The maximum drilling depth was 15 feet bgs at B1. The groundwater sample was collected by inserting dedicated one-inch diameter well screen and riser to a depth of 15 feet bgs. A peristaltic pump was used to collect groundwater sample using low-flow techniques.

Aside from a gasoline odor detected at the soil/groundwater interface at B1, no physical evidence of contamination in soil was identified in any of the borings. The PID reading at the soil/water interface in B1 was measured at 80 parts per million, which is considered moderately elevated. PID readings for all remaining soil samples at all borings showed undetected to trace levels of volatile organic vapors.

Photograph 3: Material encountered in B1. Discolored soil by gasoline impact at the water table visible at lower right.

Since residual concentrations of gasoline-related VOCs exist in groundwater at the south end of the Site, a possible volatile organic vapor intrusion condition could occur in any future unprotected building that may be constructed. MECC therefore recommends that, at a minimum, a vapor barrier designed specifically to reduce possible volatile organic vapor intrusion be installed beneath any new structure. It is also suggested that a passive sub-slab depressurization system (SSDS) should be installed under any new building floor slab as a precautionary measure.

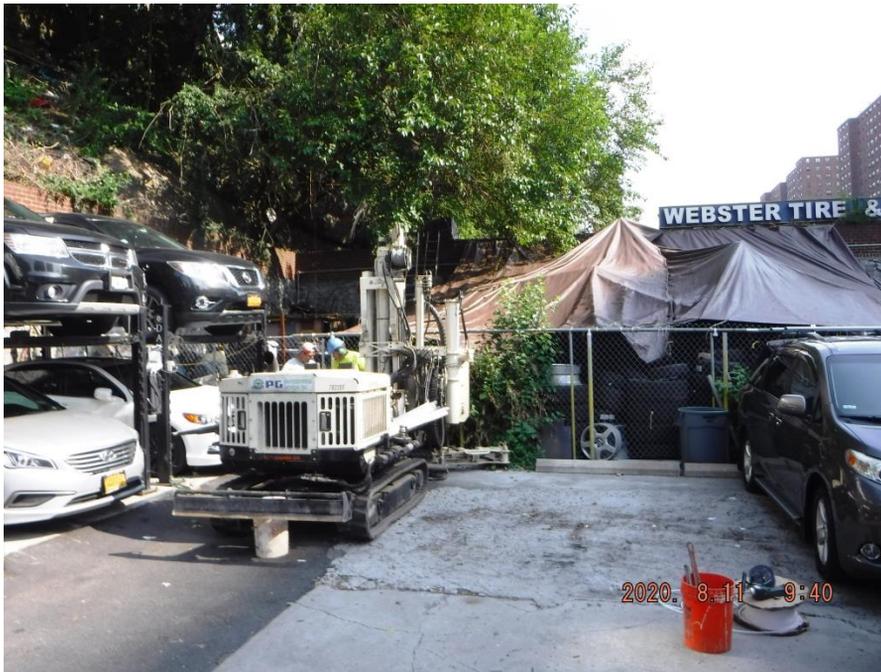
Photograph 4: Installation of B4 looking north.
