DRAFT REMEDIAL INVESTIGATION WORK PLAN
122 BRUCKNER BOULEVARD REDEVELOPMENT SITE
NYSDEC BCP SITE (*PENDING*)
122 BRUCKNER BOULEVARD
BRONX, NEW YORK

by
H & A of New York Engineering and Geology, LLP
New York, New York

File No. 0213675
September 2025

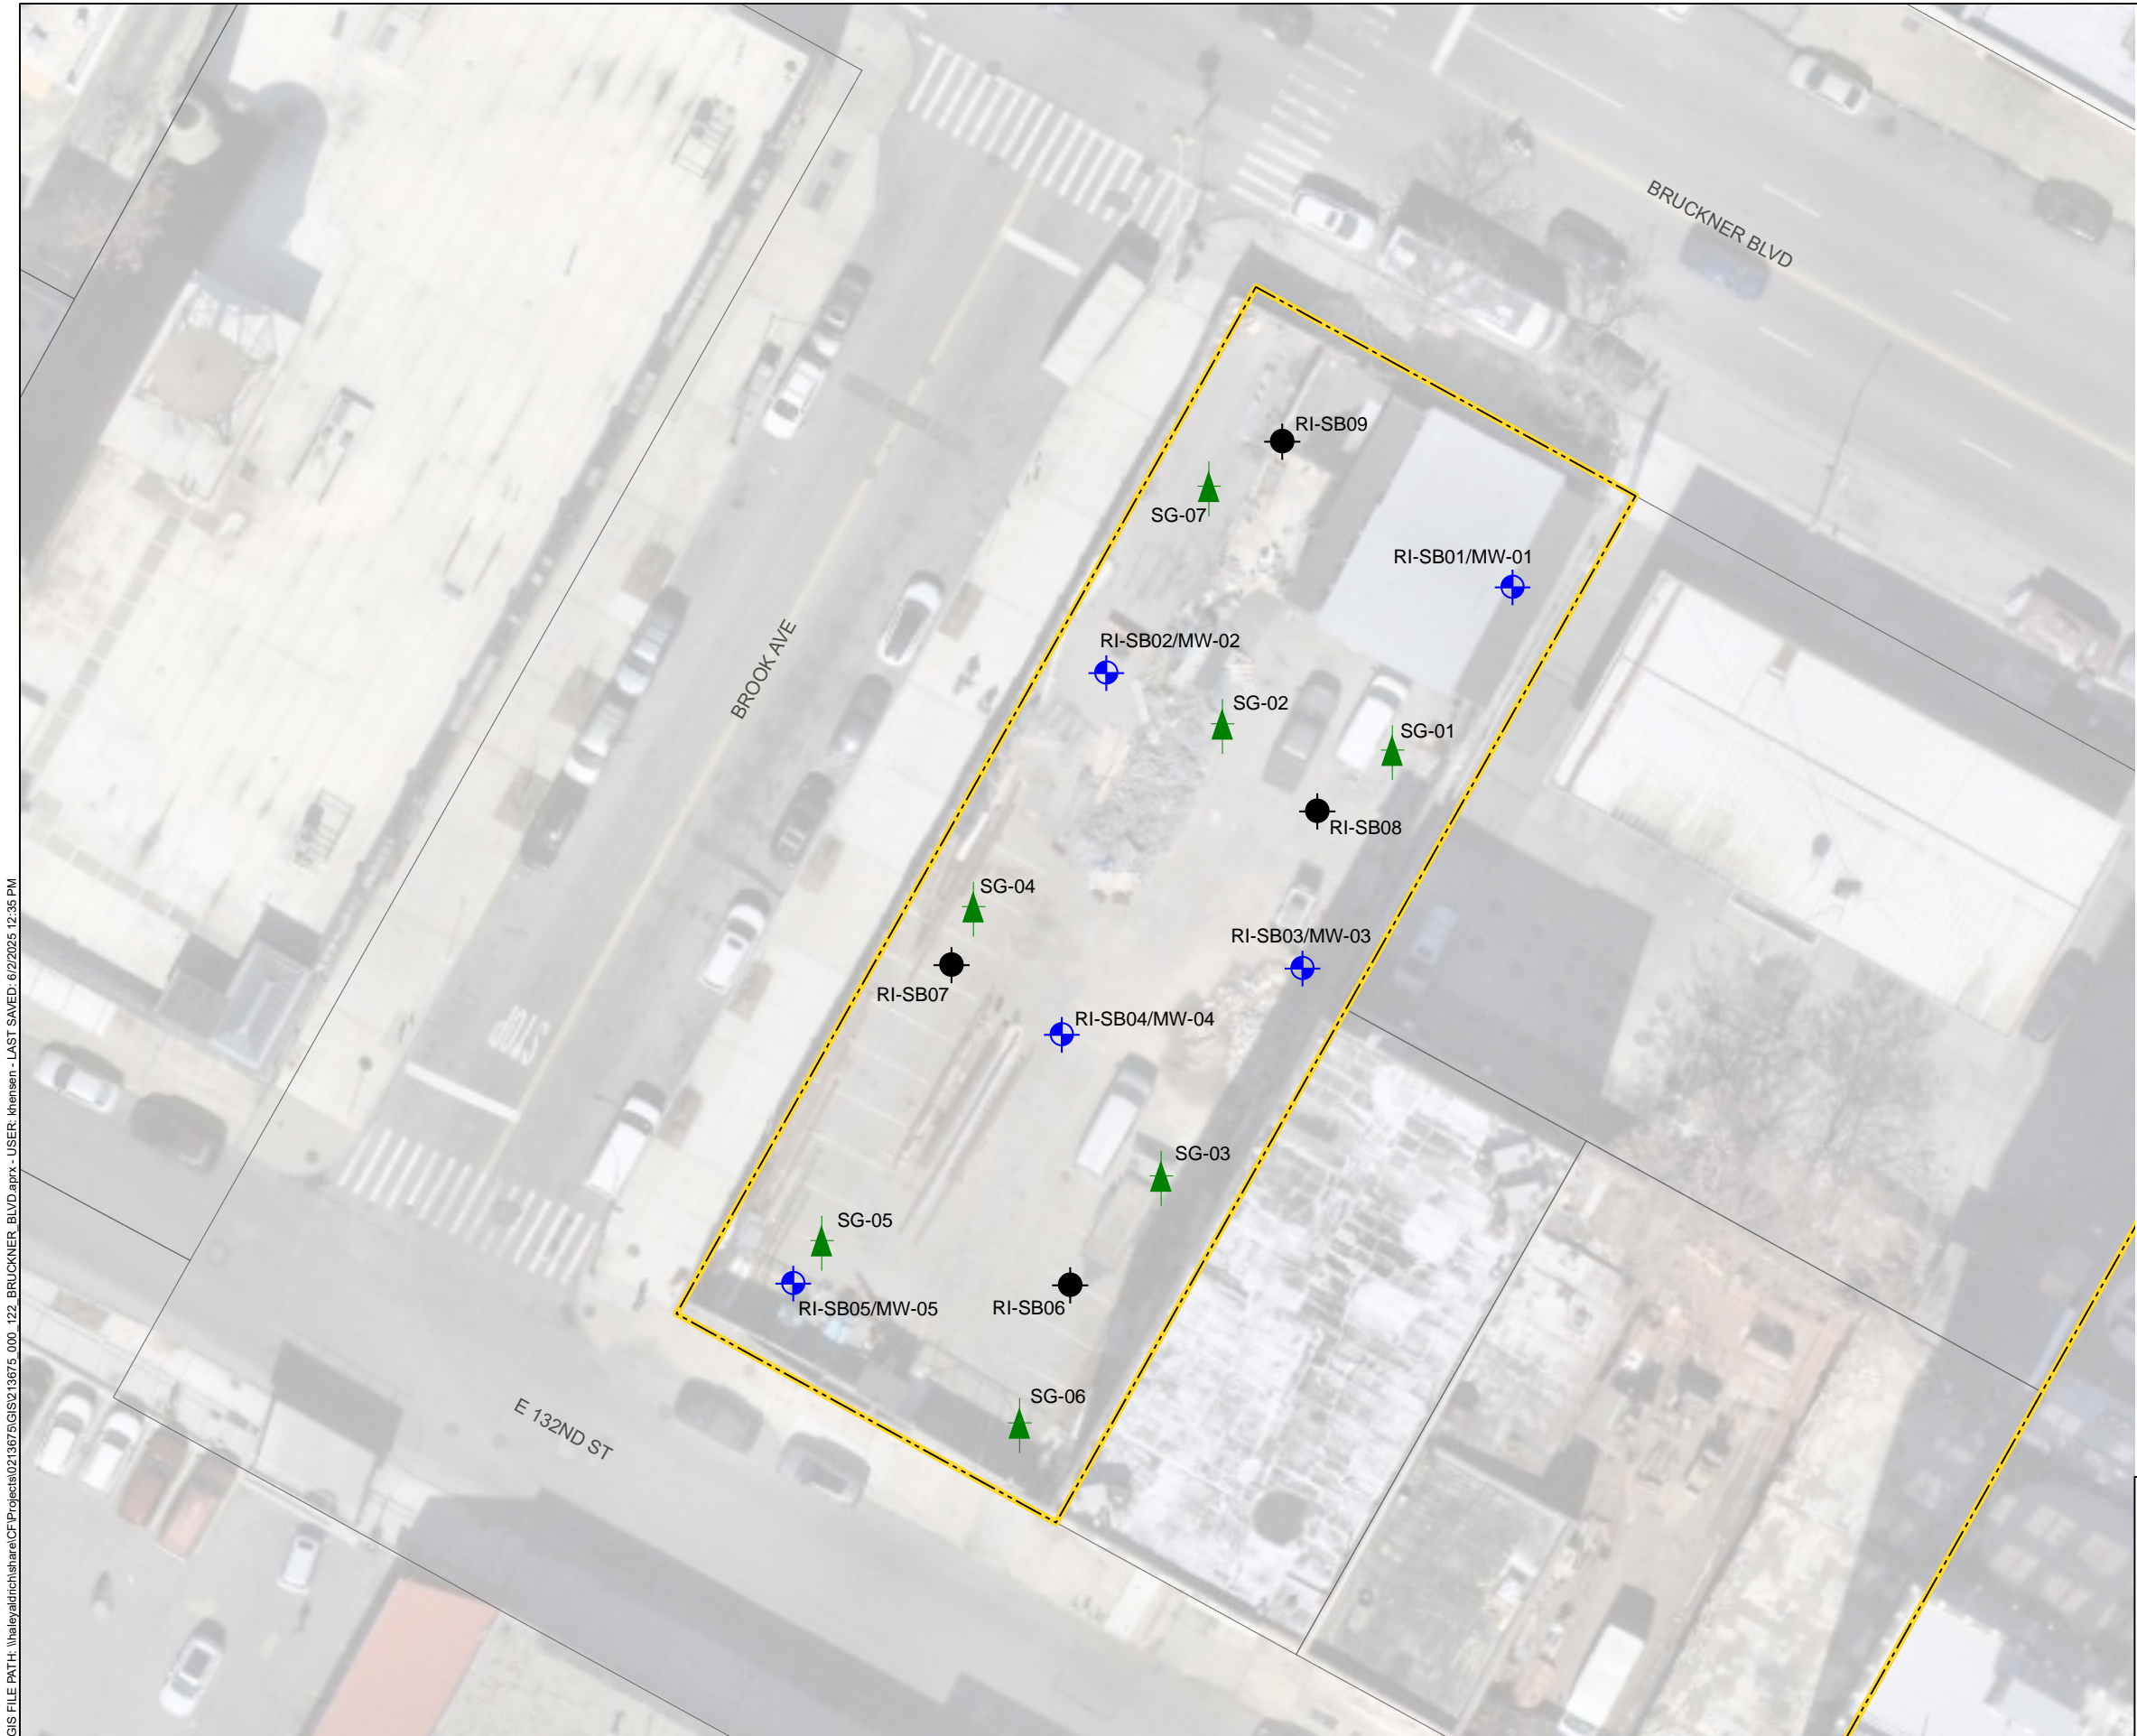
LEGEND

- SITE BOUNDARY
- PARCEL BOUNDARY
- SOIL BORING
- LEAD DELINEATION BORING
- SOIL BORING/PERMANENT MONITORING WELL
- SOIL VAPOR SAMPLE

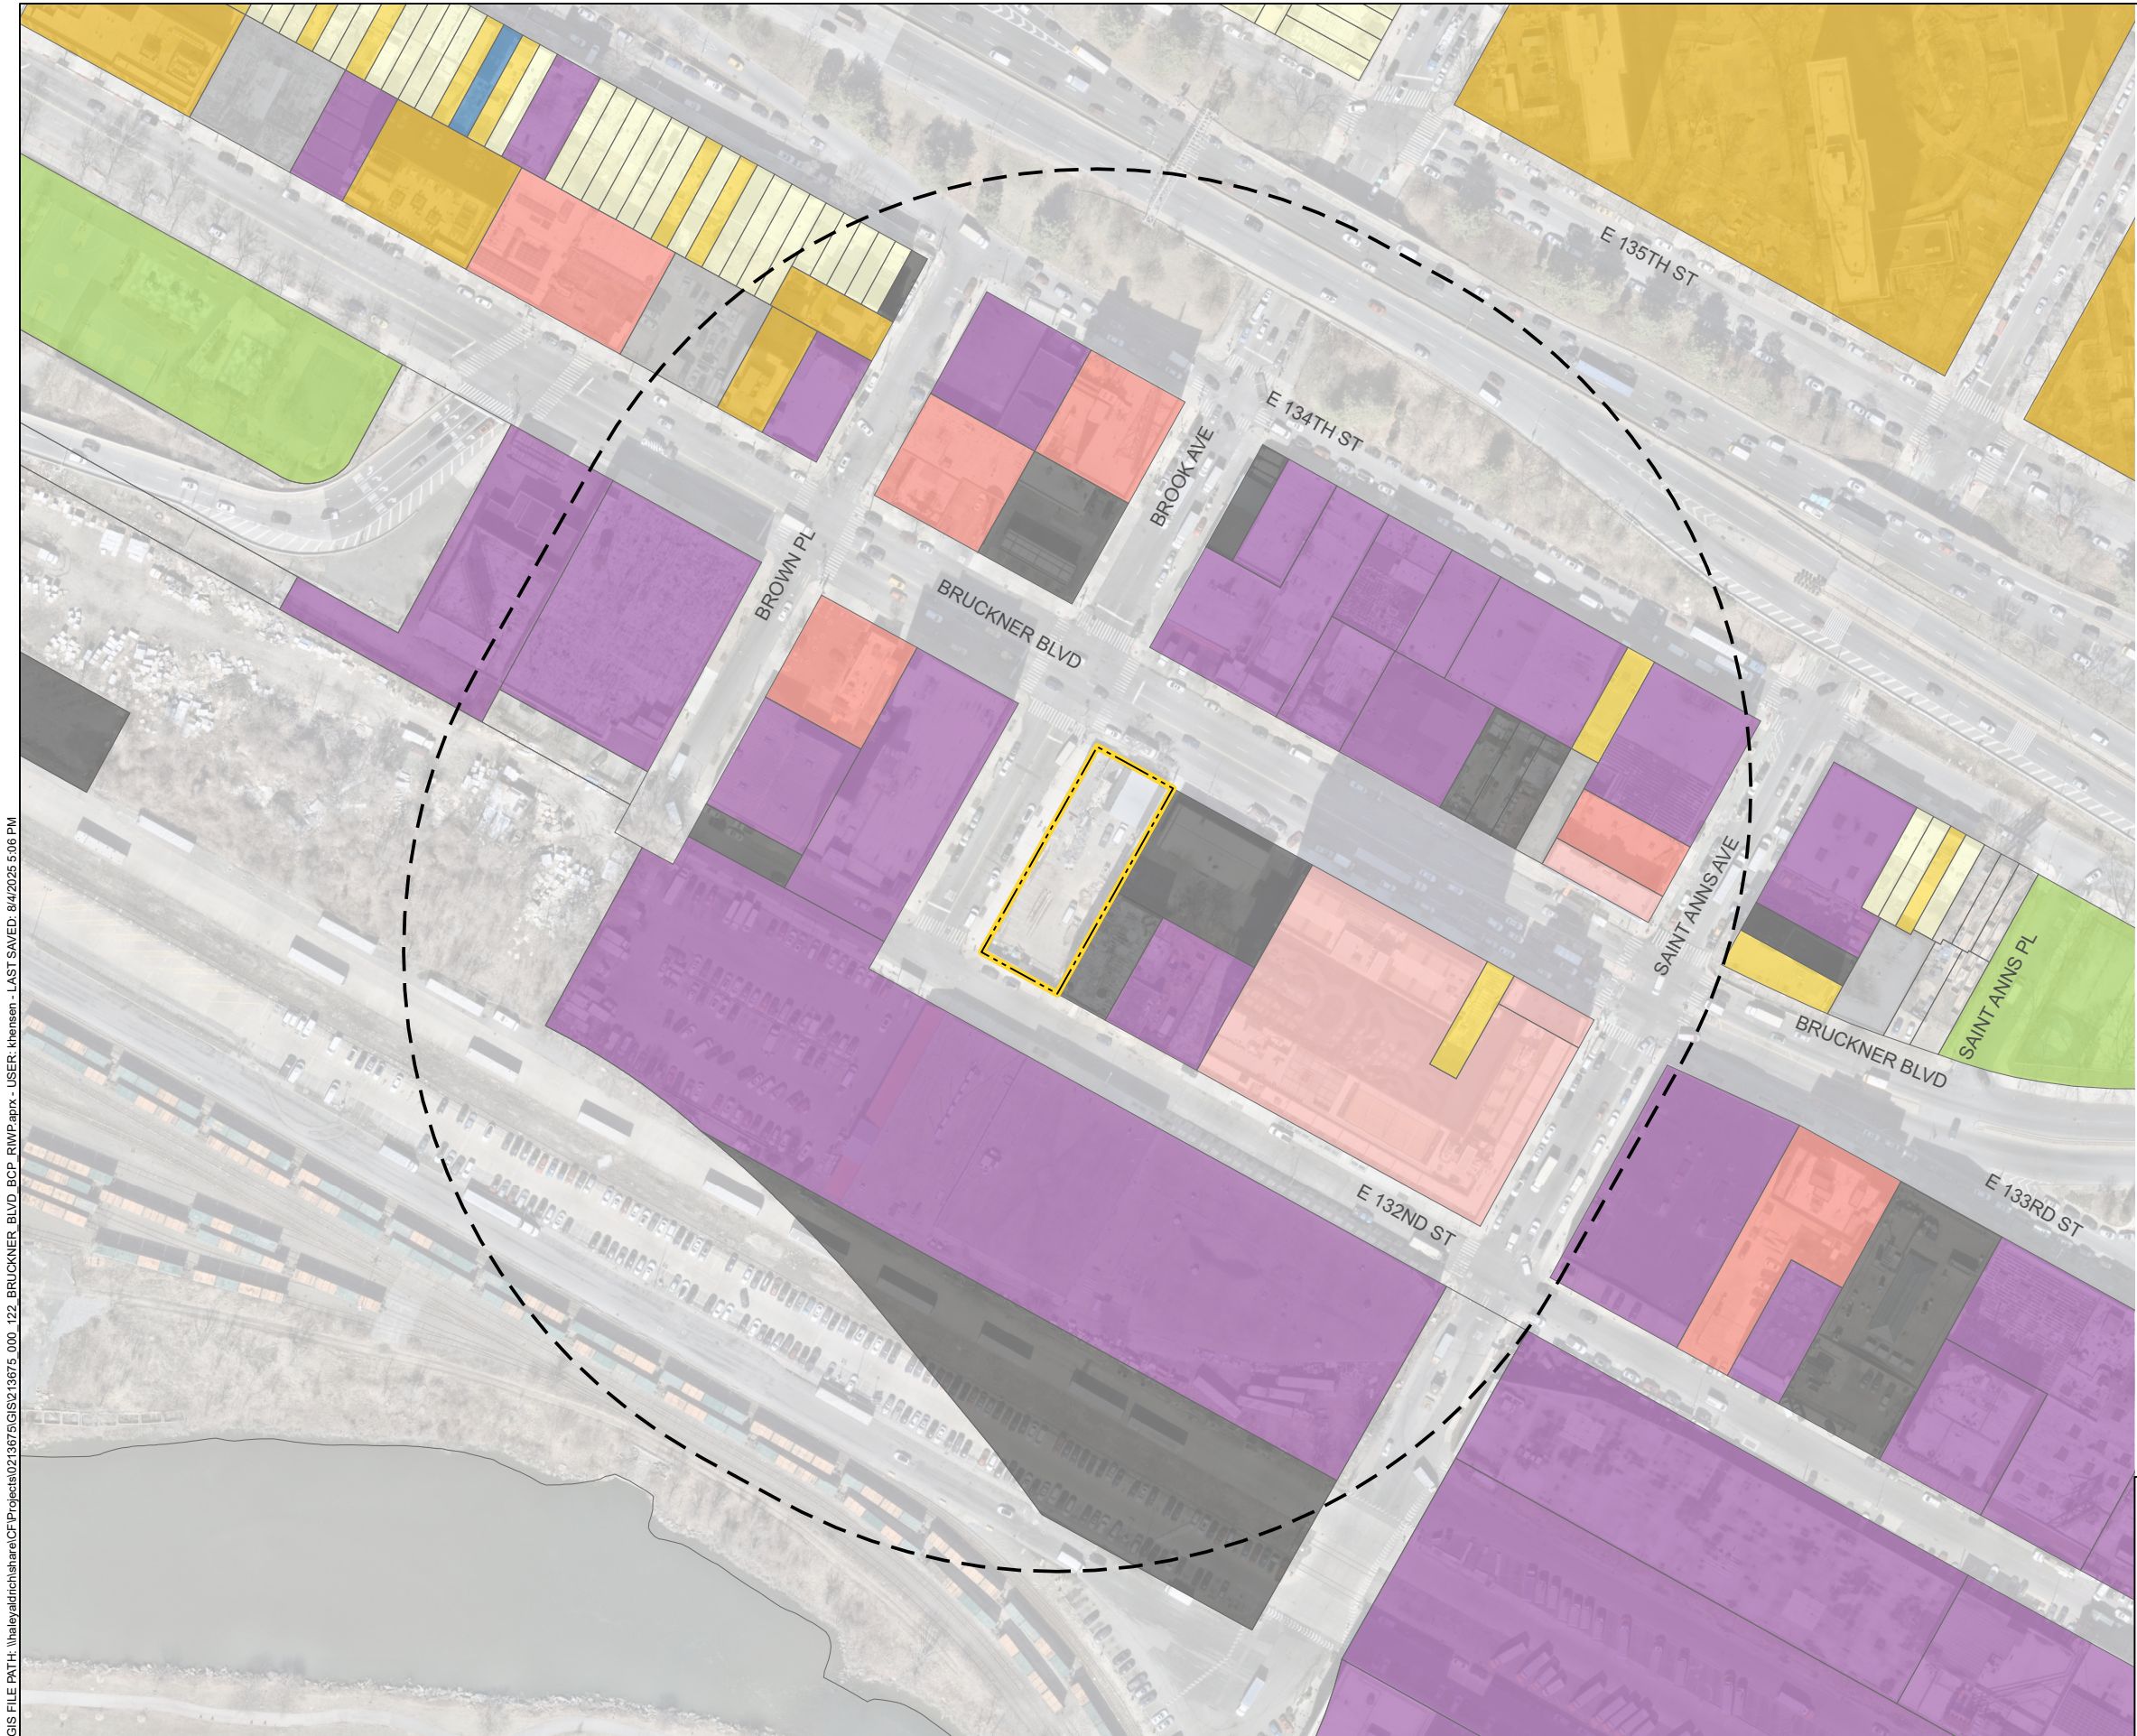
FIGURE 2

Soil samples representative of Site conditions will be collected at nine locations widely distributed across the Site, as shown on Figure 2. Three grab samples will be collected from each soil boring. One surface sample will be collected from the top 0 to 2 inches immediately beneath the impervious Site cover (i.e., surface soils). A second sample will be collected at an intermediate depth within the last 2 ft of the fill layer (estimated at 3 to 5 ft bgs, but subject to field observation). A third sample will be collected at a 2-ft interval above the groundwater interface (estimated to be encountered between 5 to 7 ft bgs, but subject to field observation). The number of samples collected during the RI may vary based on field conditions.

To further characterize soil conditions, additional on-site soil samples will be collected to meet NYSDEC Division of Environmental Remediation (DER)-10 requirements for RIs. The sampling and analysis plan is summarized in Table 1. Proposed sample locations are presented in Figure 2.

The Proposed Sample Location Map (included as Figure 2) is designed to generate sufficient data to identify the source(s) of contamination and classify subsurface conditions throughout the Site as a whole, with a particular focus on sample locations in areas of the Site that have historically revealed evidence of contamination.

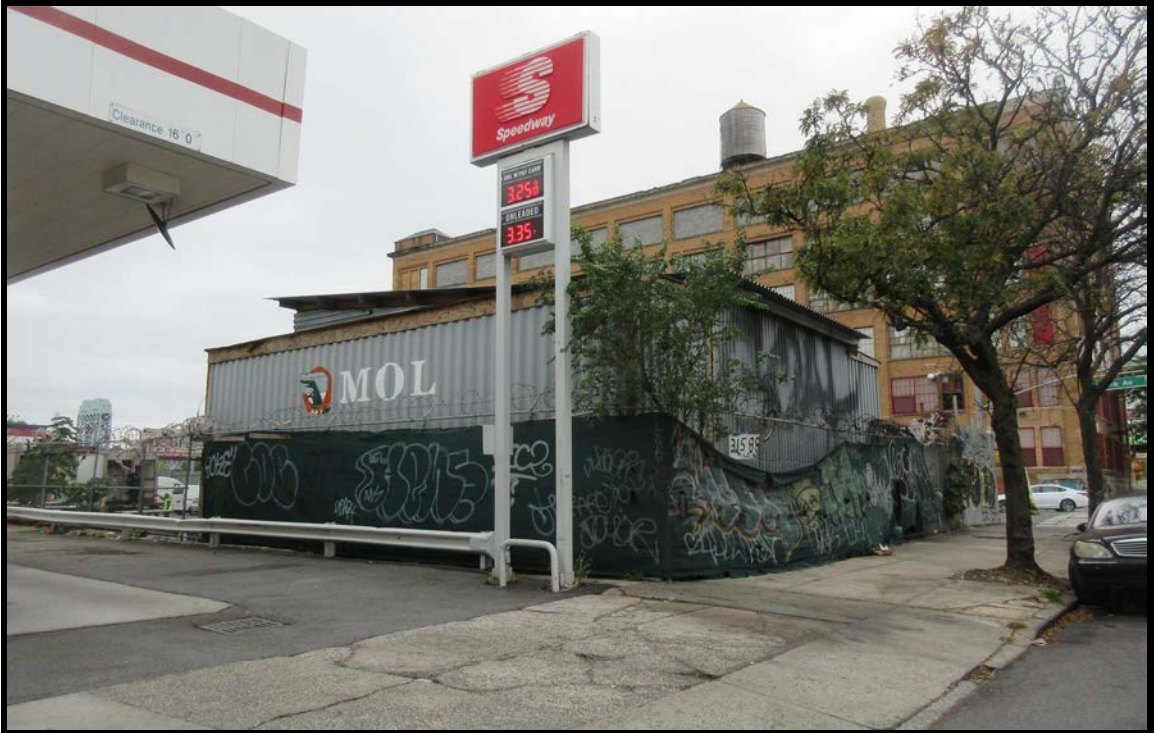
| <u>Photo No.</u> | <u>Description</u> |
|---|---|
| 7 | Western view from Bruckner Boulevard towards onsite store structure and entrance to neighboring Speedway station. |

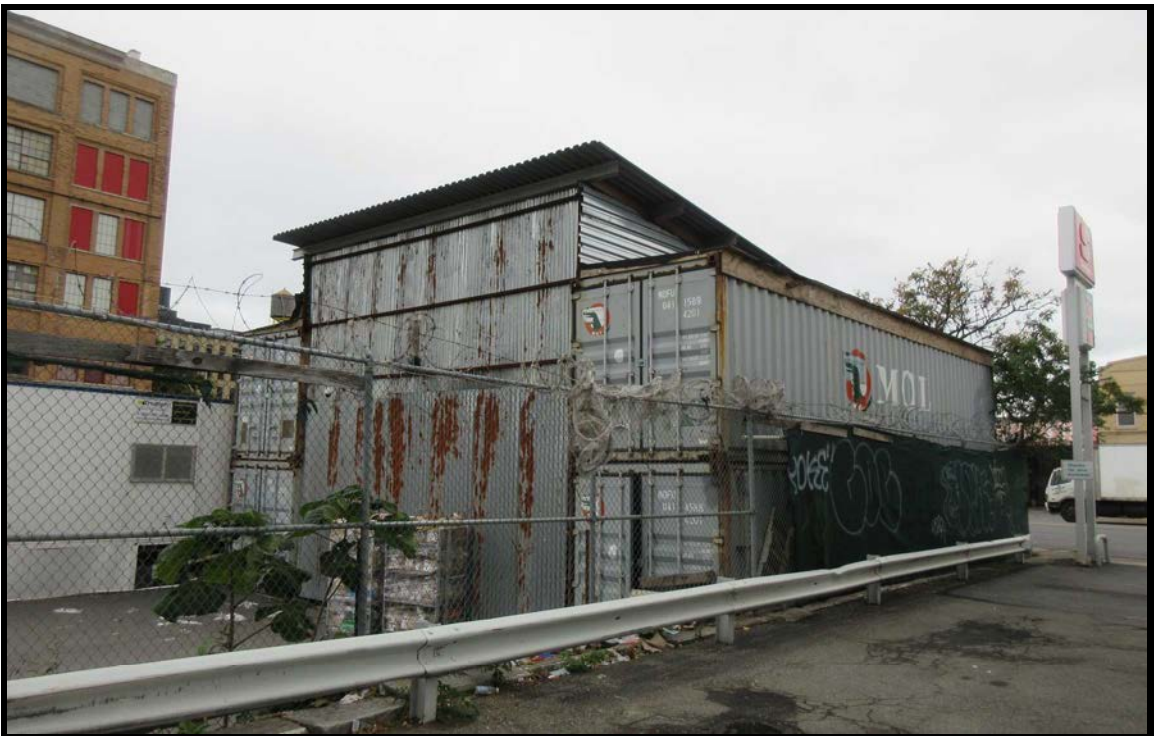
| <u>Photo No.</u> | <u>Description</u> |
|---|---|
| 8 | Northwestern view from adjoining Speedway gasoline station property towards storage structures found on subject property. |

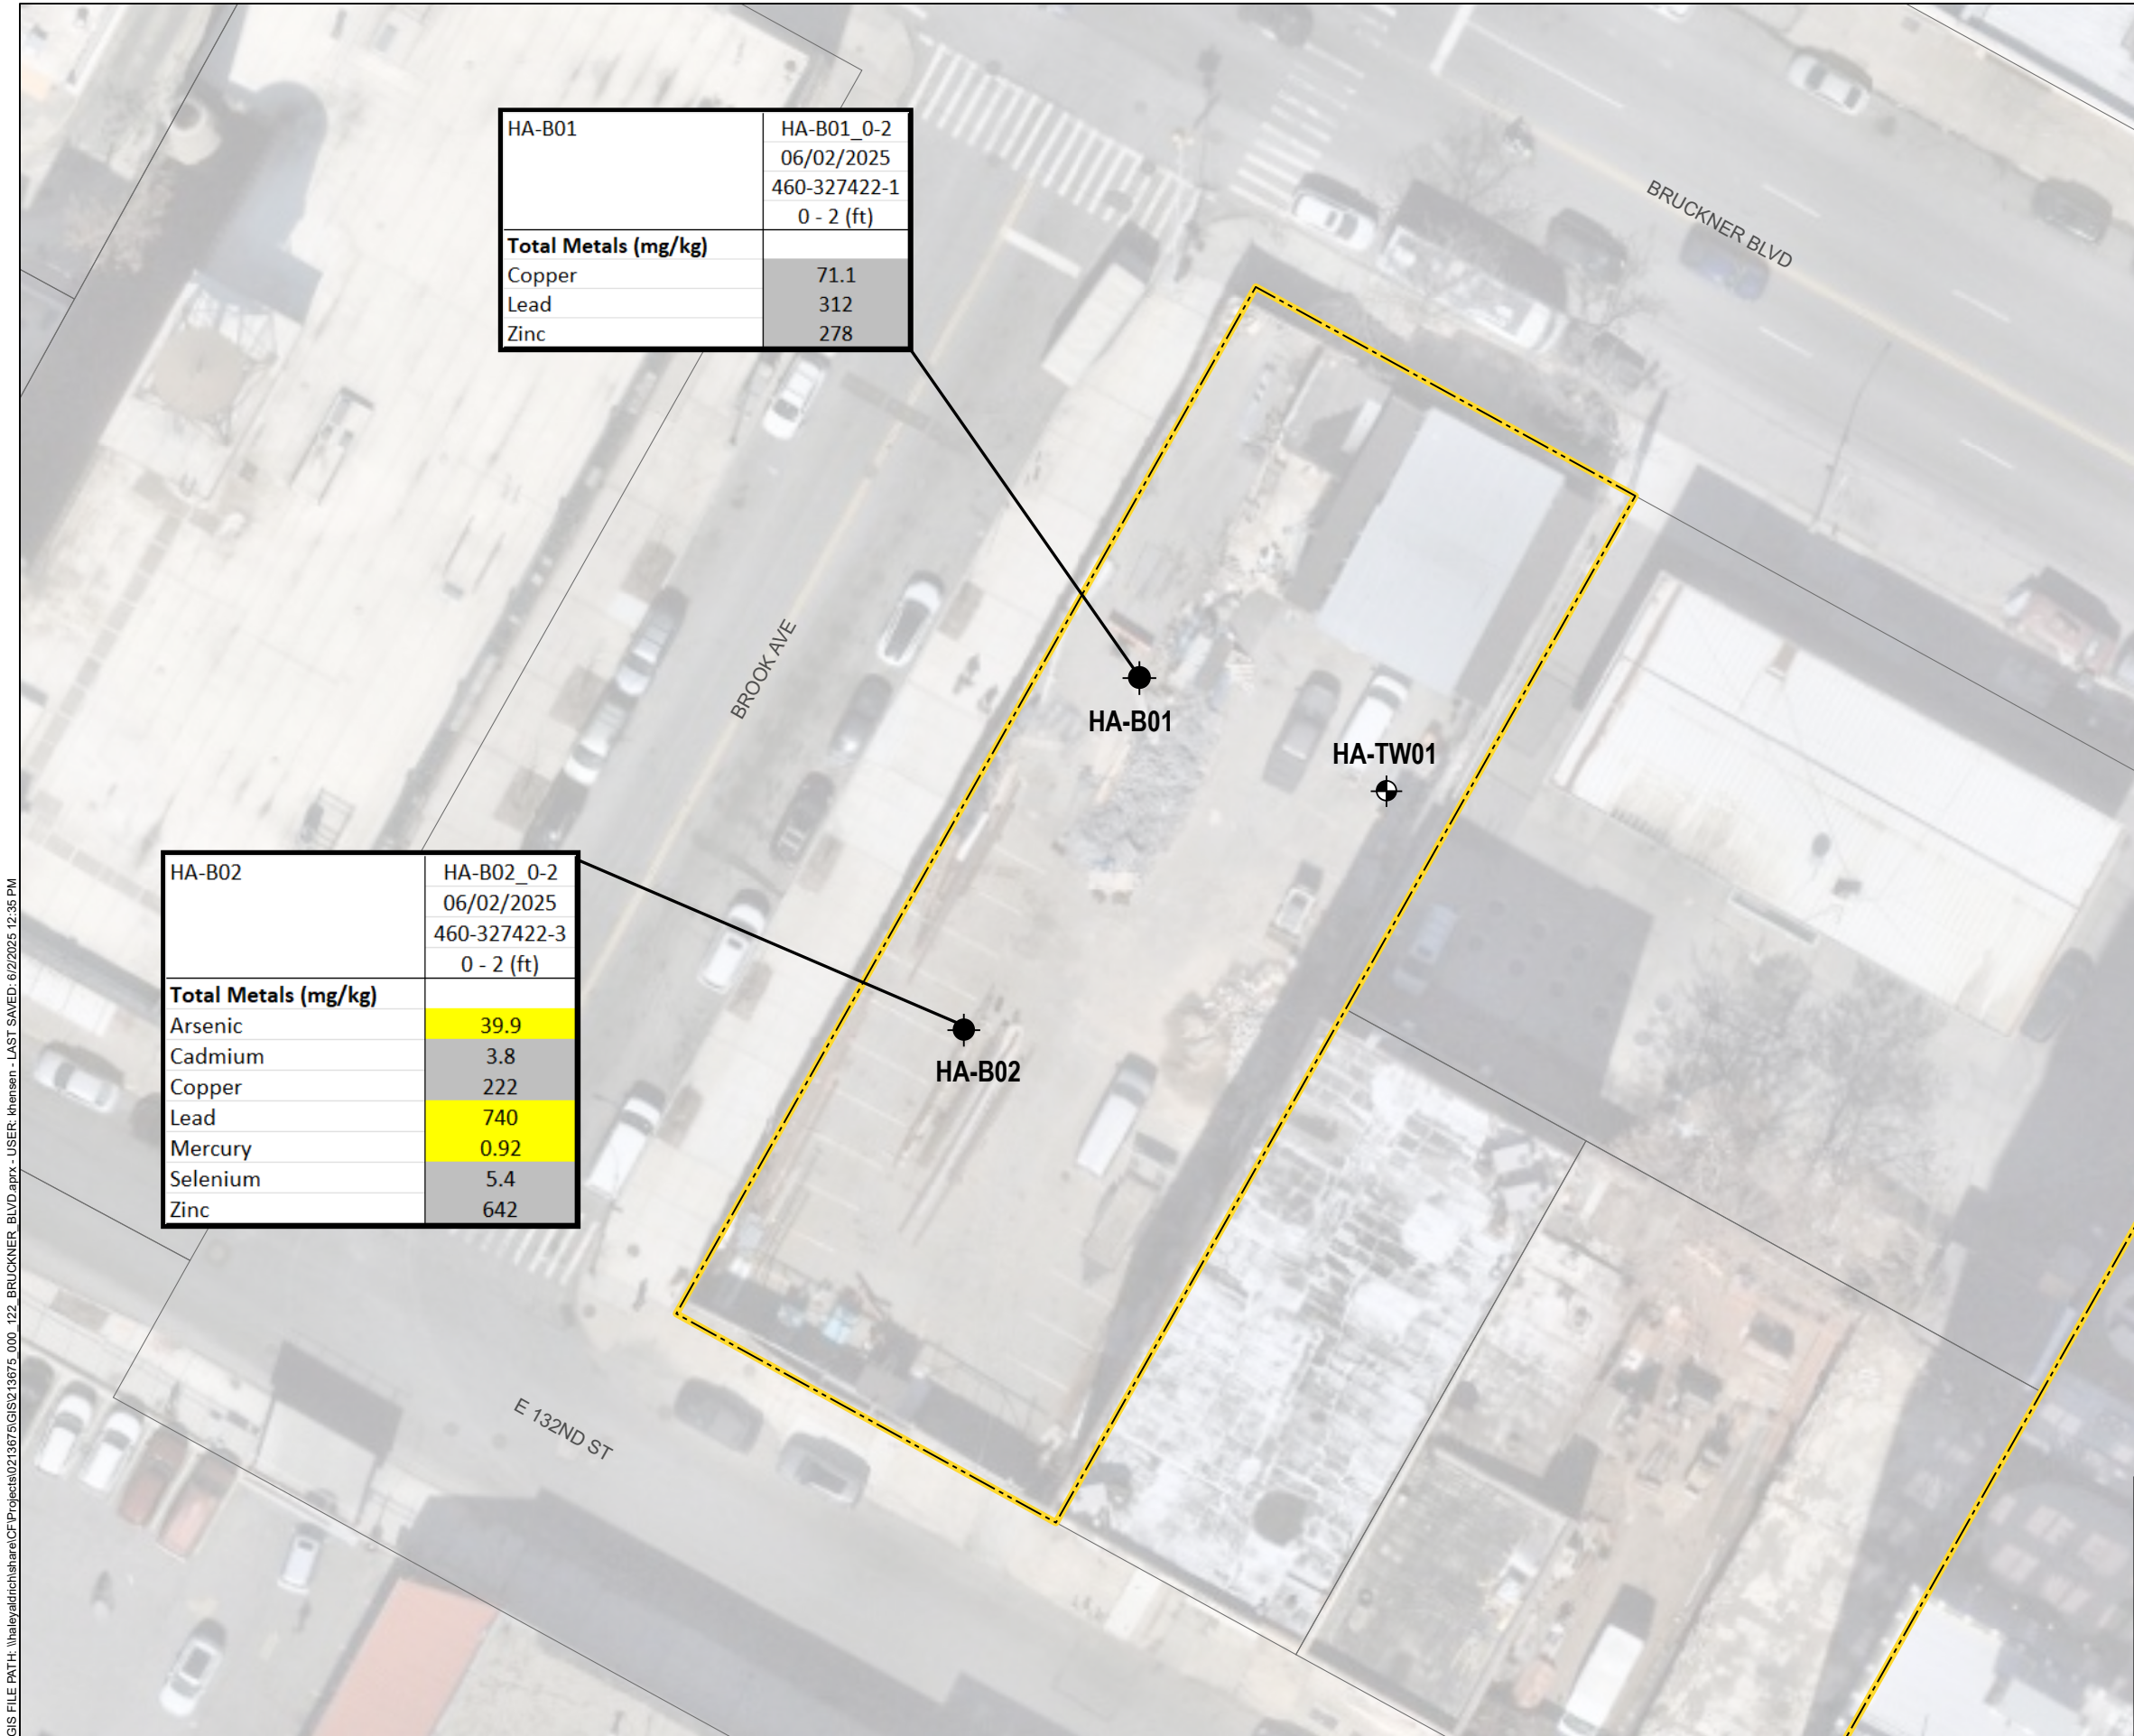
| HA-B01 | HA-B01_0-2 06/02/2025 460-327422-1 0 - 2 (ft) |
| Total Metals (mg/kg) | |
