FOCUSED SUBSURFACE SITE INVESTIGATION (FSSI)

**2737-2747 WEBSTER AVENUE
& 390 EAST 197TH STREET
BRONX, NEW YORK 10458**

PROJECT NO. M24352-1

MERRITT ENVIRONMENTAL CONSULTING CORP.

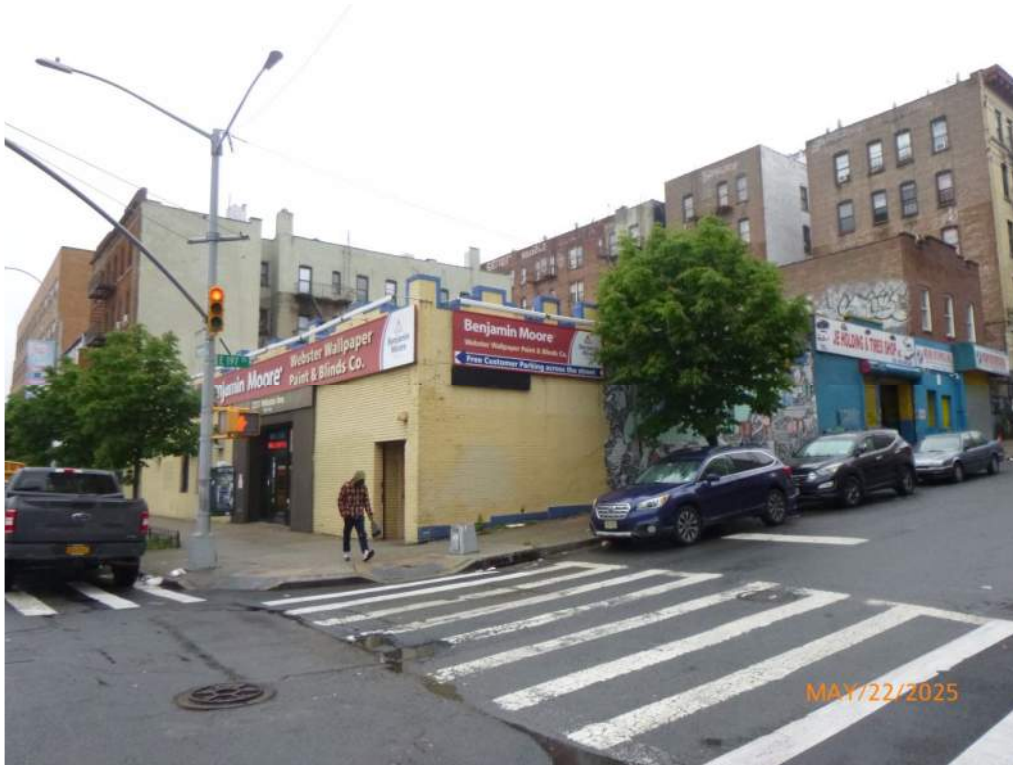
Photograph 1: View of the Site looking southwest from across the intersection of Webster Avenue and E. 197th Street. The 2737 to 2747 Webster Avenue building visible at foreground. The two smaller attached Site structures are visible at right-background.

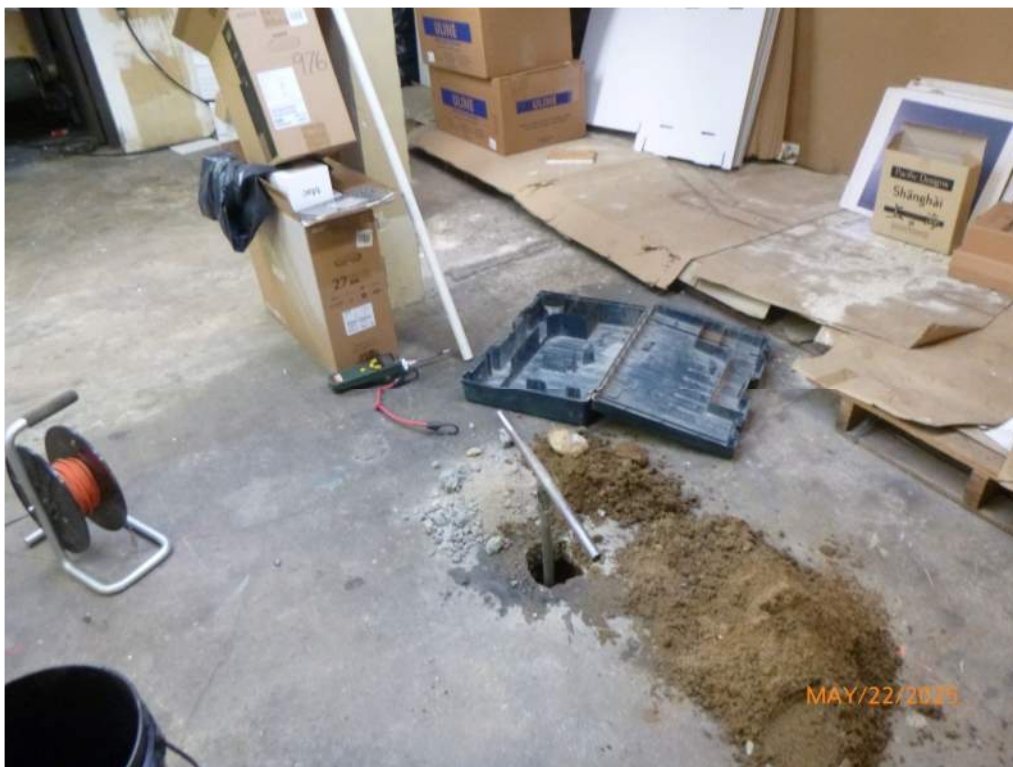
Photograph 2: Typical soil boring installation. B3 shown.

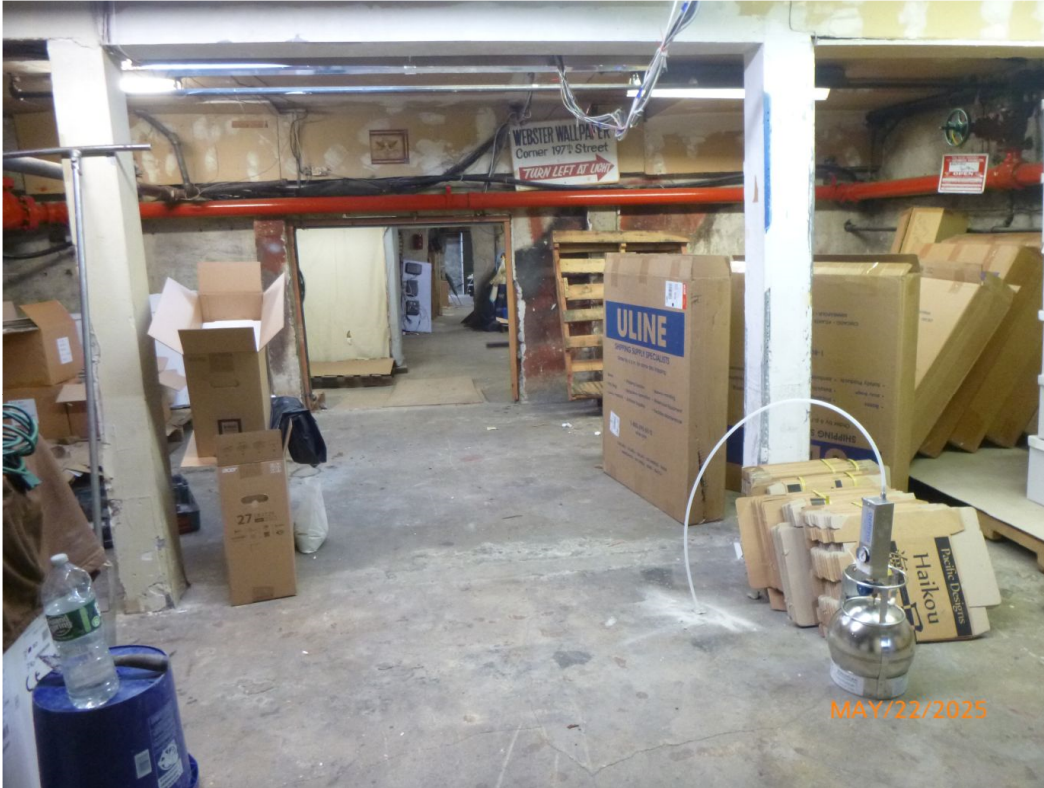
Photograph 3: Typical sub-slab soil vapor sample. SV2 shown.
