Data Report

Remedial Design Program

Former Citizens Gas Works
Manufactured Gas Plant Site
Brooklyn, New York
Brownfield Cleanup Program (BCP)
Site No. C224012

Project 093250-1-1106

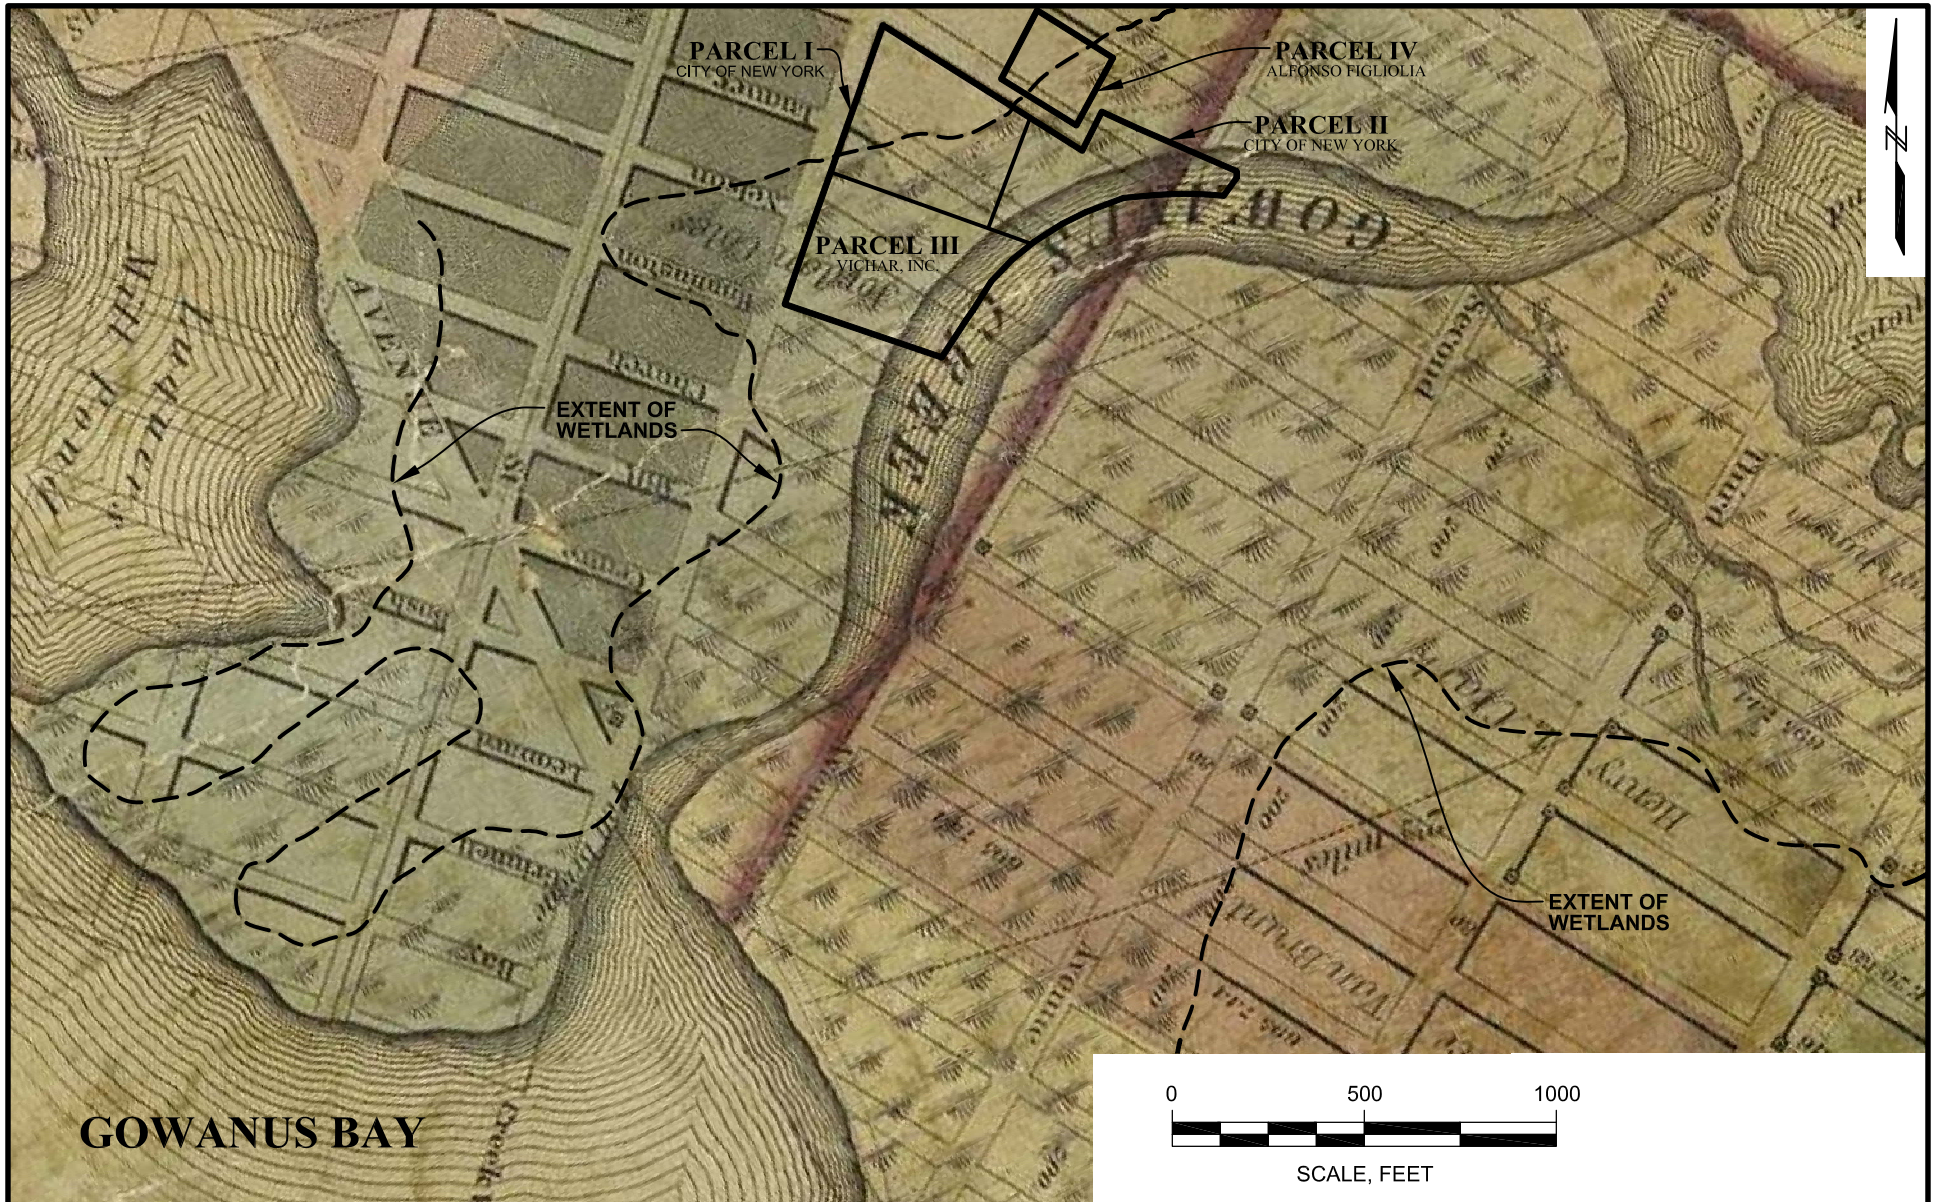
Figure 2

MAP OF THE CITY OF BROOKLYN, AS LAID OUT BY COMMISSIONERS AND CONFIRMED BY ACTS OF THE LEGISLATURE OF THE STATE OF NEW YORK, PUBLISHED BY J.H. COLTON, NEW YORK, 1849.

The bulkhead along the Gowanus Creek was constructed circa 1850 to mid-1860s, which effectively turned the creek into the canal that is in existence today. The location of the original creek can be seen in **Figure 2**. The bulkhead was constructed as a timber crib wall and aligned as shown in **Figure 5** (Hunter Research, Inc., Raber Associates, Inc. and Northern Ecological Associates, Inc.). A profile showing the subsurface conditions is included in **Figure 6**. Historical drawings, historical photographs, and recent photographs and video footage of the bulkhead are included in **Appendix C**.
