## **PERIODIC REVIEW REPORT**

**353 MCKIBBIN STREET  
BROOKLYN, NEW YORK  
NYSDEC BCP SITE NO. C224102**

**May 31, 2019**

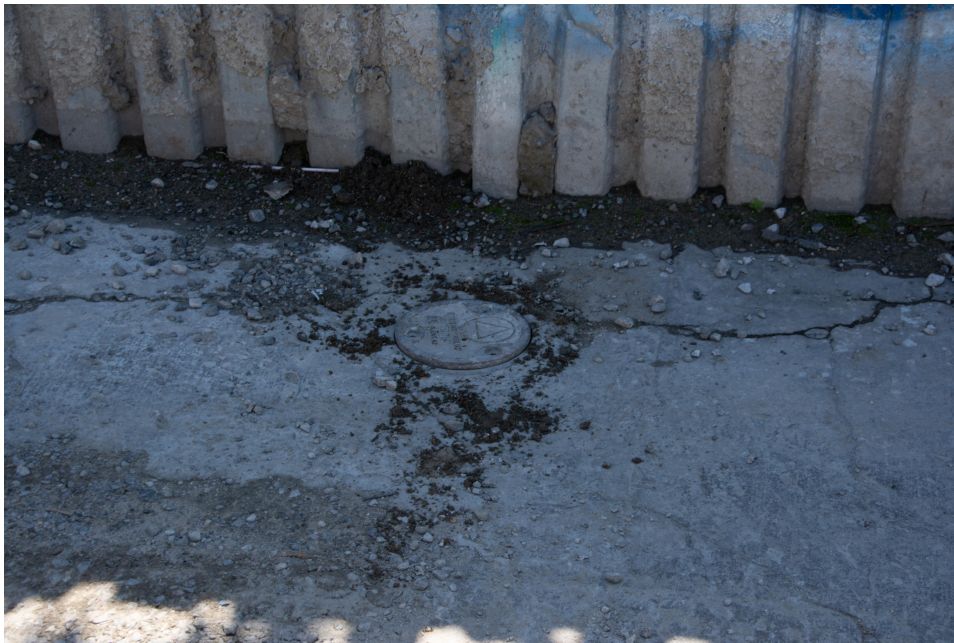
Wells located outside the fenced lot were in good condition. MW-7 needs minor repair to secure the access cover. Wells in the center of the site were covered by equipment or sediment and could not be located, (see photographs)

MW-7 in Boerum Street

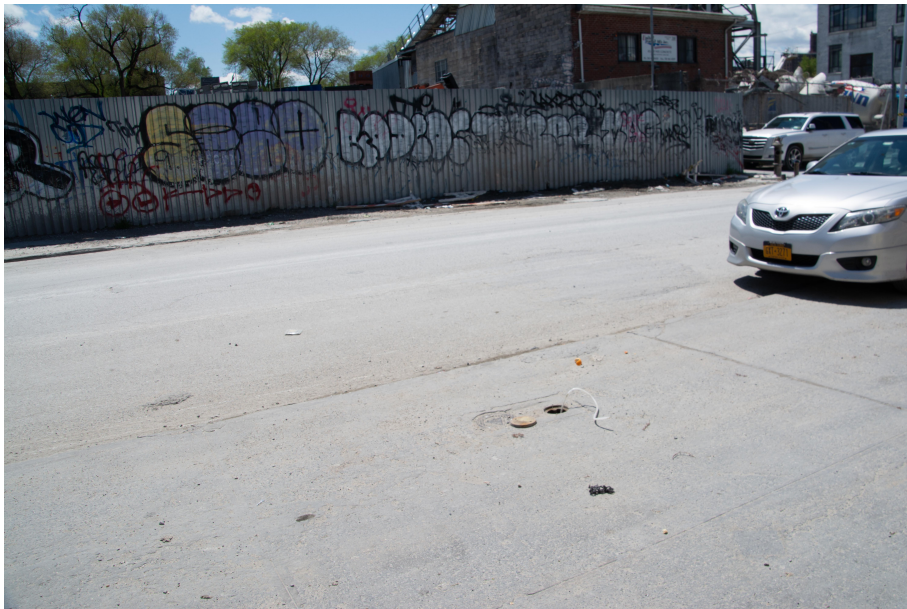
SG-9 Opened for Inspection; Boerum Street

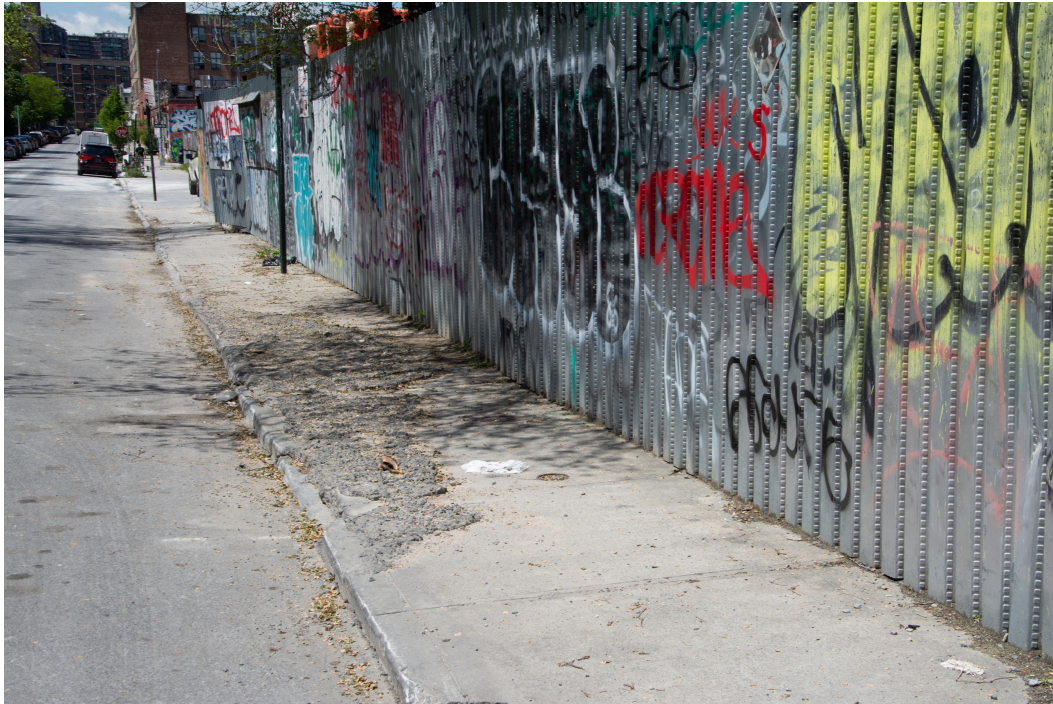
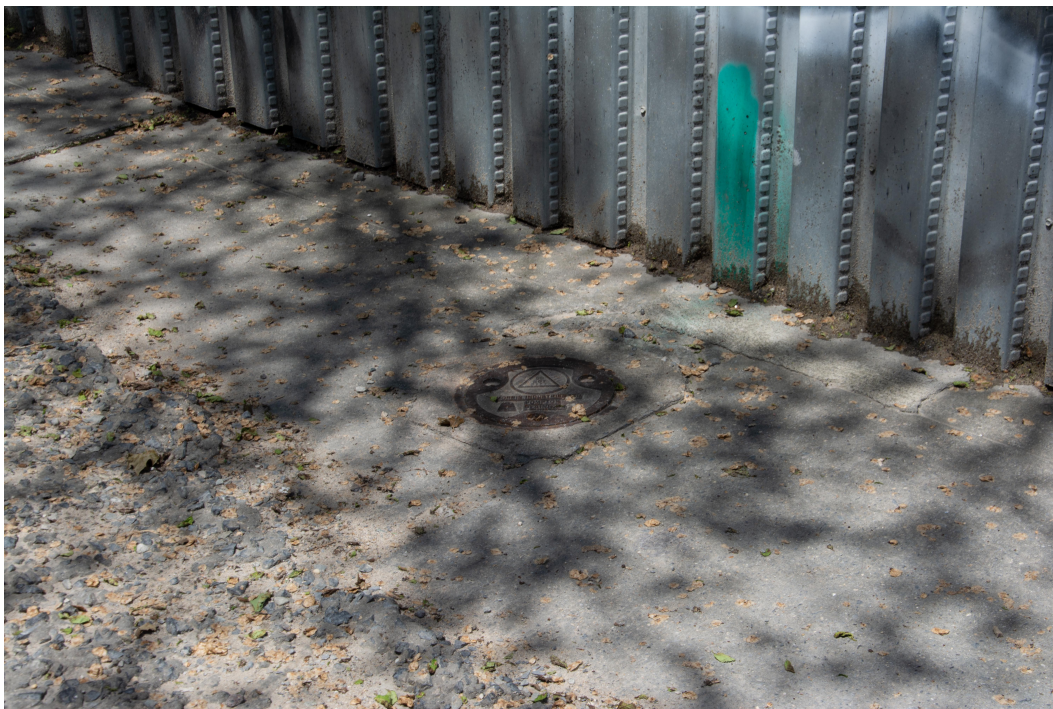
MW-8 in Bogart Street

MW-8 Close Up

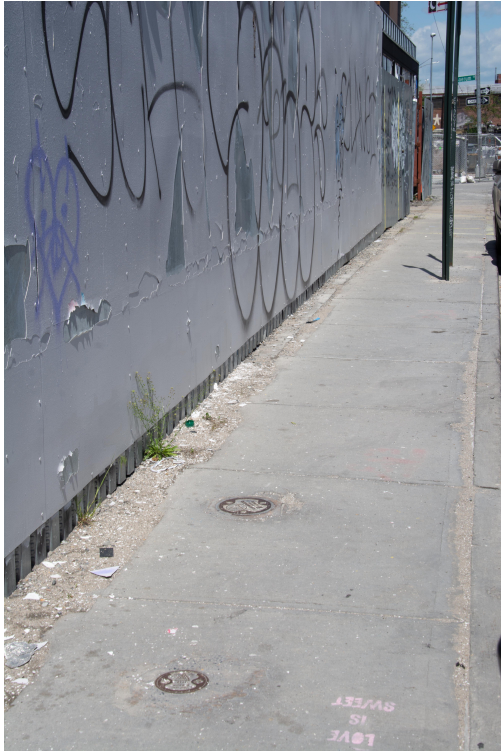
SG-4 in McKibbin Street; Former MW-9 in background  
(closed well)

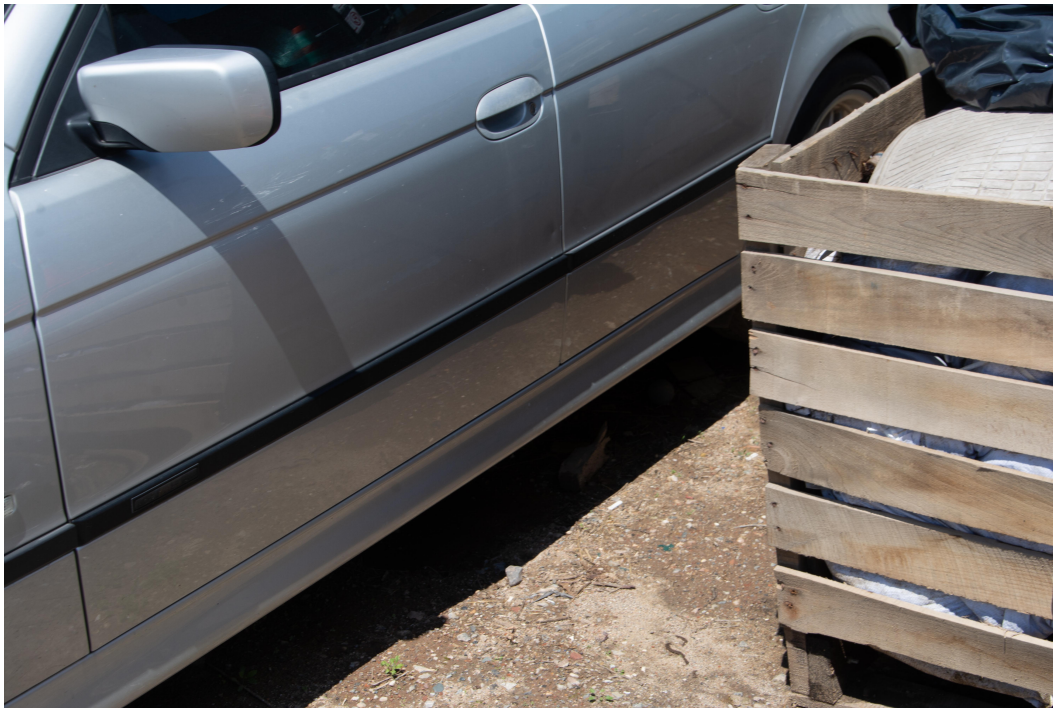
SV-5 under car

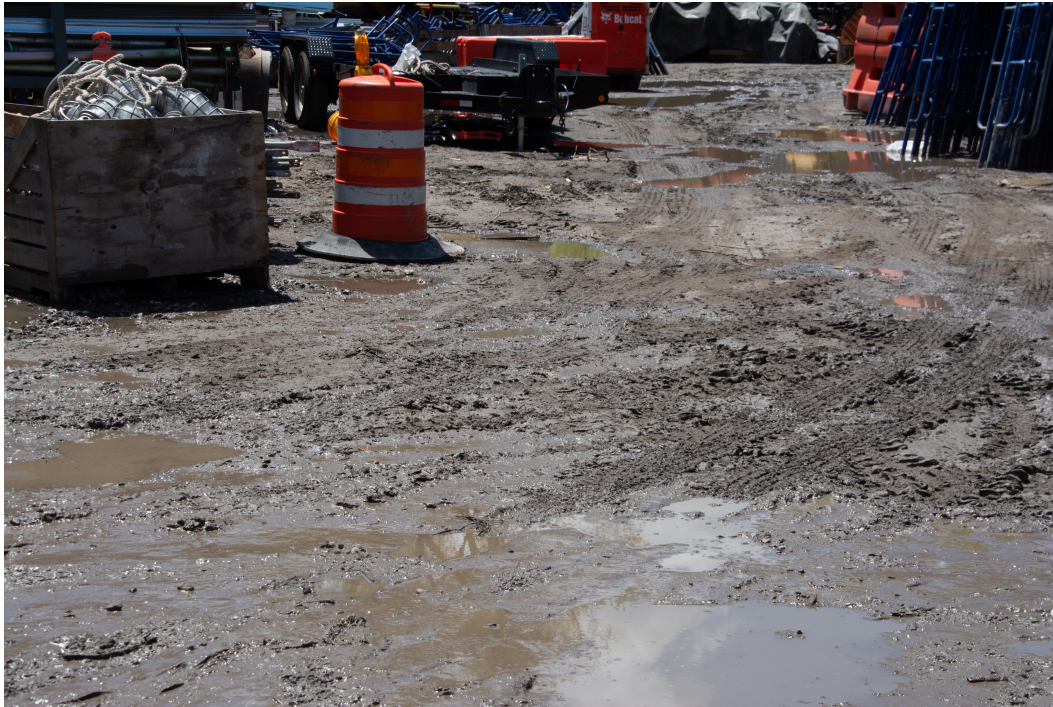
The McKibbin Street site is topographically depressed causing the collection of precipitation and snow melt and related sediment in the interior of the site, and most troubling in the vicinity of wells MW-5S, MW-5D, MW-10S and MW-10D. The result has been the loss or damage of wells in this interior area, including replacement and repair of the above-named wells as part of the CMWP in 2014, and by Langan in prior periods. Additionally, at times well identities have been obscured by the collection of sediment on top of the well protective casings resulting in misidentification of monitoring wells by the sampling crews.

These difficulties have led to the loss of well MW-10S that was last gauged on June 21, 2017. With the concurrence of the NYSDEC, well MW-10S has not been replaced. New this reporting period, we have had difficulty locating MW-5s during the winter months, in part, due to blockage by snow or equipment that could not be removed. The well was last gauged and sampled on September 27, 2018. Vapor probe SG-8 was similarly inaccessible over the winter but was recently located.

Condition of yard near MW-10D

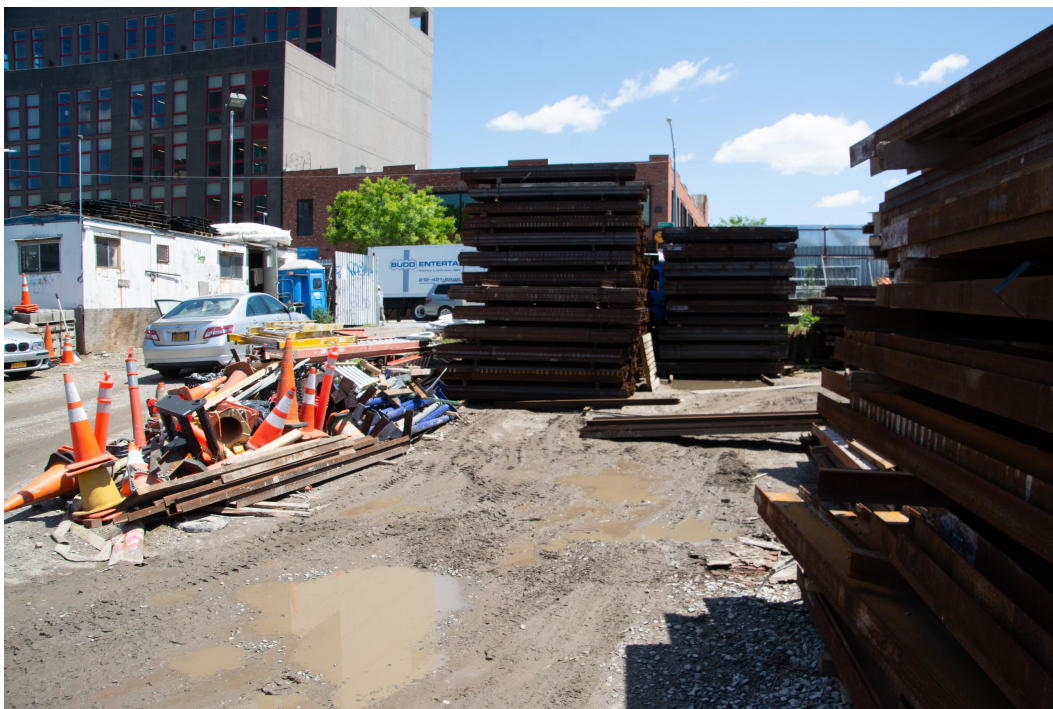
Condition of yard near SV-6; entrance ramp in background
