PROJECT:55 Eckford Street RI – C224168LOCATION:Brooklyn, New YorkCLIENT:55 Eckford St LLCWEATHER:Light to Heavy Rain

SUMMARY

ATTACHMENT B - PHOTO LOG

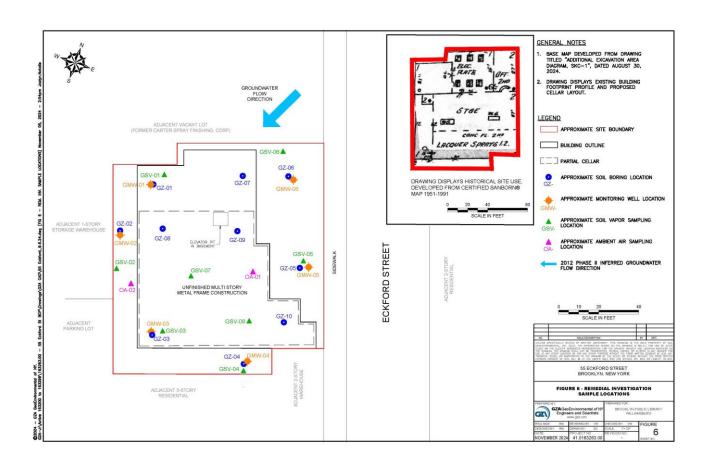
ATTACHMENT A - SITE PLAN

- 1. GZA observed soil boring drilling, logged soil borings, and collected soil samples for analysis. Soil boring locations are shown on **Attachment A**.
- 2. Coastal Environmental Solutions, Inc. (Coastal) used a Geoprobe 7822DT to advance soil boring GZ-05 to a maximum depth of 20 feet below ground surface (bgs) and a hand auger to advance soil borings GZ-08, GZ-09 and GZ-10 to a maximum depth of 10 feet bgs.

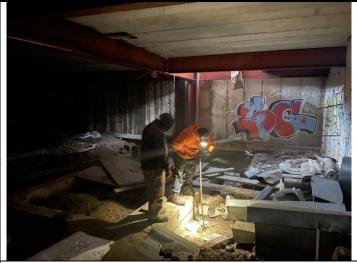
Photo No.Direction Photo Taken:Photo No.Direction Photo Taken1North2N/A

Description: Coastal advancing soil boring GZ-09.

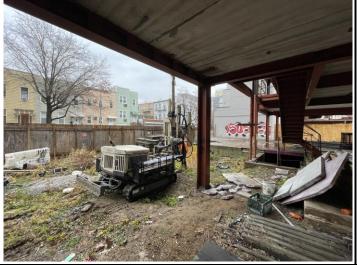
Photo No. Direction Photo Taken: Photo No. 3 Southeast 4

Description: Coastal advancing soil boring GZ-07.
