GZA DAILY FIELD SUMMARY 003

PROJECT:	55 Eckford Street RI – C224168	LOCATION:	Brooklyn, New York
CLIENT:	55 Eckford St LLC	WEATHER:	Partly Cloudy
PREPARED BY:	Matt DiLorenzo (GZA)	AVE. TEMPERATURE	38.48°F
REVIEWED BY:	Reinbill Maniquez (GZA)	AVE. DEW POINT	15.45°F
		MAX WIND SPEED	24 mph from NE
ATTACHMENTS:	A – Site Plan	PRECIPITATION	0.78 inches
	B – Photo Log		
	C – Daily Calibration and Air Monitoring Logs

ATTACHMENT A – SITE PLAN

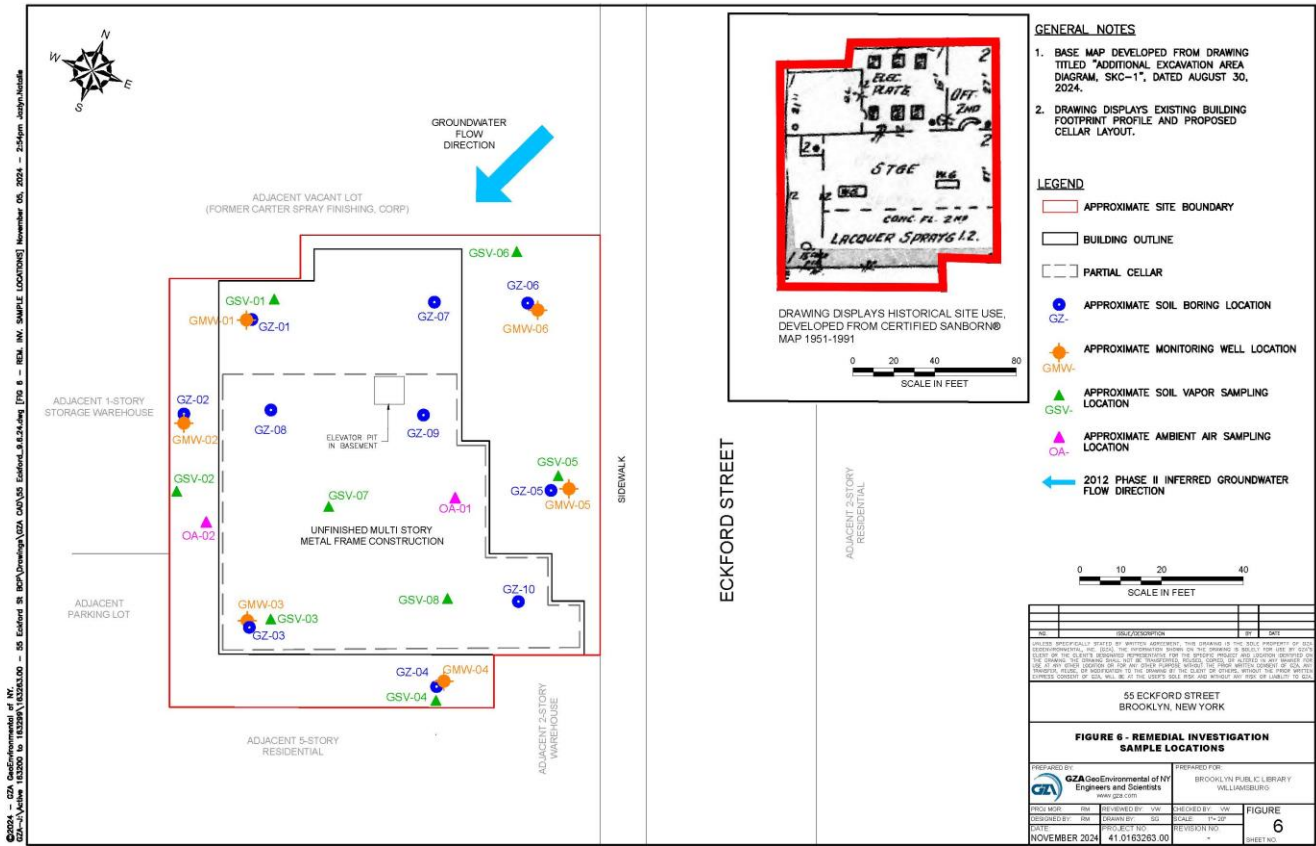
1. GZA observed soil boring drilling, logged soil borings, and collected soil samples for analysis. Soil boring locations are shown on **Attachment A**.
2. Coastal Environmental Solutions, Inc. (Coastal) used a Geoprobe 7822DT to advance soil boring GZ-01, GZ-02, GZ-03 and GZ-04 to a maximum depth of 20 feet below ground surface (bgs).
3. Coastal installed soil vapor points GSV-01 through GSV-05 to a depth of 8 feet bgs and GSV-06 through GSV-08 to a depth of 1-2 feet below the cellar level slab.

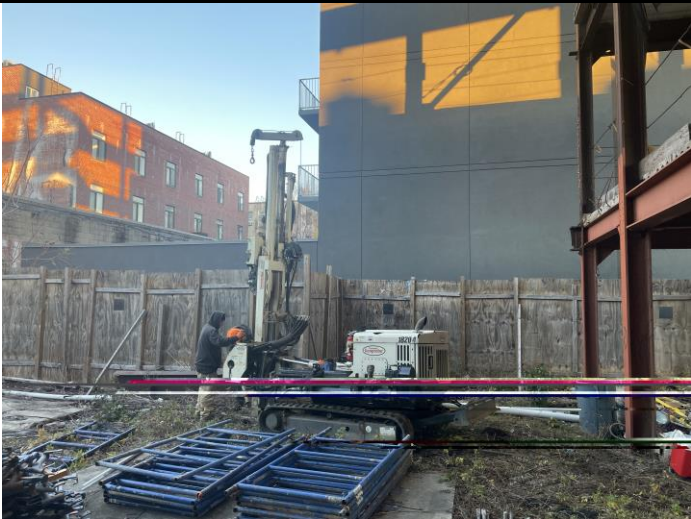
Photo No. 1	Direction Photo Taken: North	Photo No. 2	Direction Photo Taken South

Description: Coastal advancing soil boring GZ-01.		Description: Coastal advancing soil boring GZ-02.	
Photo No. 3	Direction Photo Taken: N/A	Photo No. 4	Direction Photo Taken N/A

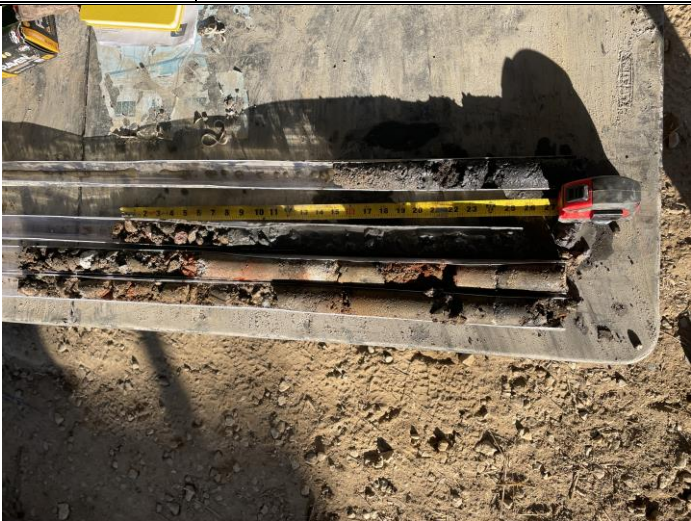
Description: Macrocores collected from soil boring GZ-03.		Description: GZA using handheld PID to collect direct reading measurements from macrocore soil sample from GZ-04.

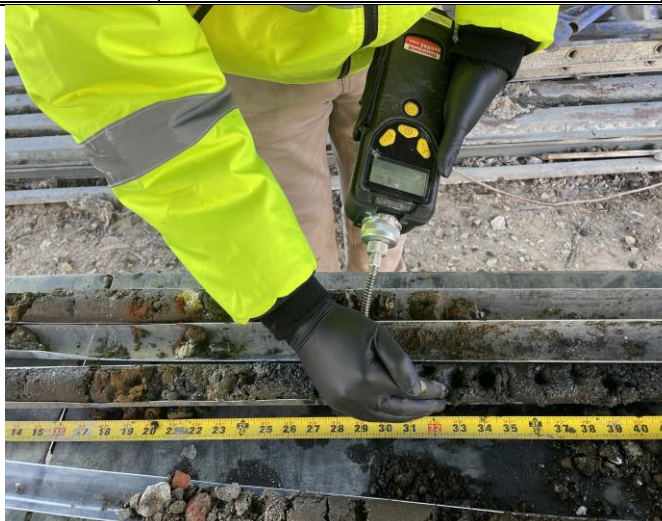
- GZA used a handheld PID to collect direct reading measurements throughout each sleeve of recovered soil. The highest reading of 106.2 ppm was recorded at approximately 15' bgs at soil boring GZ-01.
