# GZA DAILY FIELD SUMMARY 010

DATE: 8/21/2025  
FILE NO: 41.0163263.10

PROJECT: 55 Eckford Street RI – C224168  
CLIENT: 55 Eckford St LLC  
PREPARED BY: Jazlyn Natalie (GZA)  
REVIEWED BY: Reinbill Maniquez (GZA)

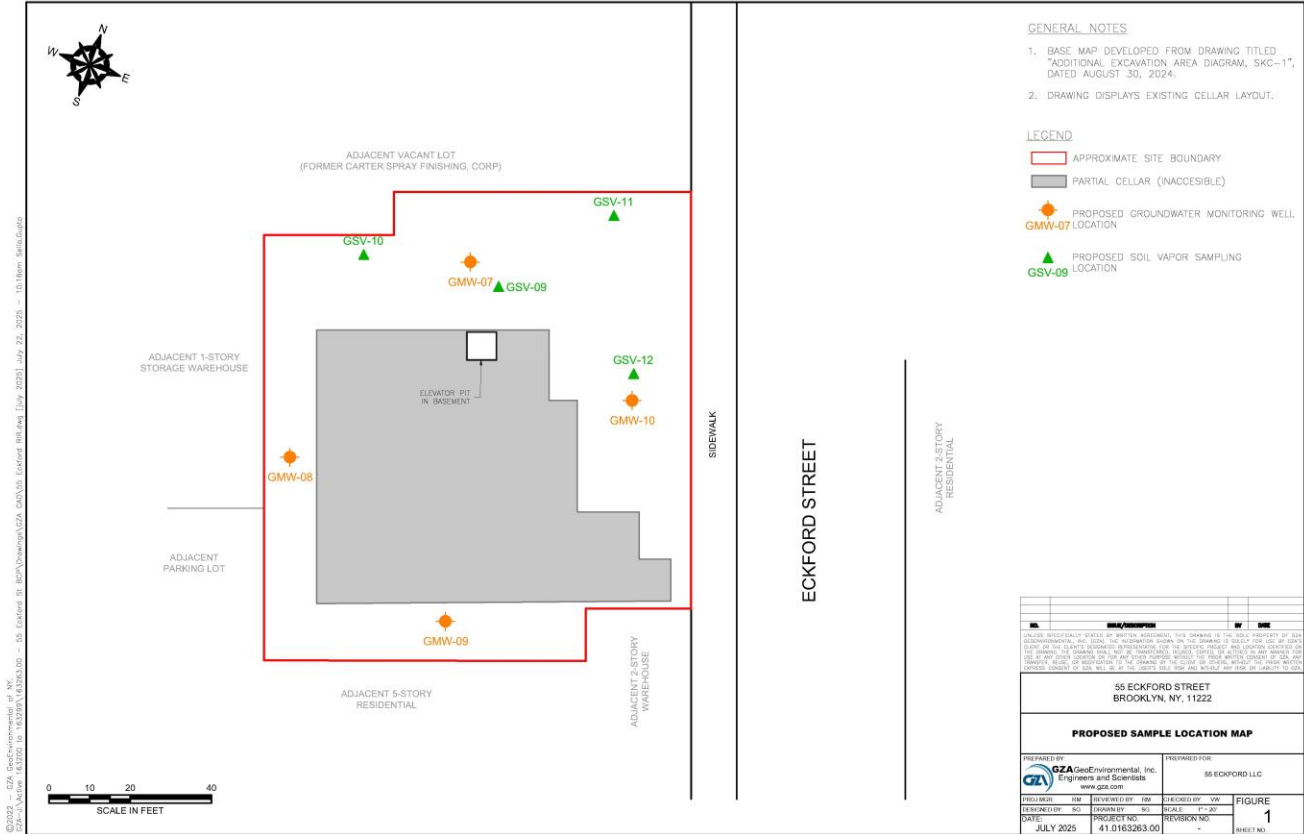
ATTACHMENT A – SITE PLAN

1. Coastal Environmental Solutions, Inc. (Coastal) used a Geoprobe 6620DT with Hollow Stem Augers to install monitoring wells GMW-07 and GMW-08 to approximately 20 feet below ground surface; screens were set from 10 to 20 feet bgs. Monitoring well locations are shown on **Attachment A**.
2. Coastal performed boring drilling prior to well installation to determine groundwater elevation following the demolition of the 6-story steel structure onsite. GZA observed the drilling and logged general descriptions of soil borings.
3. Renovation Group previously performed demolition of the 6-story steel structure onsite.
