GZA DAILY FIELD SUMMARY 011

PROJECT: 55 Eckford Street RI – C224168
CLIENT: 55 Eckford St LLC
PREPARED BY: Jazlyn Natalie (GZA)
REVIEWED BY: Reinbill Maniquez (GZA)

The following report summarizes the daily activities performed under the Supplemental Remedial Investigation Work Plan (RIWP) at 55 Eckford Street, Brooklyn, NY. The Site has entered into an agreement with the New York State Department of Environmental Conservation (NYSDEC) under the New York State Brownfield Cleanup Program (BCP), BCP Site No. C224168. The Supplemental RIWP was approved by the NYSDEC on July 22, 2025. Unless otherwise stated, the work observed and documented by GZA was performed in accordance with the Contract Documents.

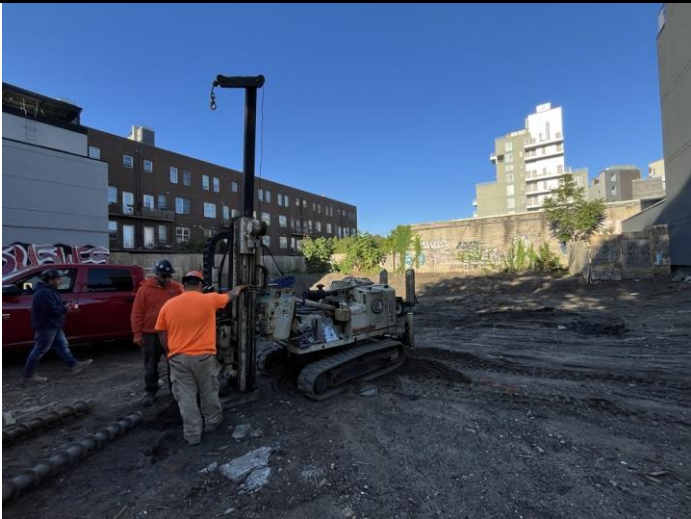
Photo No. 1	Direction Photo Taken: Southwest	Photo No. 2	Direction Photo Taken South

Description: Coastal drilling GMW-10 with Geoprobe hollow stem augers.		Description: Coastal developing monitoring well GMW-09.	
Photo No. 3	Direction Photo Taken: North	Photo No. 4	Direction Photo Taken N/A

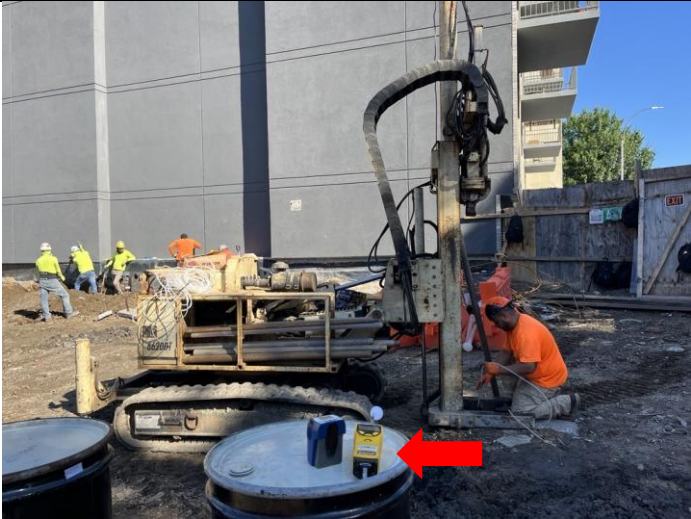
Description: Coastal installing soil vapor probe GSV-12. Air monitoring performed by GZA using handheld equipment.		Description: Helium tracer test performed at GSV-12 prior to sample collection.
