REMEDIAL INVESTIGATION REPORT

363 BOND STREET AND 388 CARROLL STREET Brooklyn, New York

Tax Map Block 452, Lots 1 and 15
NYCOER Project No. 13EH-A196K
NYSDEC Spill No. 05-01697
NYSDEC Brownfield Cleanup Site No. C224173
USEPA No. 422395.DE.02

24 November 2014
100287501

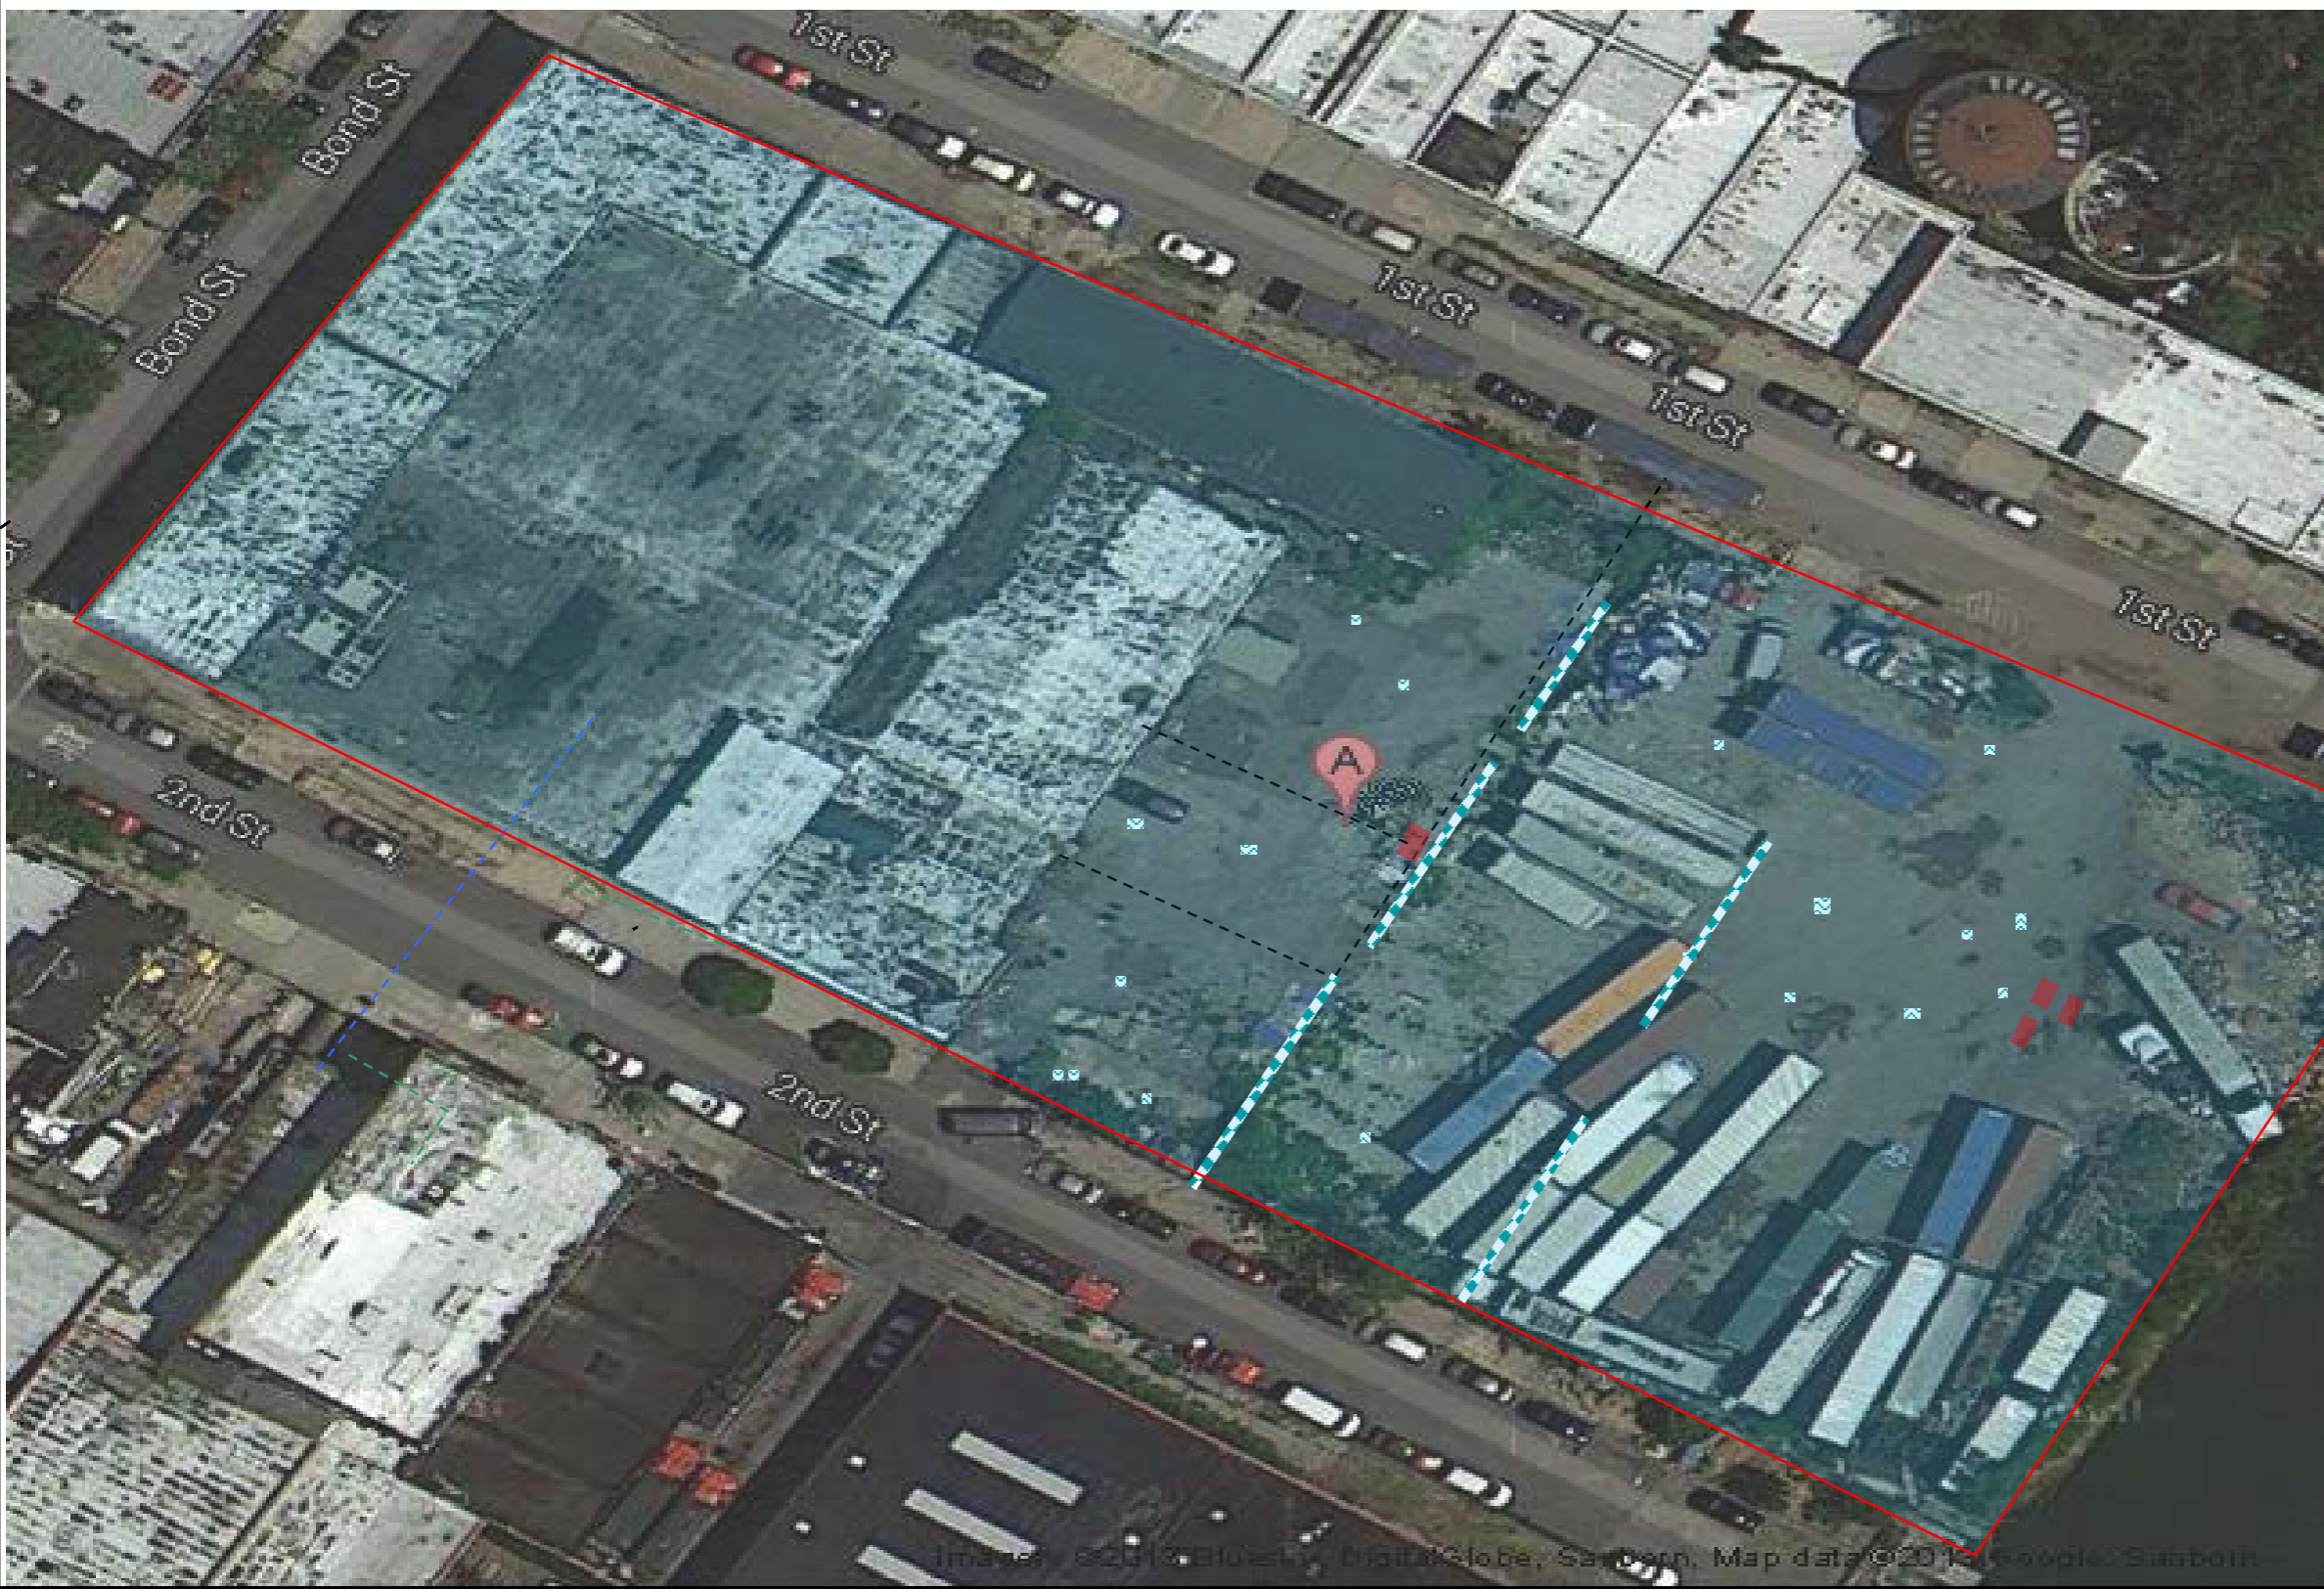
1- All anomalies were marked in the field.

Anomaly (Former Foundation Structures)

Anomalies (Detected with EM)

The project site was first screened using the Geonics(tm) electromagnetic detector by carrying the instrument over the boring locations at the site in 5' x 5' traverses. When evidence of anomalies were observed, the Ditch-witch(tm) utility locator was then used to determine if the anomalies were utilities or other large sub-surface metal objects. Finally, GPR profiles were collected over each metal-detector anomaly and inspected for reflections, which could be indicative of major anomalies.
