MEMORANDUM

Subject: Monthly Progress Report
Former Cleaner Sales and Equipment Corp. NYSDEC Site No. C224177

PHOTOGRAPHS FROM JULY 22, 2022 SITE WALK AND SUBSEQUENT SLAB REPAIRS

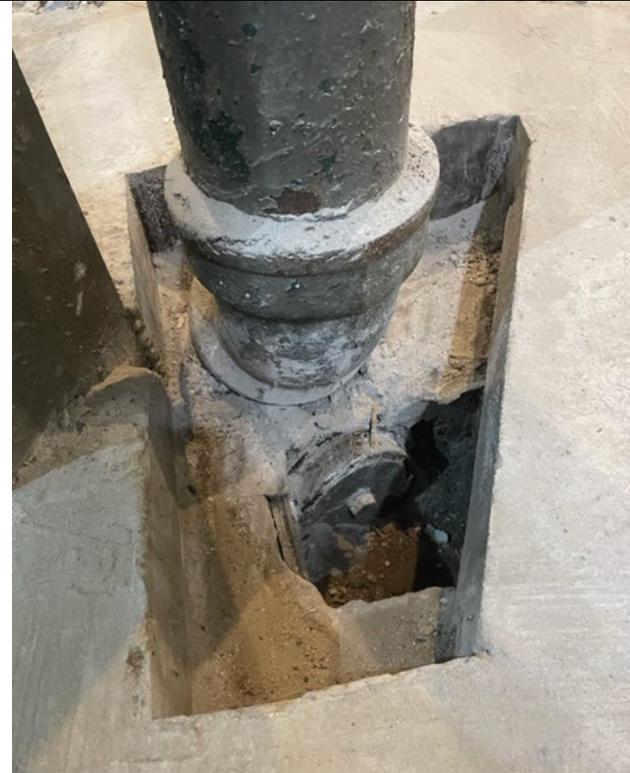
sewer pipe was a pre-existing, irregular slab cutout that was left to accommodate a sewer clean out (attached Photo 1). This area is currently used as storage space, and was previously the office space for the real estate group at the back of the coffee shop (see attached figure). We believe this slab cutout has been in place since the building was converted to commercial space in the early 2000s, but it had been concealed by the demising wall until July 2022.

Integral cleaned out the debris in the slab cutout and observed an approximately 4- by 6-inch area of exposed soil (Photo 1). Integral used a photoionization detector to check the soil and there were no detections of volatile organic compounds. Integral showed the cutout to the building superintendent and requested this that it be filled as soon as possible. Air filtration units are running in that storage space. Representatives from 135 Kent LLC confirmed that the slab cutout was filled with concrete and that the space around the sewer pipe was sealed (Photo 2). Integral confirmed the adequacy of the repair during a site visit on August 3, 2022.

Photo 1. Slab cutout at base of vertical sewer pipe

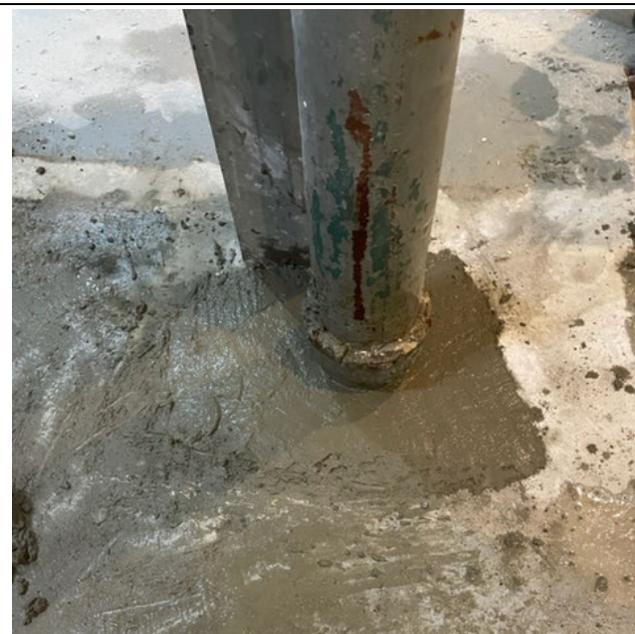
Photo 2. Slab cutout at base of vertical sewer pipe filled with concrete

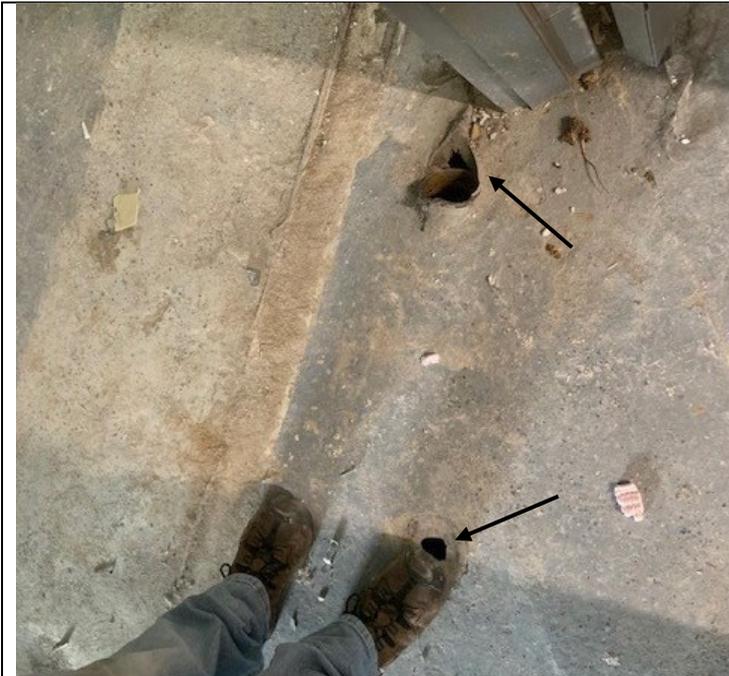
Separately, Blossom ice cream is no longer a tenant as of July 2022 and the space previously occupied by Blossom is now vacant. When reviewing conditions in that space Integral noted two pipe openings that were exposed when Blossom's equipment was removed (Photo 3). Integral noted one opening was filled during the August 3 site visit (Photo 4); and is working with the building superintendent to identify a means of capping the second pipe opening. Air filtration units are running in that space.

Photo 3. Pipe openings identified in former Blossom ice cream commercial space

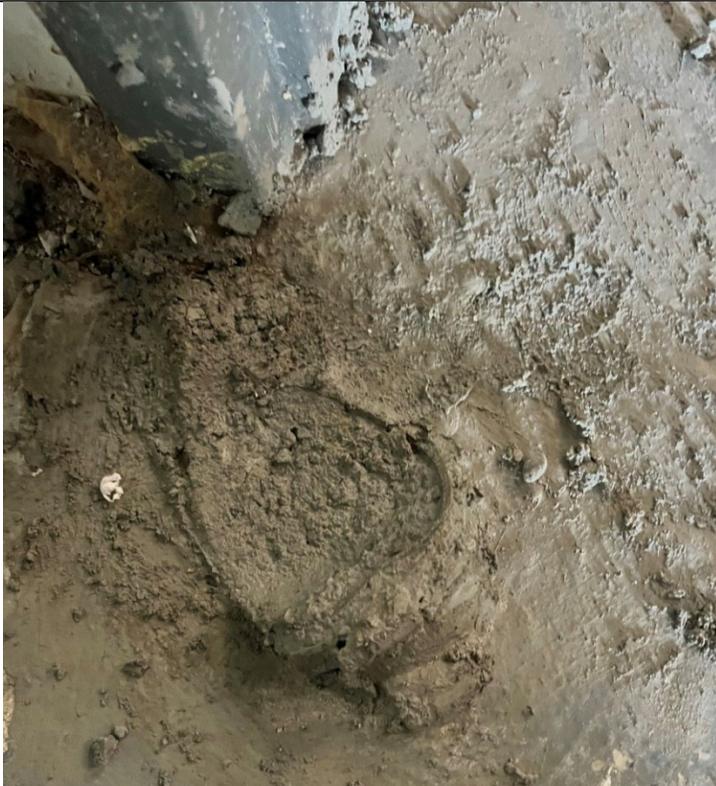
Photo 4. Concrete filling pipe opening shown in upper portion of Photo 3

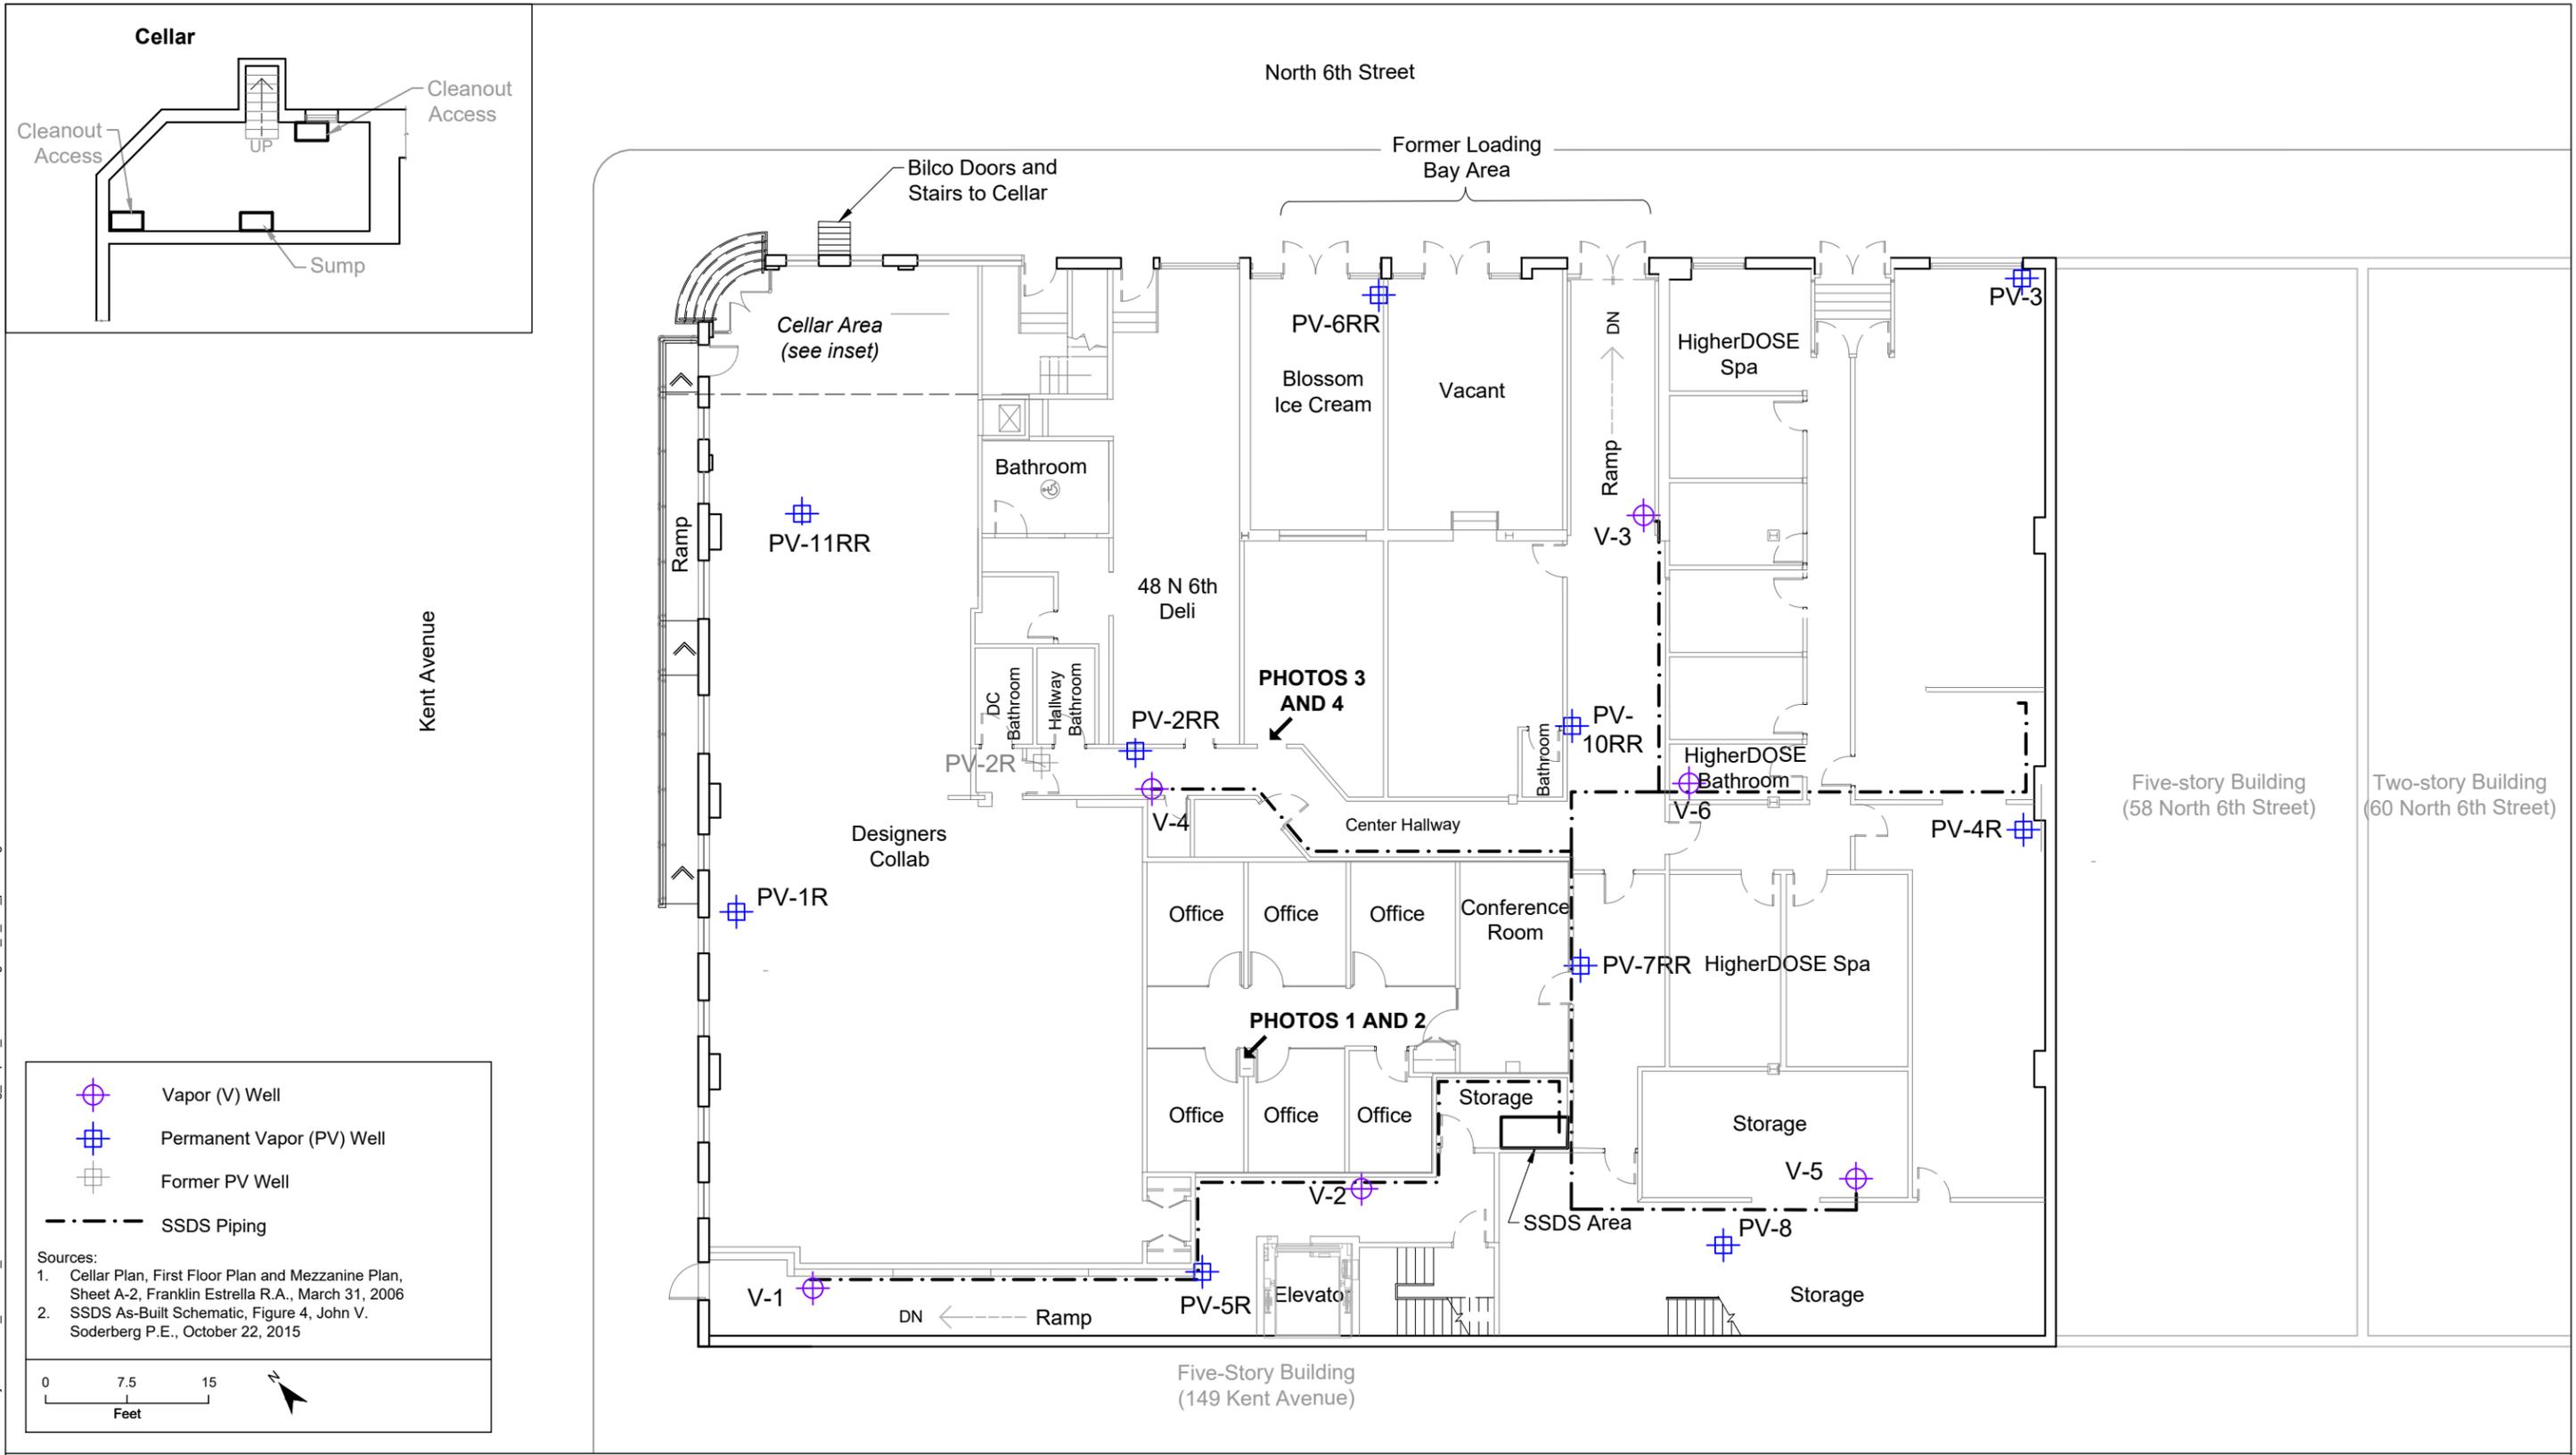
Integral performed SSDS monitoring of accessible VMPs and SSDS suction points on July 22, 2022. Pressure readings were collected from VMPs; airflow velocity readings were collected from SSDS suction points. VMPs and suction points are shown on attached Figure 1. The results of the July 22, 2022 monitoring event for all SSDS suction points and VMPs are presented in Table 1 below.

Figure 1.
 Site Sub-Slab Depressurization System and Monitoring Points
 135 Kent Avenue, Brooklyn, NY
