**Subject: Monthly Progress Report for 135 Kent Ave, Brooklyn, NY**  
**Former Cleaner Sales & Equipment Corp. Site**  
**NYSDEC BCP Site No. C224177**

## **MONTHLY PROGRESS MEMORANDUM**

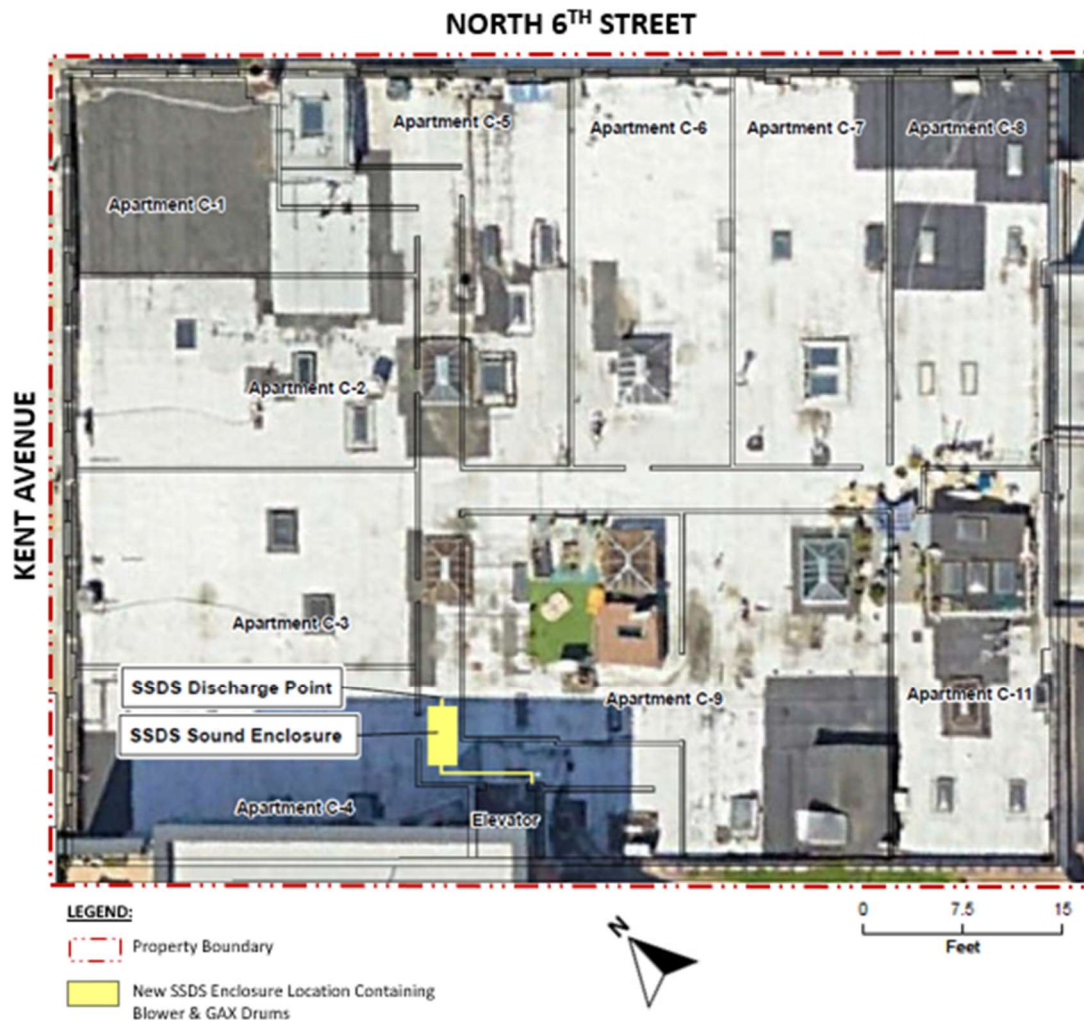
**Figure 2 – Rooftop SSDS Equipment Location**

- b. Inspected the slab integrity across the Site and visually inspected for possible exposure pathways. Several portions of the slab have been patched and repaired since the SSDS pit installation and ramp removal work in March 2025.
- c. Collected pressure and PID readings from the system before and after activated carbon drums. The SSDS equipment compound location is shown in the attached Figure 2.
- d. Inspected all system piping and looked for leaks.
