Subject: Monthly Progress Report for 135 Kent Ave, Brooklyn, NY
Former Cleaner Sales & Equipment Corp. Site
NYSDEC BCP Site No. C224177

MONTHLY PROGRESS MEMORANDUM

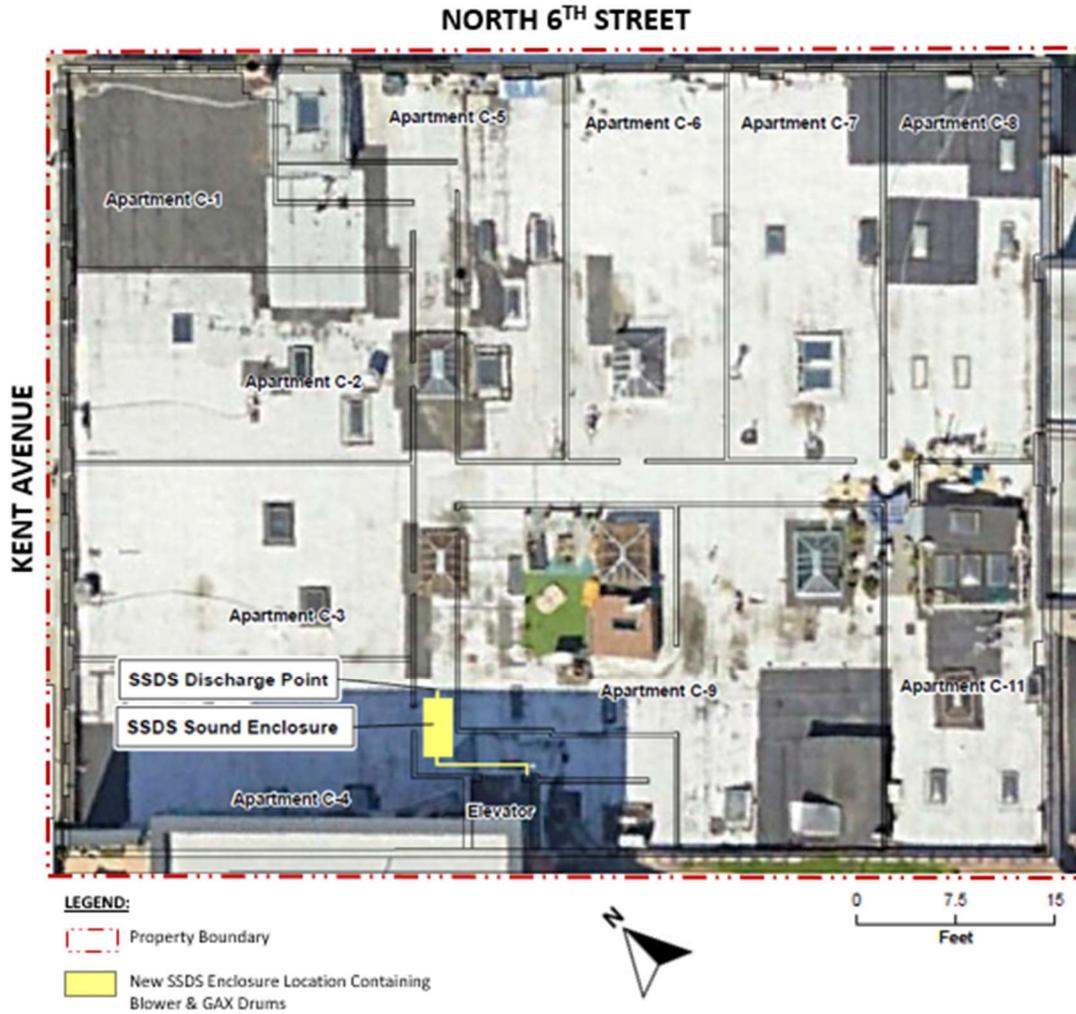
Figure 2 – Rooftop SSDS Equipment Location

The SSDS pit replacement and slab modification/repair work commenced on March 6, 2025, and was completed on March 10, 2025. The equipment compound was relocated to the rooftop on March 14, 2025, and the system was only off for an 8-hour period during the relocation. The residential tenants on the second floor of the building were provided with updated contact information including phone numbers and emails for Rock Enviro and Matrix staff. Rock Enviro conducted weekly monitoring events starting March 21, 2025, and continued through April 11, 2025. Additional monitoring was conducted during the onsite meeting with NYSDEC in attendance on April 24, 2025, and monthly monitoring event has resumed with the monitoring in May 2025.
