**Subject: Monthly Progress Report for 135 Kent Ave, Brooklyn, NY**  
**Former Cleaner Sales & Equipment Corp. Site**  
**NYSDEC BCP Site No. C224177**

## **MONTHLY PROGRESS MEMORANDUM**

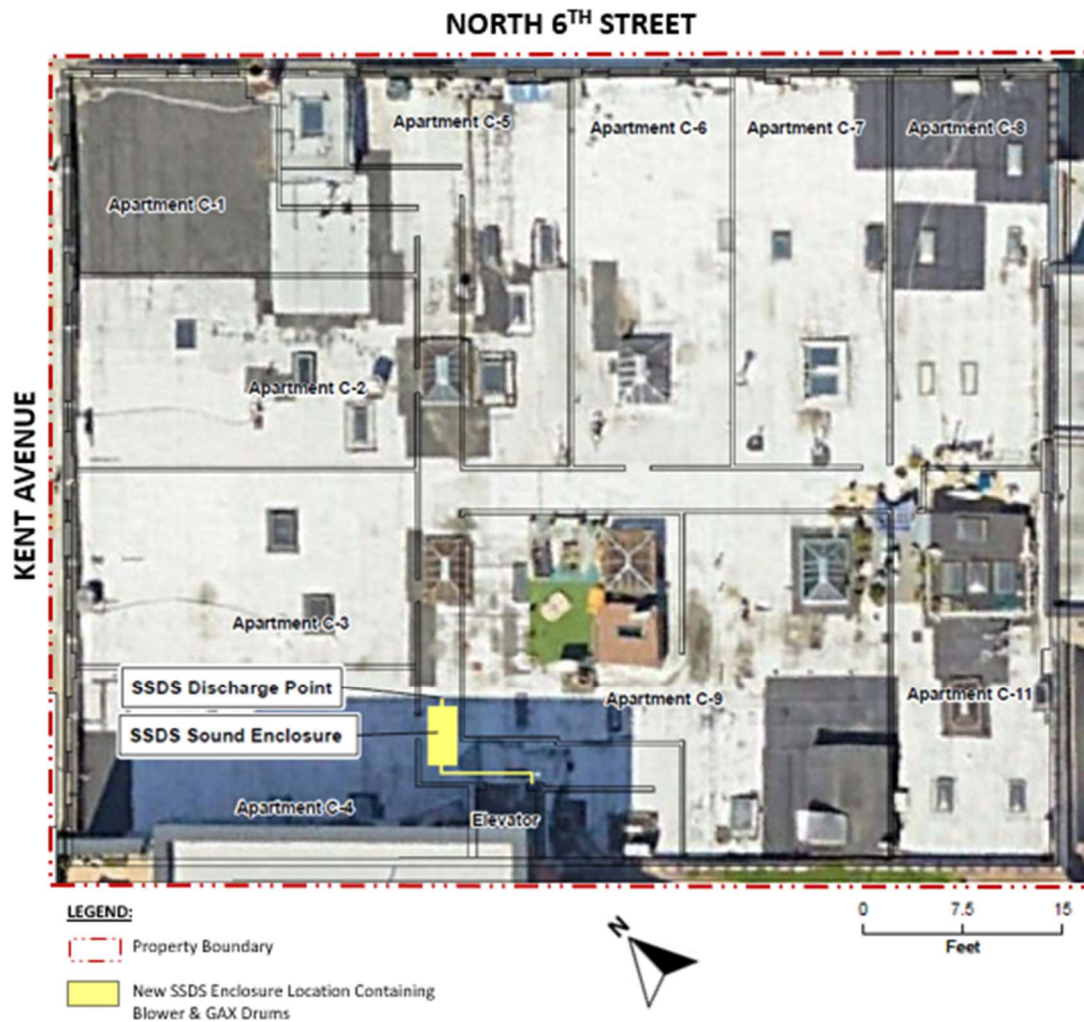
**Figure 2 – Rooftop SSDS Equipment Location**

- b. Inspected the slab integrity across the Site and visually inspected for possible exposure pathways.
  - c. Inspected the SSDS enclosure, blower, carbon drums and system piping. Collected pressure and PID readings from the system before, between, and after activated carbon drums. The SSDS equipment compound location is shown in the attached Figure 2.

The SSDS pit replacement and slab modification/repair work commenced on March 6, 2025, and was completed on March 10, 2025. The equipment compound was relocated to the rooftop on March 14, 2025, and the system was inactive for an 8-hour period during the relocation. The residential tenants on the second floor of the building were provided with updated contact information including phone numbers and emails for Rock Enviro and Matrix staff. Rock Enviro conducted weekly monitoring events starting March 21, 2025, and continued through April 11, 2025. Additional monitoring was conducted during the onsite meeting with NYSDEC in attendance on April 24, 2025, and monthly monitoring resumed with the monitoring between May 2025 and October 2025.
