**Subject: Monthly Progress Report for 135 Kent Ave, Brooklyn, NY**  
**Former Cleaner Sales & Equipment Corp. Site**  
**NYSDEC BCP Site No. C224177**

## **MONTHLY PROGRESS MEMORANDUM**

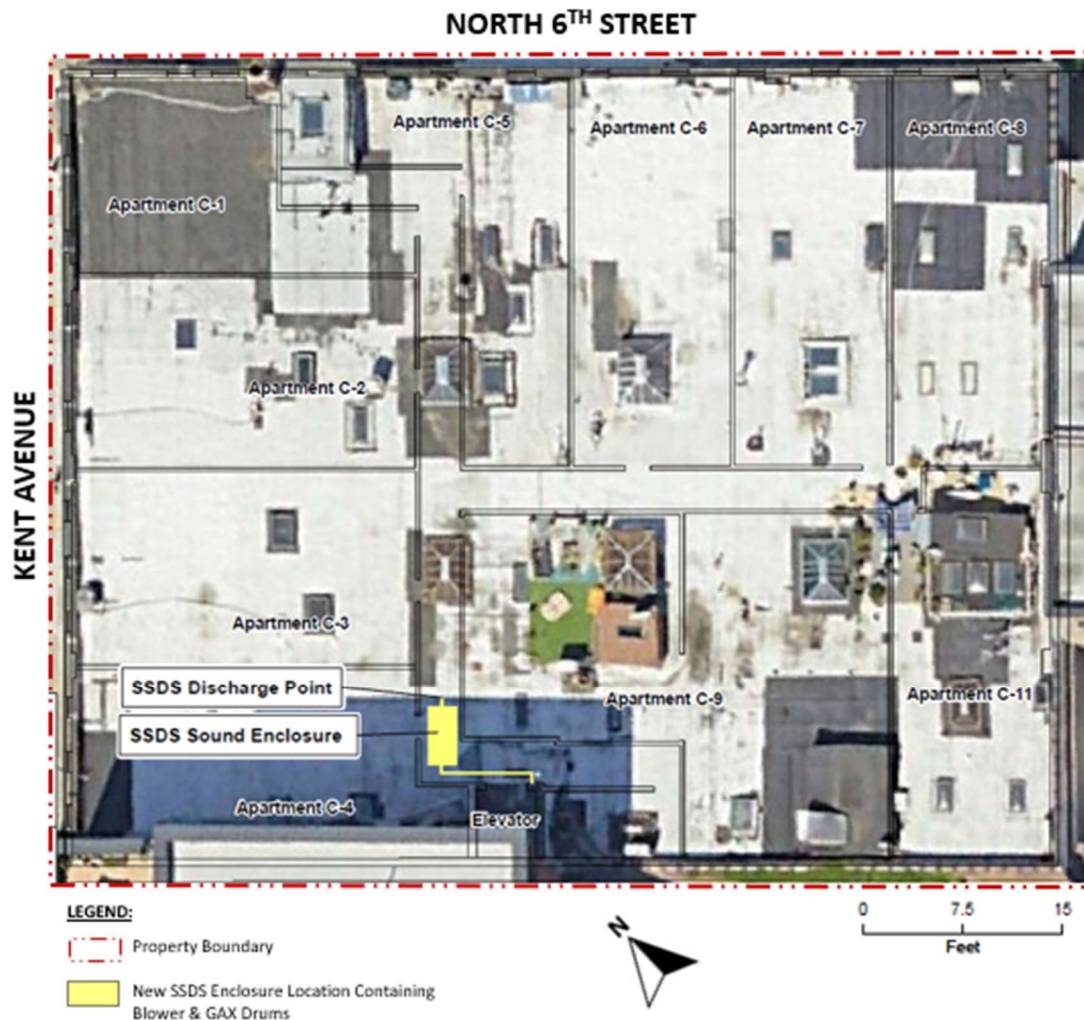
**Figure 2 – Rooftop SSDS Equipment Location**

- b. Inspected the slab integrity across the Site and visually inspected for possible exposure pathways.
  - c. Inspected the SSDS enclosure, blower, carbon drums and system piping. Collected pressure and PID readings from the system before, between, and after activated carbon drums. The SSDS equipment compound location is shown in the attached Figure 2.
