Subject: Monthly Progress Report for 135 Kent Ave, Brooklyn, NY
Former Cleaner Sales & Equipment Corp. Site
NYSDEC BCP Site No. C224177

MONTHLY PROGRESS MEMORANDUM

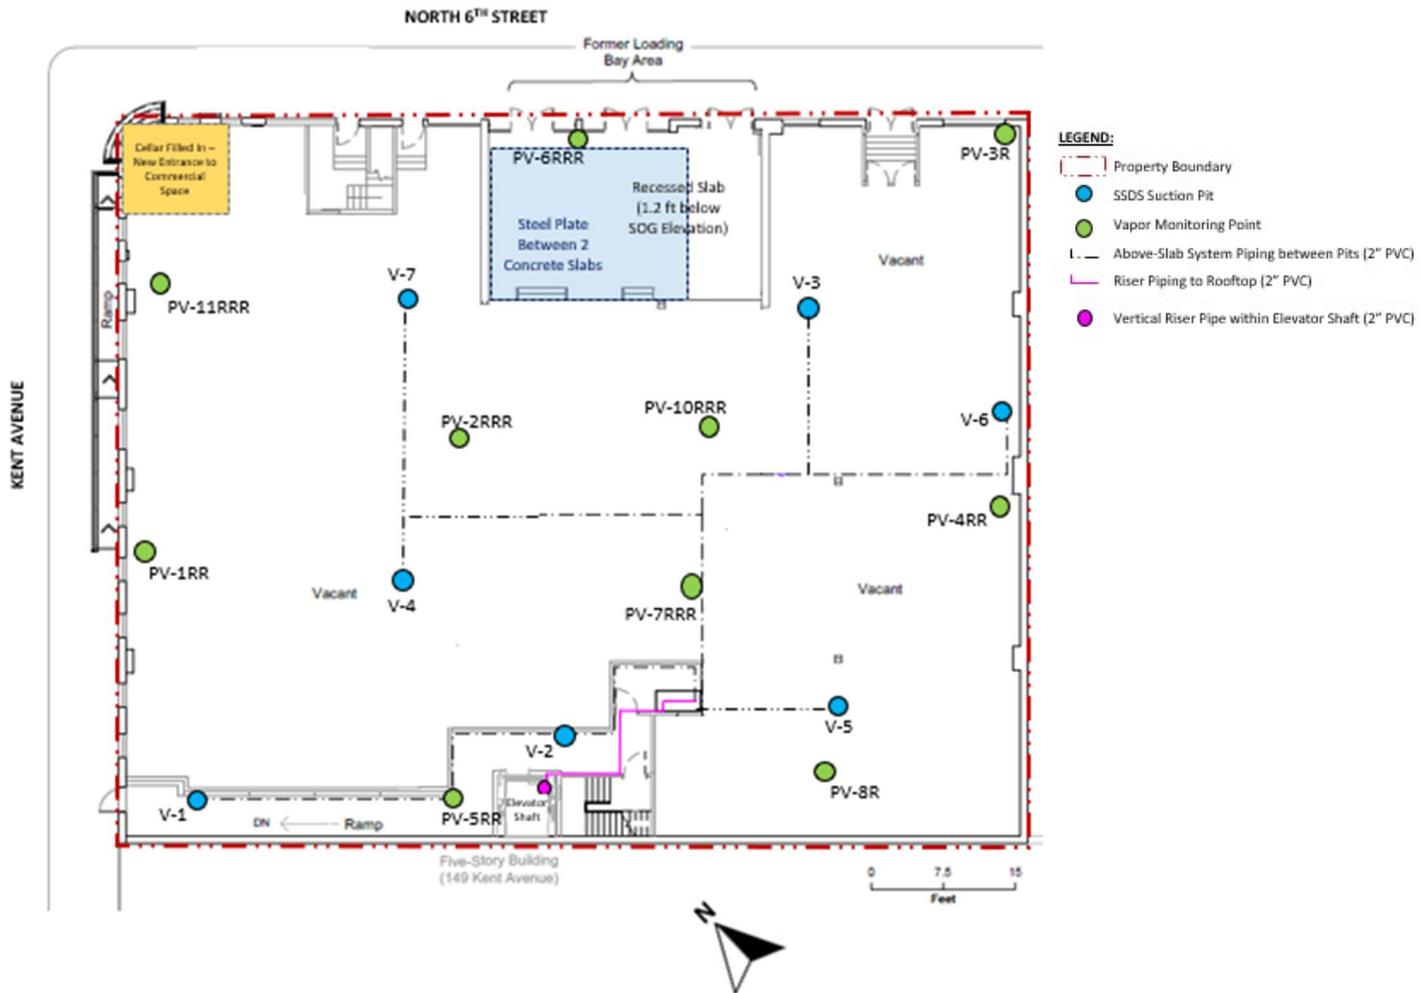
Figure 1 – First Floor SSDS Layout

1. Rock Enviro conducted a monthly site inspection on January 30, 2026. The following was conducted as part of this inspection:
 - a. Collected sub-slab differential pressure measurements at vapor monitoring points (VMPs) and airflow/velocity readings within riser pipes directly above suction pits across the slab-on-grade area. SSDS suction pits and vapor monitoring points are shown in the attached Figure 1.

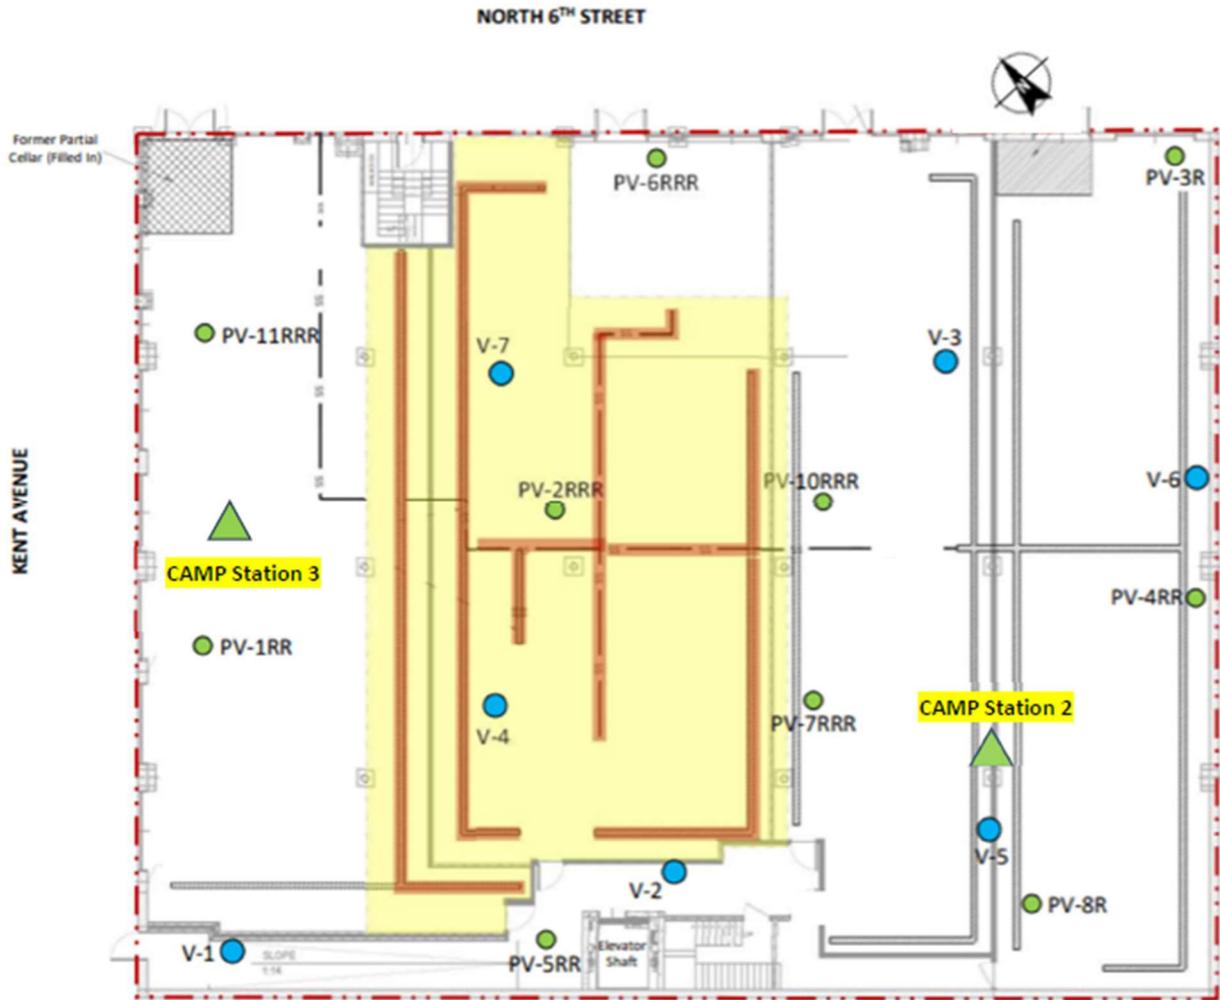
Figure 2 – Proposed Trenching Plan

- Rock Enviro submitted a Notification of Intent to Commence Approved Trenching Work to NYSDEC, dated January 7, 2026. The proposed work will consist of trenching across the vacant commercial space located on the ground floor of the building. The trenches will be cut into the ground-floor slab for the installation of wastewater lines. Section 2.3.2 of the NYSDEC-approved Engineering Control Modifications Work Plan (ECMWP), dated August 6, 2024, details the proposed trenching for wastewater lines, and Section 2.3.3 details slab removal and excavation procedures associated with trenching work. The preparation work for the trenching began on January 27, 2026, and consisted of the construction of enclosures and receiving a delivery of 100 55-gallon drums. The enclosures were near completion by the end of the day on January 28, 2026; however, because there were some discussions about possibly changing the layout of water/wastewater lines, the work was postponed. The trenching work will not resume until the plans have been finalized. Once the design is finalized the trenching work will be rescheduled. This is not anticipated until at least March/April.

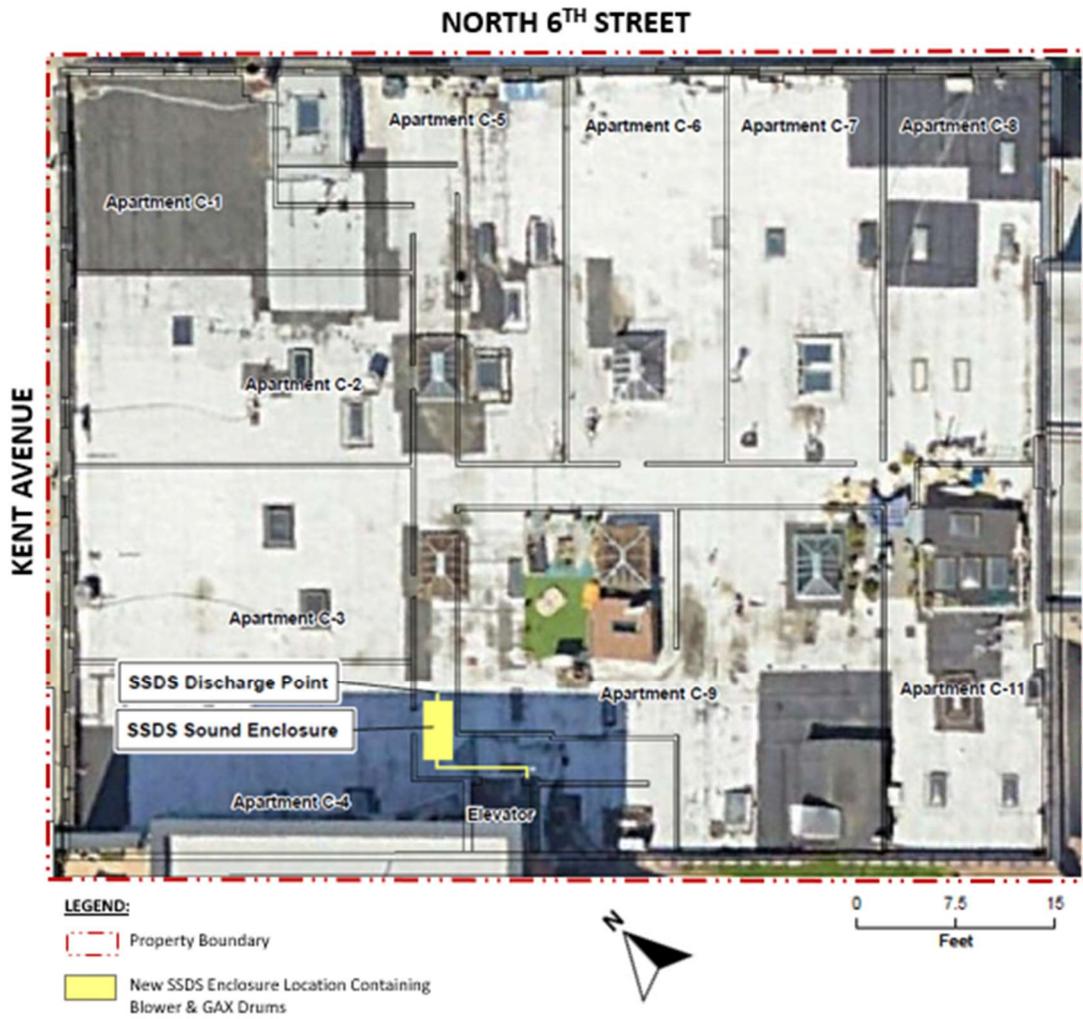
Figure 3 – Rooftop SSDS Equipment Location

- b. Inspected the slab integrity across the Site and visually inspected for possible exposure pathways.
 - c. Inspected the SSDS enclosure, blower, carbon drums and system piping. Collected pressure and PID readings from the system before, between, and after activated carbon drums. The SSDS equipment compound location is shown in the attached Figure 2.
