Subject: Monthly Progress Report for 135 Kent Ave, Brooklyn, NY
Former Cleaner Sales & Equipment Corp. Site
NYSDEC BCP Site No. C224177

MONTHLY PROGRESS MEMORANDUM

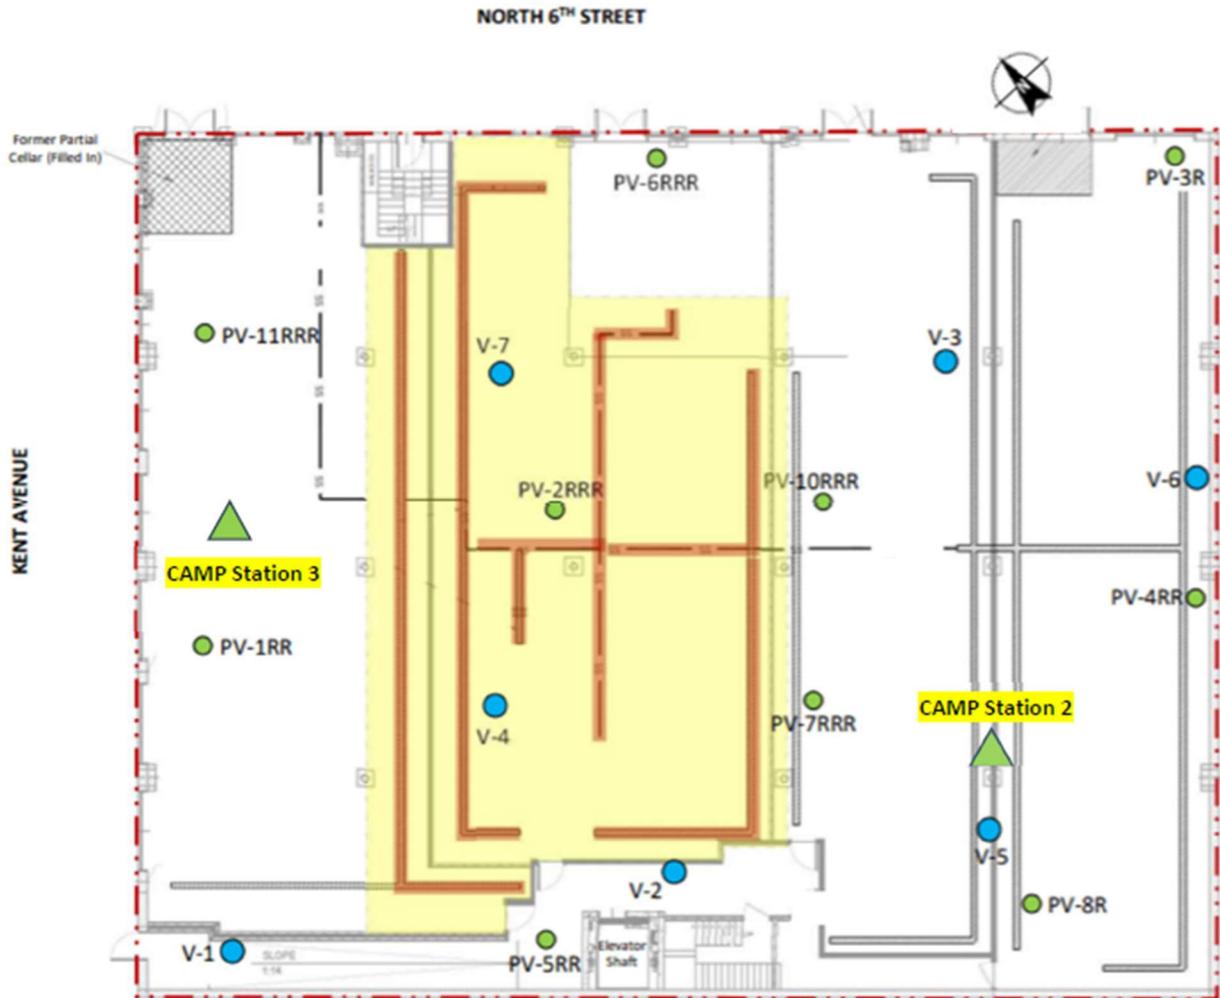
Figure 2 – Proposed Trenching Plan

Between January 27, 2026, and January 28, 2026, Rock Enviro oversaw the preparation work needed in advance of proposed trenching and slab work across a portion of the ground floor's slab-on-grade foundation. The trenching/slab work was needed to reroute and install water and wastewater lines across a new tenant space. These plans were designed so that sinks, toilets and drains would be located in portions of the building where bathrooms, kitchens and floor drains would be located. The proposed trenching work area/tenant space), covers an estimated 2,900 SF area. The work area spans from the northern portion of the building facing S. 6th Street to the hallway used for a residential access on the south side of the building. The proposed work area is 16-feet to 33-foot-wide, and is approximately 19 feet to the east of the western property boundary and 42 feet to the west of the eastern property boundary (see the attached **Figure 2** showing the proposed work area).

A third CAMP station was present on the second floor during preparation work for trenching/slab work on 1/27 & 1/28/2026. The three CAMP stations will be placed in similar locations and operated when trenching/slab work continues.

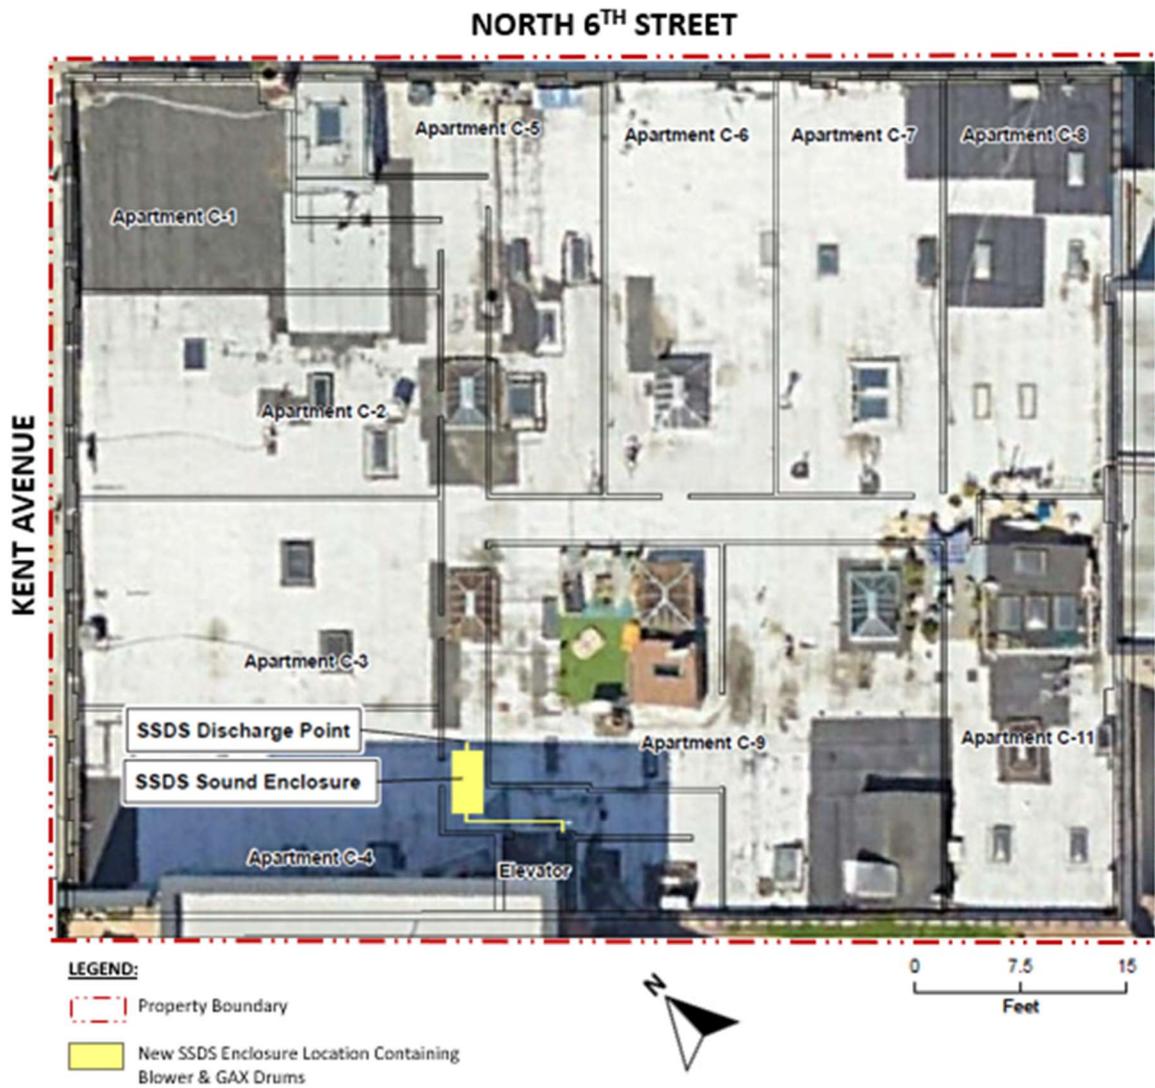
Figure 3 – Rooftop SSDS Equipment Location

1. Rock Enviro conducted a monthly site inspection on February 27, 2026. The following was conducted as part of this inspection:
 - a. Collected sub-slab differential pressure measurements at vapor monitoring points (VMPs) and airflow/velocity readings within riser pipes directly above suction pits across the slab-on-grade area. SSDS suction pits and vapor monitoring points are shown in the attached **Figure 1**.
 - b. Inspected the slab integrity across the Site and visually inspected for possible exposure pathways.
 - c. Inspected the SSDS enclosure, blower, carbon drums and system piping. Collected pressure and PID readings from the system before, between, and after activated carbon drums. The SSDS equipment compound location is shown in the attached **Figure 3**.
 - d. Inspected all system piping and looked for leaks.
