**Subject: Monthly Progress Report for 135 Kent Ave, Brooklyn, NY**  
**Former Cleaner Sales & Equipment Corp. Site**  
**NYSDEC BCP Site No. C224177**

## **MONTHLY PROGRESS MEMORANDUM**

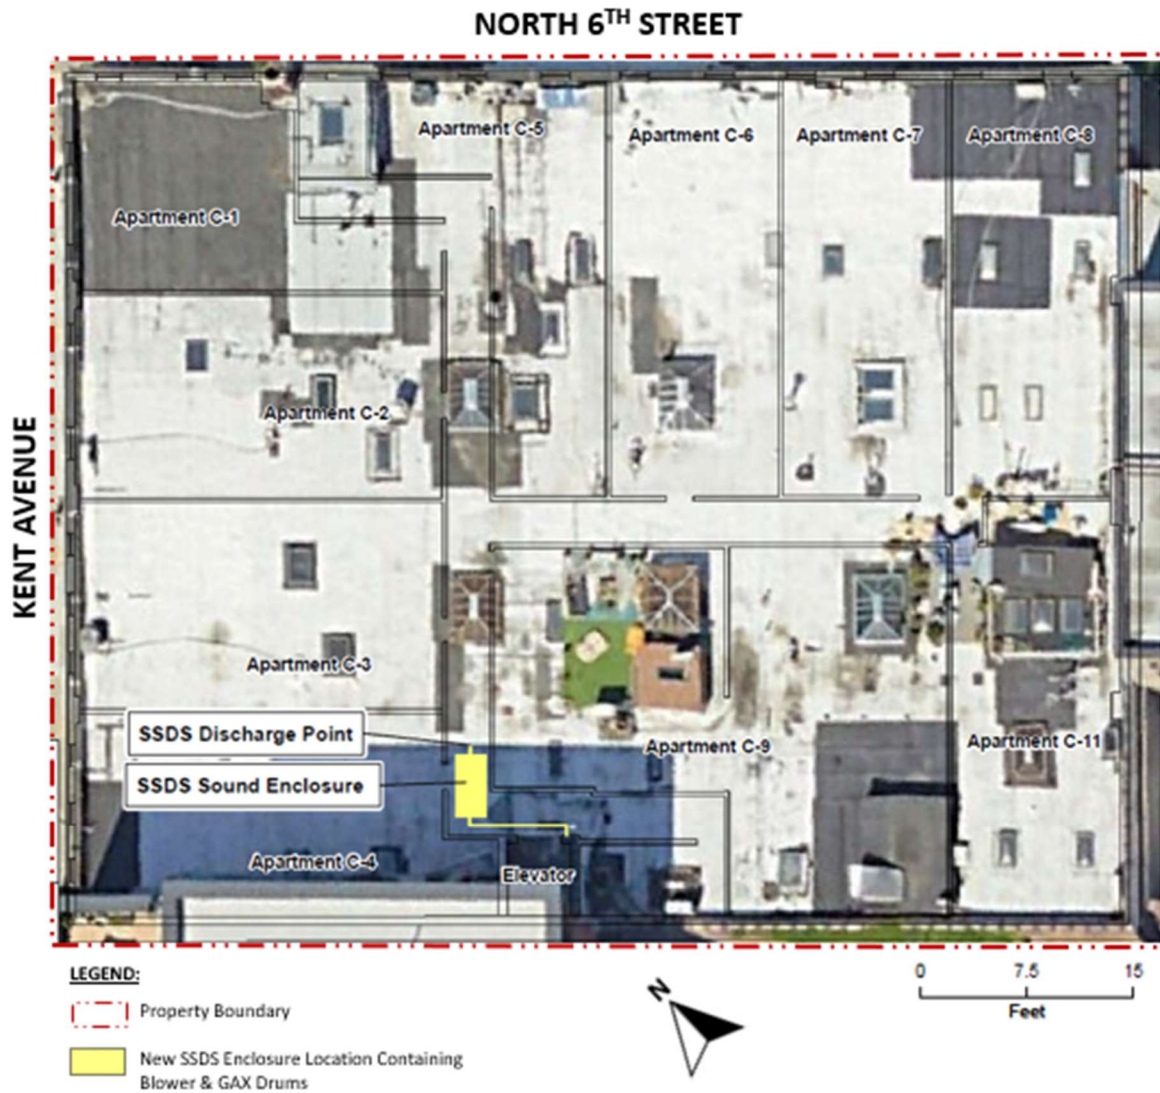
**Figure 2 – Rooftop SSDS Equipment Location**

1. Arsdale conducted a monthly site inspection on June 30, 2026. The following was conducted as part of this inspection:
  - a. Collected sub-slab differential pressure measurements at vapor monitoring points (VMPs) and airflow/velocity readings within riser pipes directly above suction pits across the slab-on-grade area. SSDS suction pits and vapor monitoring points are shown in the attached **Figure 1**.
  - b. Inspected the slab integrity across the Site and visually inspected for possible exposure pathways.
  - c. Inspected the SSDS enclosure, blower, carbon drums and system piping. Collected pressure and PID readings from the system before, between, and after activated carbon drums. The SSDS equipment compound location is shown in the attached **Figure 2**.
  - d. Inspected all system piping and looked for leaks.
